Inspection Photos

API: 009-05317

Operator: DOVER ATWOOD CORPORATION

Inspection Date: 2/12/2026

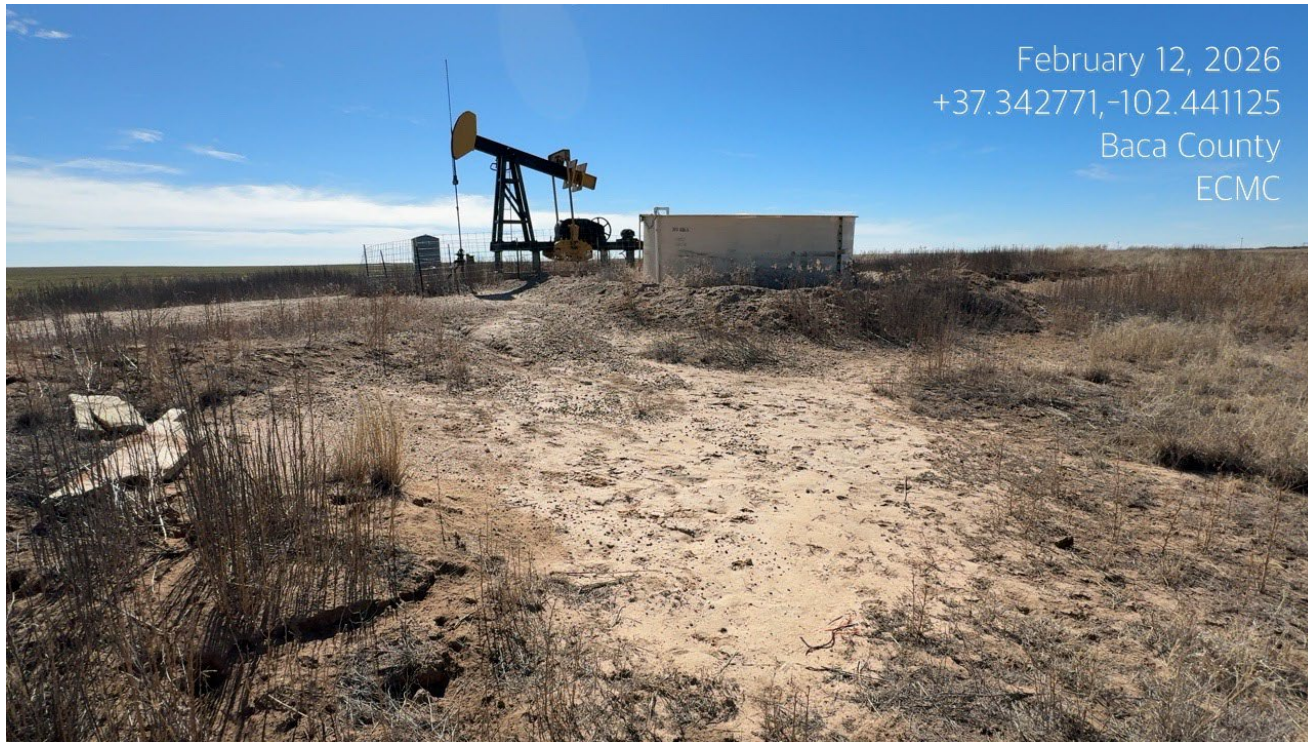
Photo 1. Facing south toward the wellsite location. No production shown since 11/2023.

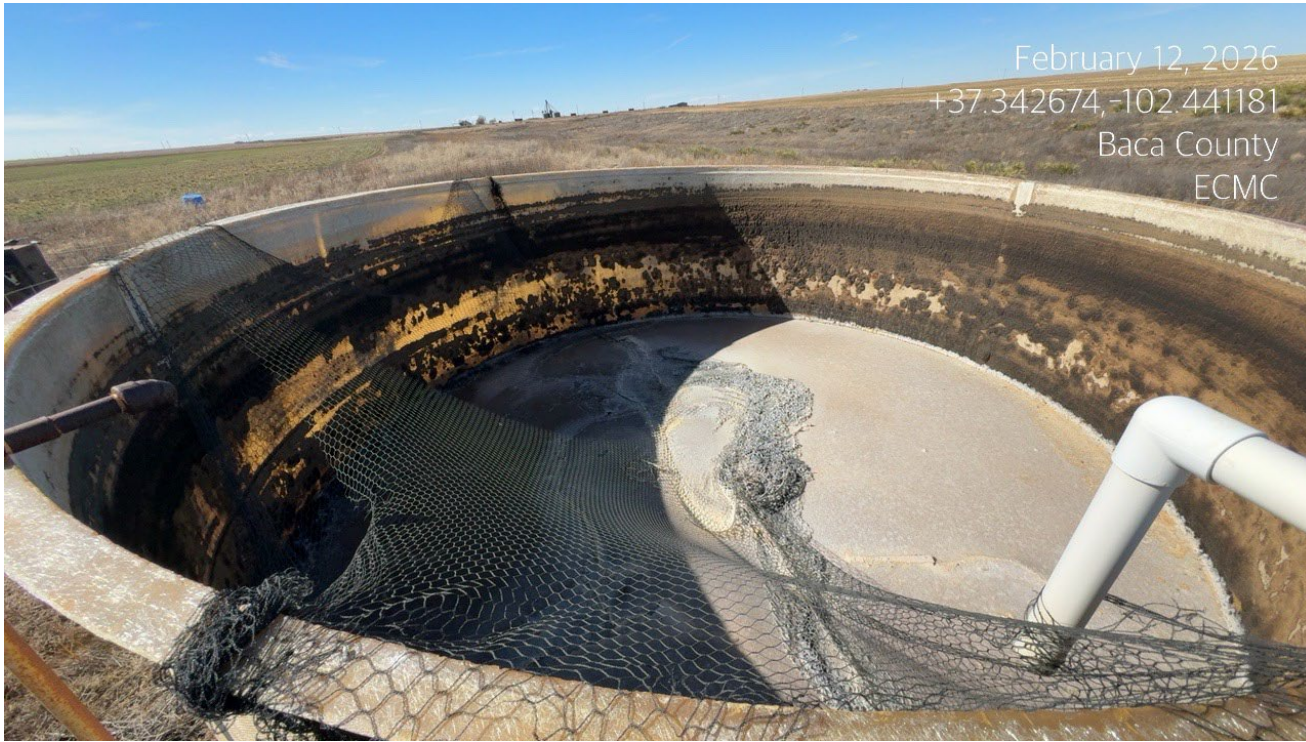
Photo 2. The netting on the open top tank is in disrepair.

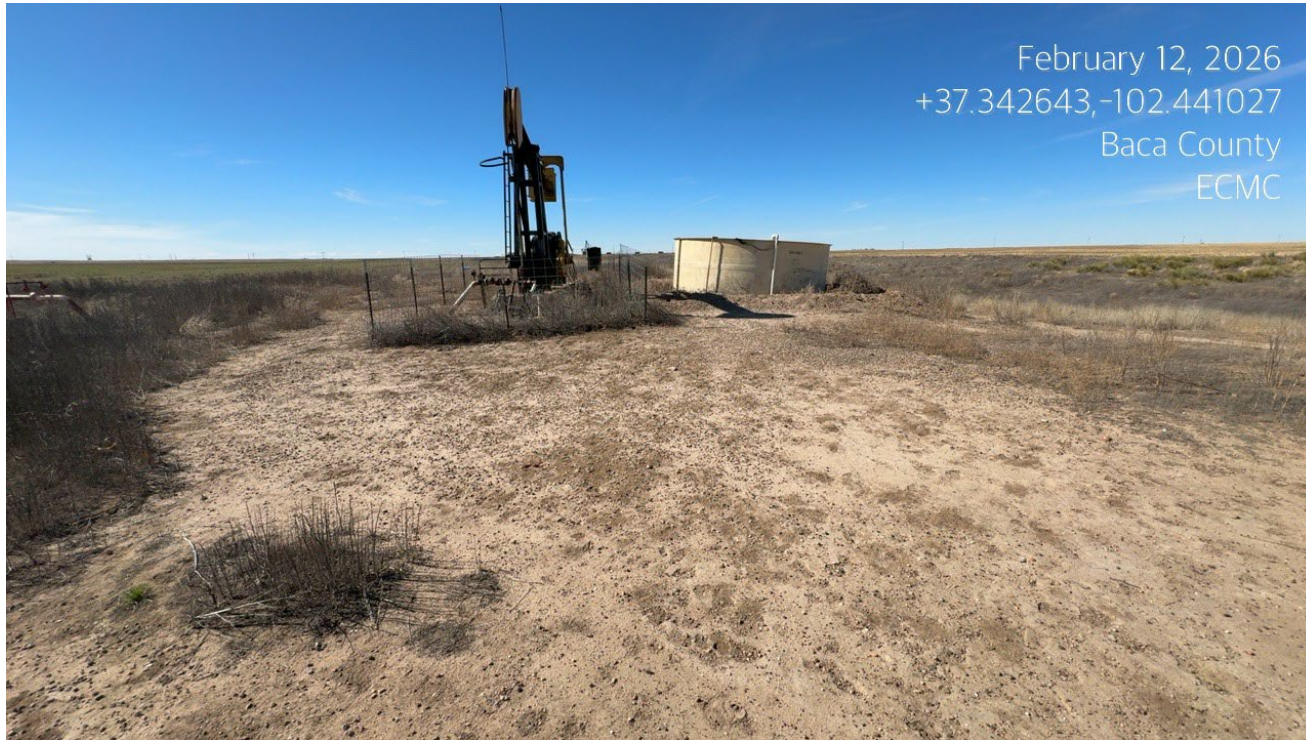
Photo 3. Facing west at the location. Areas around the location have no vegetation.

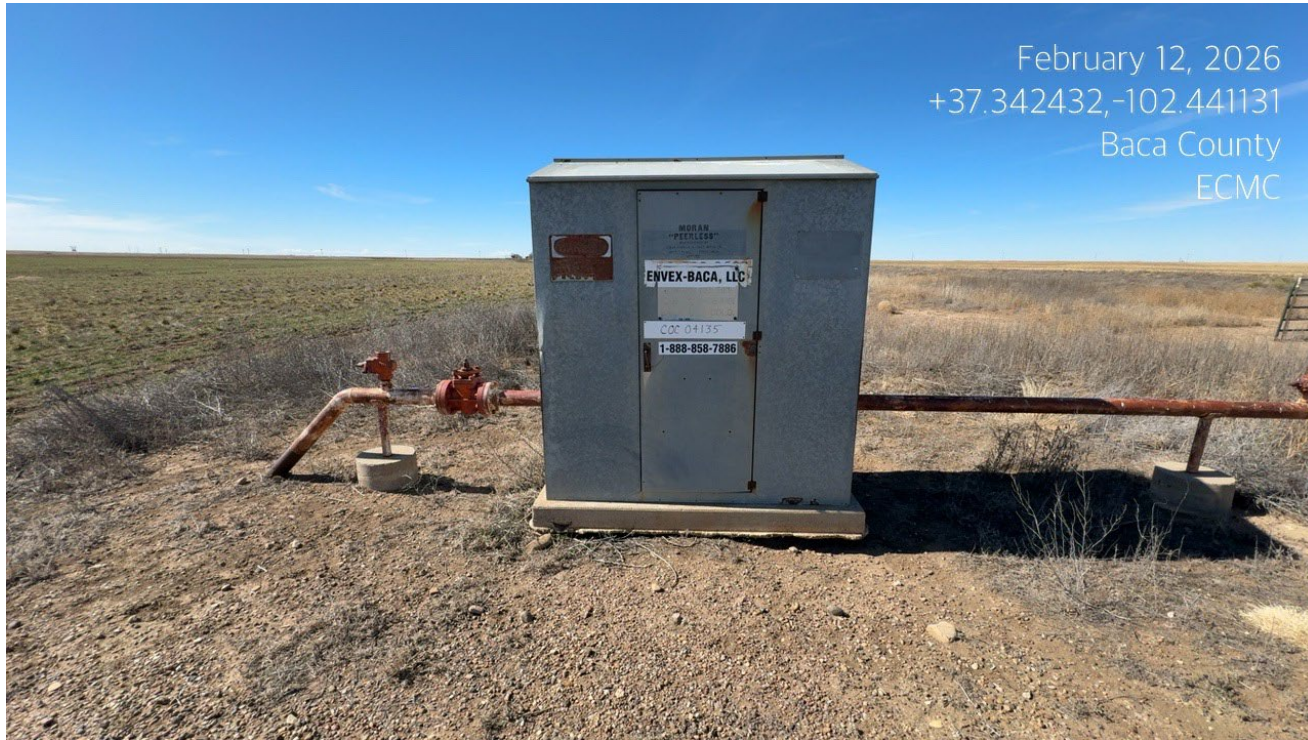
Photo 5. Sign post at the meter shed does not contain the required signage information.
