TEP ROCKY MOUNTAIN LLC Clough RWF 22-14 Location # 335853

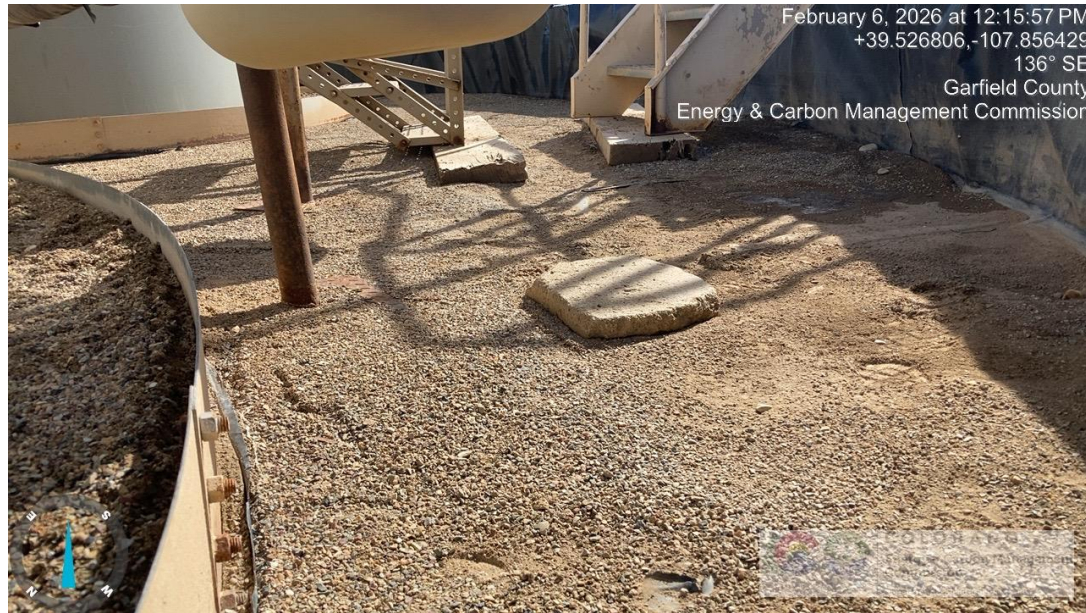
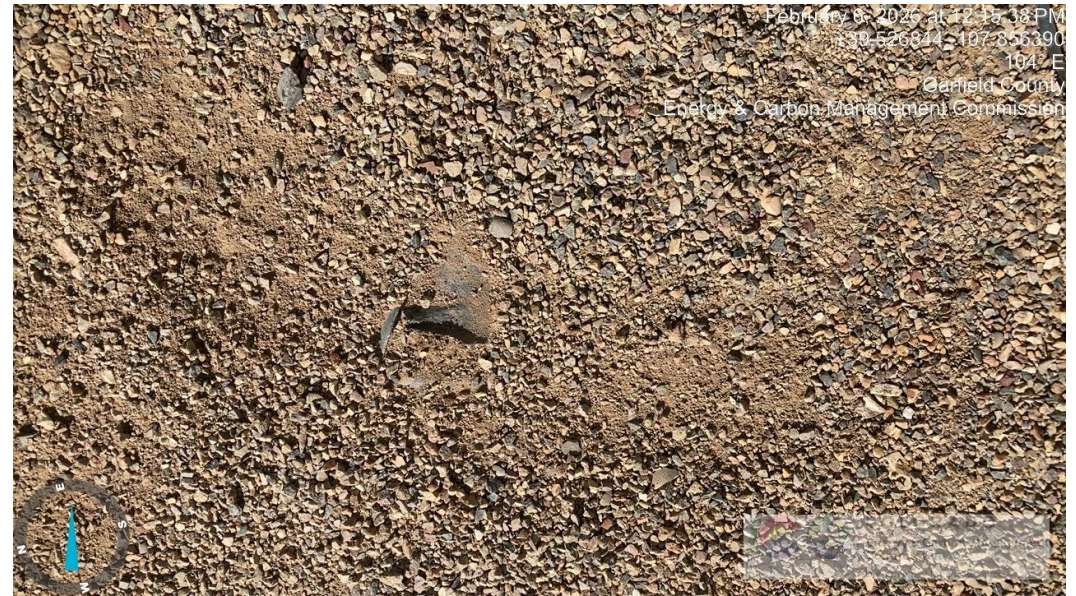
Damage to tank battery liner.

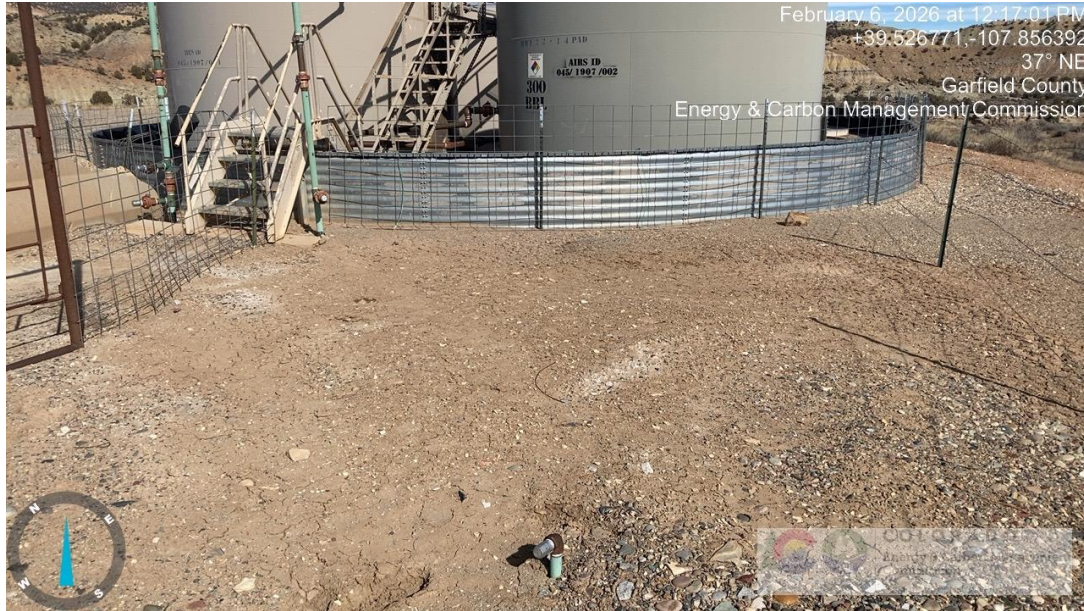
1" unused riser missing OOSLAT tag

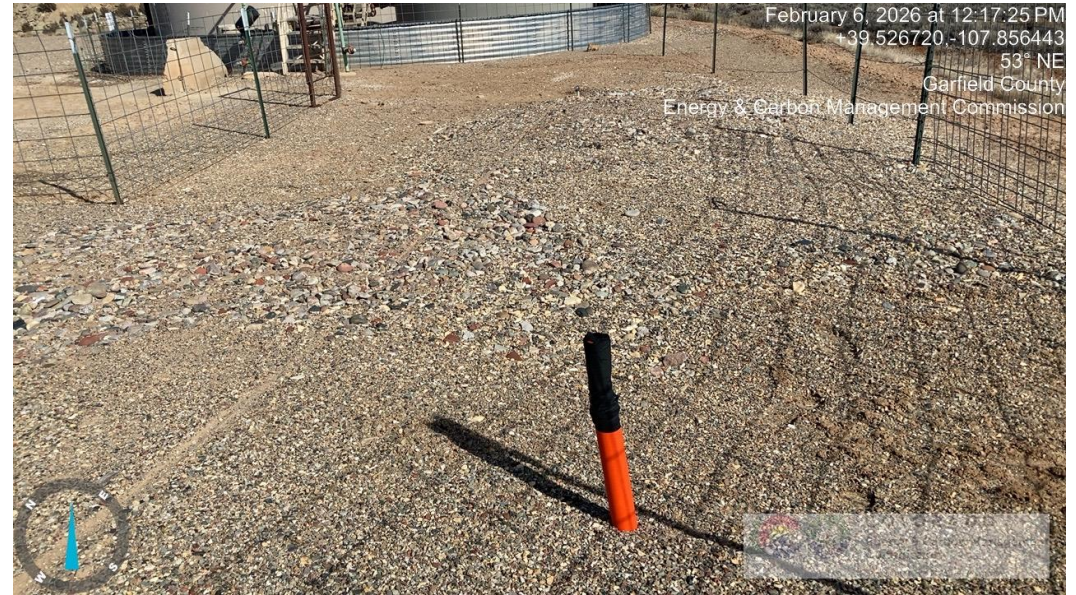
2" unused poly pipe no OOSLAT

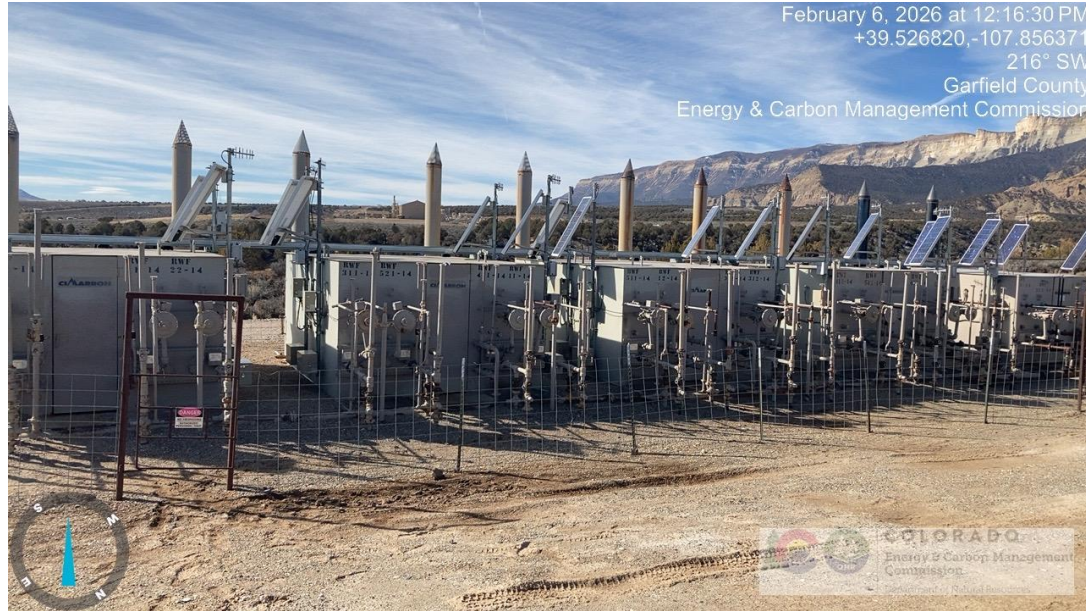
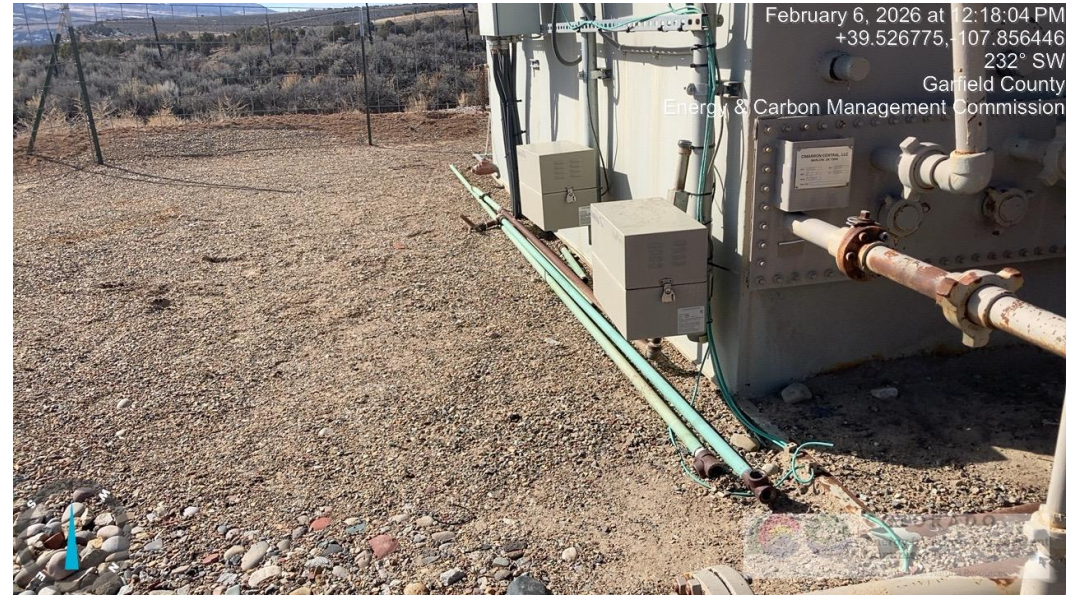
Unused equipment next to separator.
