**GP-25 CO<sub>2</sub> Well Location Photos**  
**API 05-083-06685**  
**Location ID 419721**  
**FIRR #404546038**

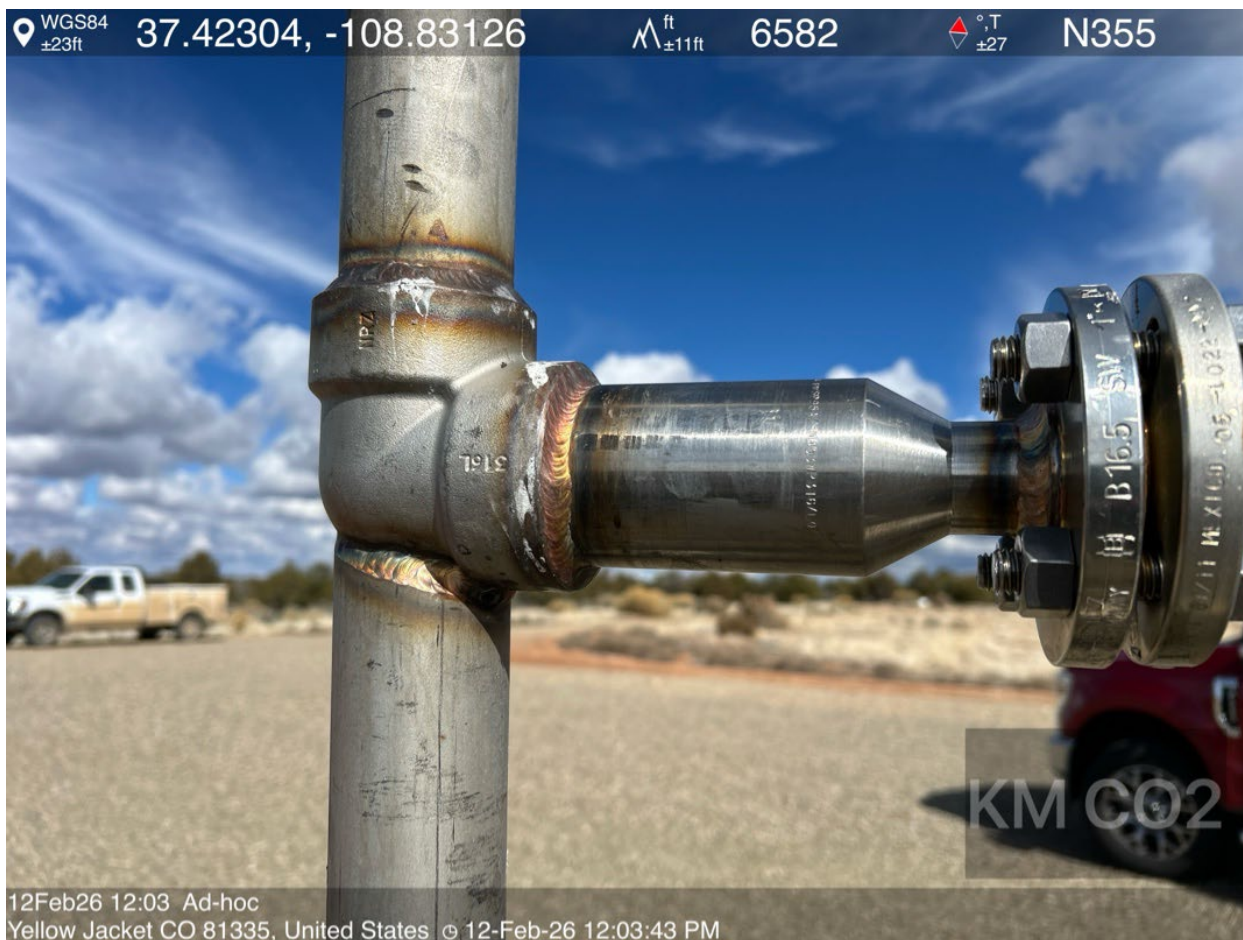
**Photo #2.** Close up view of the GP-25 flowline relief valve piping, where water was observed leaking. The drip leak on the relief valve piping was terminated.

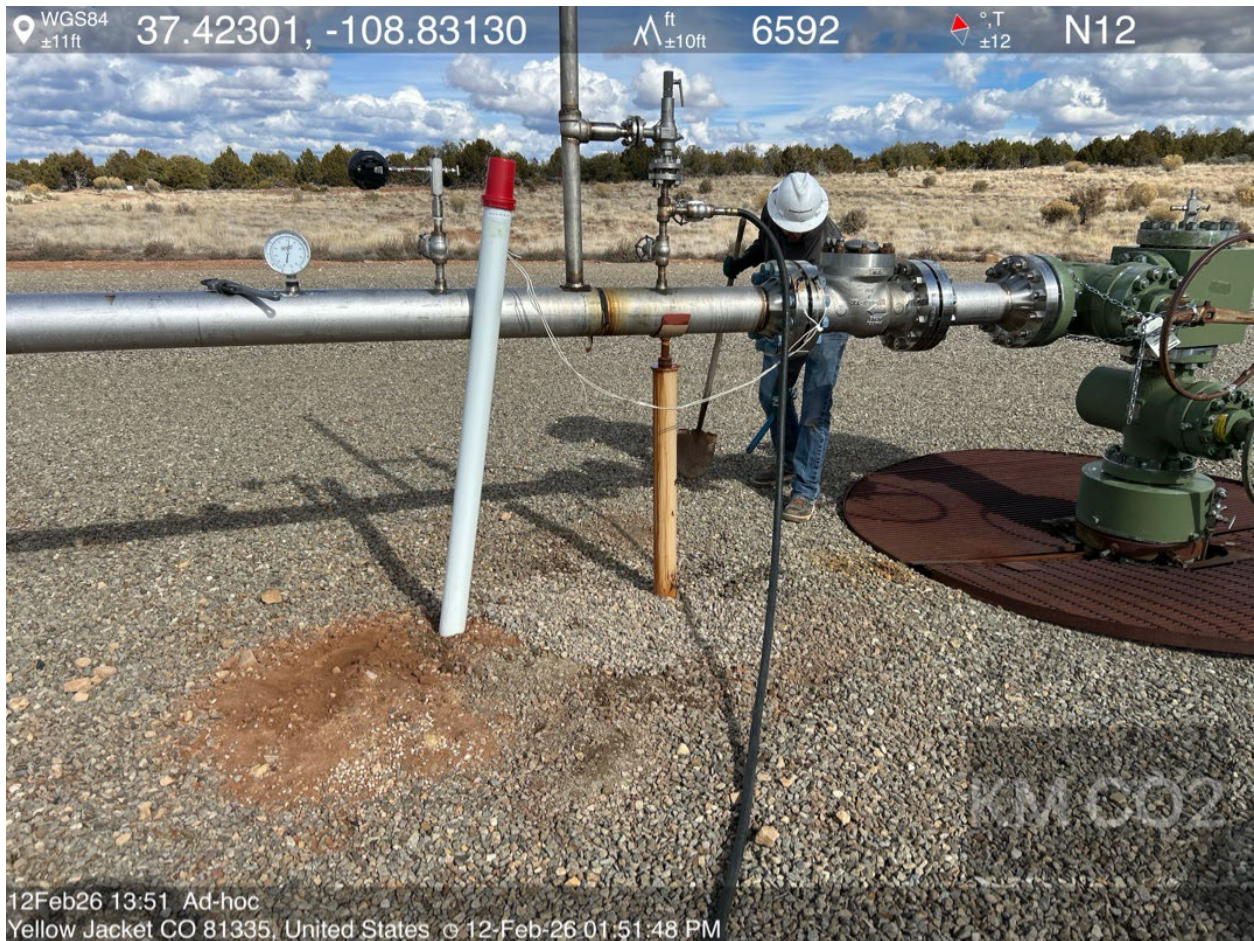
**Photo #3.** View of the GP-25 flowline and relief valve piping, with impacted soils removed.

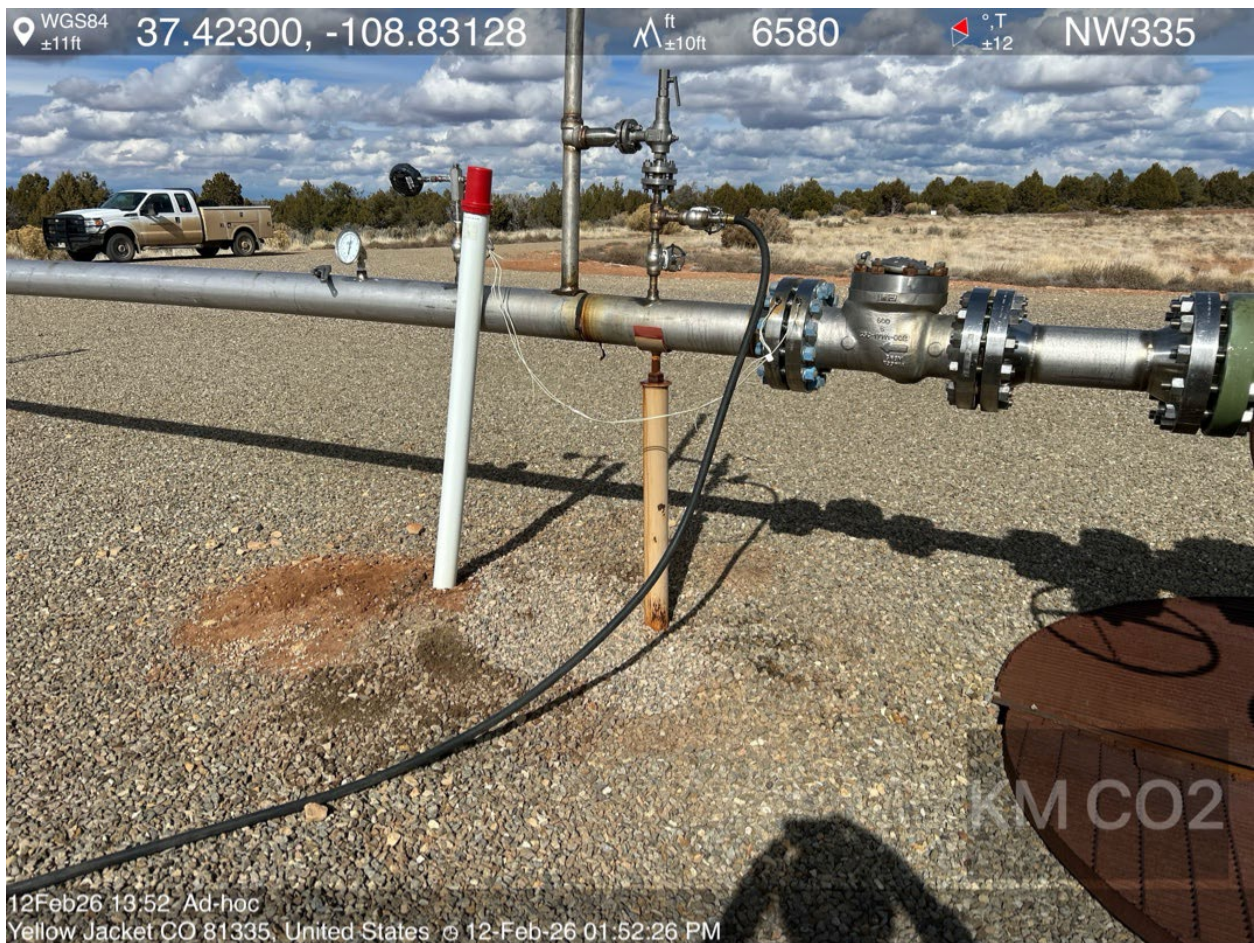
**Photo #4.** View of the GP-25 flowline and relief valve piping, with impacted soils removed.
