Inspection Photos

Kinder Morgan YB-4

API # 05-083-06587

Inspector Name: James Blair. Inspection Date: 02/02/2026

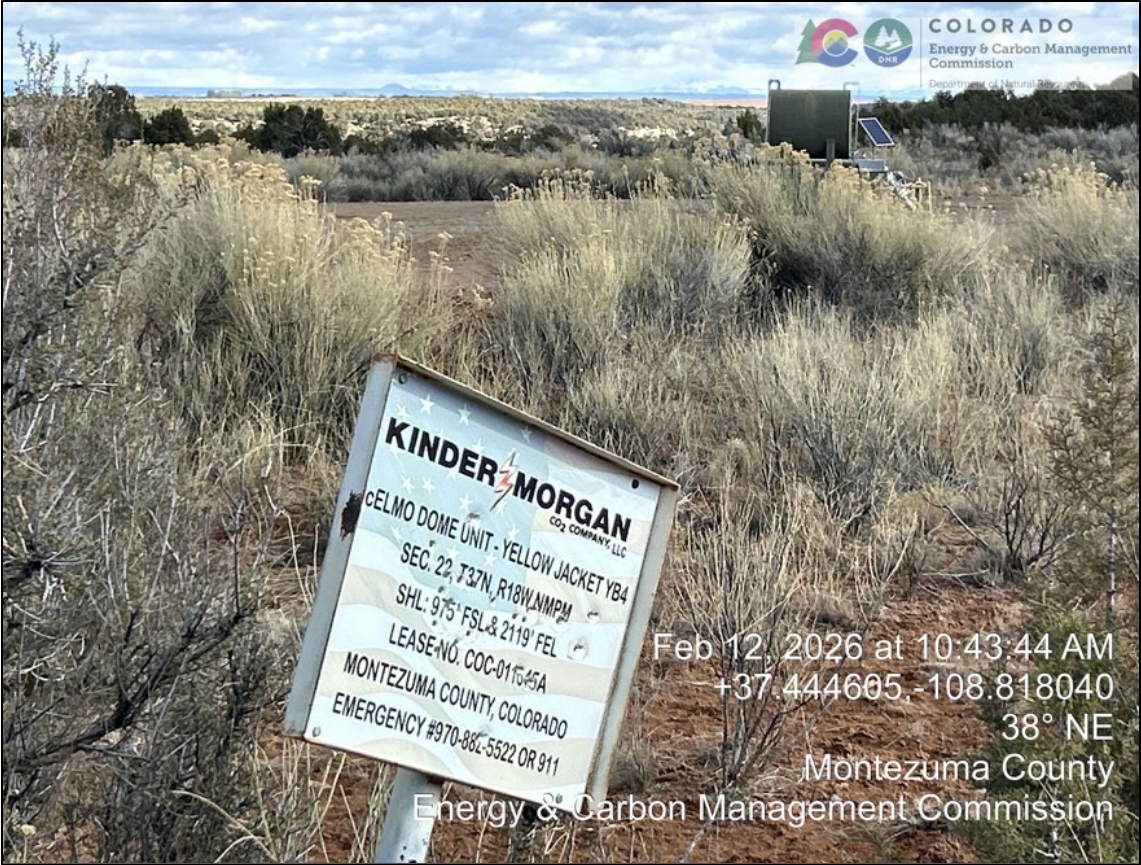
1. Well sign with well in background.

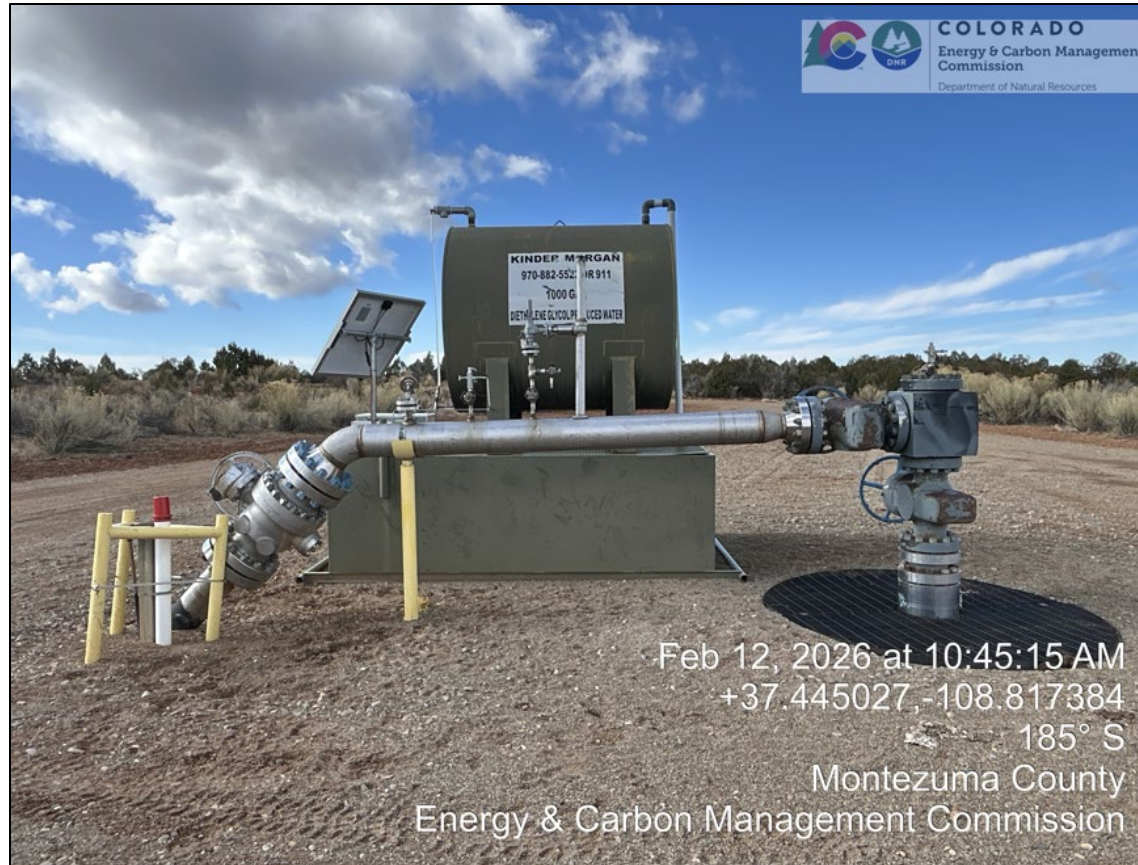
2. Wellhead, well cellar, 1000 gallon diethylene glycol/produced water tank over secondary containment, 6" flowline with valve, annular vent behind barricaded, and solar pump. Contact information present.

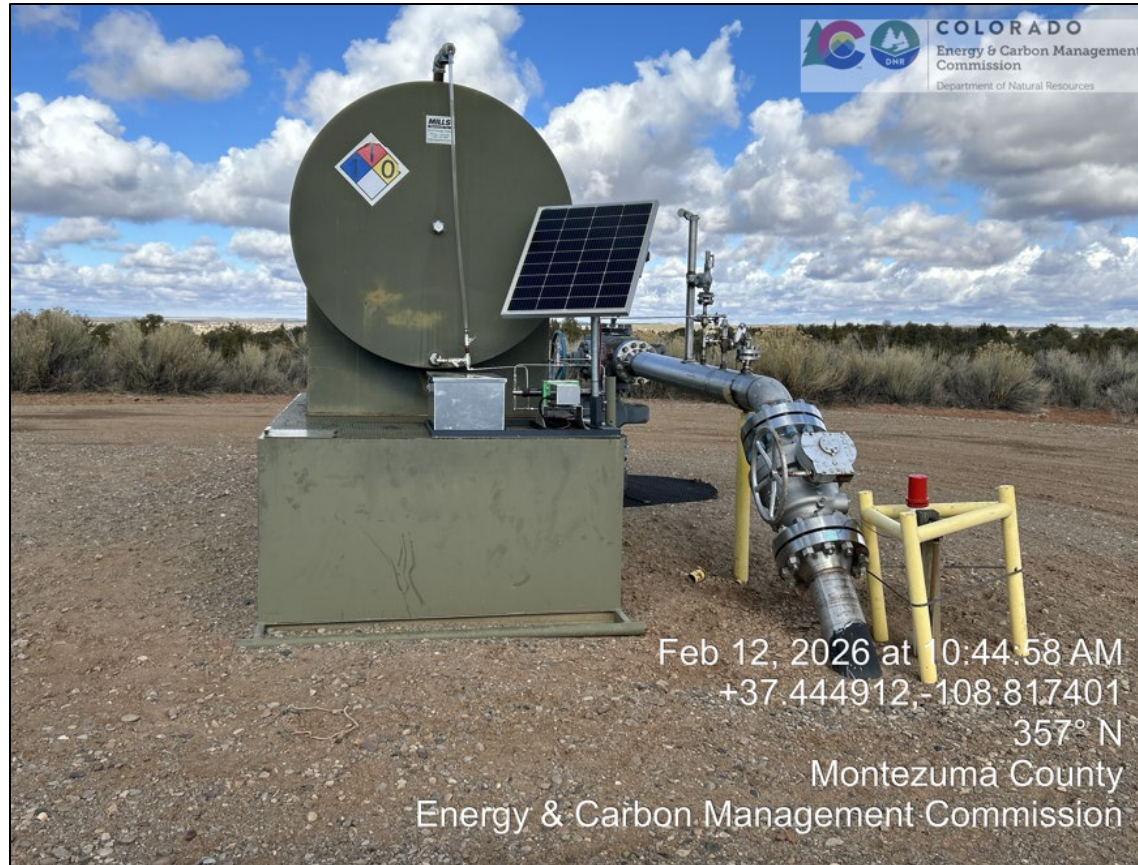
3. Tank and flow line. Hazcom placard visible.

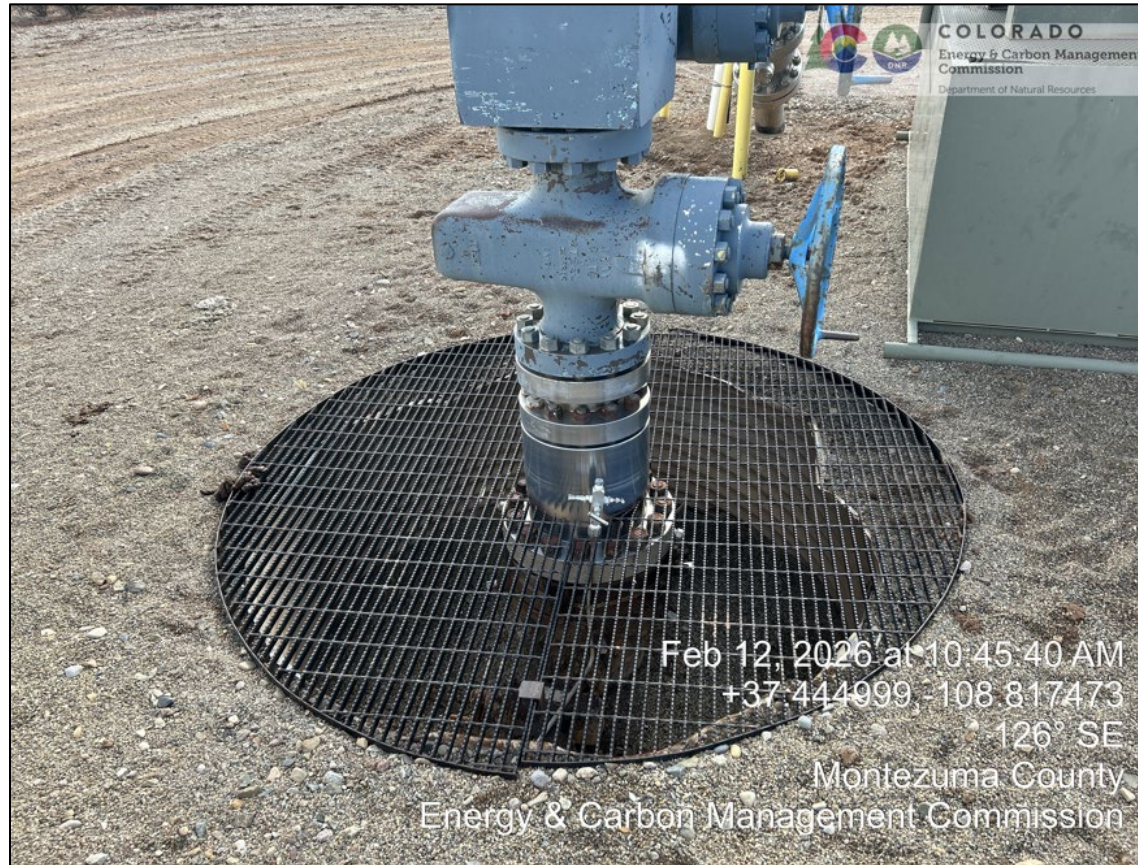
4. Well cellar, wellhead and bradenhead.

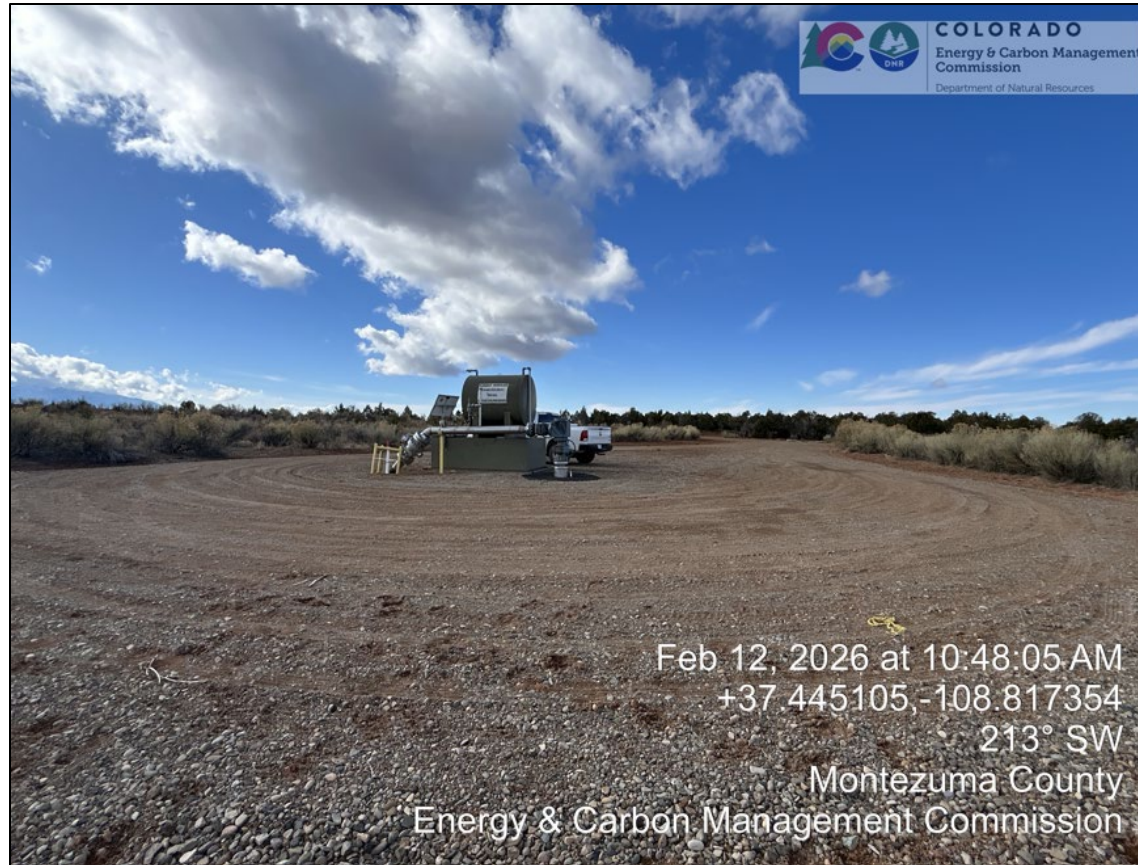
5. Well pad.

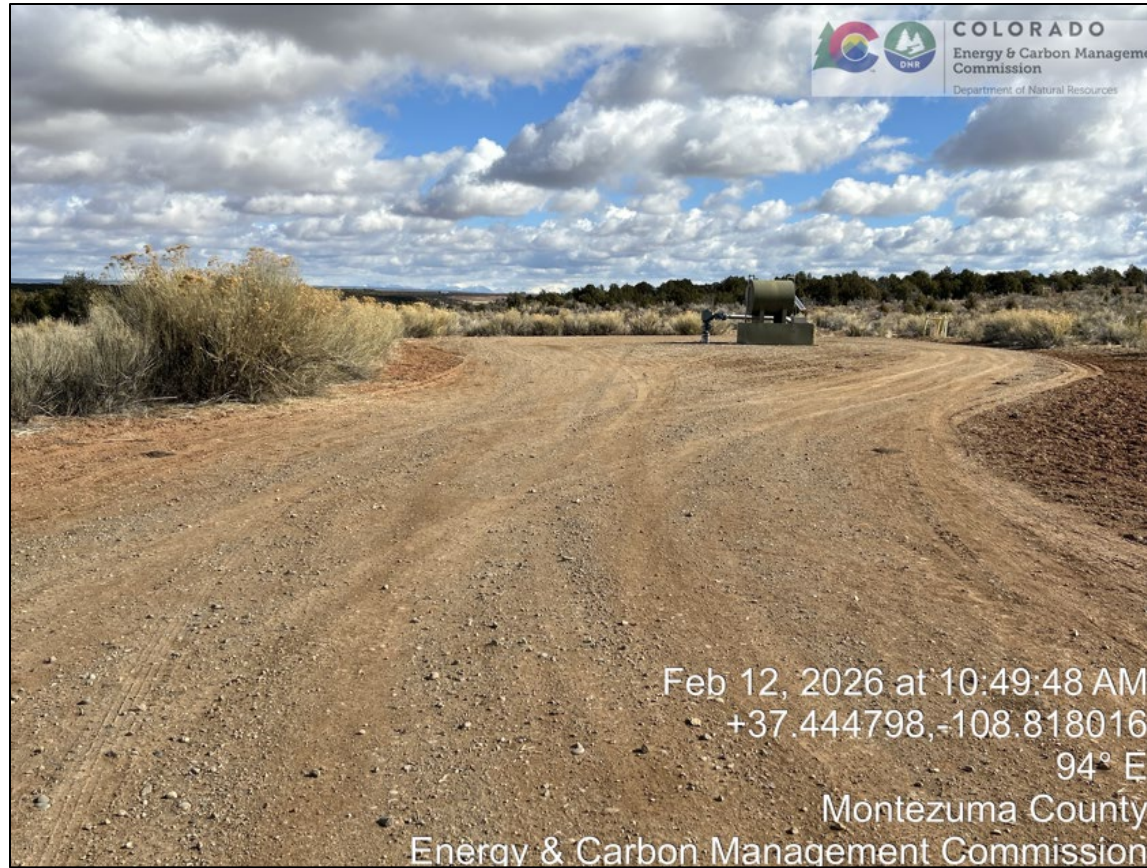
6. Well pad.

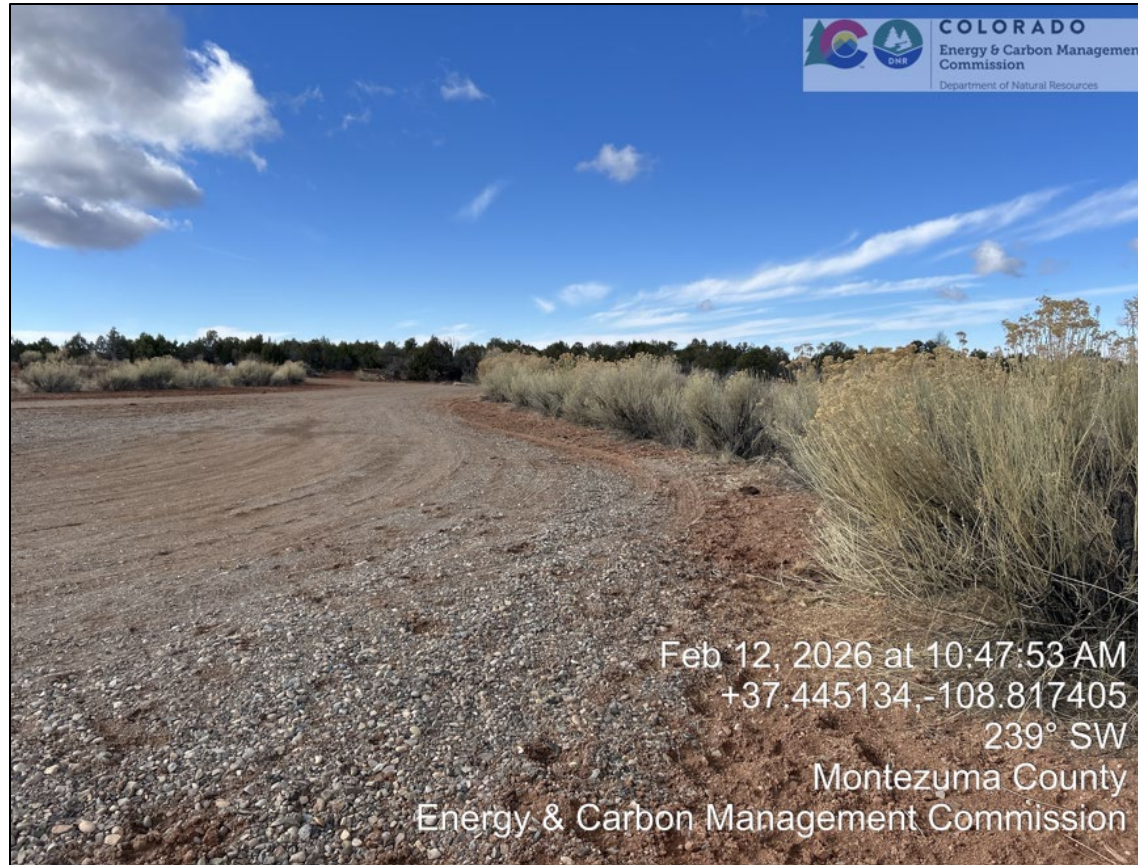
7. Well pad and reclamation vegetation.

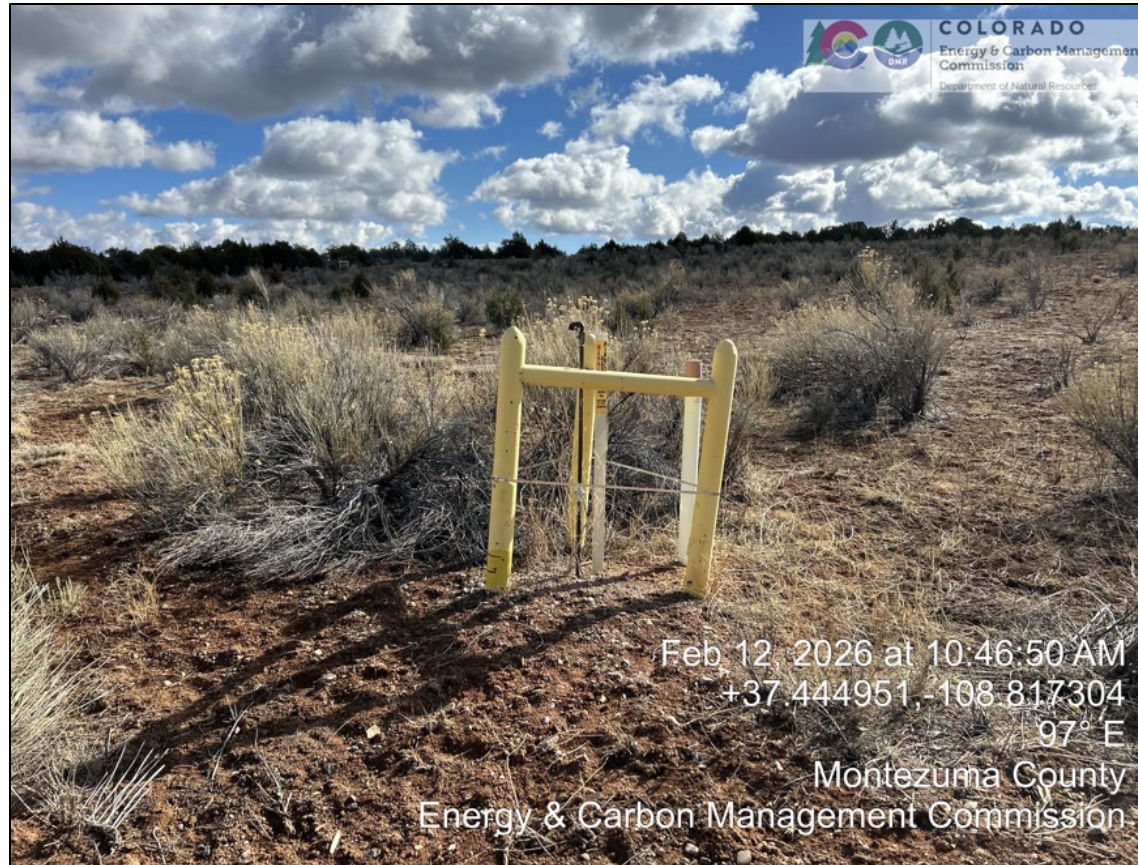
8. Annular vent behind pipe barricade.

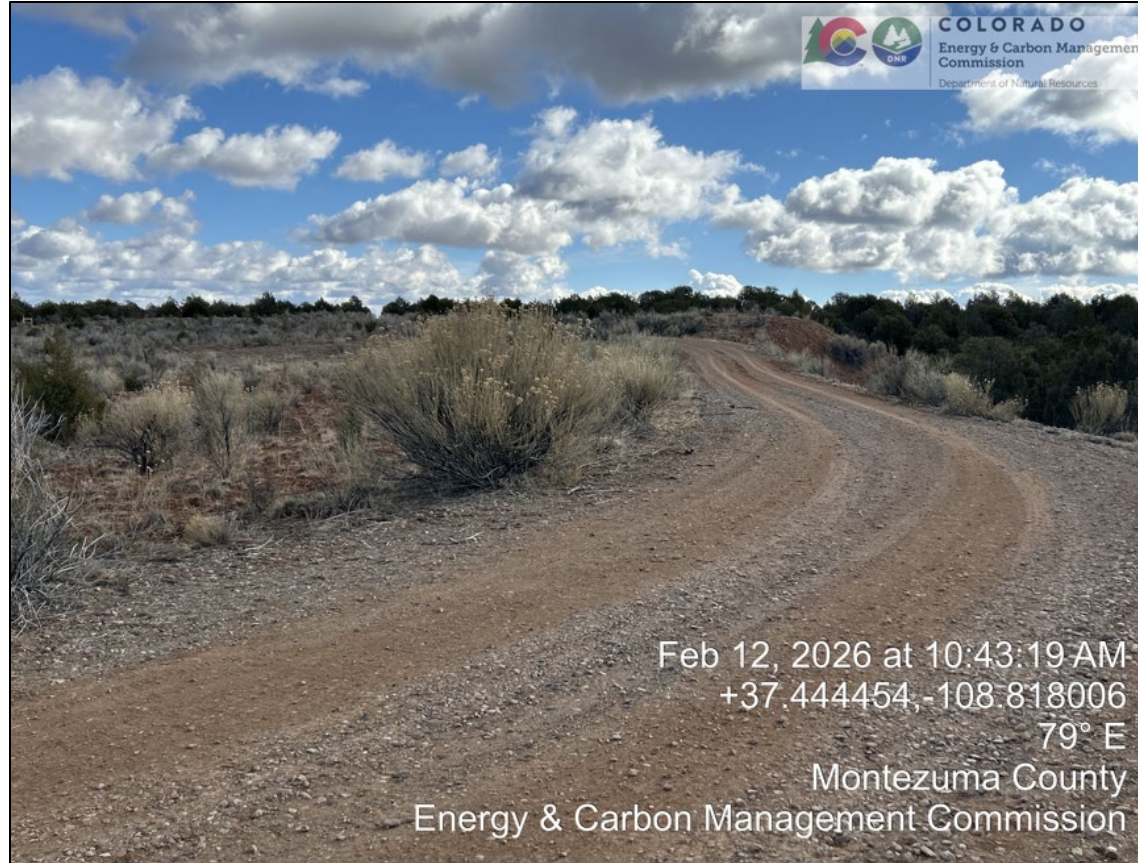
9. Access road.

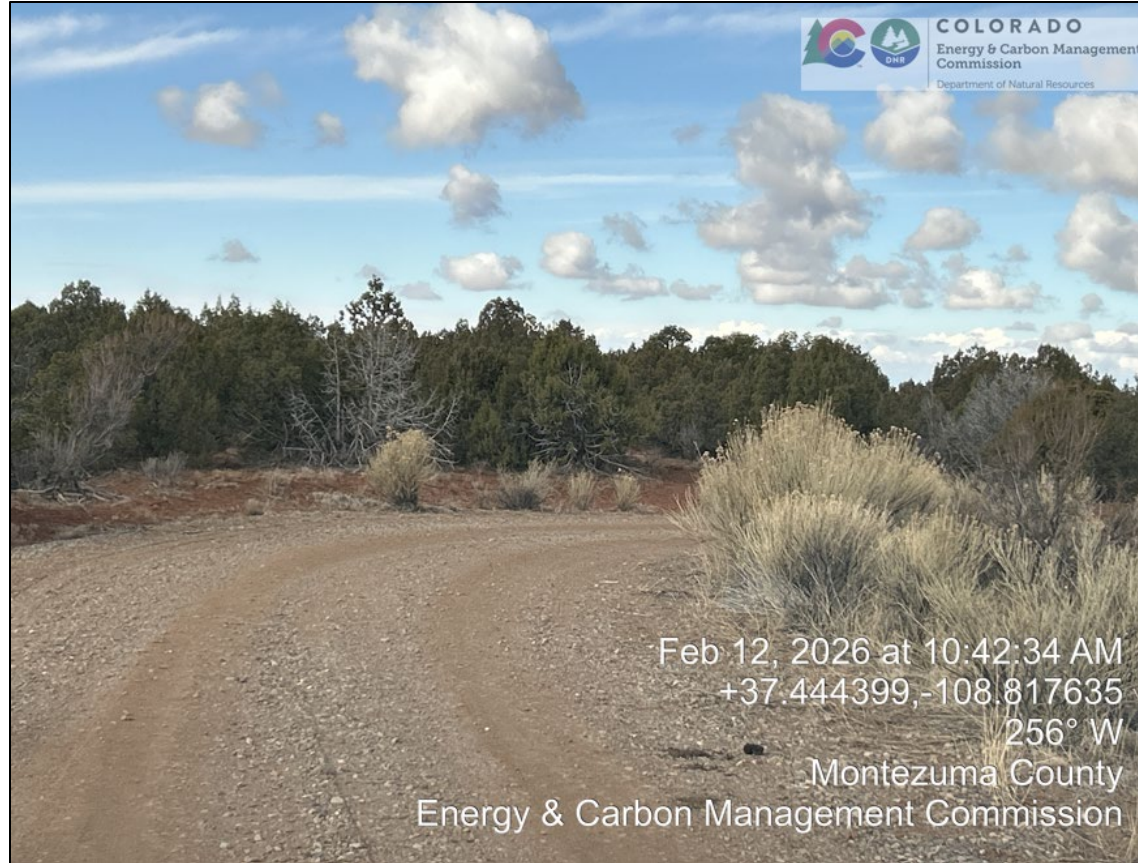
10. Access road.
