Inspection Photos
Kinder Morgan McElmo Dome Unit 15-37-18 YD-2
API # 05-083-06384
Inspector Name: James Blair. Inspection Date: 02/12/2026
Inspection Doc #: 721100135

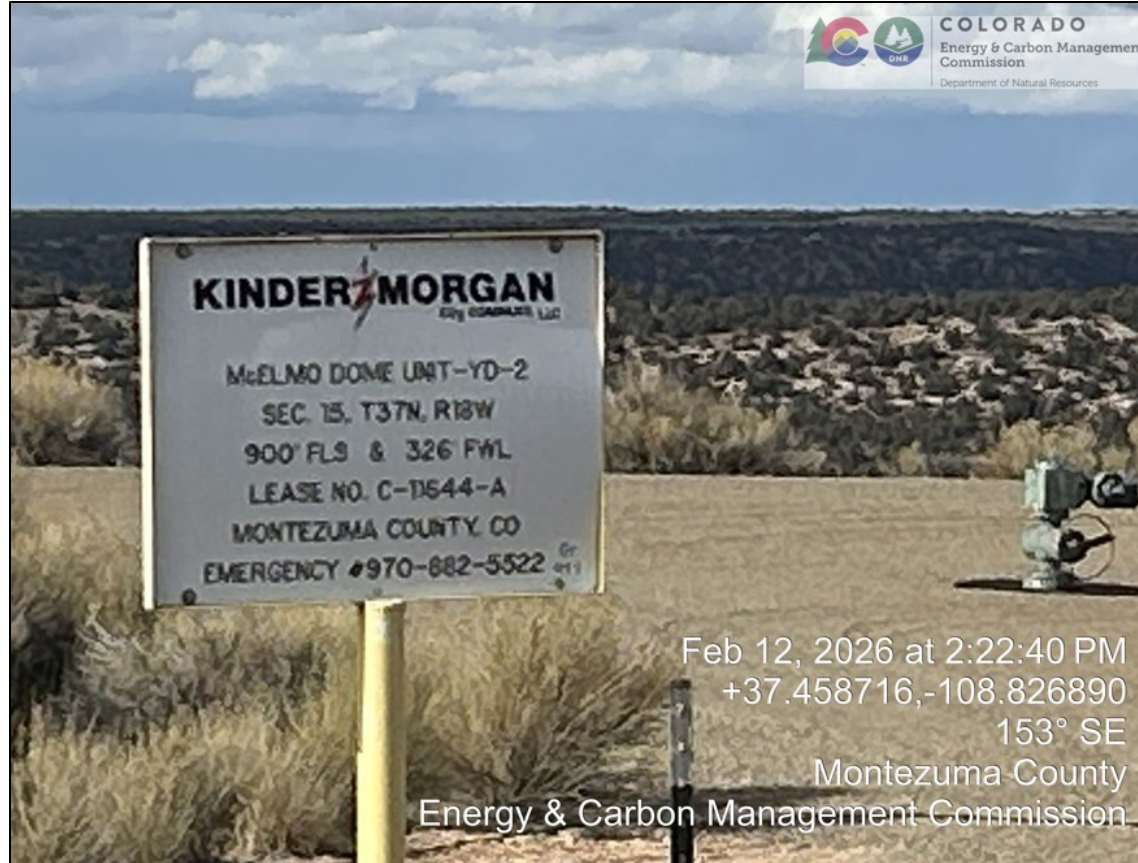
1. Well sign.

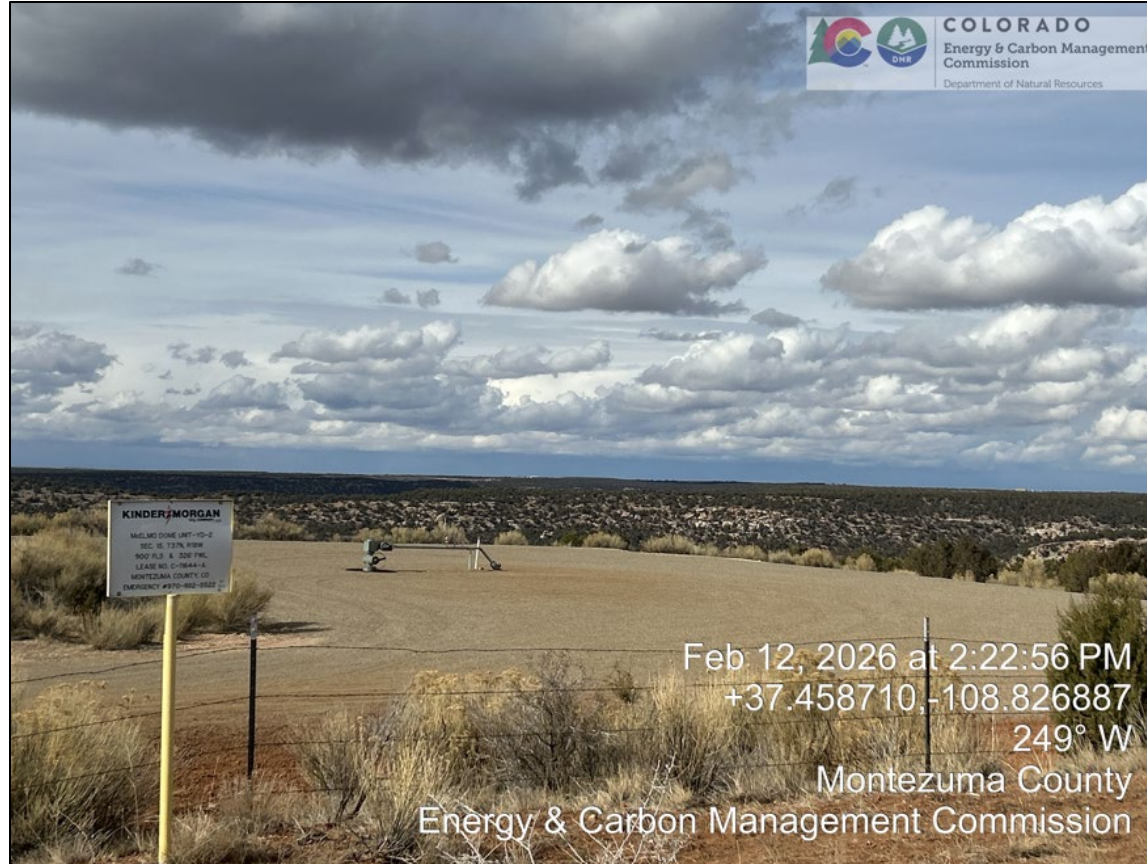
2. Well pad overview from BLM road.

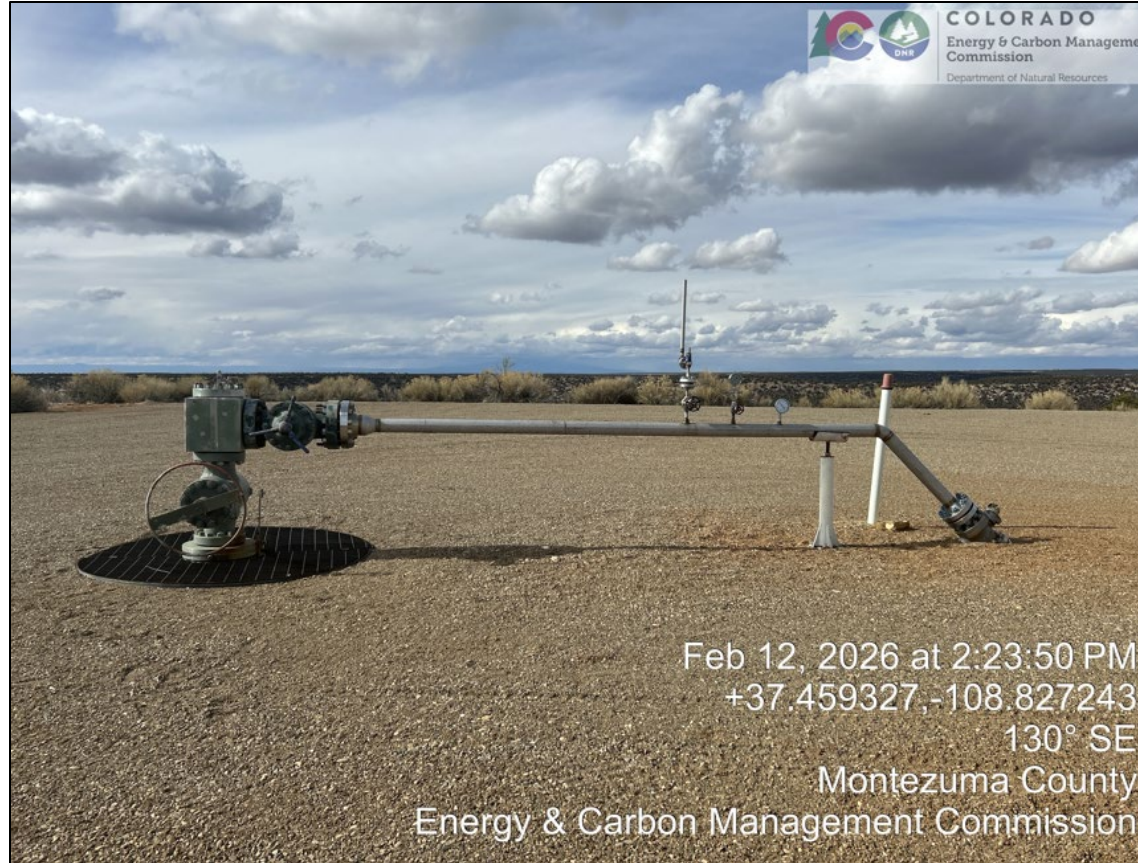
3. Wellhead, 4" stainless steel flow line and valve.

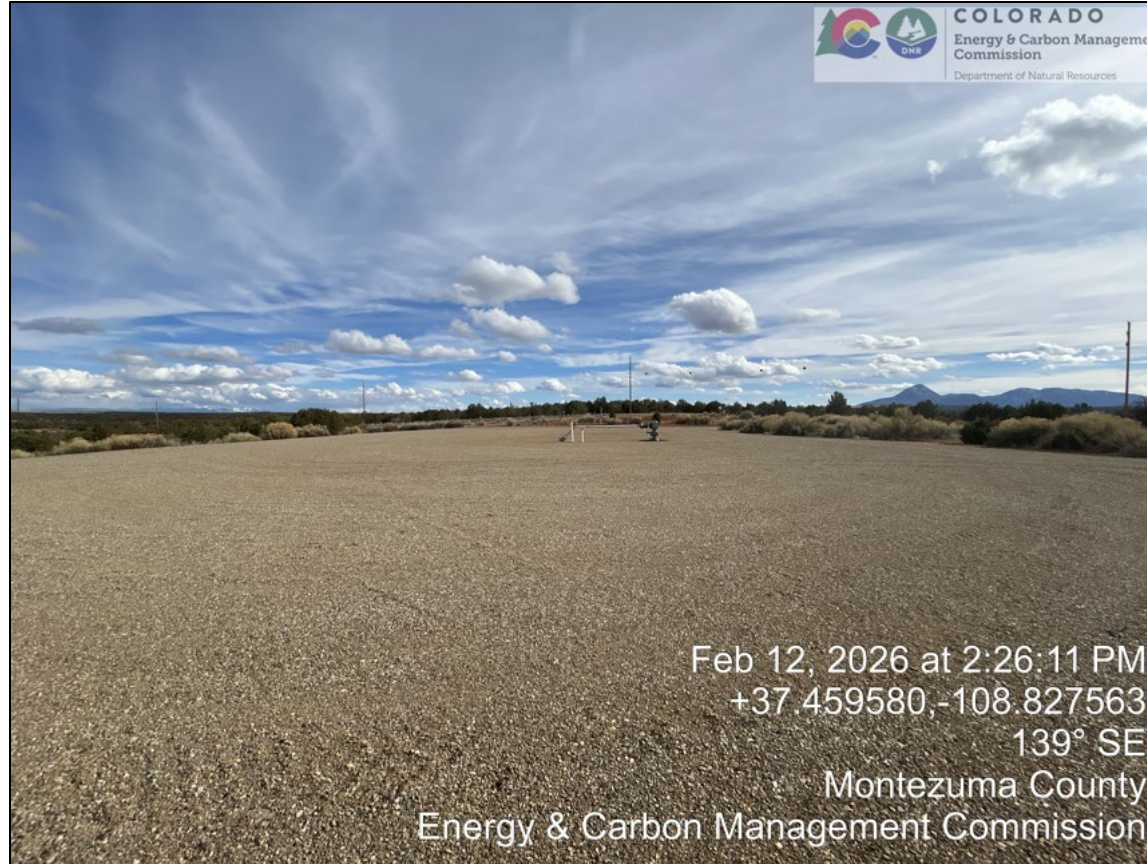
4. View of pad looking southeast.

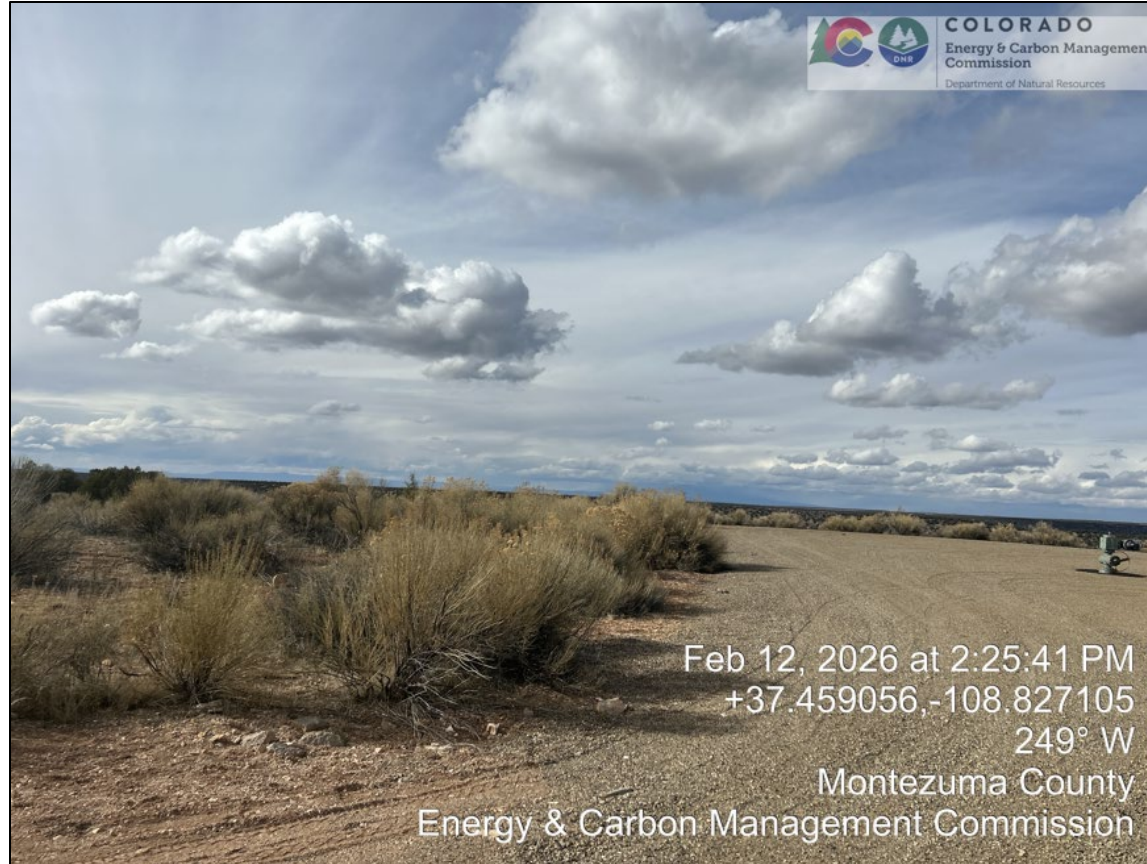
5. View of pad margin and reclamation vegetation.

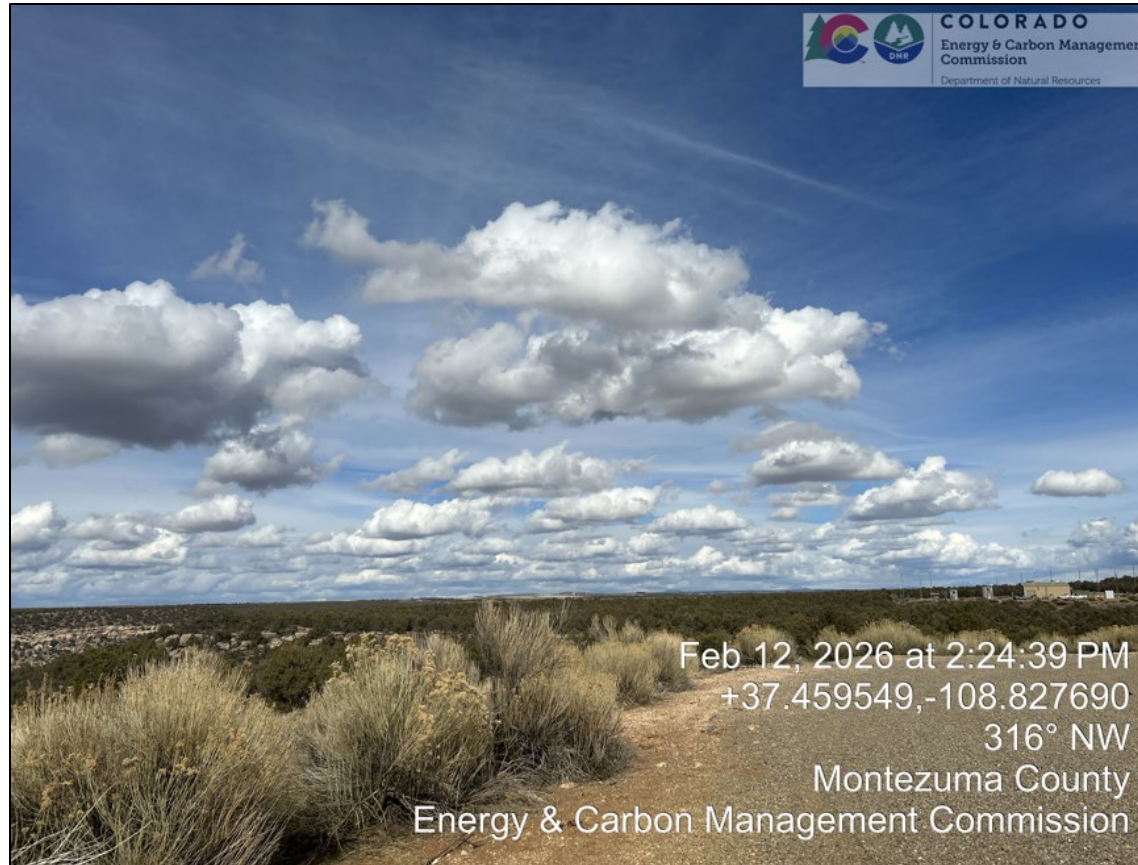
6. View of pad margin and reclamation vegetation.

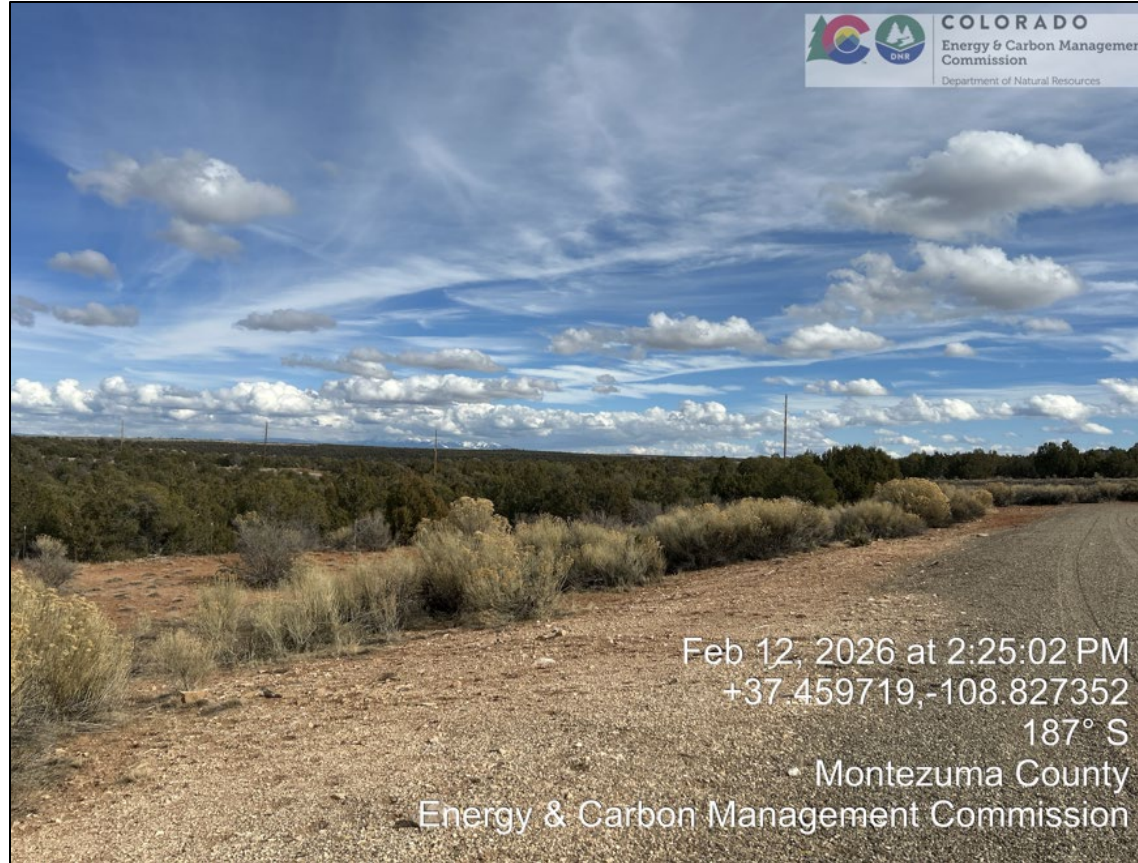
7. View of pad margin and reclamation vegetation.

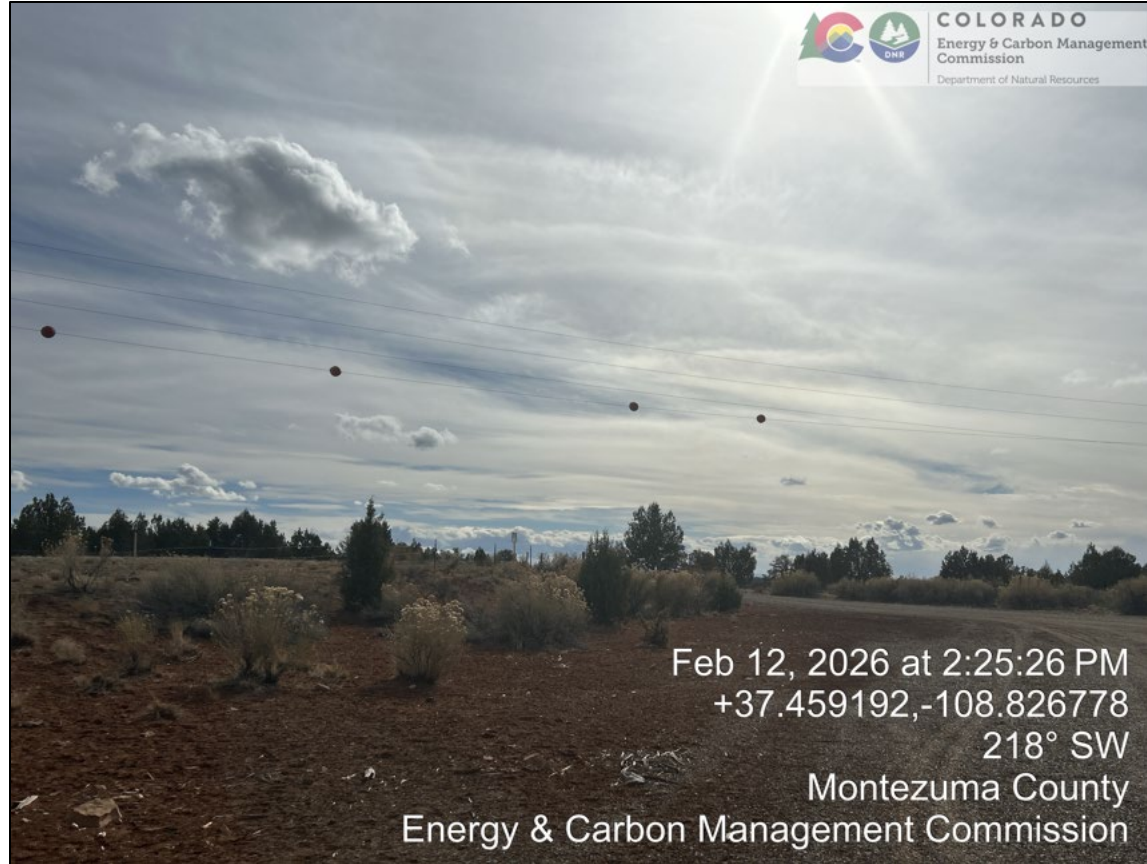
8. View of pad margin and reclamation vegetation.
