Inspection Photos
Kinder Morgan HF-3
API # 05-083-06646

Inspector Name: James Blair. Inspection Date: 02/16/2026
Inspection Doc #: 721100152

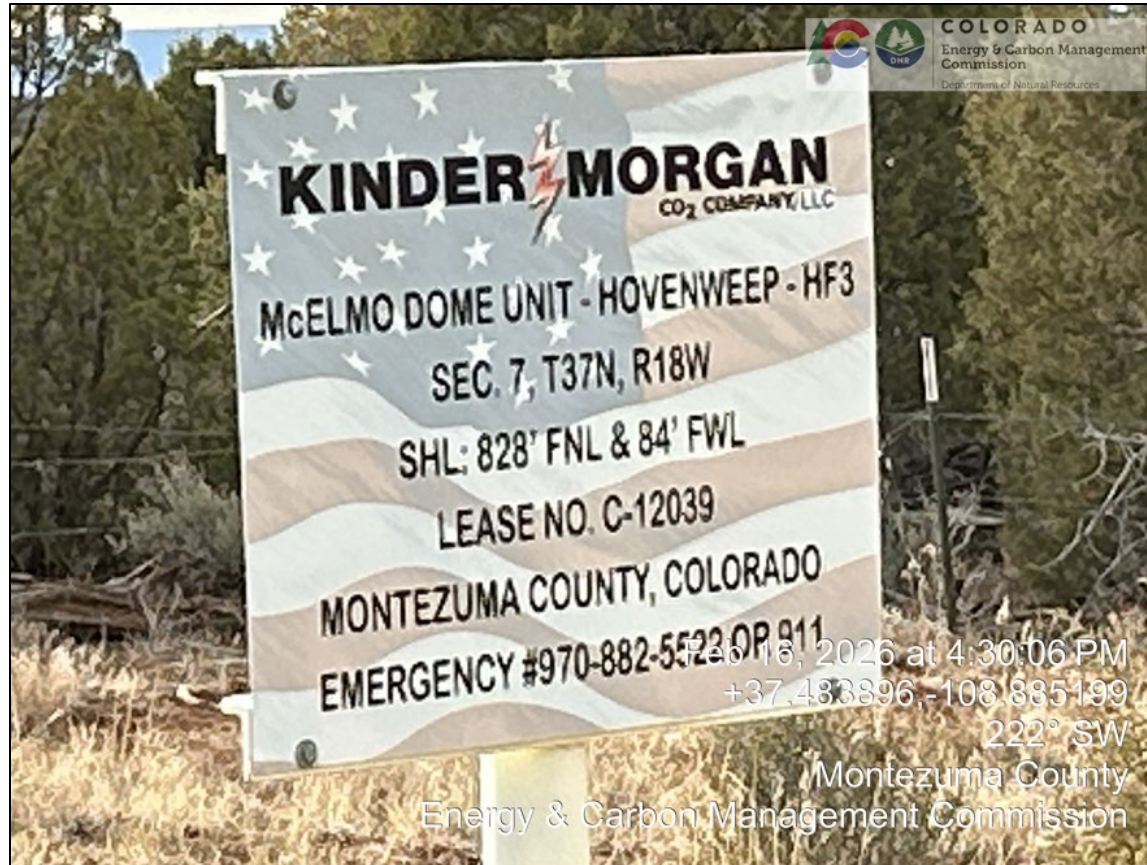
1. Well sign near pad entrance gate.

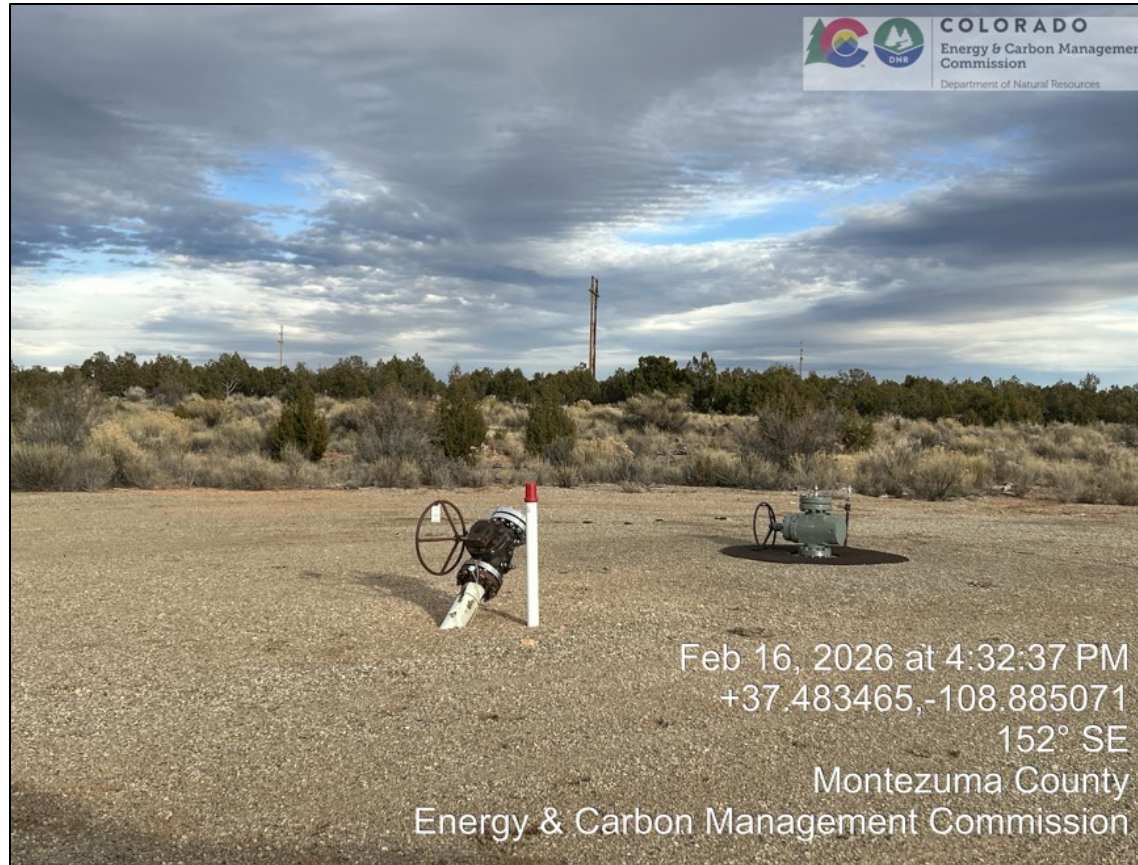
2. Wellhead and flow line riser. OOSLAT present.

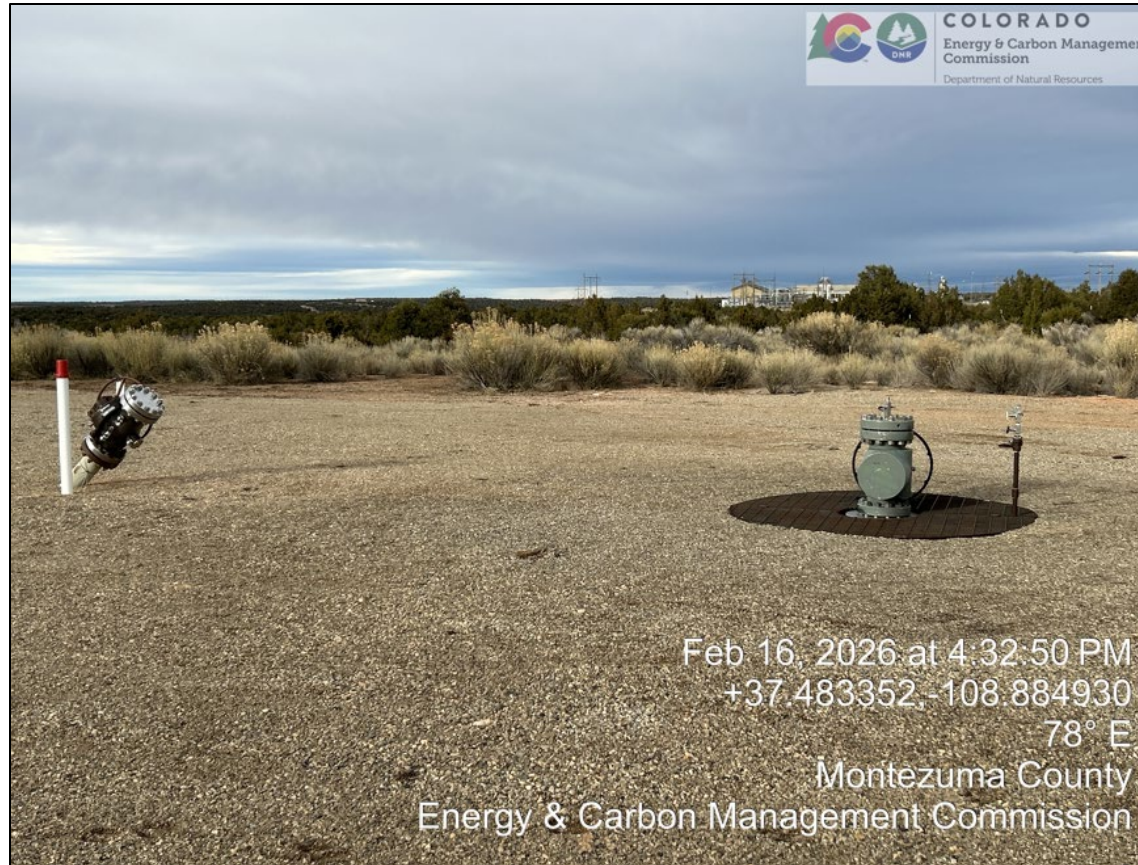
3. Wellhead and flow line riser.

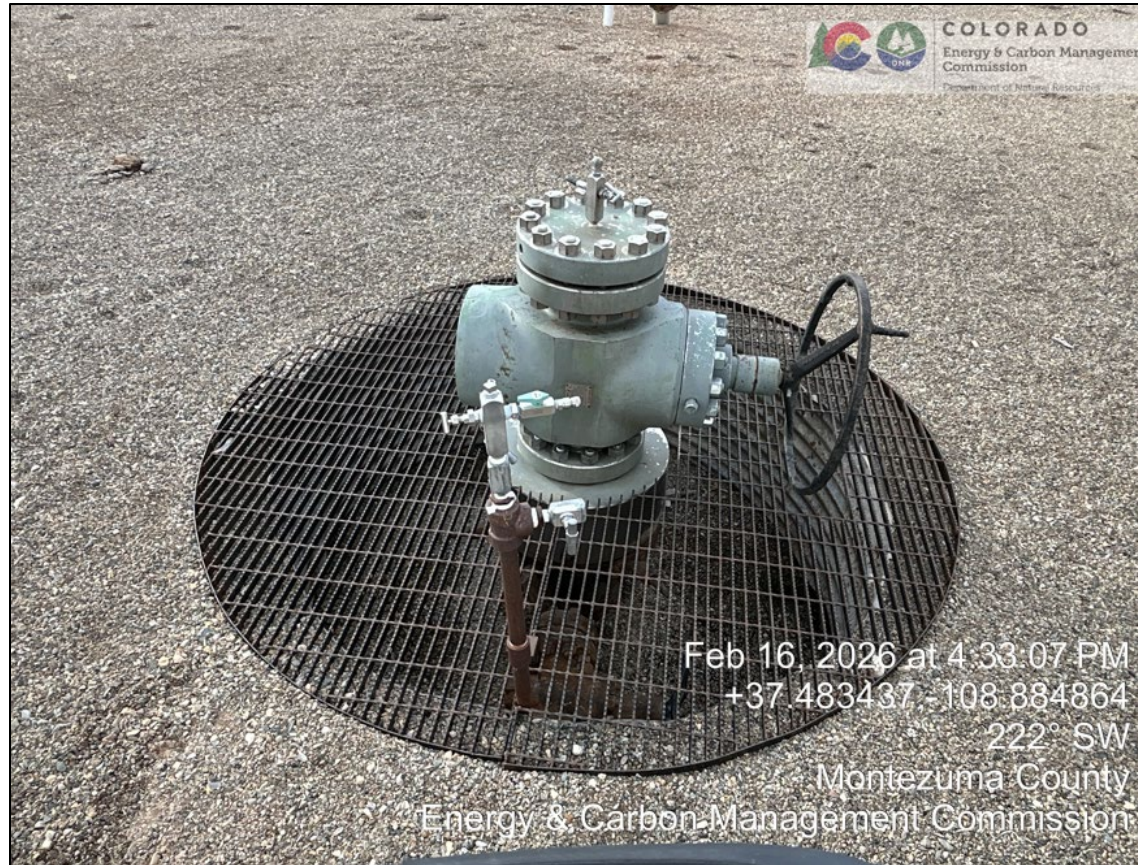
4. Wellhead. Bradenhead is accessible.

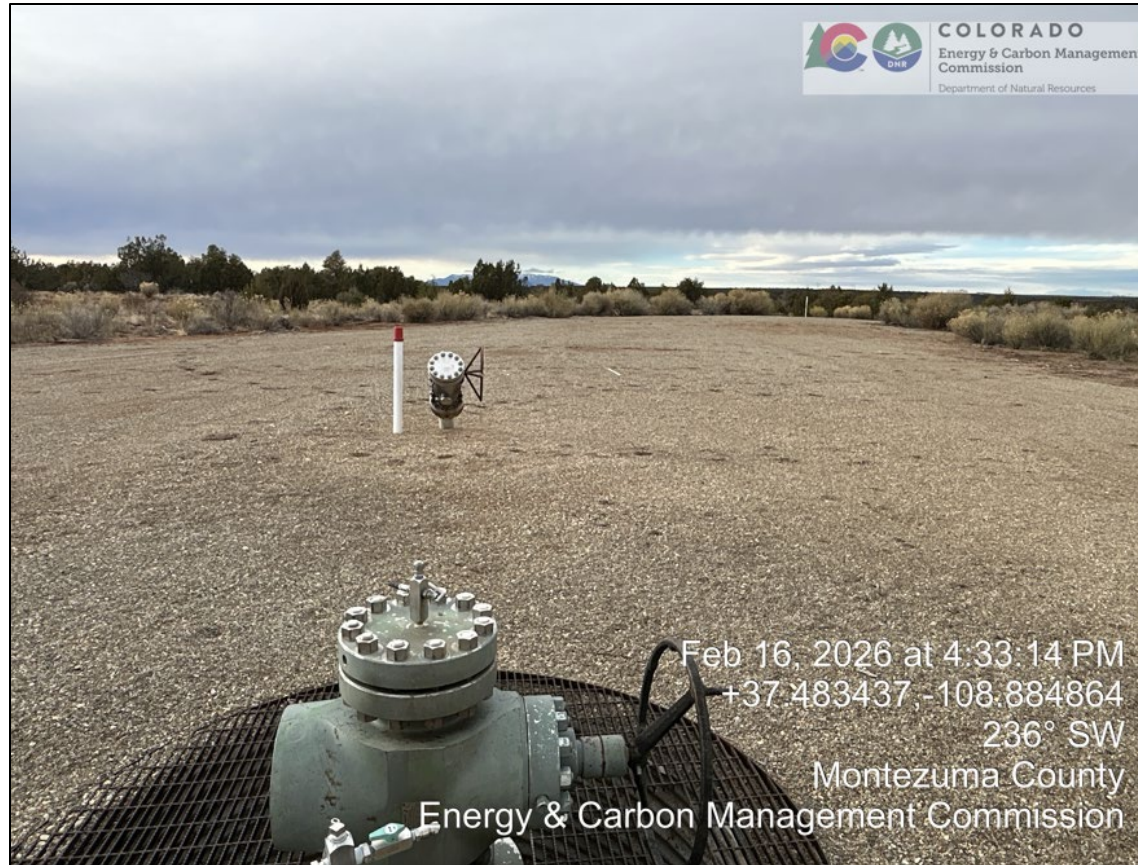
5. Wellhead and flow line riser. Well pad is clean and free of undesirable vegetation.

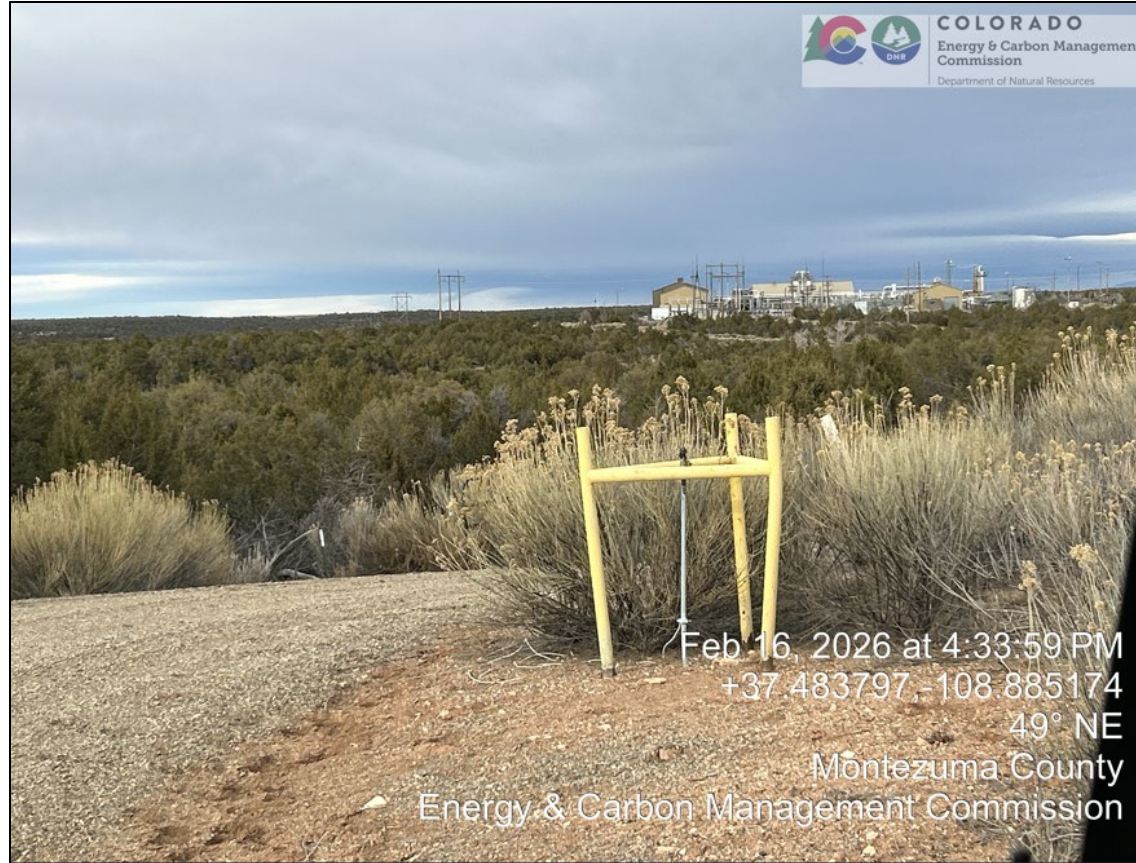
6. Annular vent.

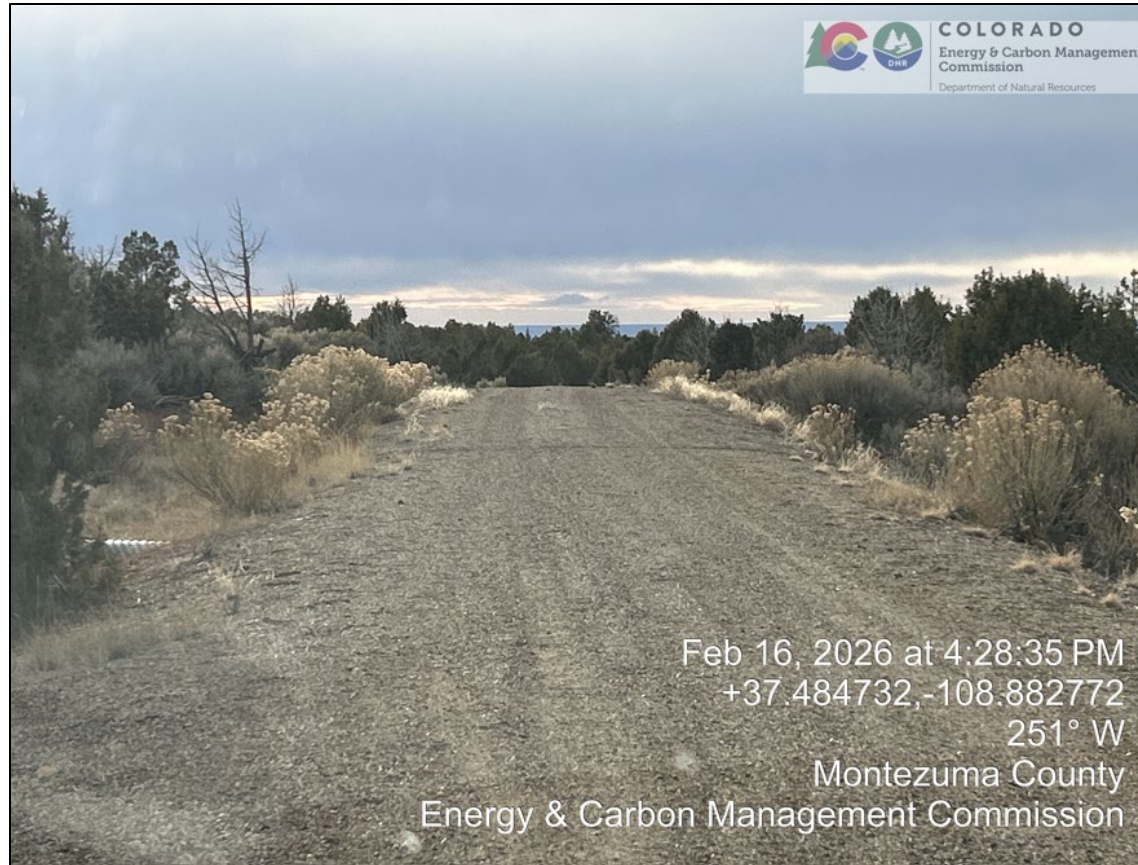
7. Access road. Note culvert on left side of road.

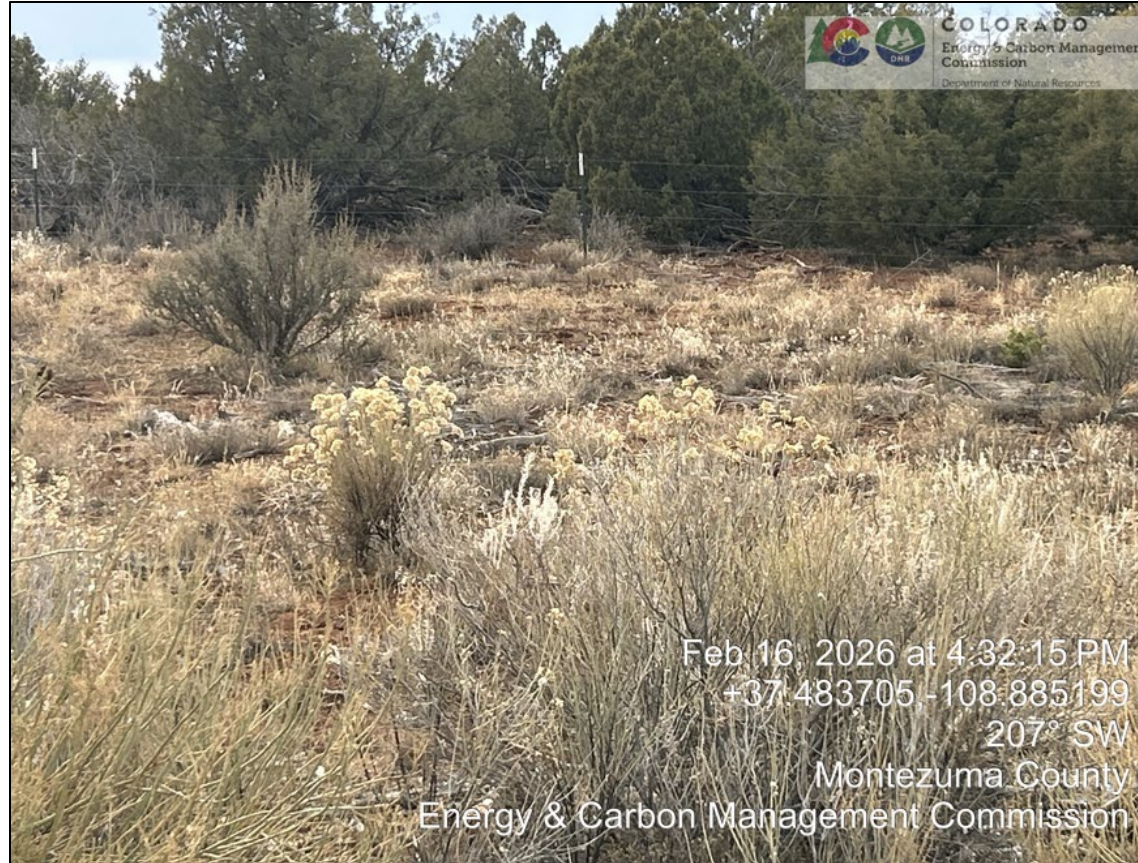
8. Interim vegetation and 4 strand barbed wire fence surrounding pad within location.
