**Inspection Photos**  
**UPRR 50 Pan Am D-1**  
**Spill ID 482826/Remediation Project No 27721**

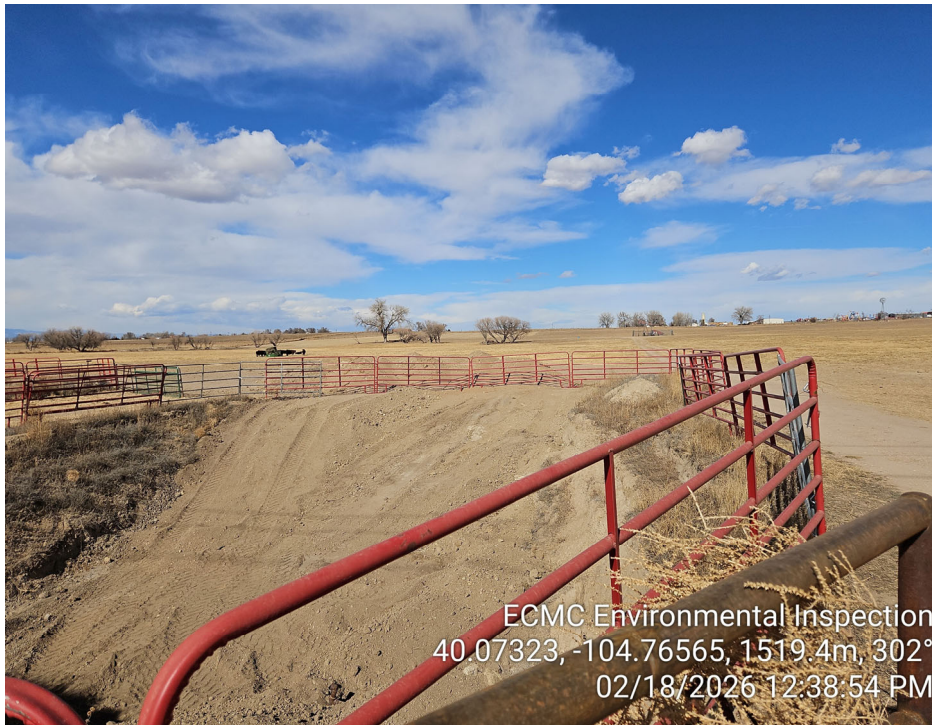
**Photo 1 – Open excavation; excavation has been partially backfilled**

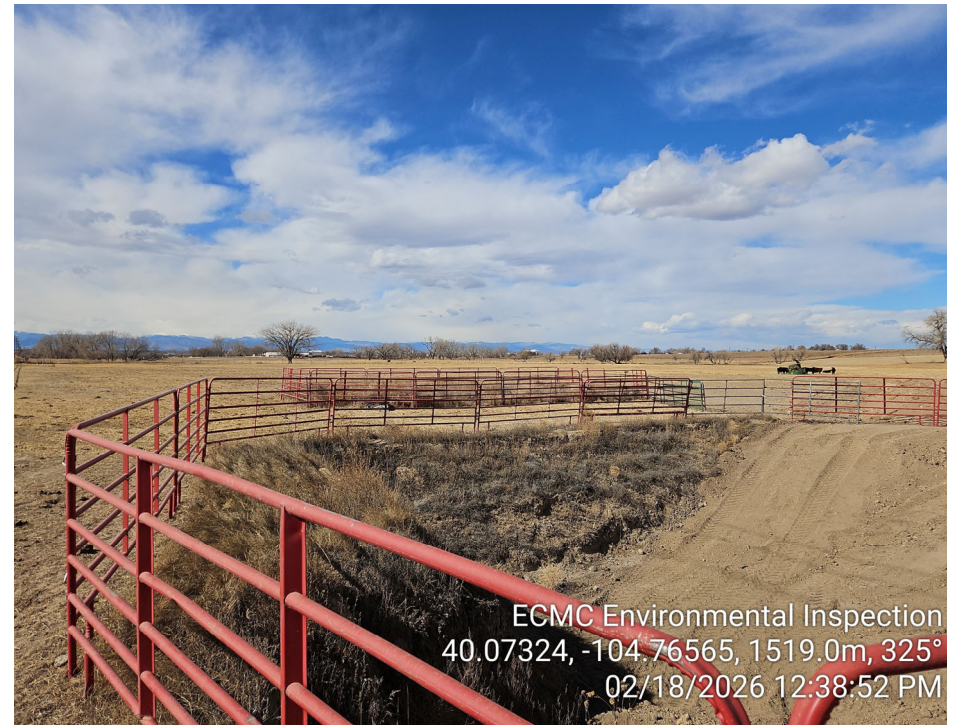
**Photo 2 - Open excavation; excavation has been partially backfilled**

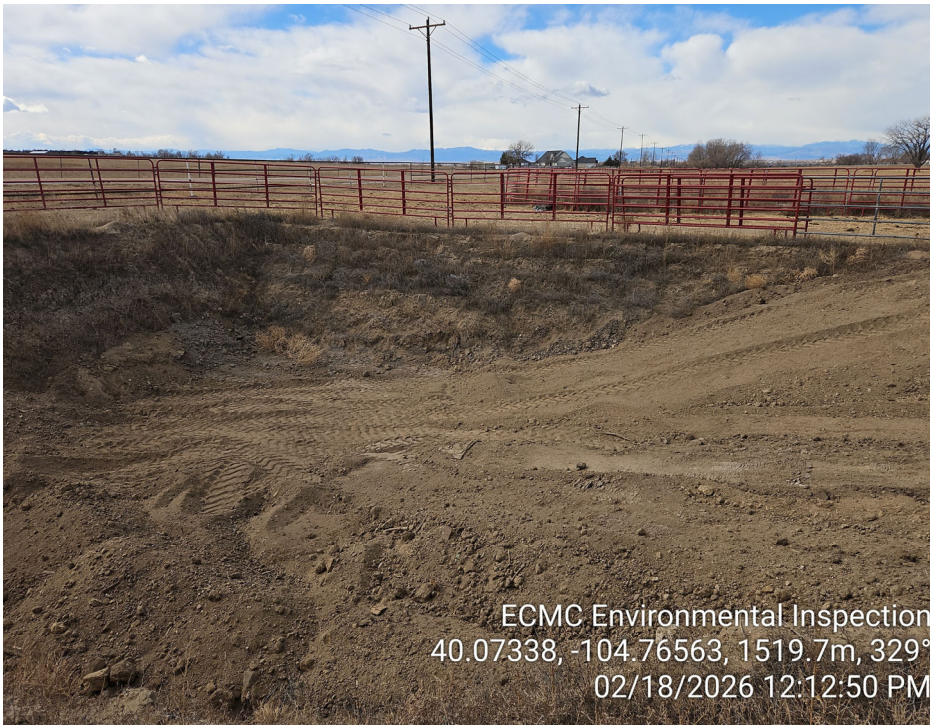
**Photo 3 - Open excavation; excavation has been partially backfilled**

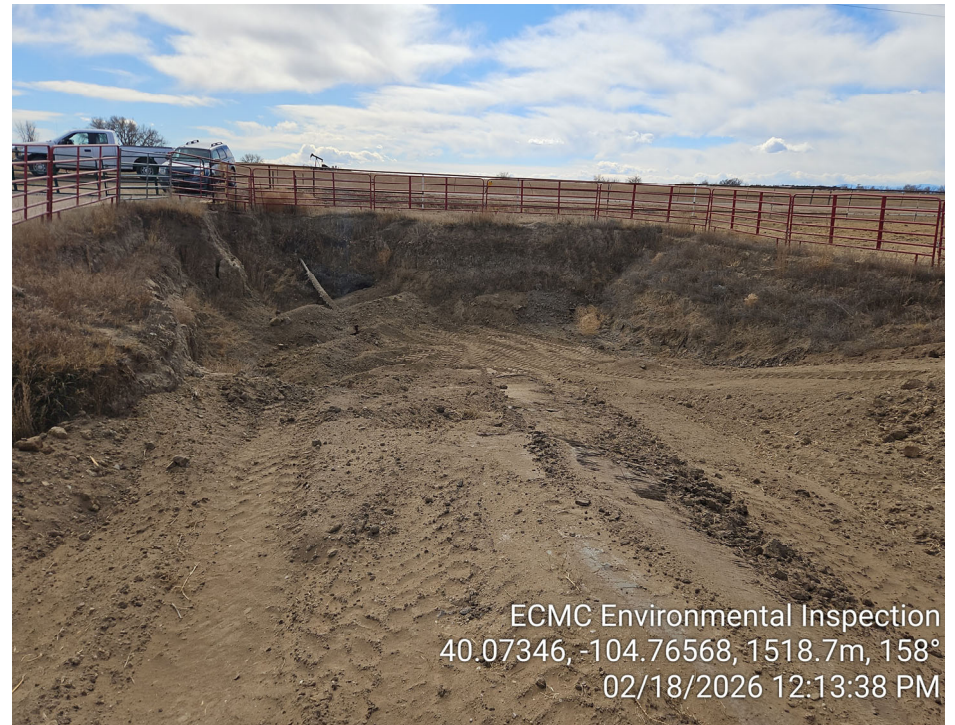
**Photo 4 - Open excavation; excavation has been partially backfilled**

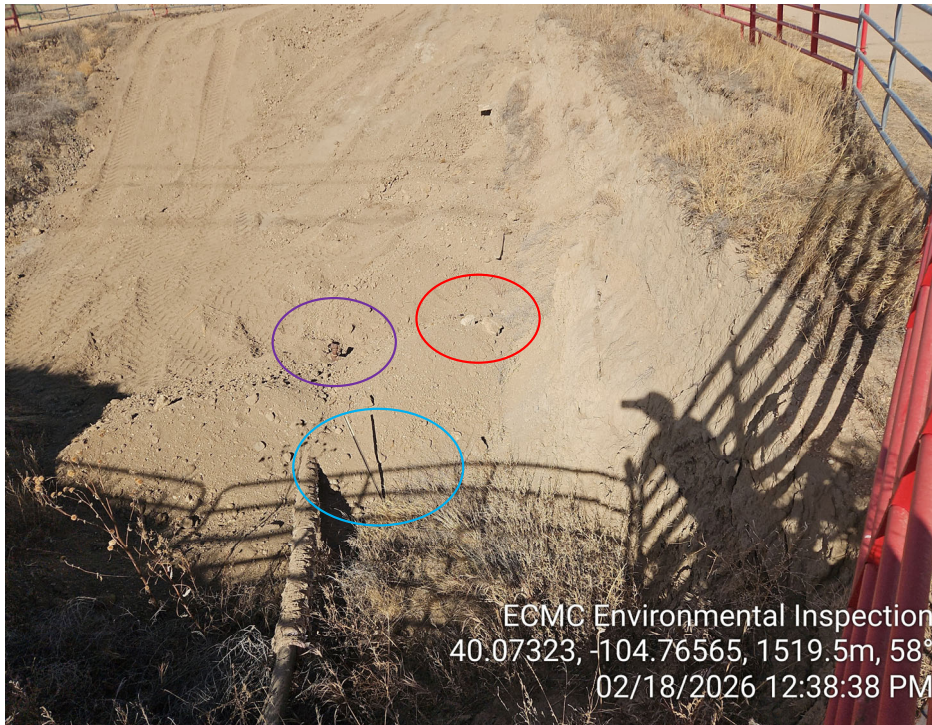
**Photo 5 – Cement in backfill in open excavation (red). Uncapped pipe (purple) and t-post (blue) present in open excavation.**

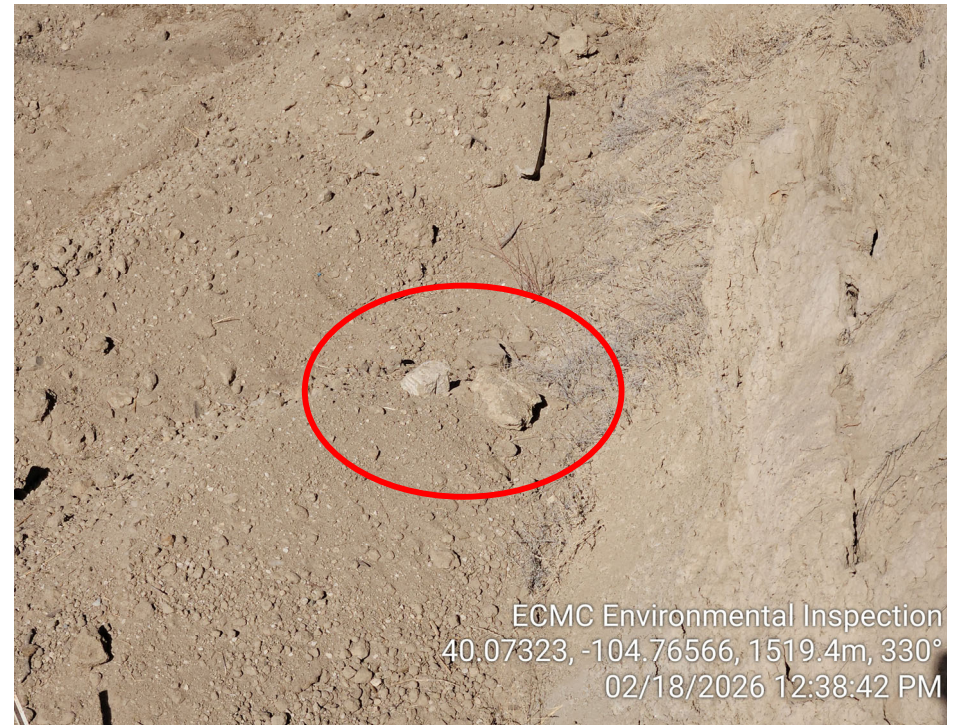
**Photo 6 – Cement used in backfill in open excavation.**

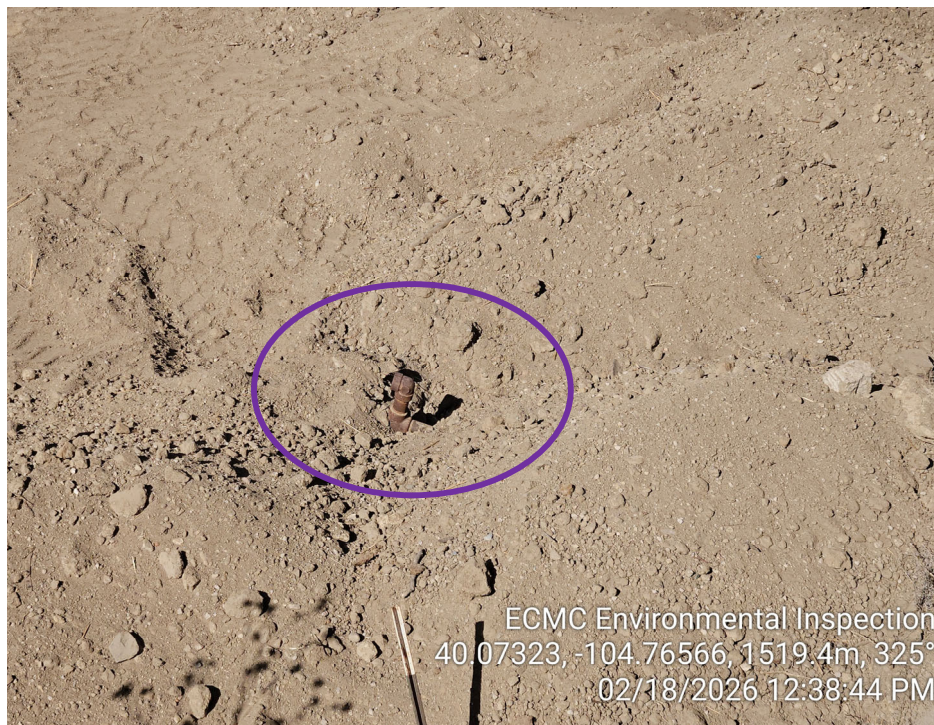
**Photo 7 - Uncapped pipe in open excavation.**

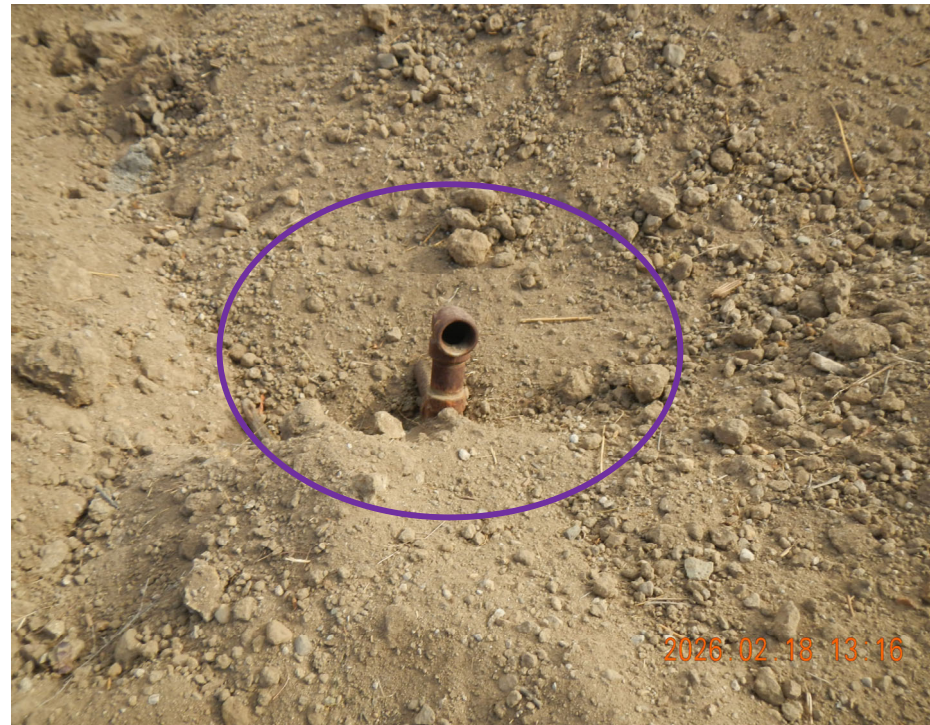
**Photo 8 - Uncapped pipe in open excavation.**

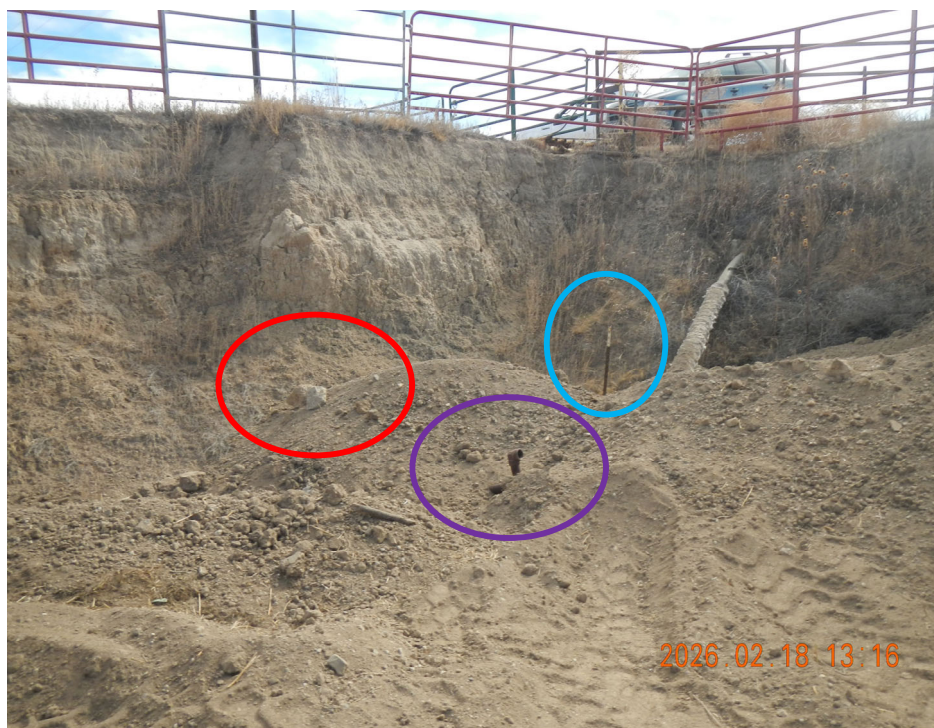
**Photo 9 - Cement in backfill in open excavation (red). Uncapped pipe (purple) and t-post (blue) present in open excavation.**

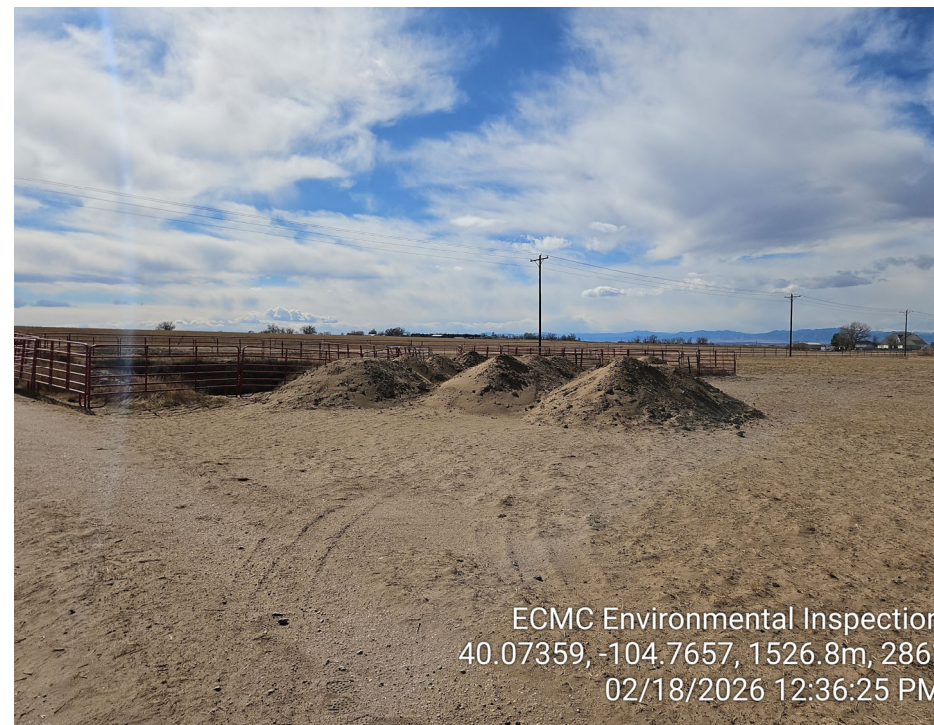
**Photo 10 – Soil stockpiles on location for backfill**

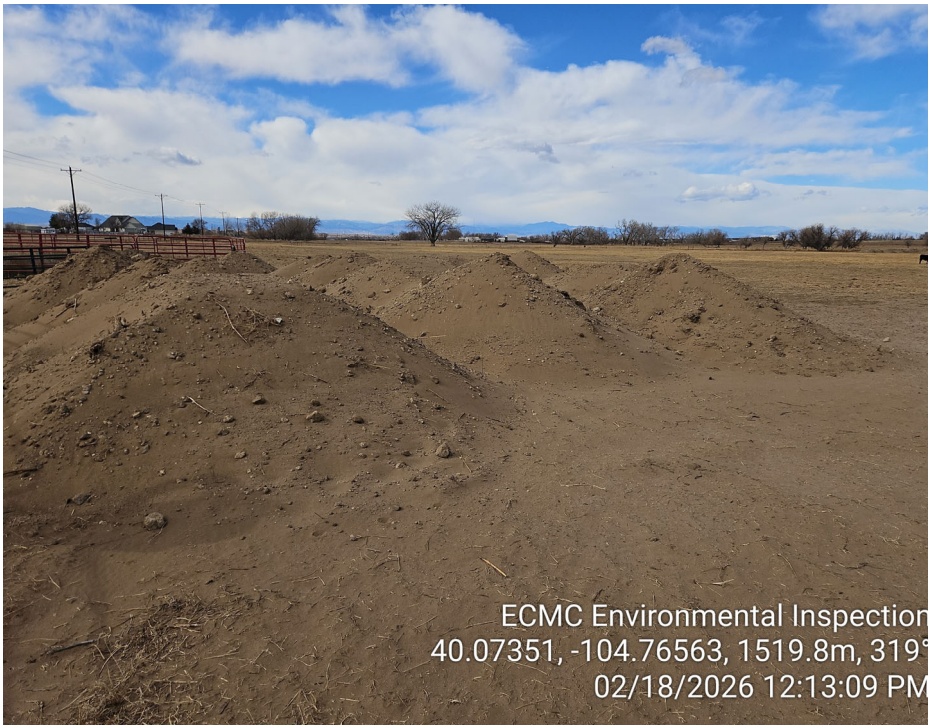
**Photo 11 - Soil stockpiles on location for backfill**

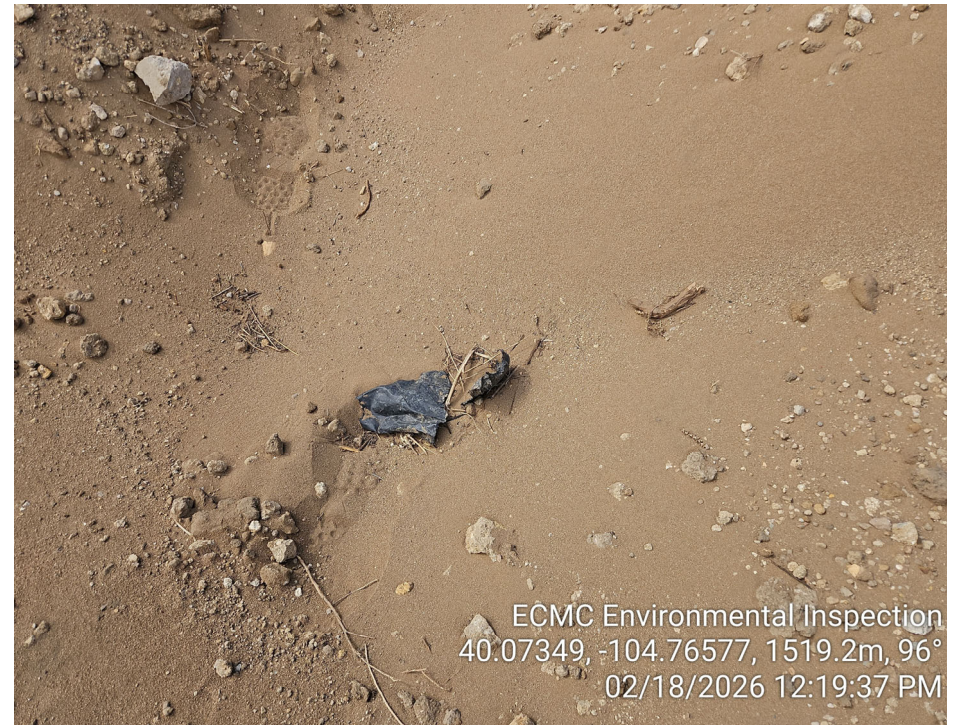
**Photo 12 - Soil stockpiles on location for backfill;  
trash present in backfill**

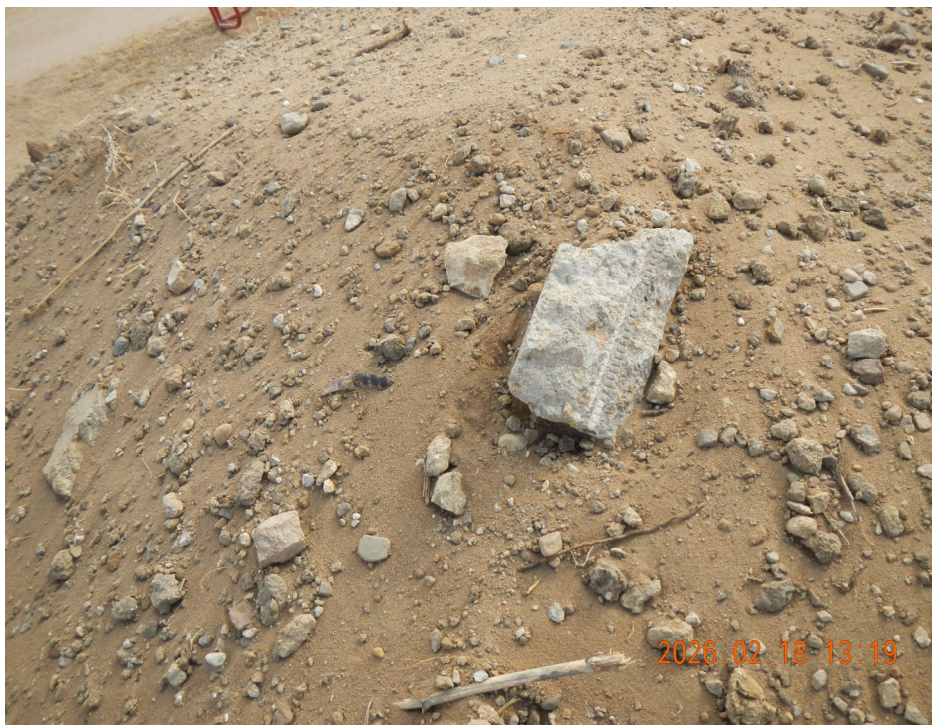
**Photo 13 - Soil stockpiles on location for backfill;  
concrete present in backfill**

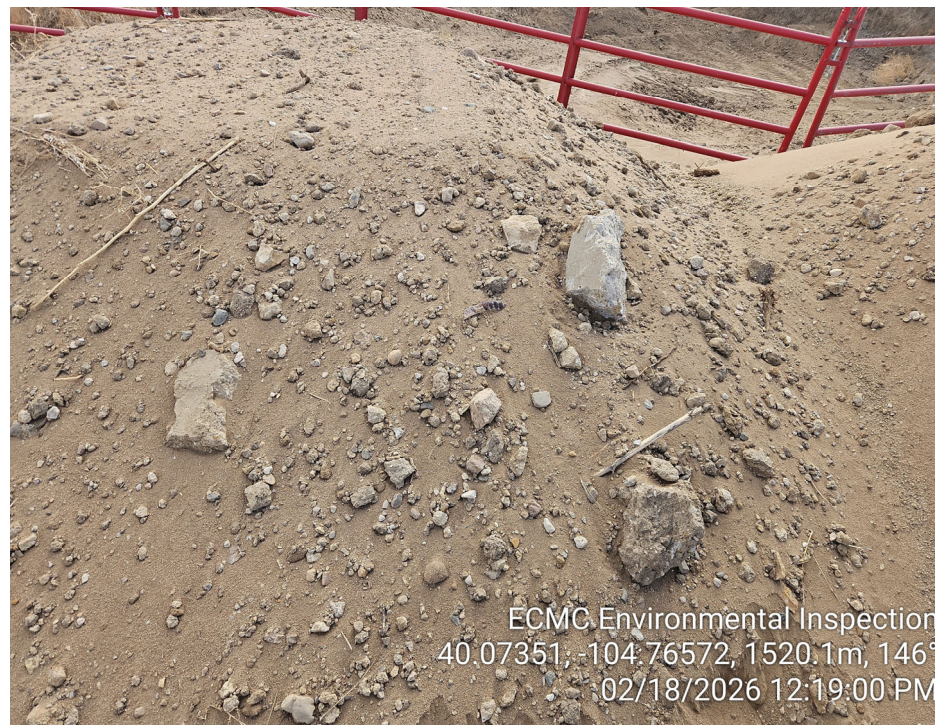
**Photo 14 - Soil stockpiles on location for backfill;  
concrete present in backfill**

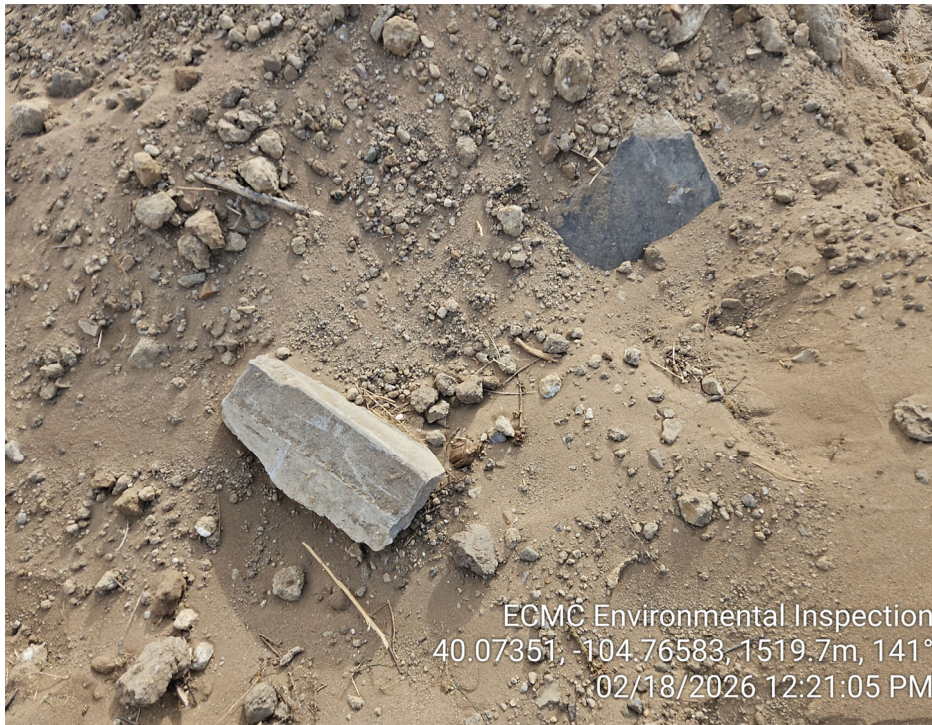
**Photo 15 - Soil stockpiles on location for backfill;  
concrete present in backfill**

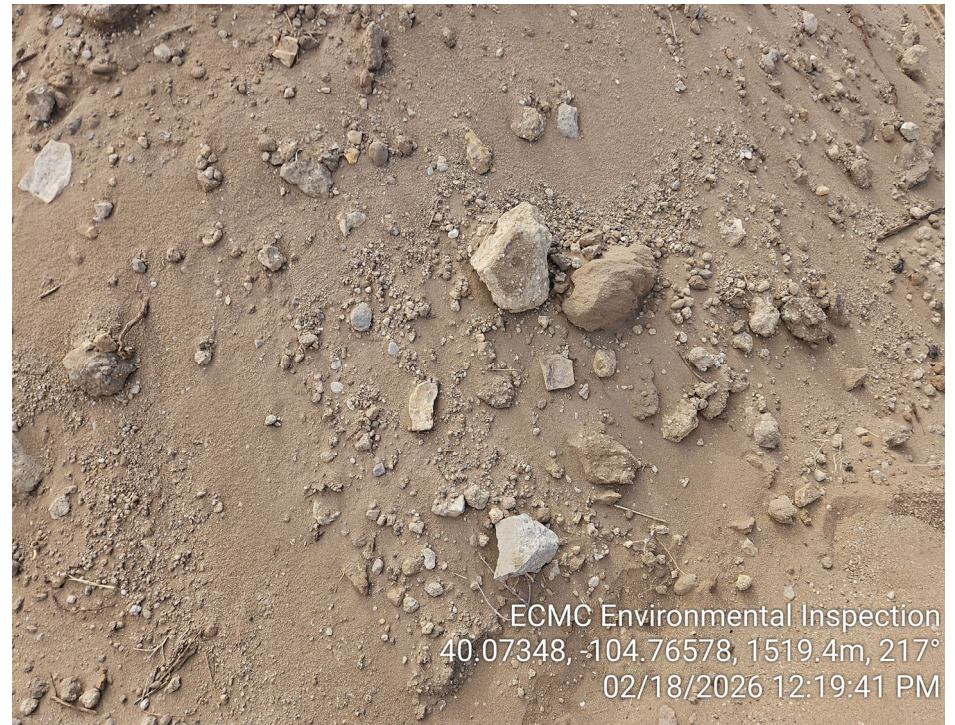
**Photo 16 - Soil stockpiles on location for backfill;  
concrete present in backfill**

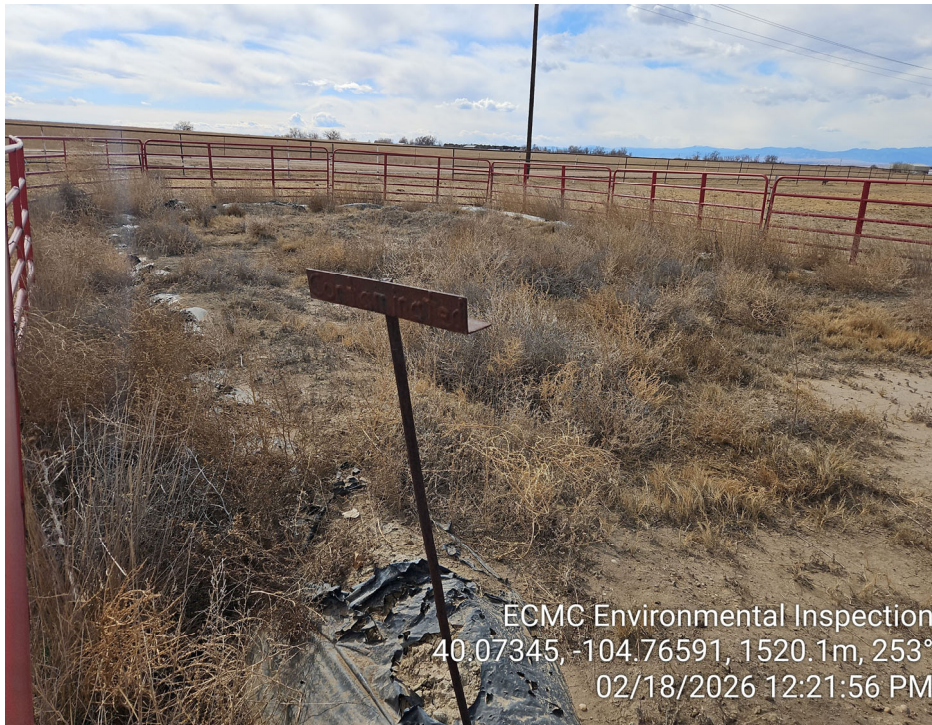
ECMC Environmental Inspection  
40.07345, -104.76591, 1520.1m, 253°  
02/18/2026 12:21:56 PM

**Photo 17 – Area of previously stockpiled contaminated soil; a small amount of soil remains within the stockpile. “Contaminated” marker and liner still present. Holes in liner visible. Weeds throughout.**

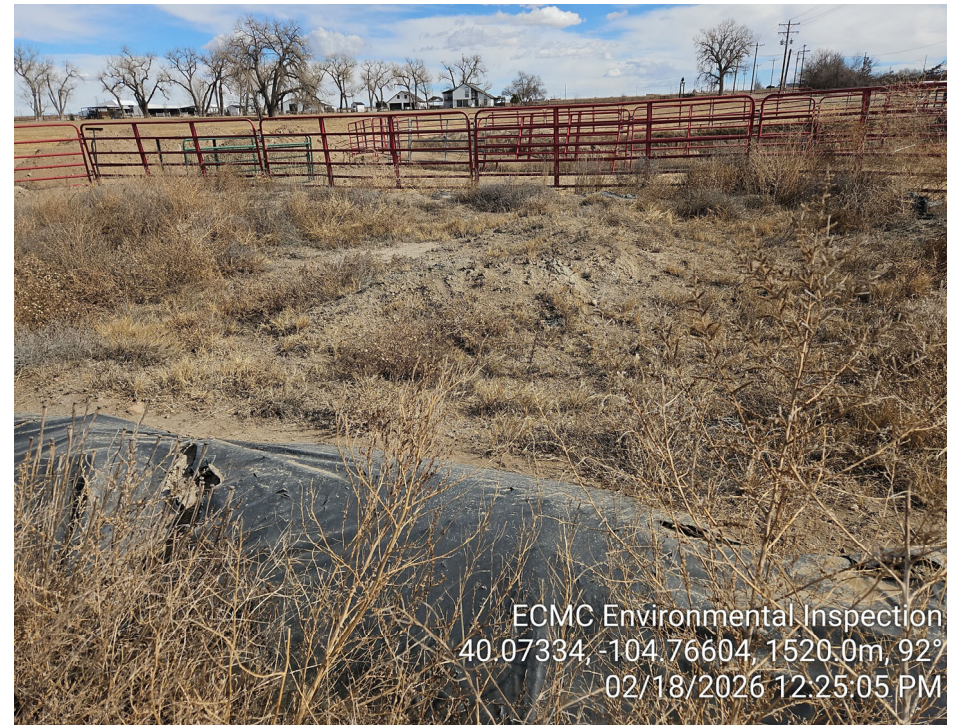
ECMC Environmental Inspection  
40.07334, -104.76604, 1520.0m, 92°  
02/18/2026 12:25:05 PM

**Photo 18 – Area of previously stockpiled contaminated soil; a small amount of soil remains within the stockpile. “Contaminated” marker and liner still present. Holes in liner visible. Weeds throughout.**

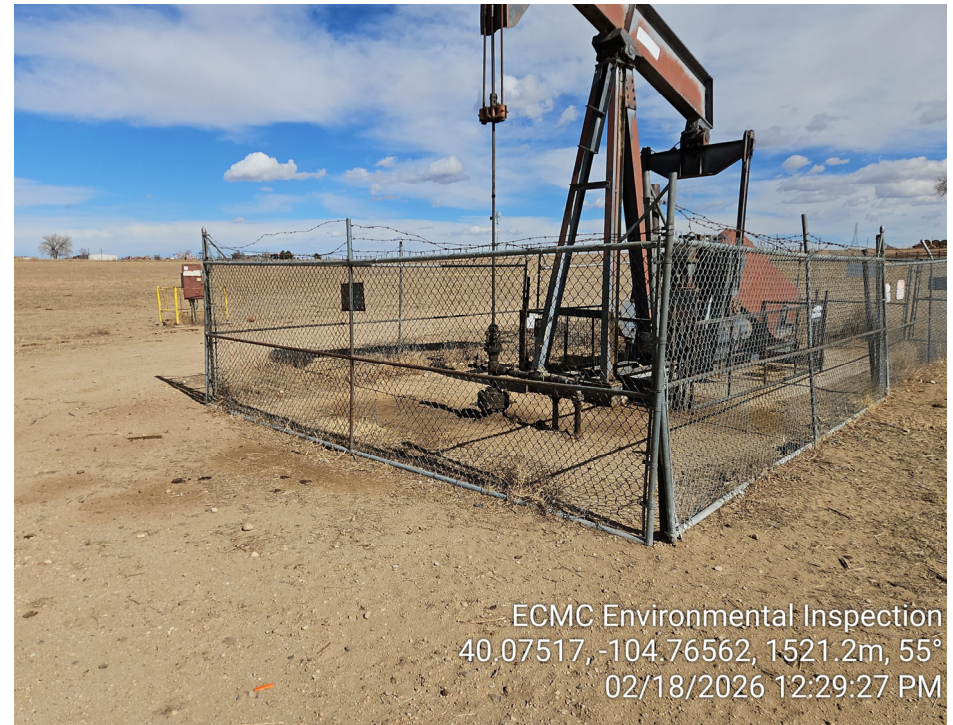
Photo 20 – UPRR 50 Pan Pam D#1 wellhead. Stained soil at wellhead and surrounding area.

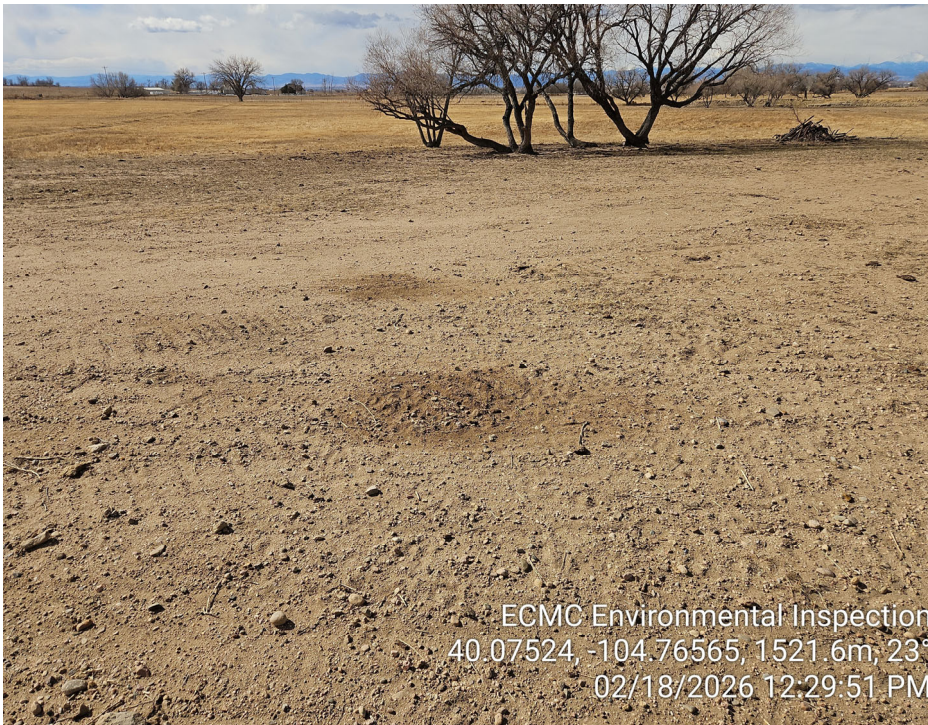
**Photo 21 – Stained soil present near UPRR 50 Pan Pam D#1 wellhead.**

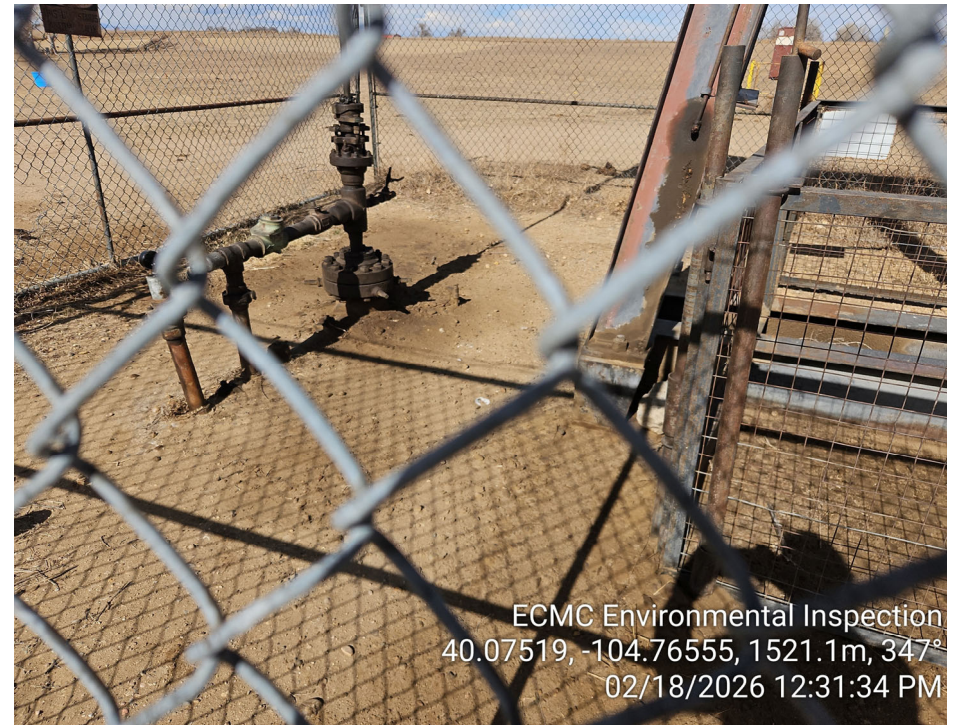
**Photo 22 - UPRR 50 Pan Pam D#1 wellhead. Stained soil at wellhead and surrounding area.**
