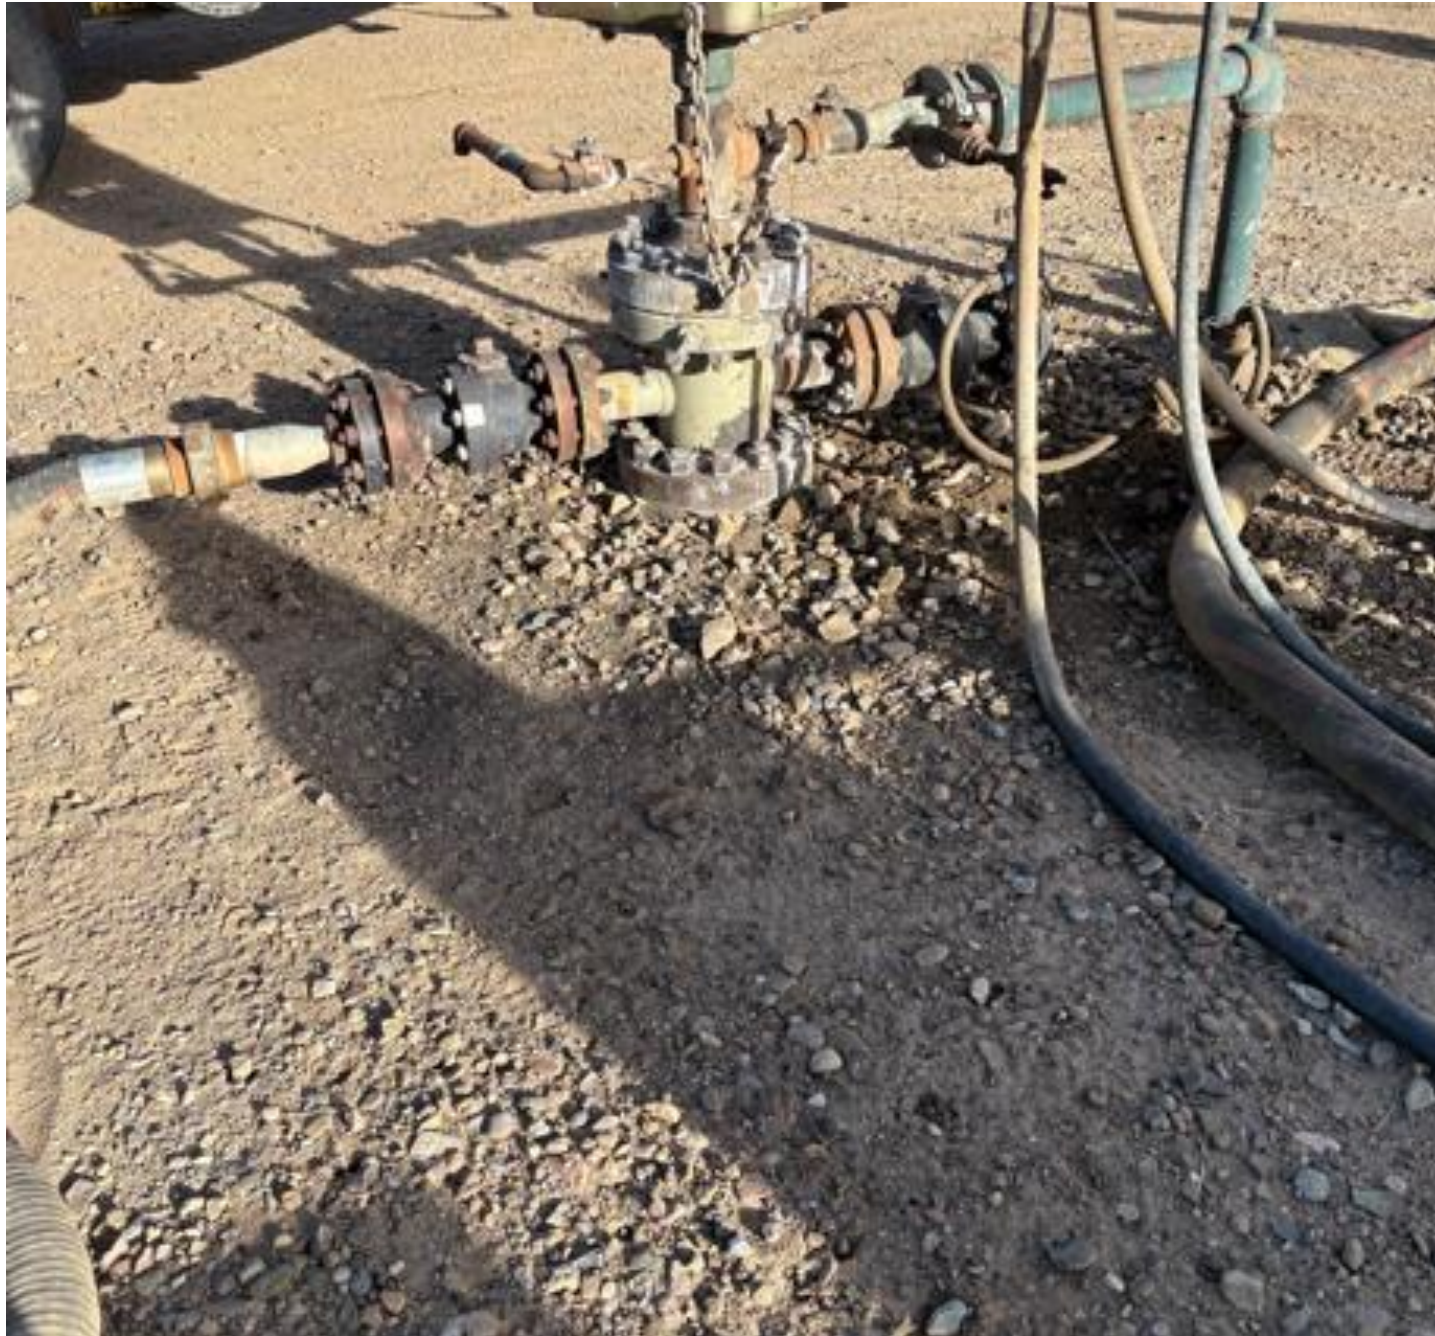
PHOTO 1: THE AREA OF IMPACTED SOIL AROUND THE WELLHEAD HAS BEEN REMOVED AND REPLACED WITH FRESH PAD MATERIAL. THE SELF INSPECTION PROCESS HAS BEEN REVIEWED AND THIS LOCATION WITH BE MONITORED FOR ANY FURTHER POTENTIAL COMPLIANCE ISSUES.
