# Interim Reclamation and Stormwater Inspection

Operator: KERR MCGEE OIL & GAS ONSHORE LP - 47120

Location ID: 428867

Well Name: Rehder #X06-20D

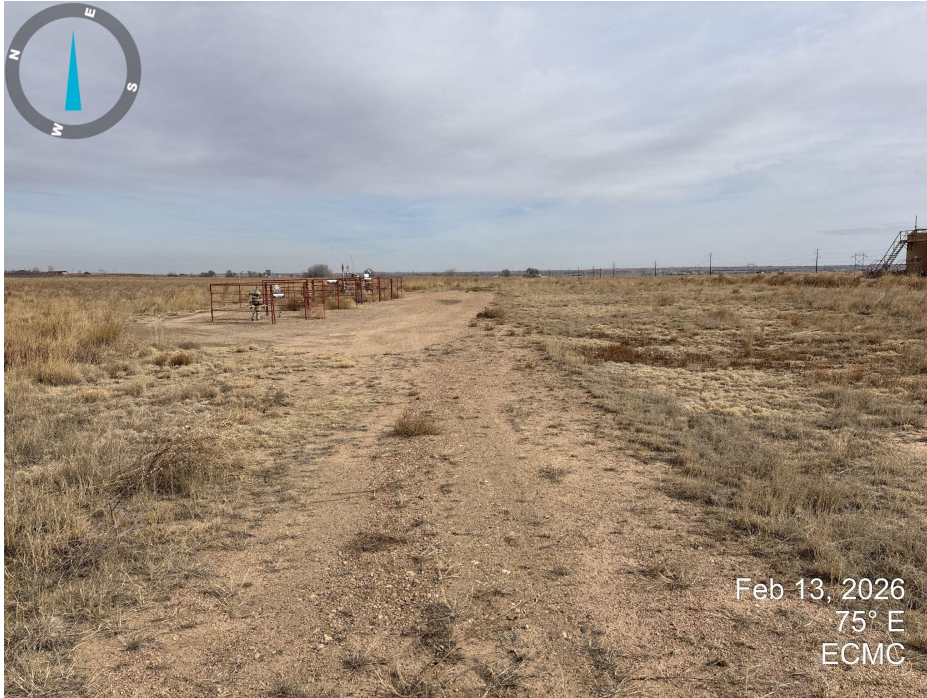
**Photo 1.** Looking east down the access road across the well area. Desirable perennial vegetation appears to be progressing in the interim area. Tumbleweed is present touching equipment.

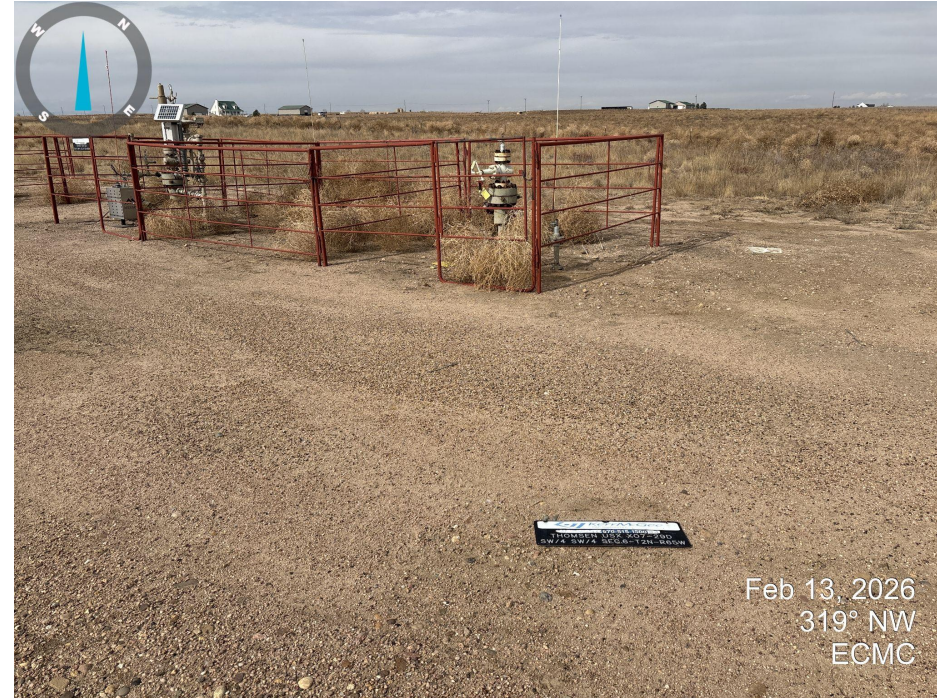
**Photo 2.** Looking north across the eastern wells. Signs appear to have been damaged by wind.

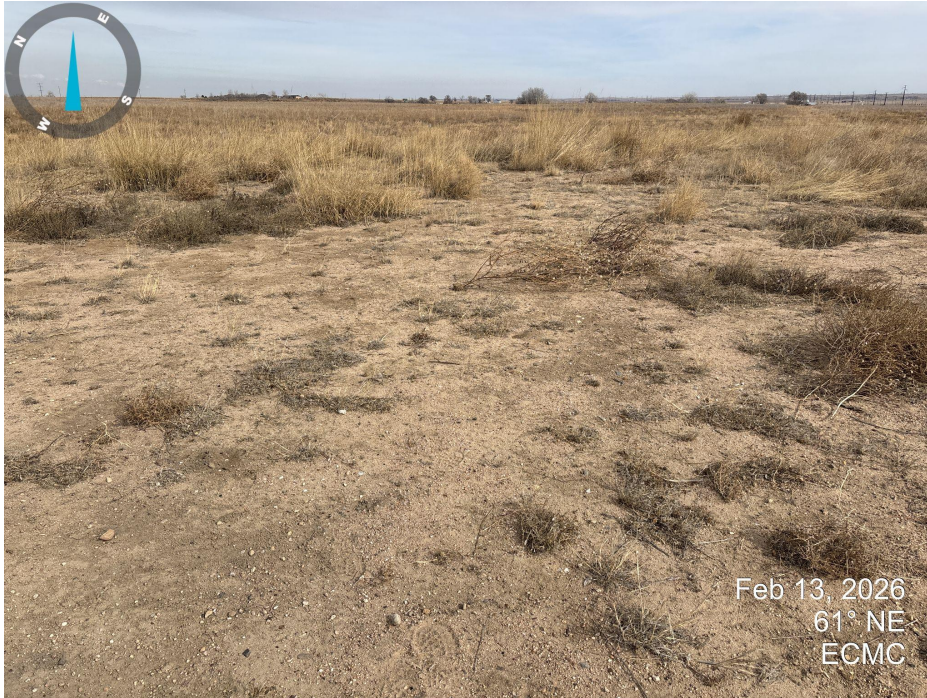
**Photo 3.** Looking east across the eastern portion of the well turnaround area. It appears some desirable vegetation is progressing in this area.

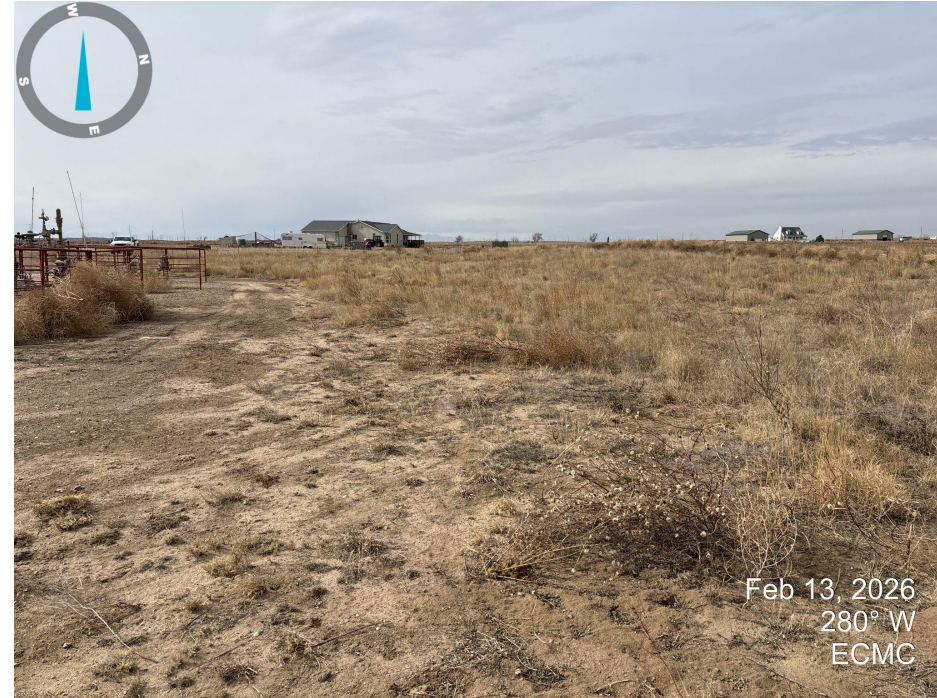
**Photo 4.** Looking west down the north side of the well area. Desirable perennial vegetation is present in the interim area.

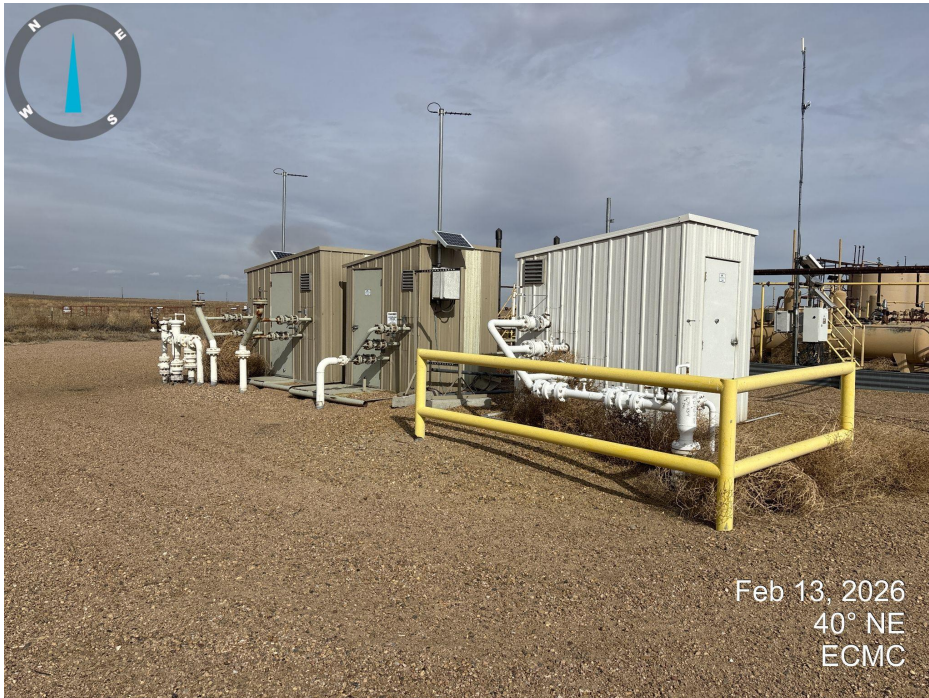
**Photo 5.** Photo taken at the wet side of the tank battery. Tumbleweed present.

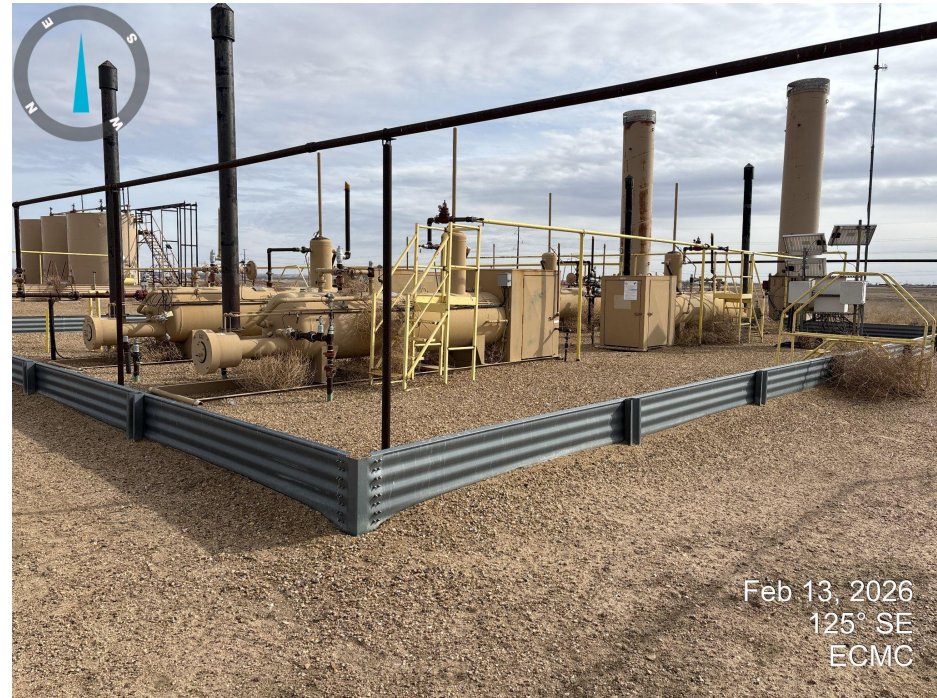
**Photo 6.** Separators at the tank battery have tumbleweed in contact with equipment.

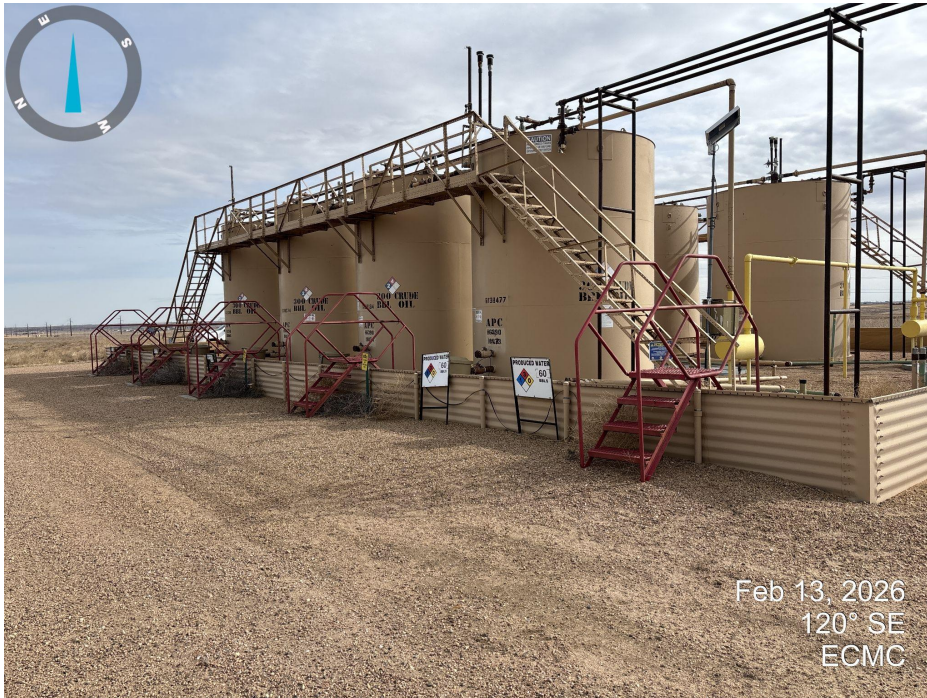
**Photo 7.** Storage tanks on the east side of the tank battery.

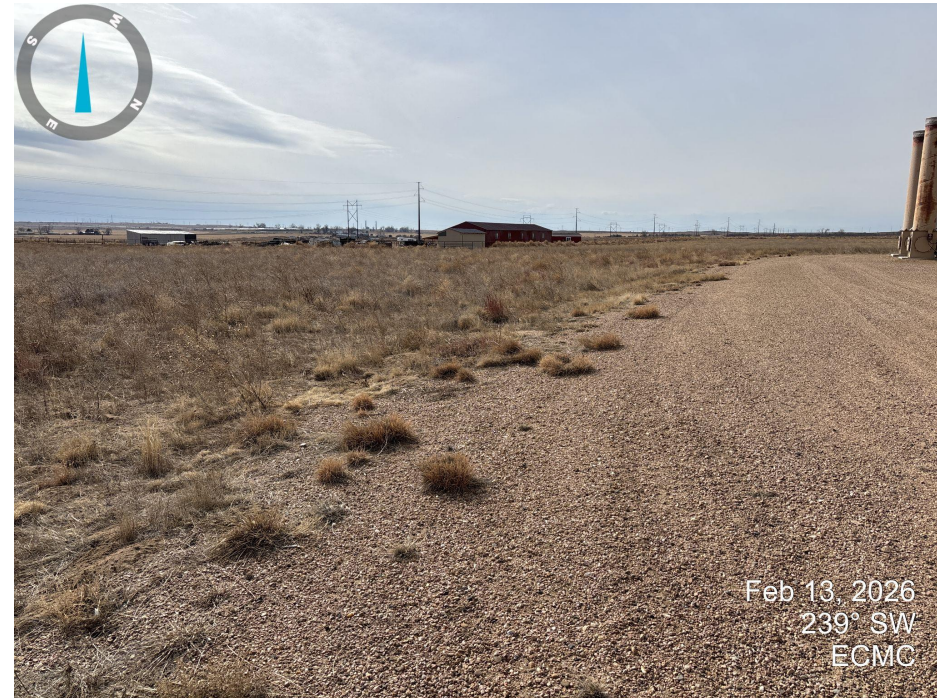
**Photo 8.** Looking west across the south side of the tank battery interim area. Desirable perennial vegetation appears to be progressing in this area.

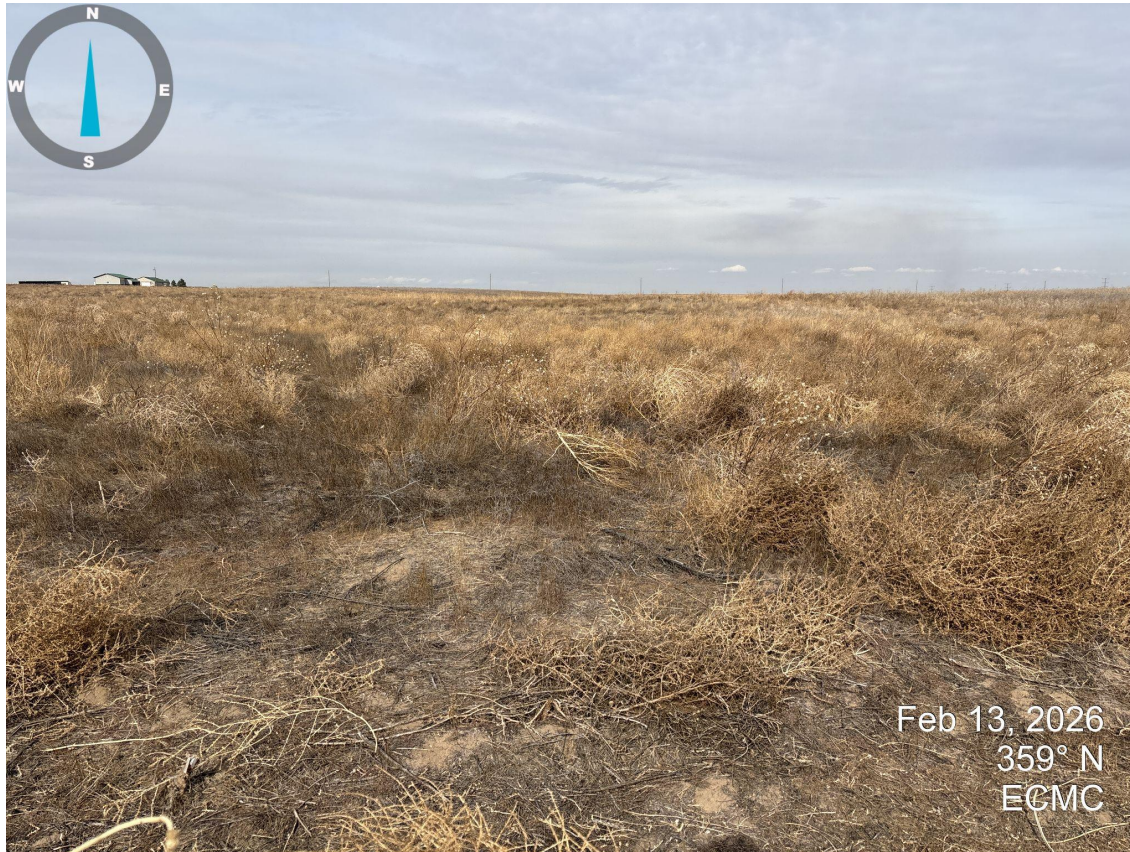
**Photo 9.** Reference vegetation to the north of the well area. Reference vegetation is primarily undesirable weedy species.
