# QB ENERGY OPERATING LLC FEDERAL HAGEN-67S95W 16NESE Facility # 335041

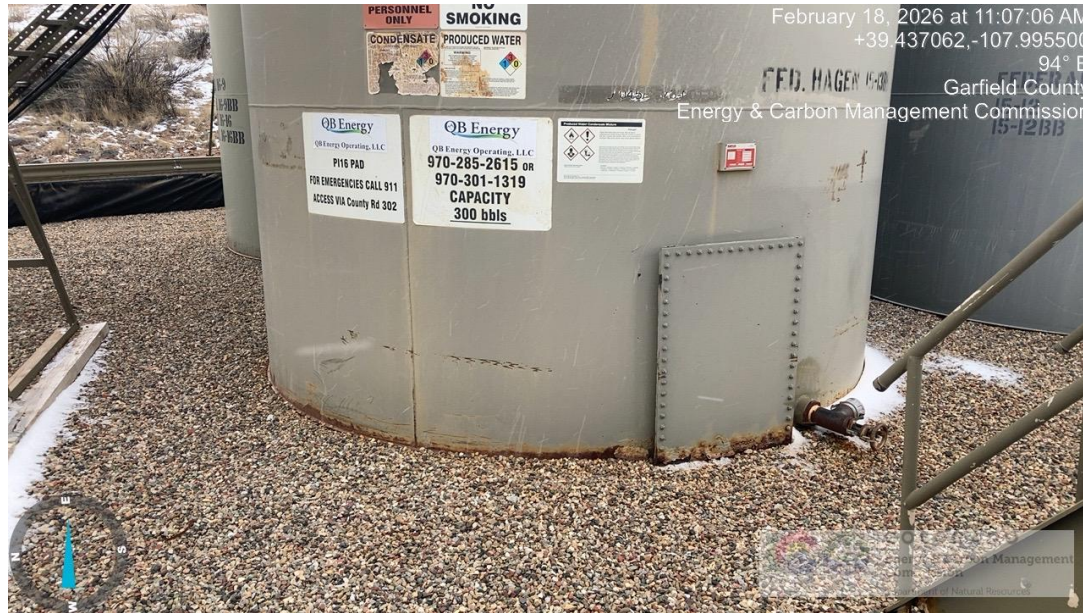
**Flaking rusted tank around bottom of tank man hatch.**

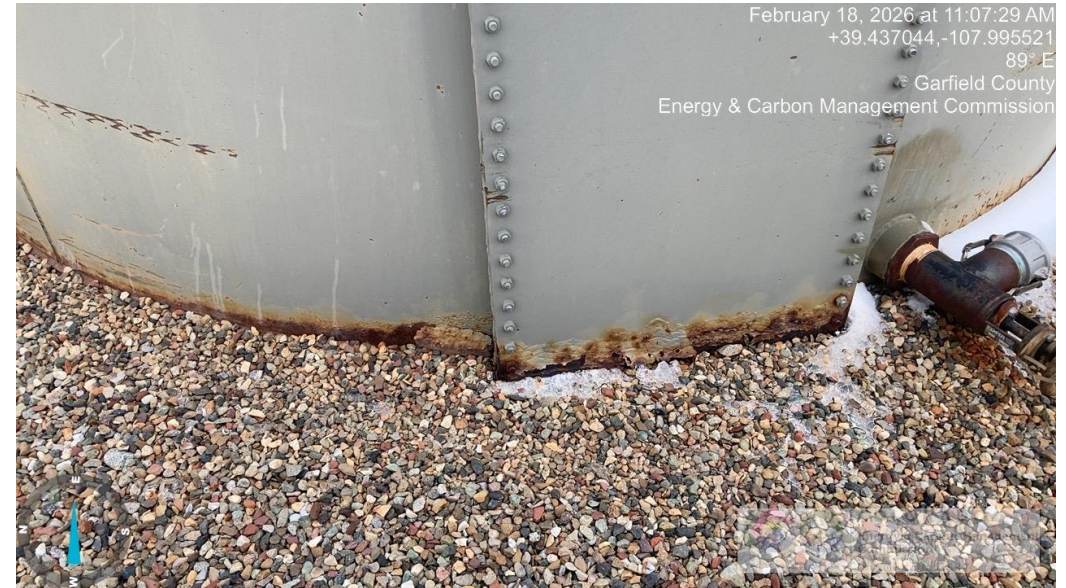
**Flaking rusted tank around bottom of tank man hatch.**

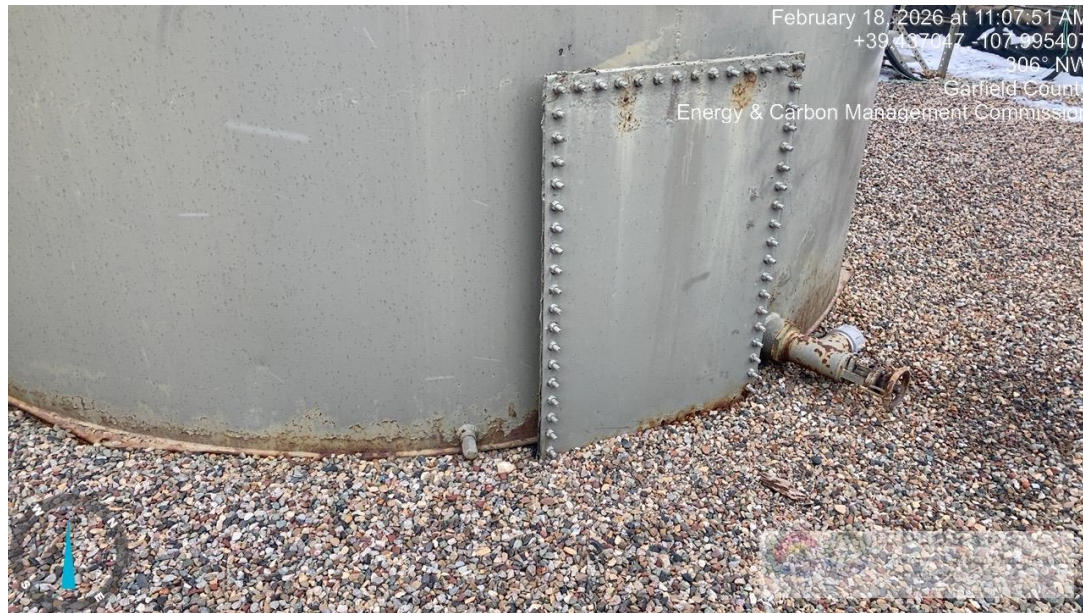
**Rusty bottom on the tank man hatches.**

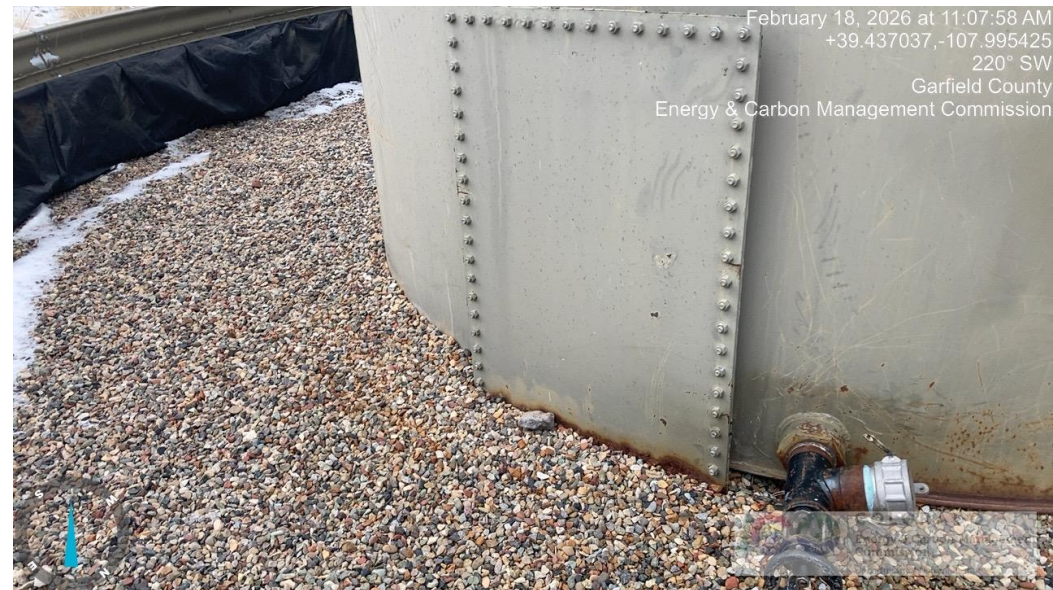
**Rusty bottom on the tank man hatches.**

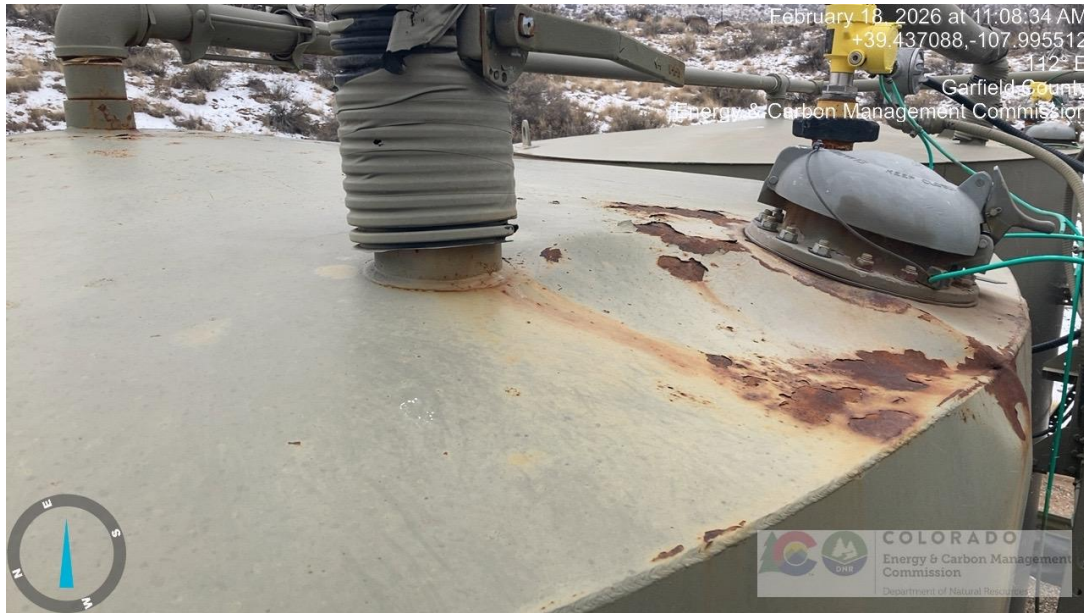
**Tank damage on top of tank at tank thief hatch.**

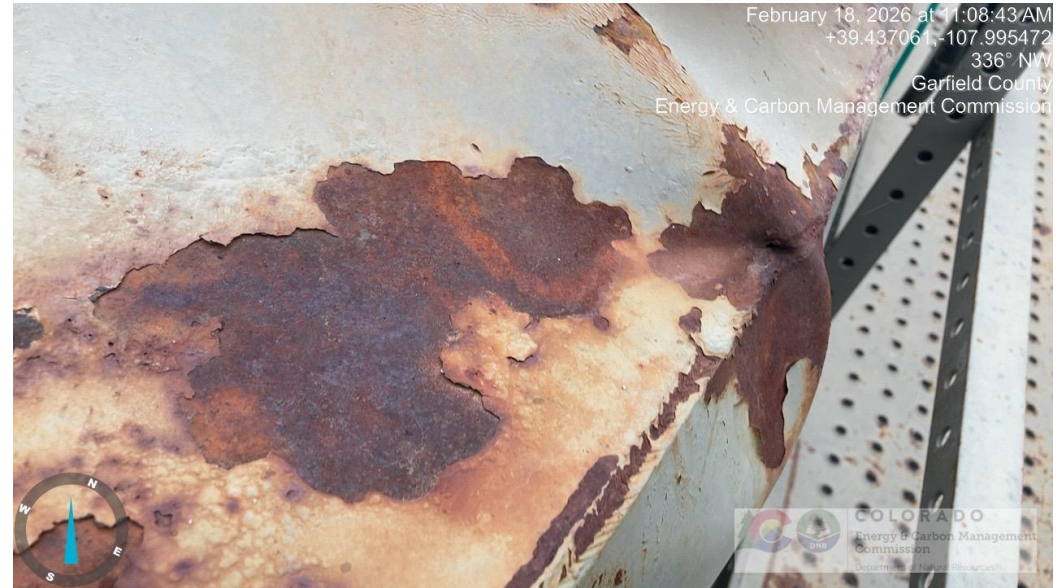
**Hole in tank seem from tank damage.**

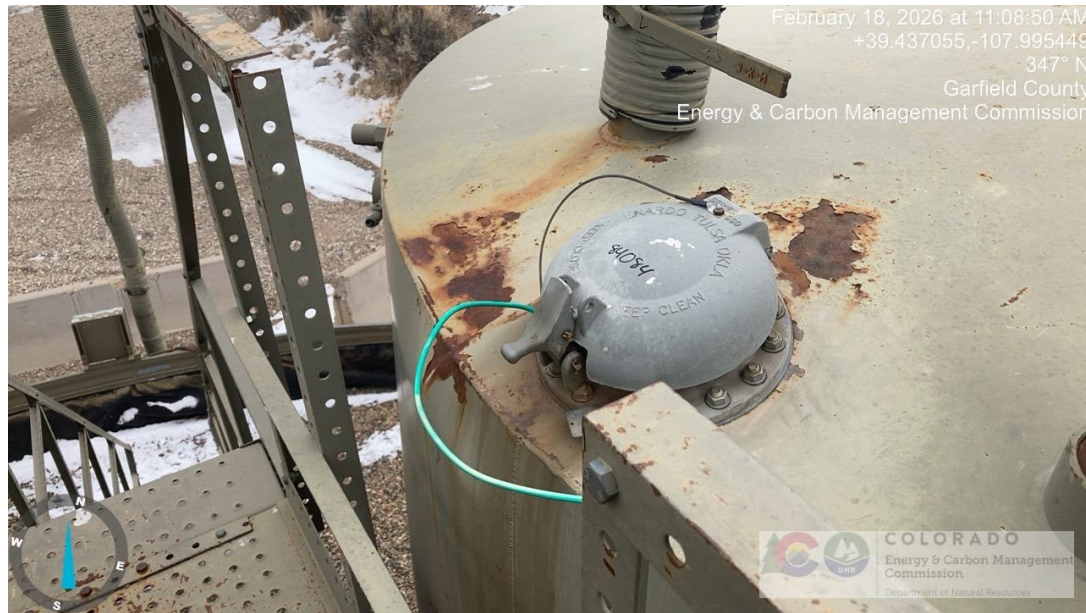
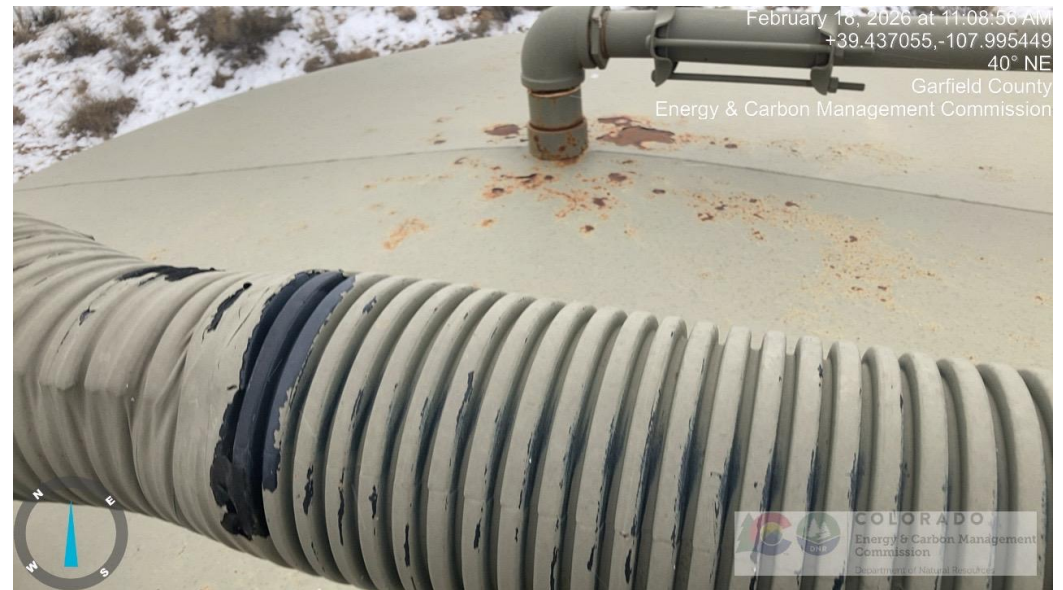
**Rust corrosion in middle of tank top.**
