Inspection Photos

Location Name: LARAMIE ENERGY LLC CC 0629-02 Pad

Location ID: 335149

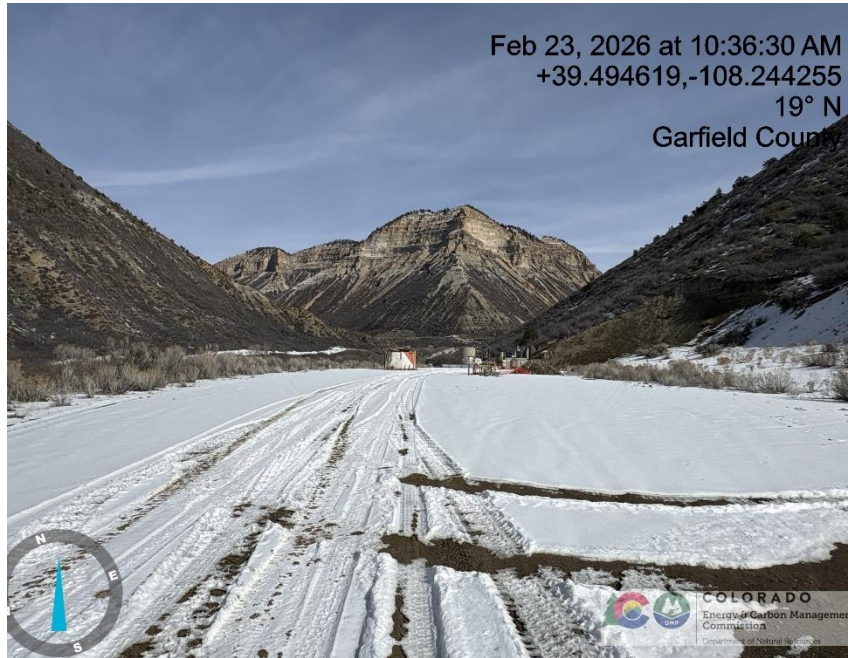
Photo # 1557 From entrance to location

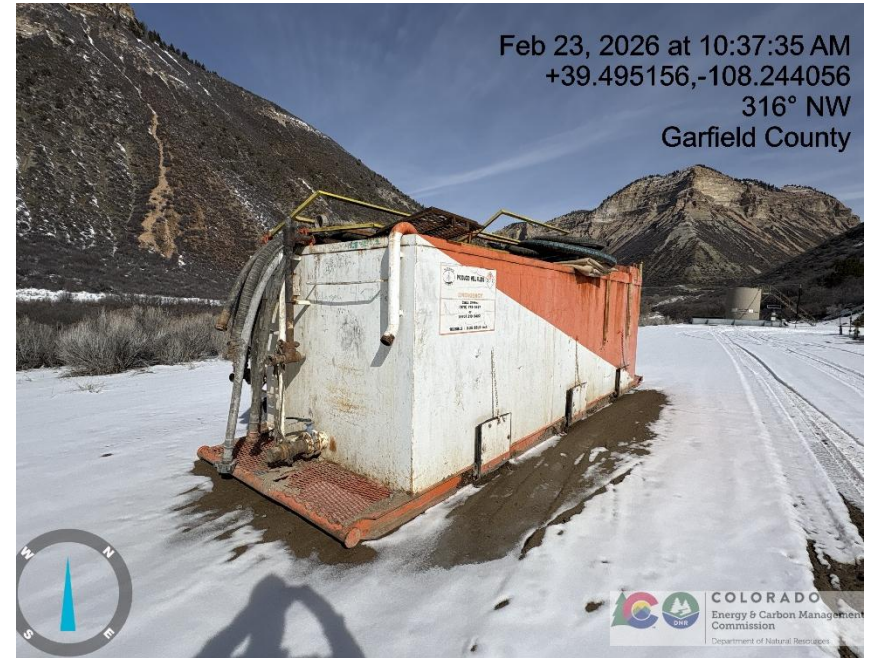
Photo # 1562 Stored/unused equipment

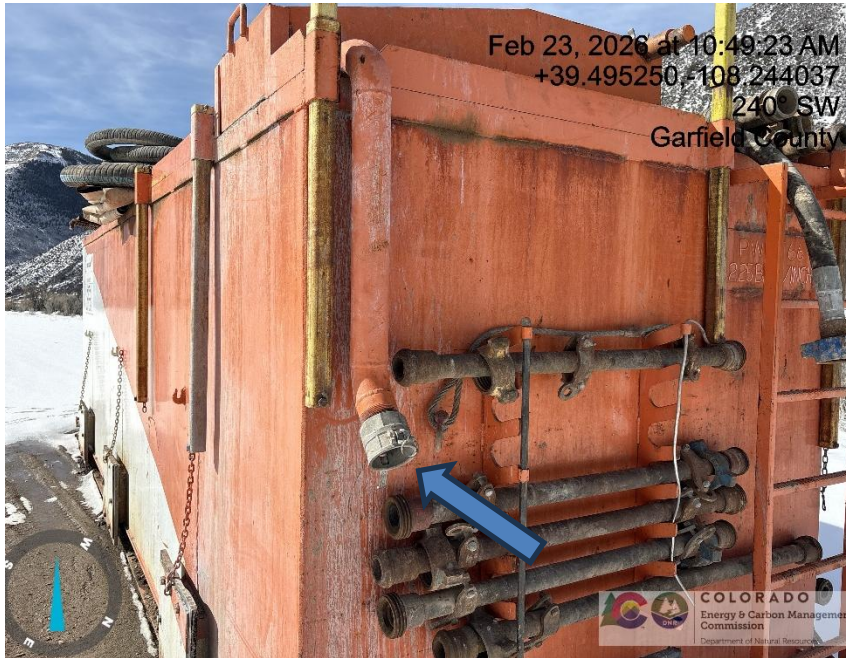
**Photo # 1563 Open ended pipe on stored equipment
/wildlife hazard/available for entry by wildlife**

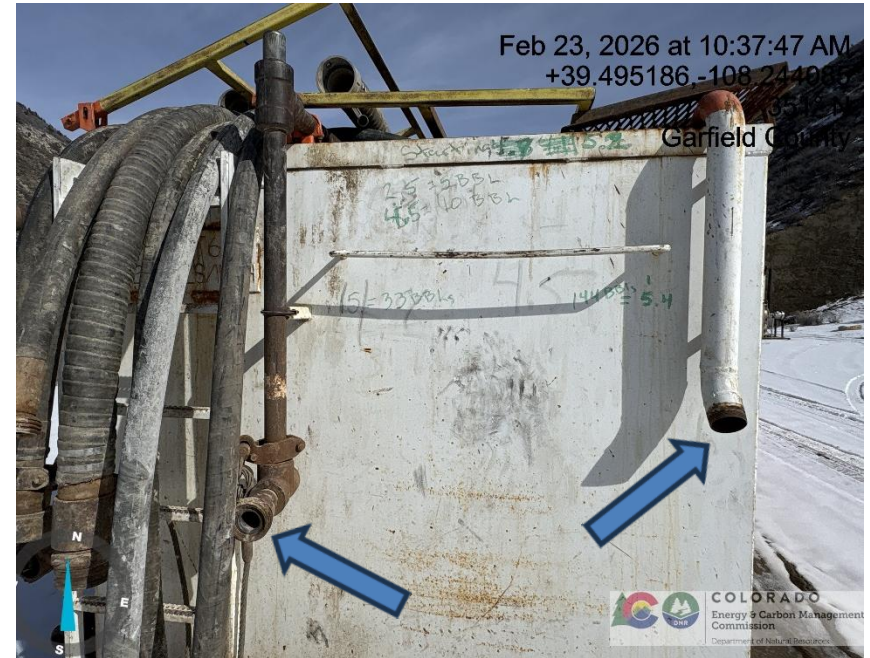
**Photo # 1564 Open ended pipes on stored equipment
/wildlife hazards/available for entry by wildlife**

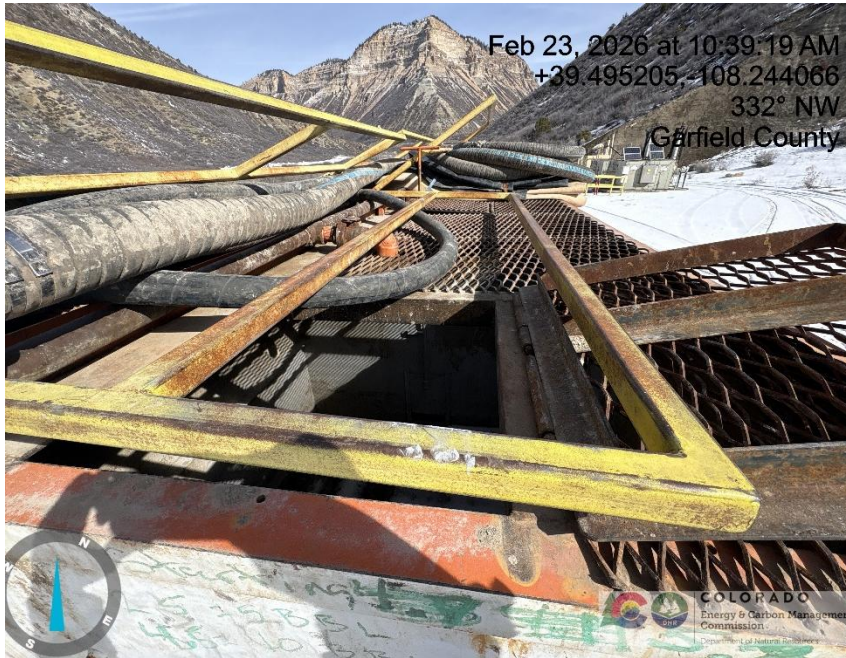
Photo # 1565 Open hatch on stored equipment/wildlife hazard/available for entry by wildlife

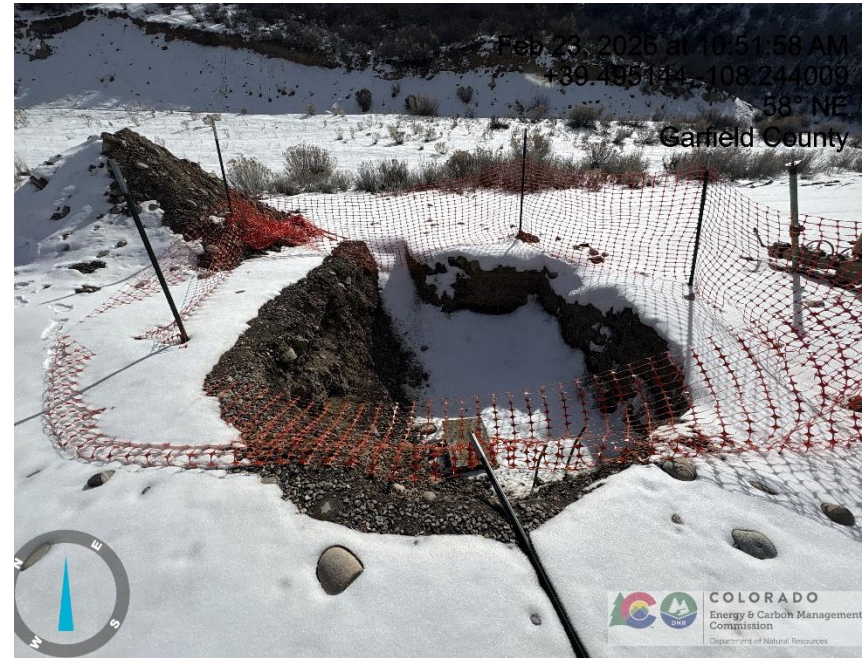
Photo # 1566 Wildlife & safety protection around hole needs maintenance

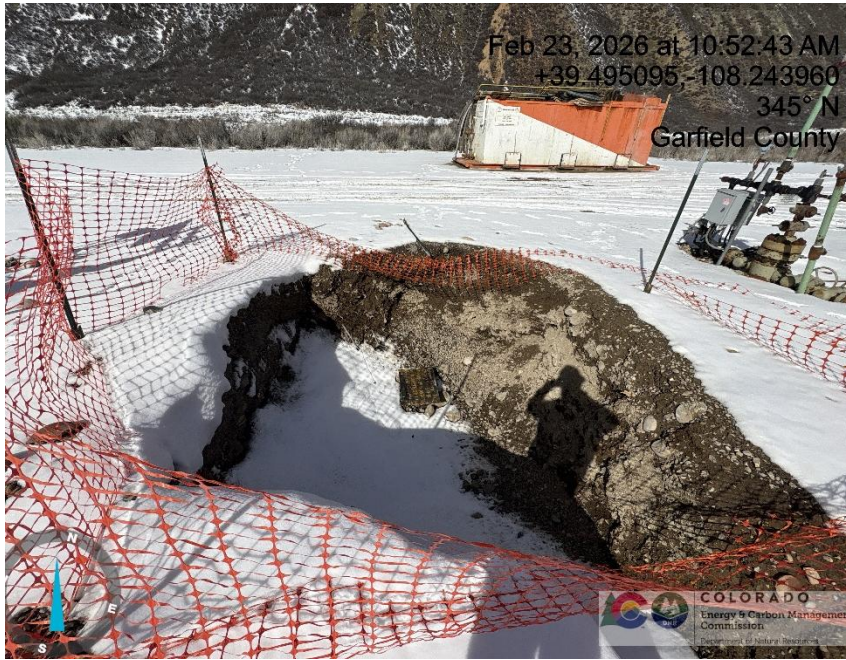
Photo # 1567 Wildlife & safety protection around hole needs maintenance

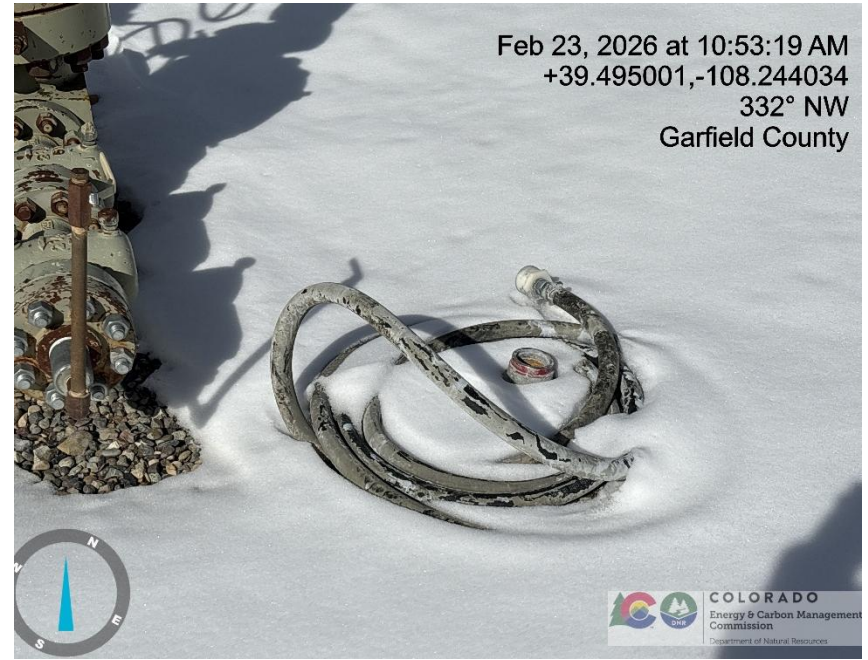
Photo # 1568 Debris

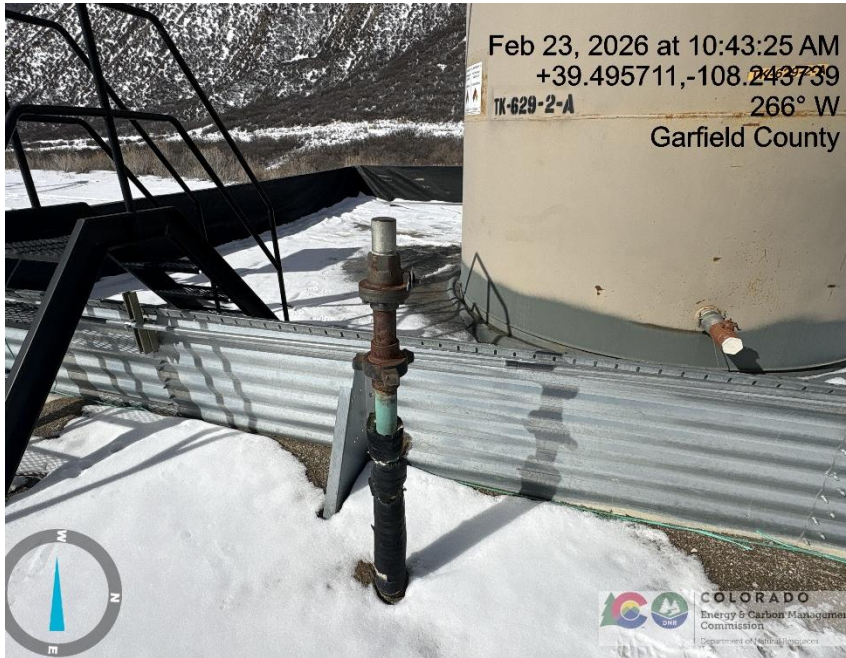
Photo # 1569 Unused flowline lacks lockout tagout (OOSLAT)

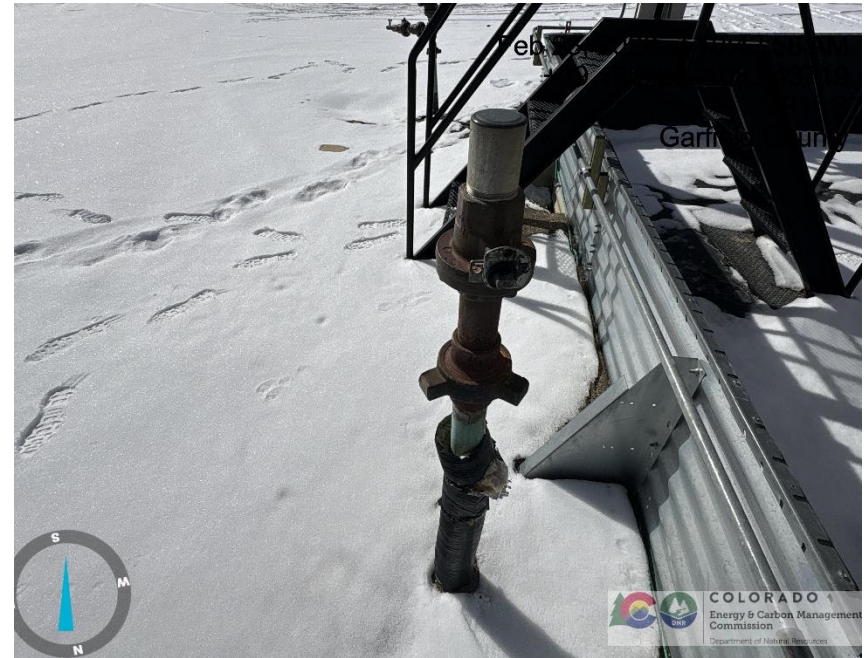
Photo # 1570 Unused flowline lacks lockout tagout (OOSLAT)
