Inspection Photos

Location Name: LARAMIE ENERGY LLC SHELL 0797-03B Pad

Location ID: 335482

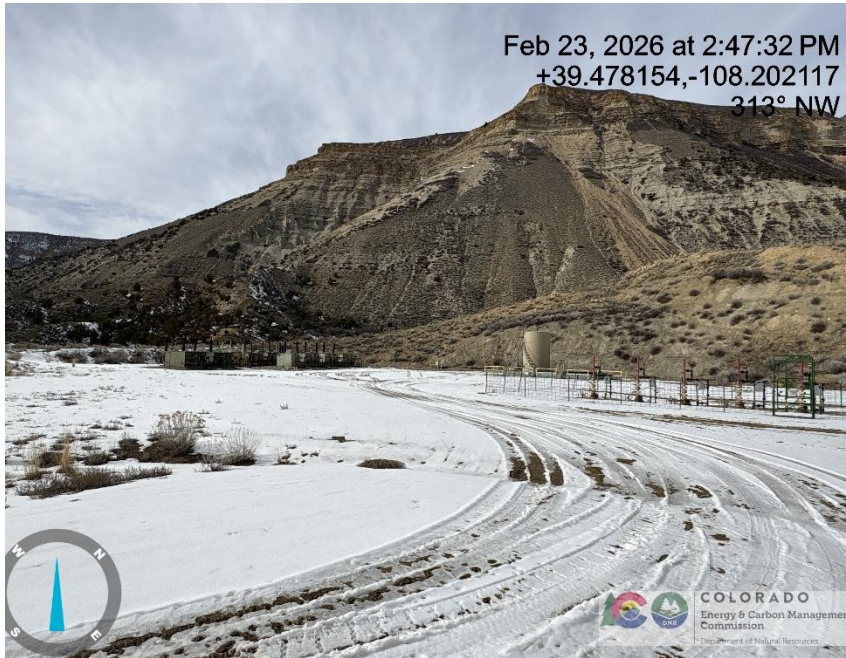
Photo # 2788 From entrance to location

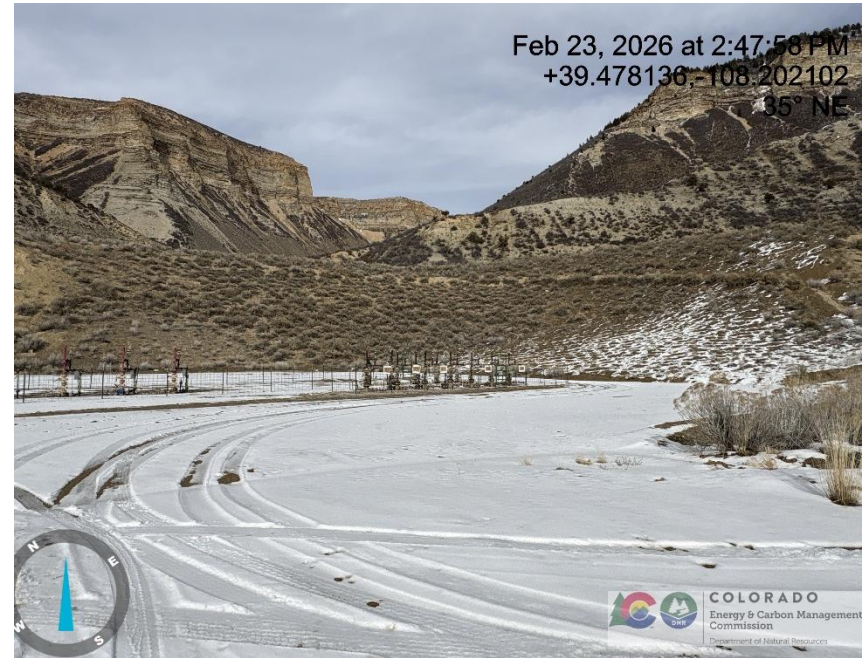
Photo # 2789 From entrance to location

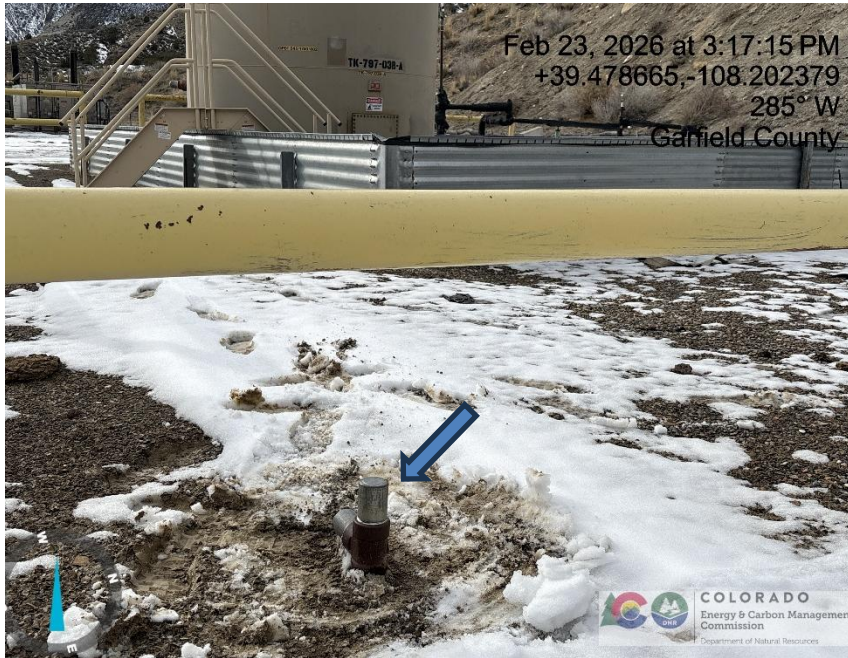
Photo # 2800 Unused flowline lacks lockout tagout (OOSLAT)

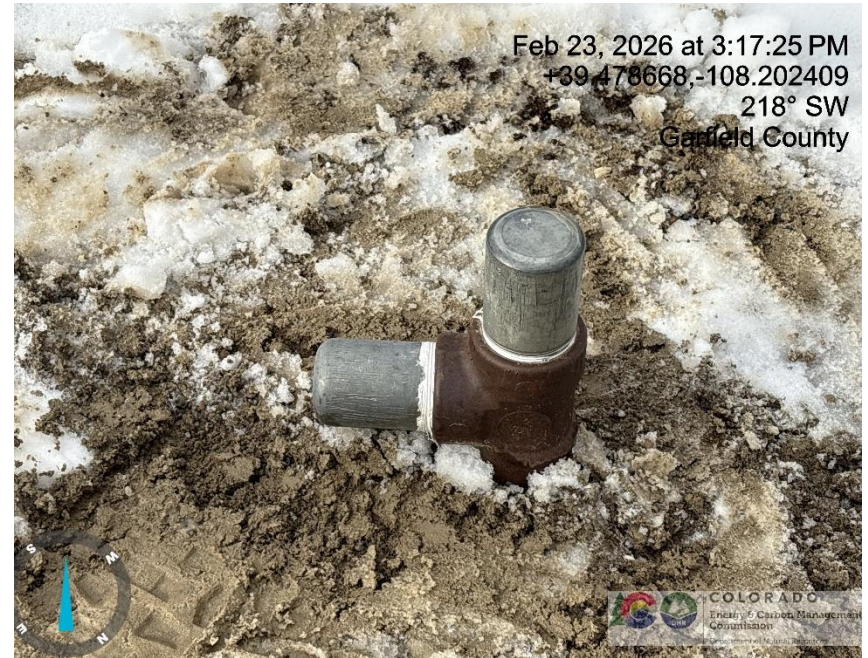
Photo # 2801 Unused flowline lacks lockout tagout (OOSLAT)

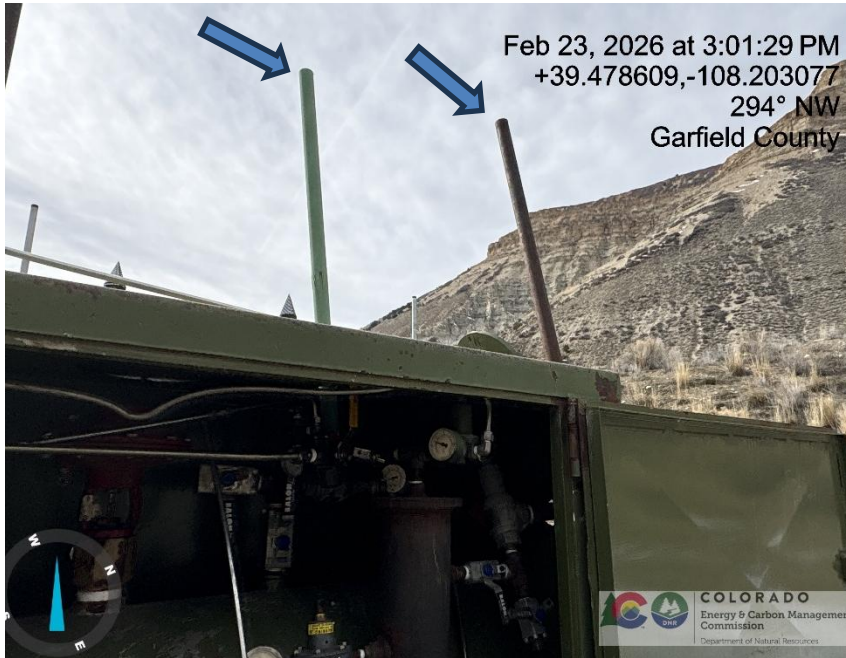
Photo # 2802 PRV vent lines do not comply with CECMC pressure safety device rules

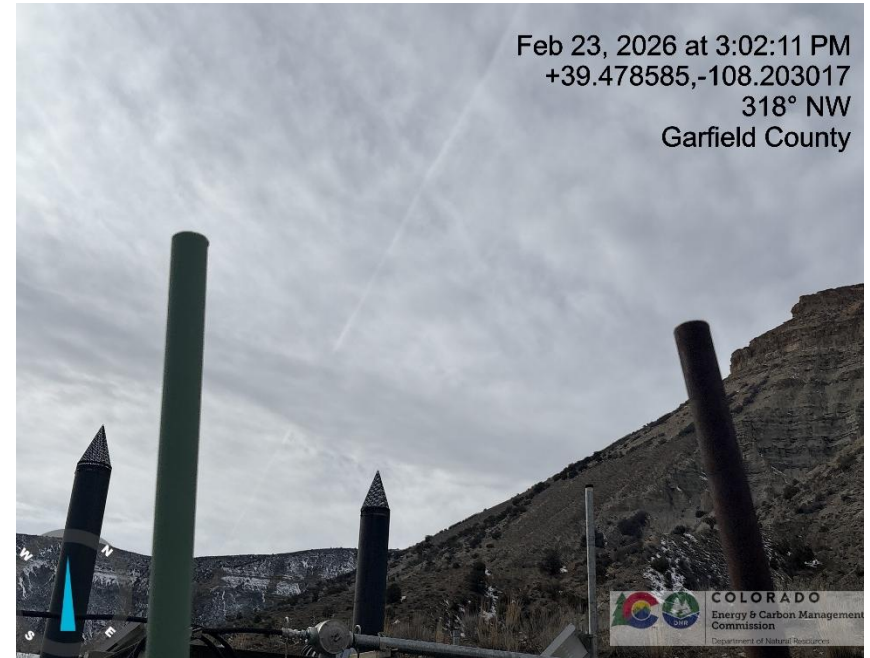
Photo # 2803 PRV vent lines do not comply with CECMC pressure safety device rules

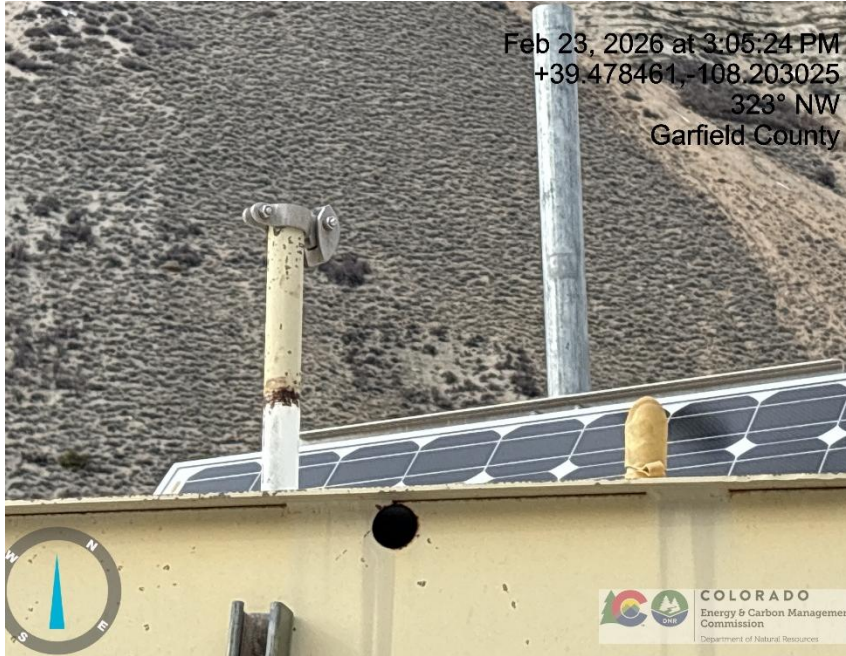
Photo # 2804 PRV vent line does not comply with CECMC pressure safety device rules

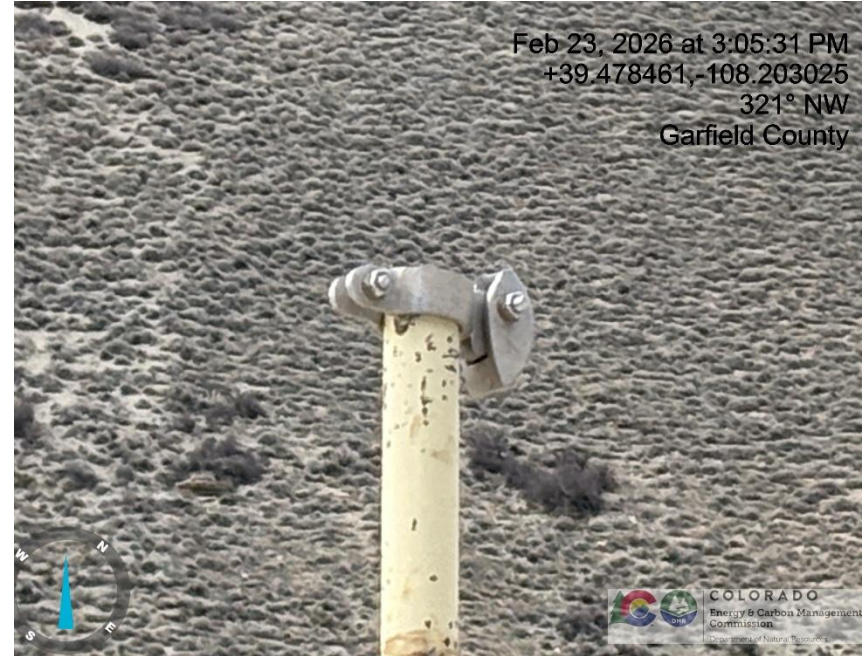
Photo # 2805 PRV vent line does not comply with CECMC pressure safety device rules

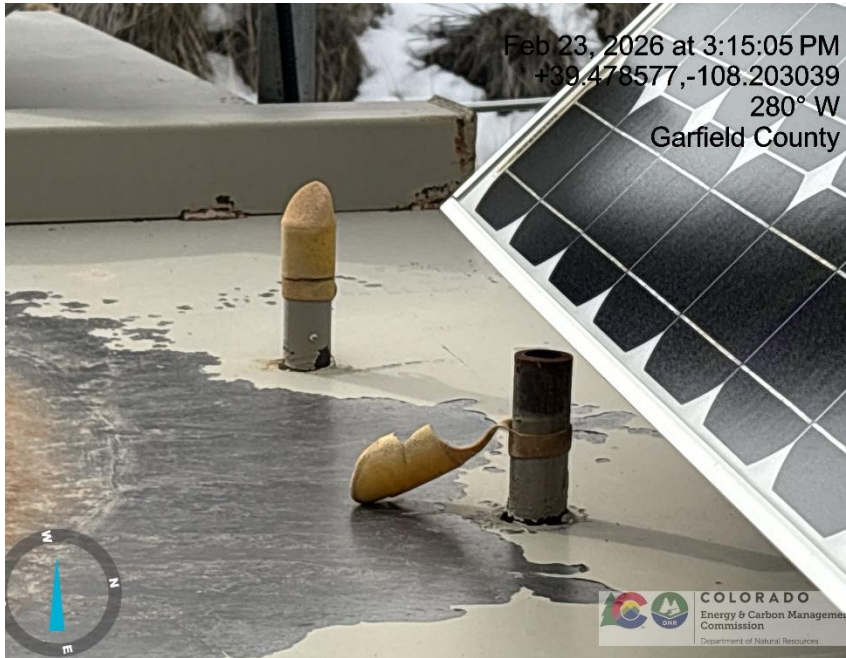
Photo # 2806 Rupture disc vent line does not comply with CECMC pressure safety device rules

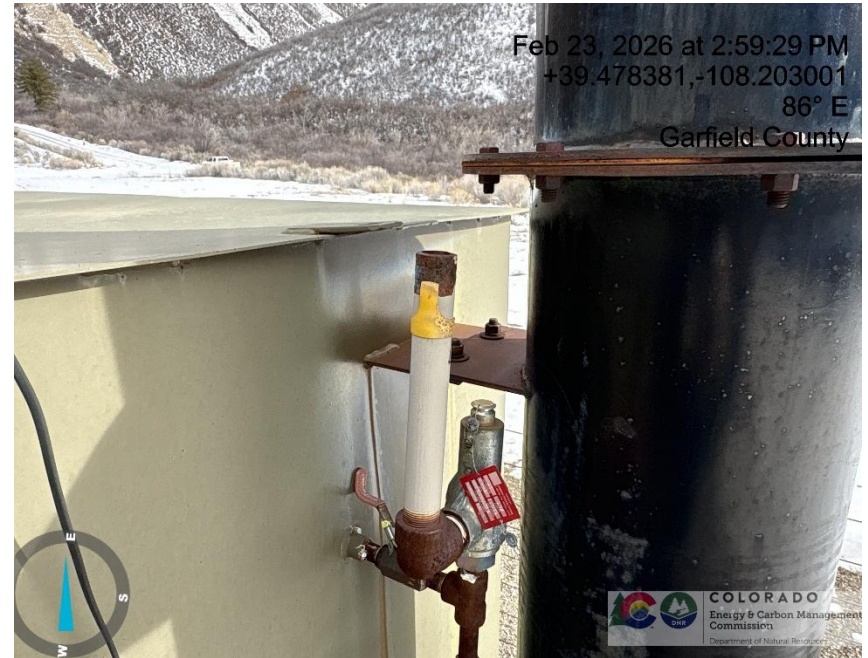
Photo # 2807 PRV vent line does not comply with CECMC pressure safety device rules
