Inspection Photos

Location Name: Lorencito 12-2-34-66

Location ID: 307588

API #: 05-071-06647

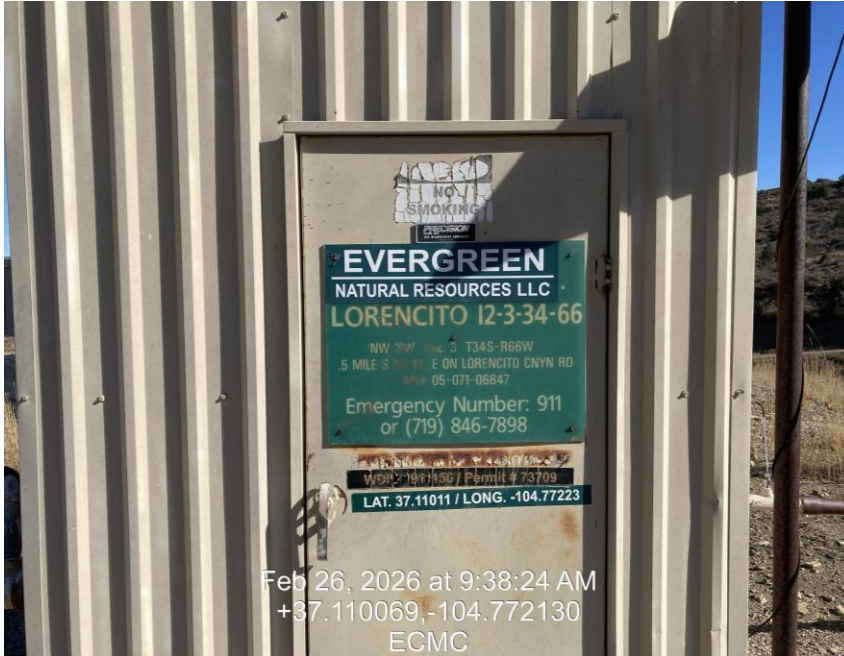
Photo 1: Well Placard

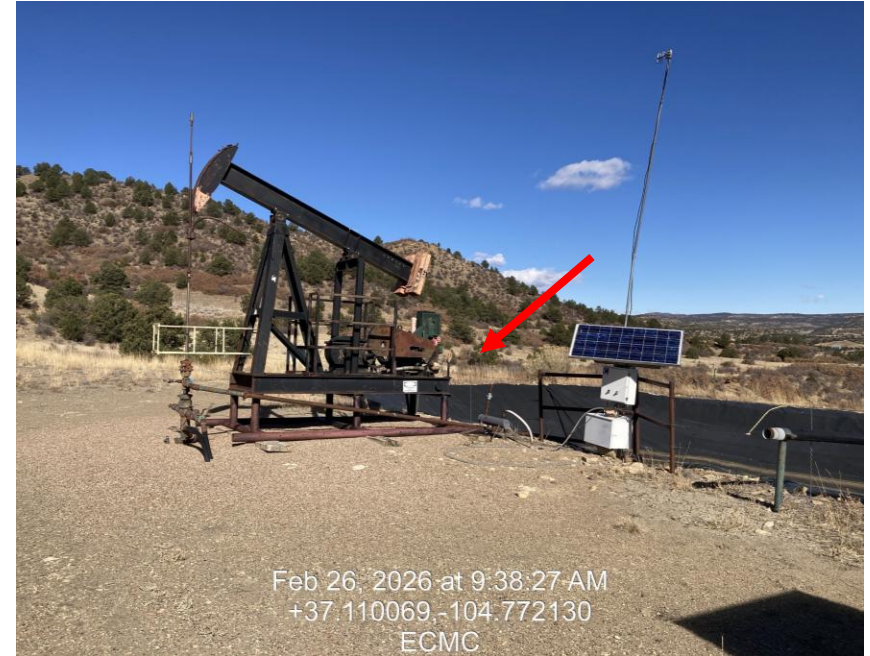
Photo 2: Wellhead and equipment

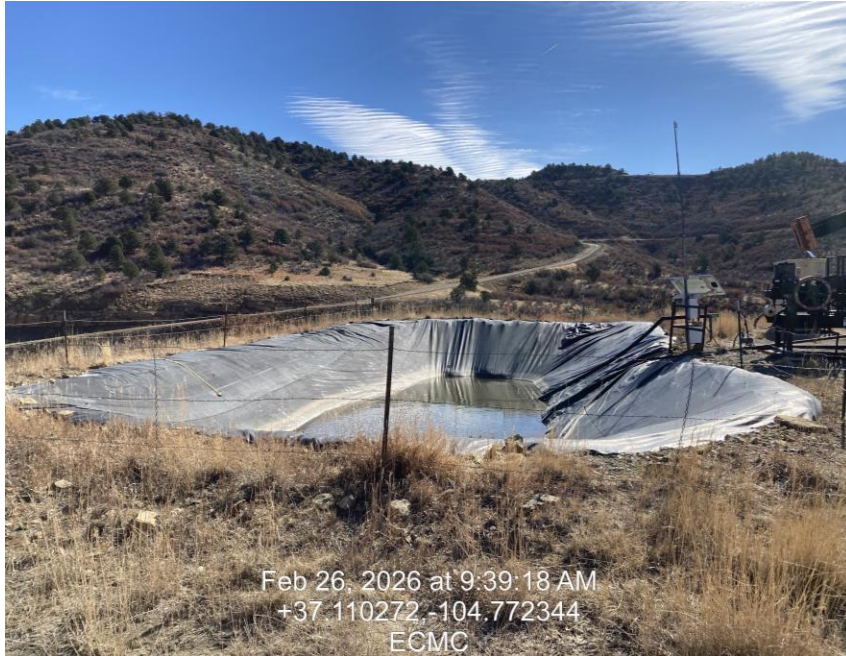
Photo 3: Pit Facility ID 261259

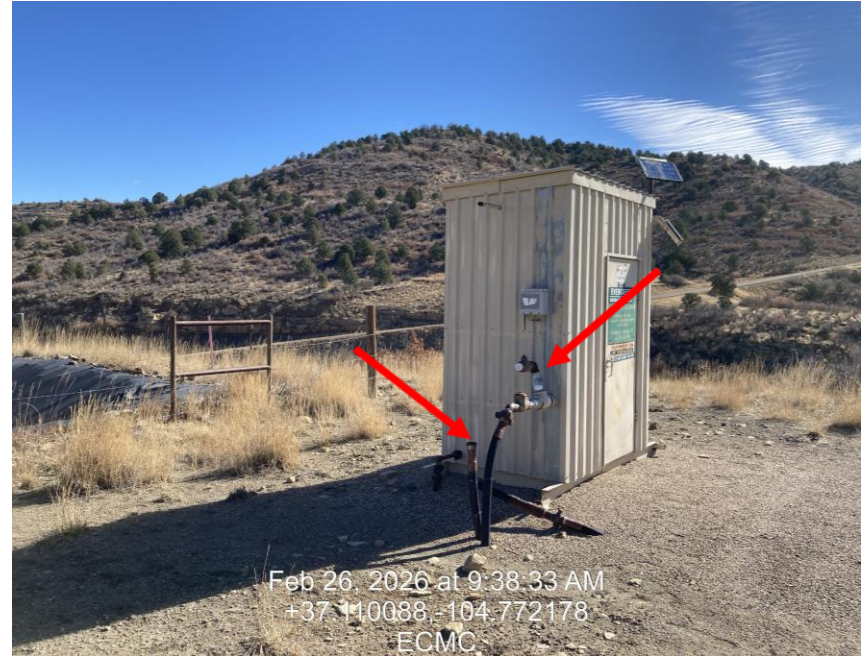
Photo 4: Meter house, disconnected flowlines

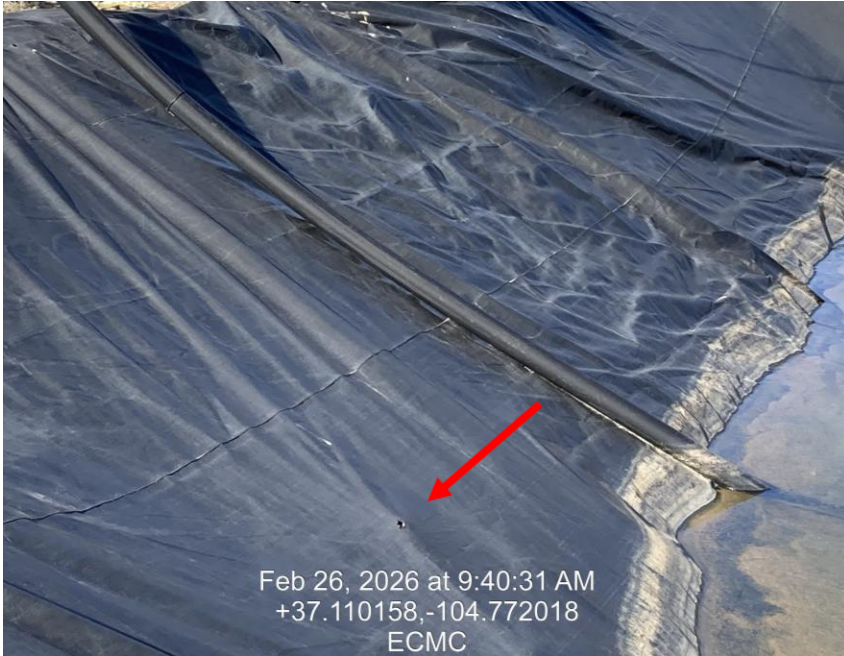
Photo 5: Hole in pit liner

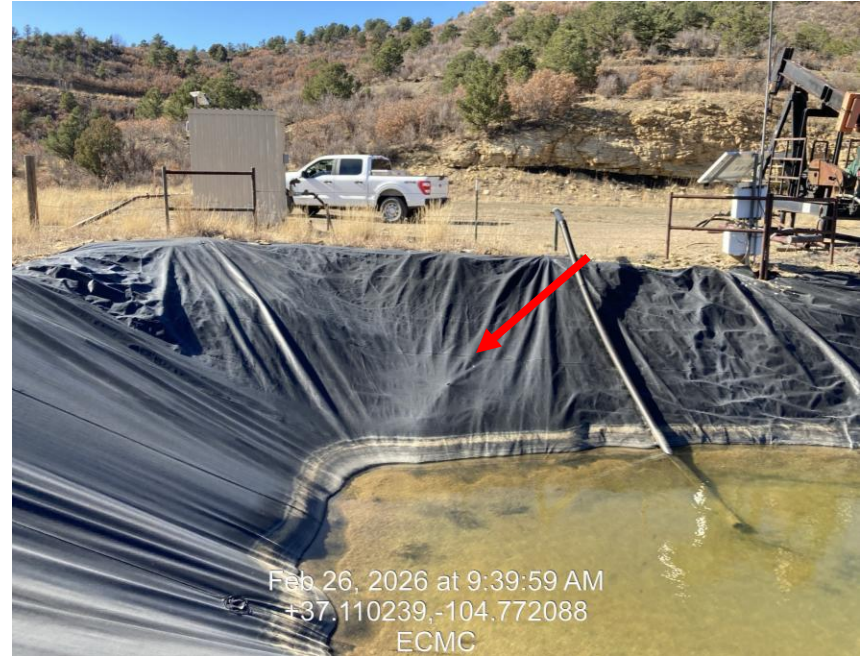
Photo 6: Hole in pit liner
