**ECMC Inspection Photos - KP Kauffman**  
**Location: Facility 8 at Maggie Norden B 1**  
**Date 02/26/2026**

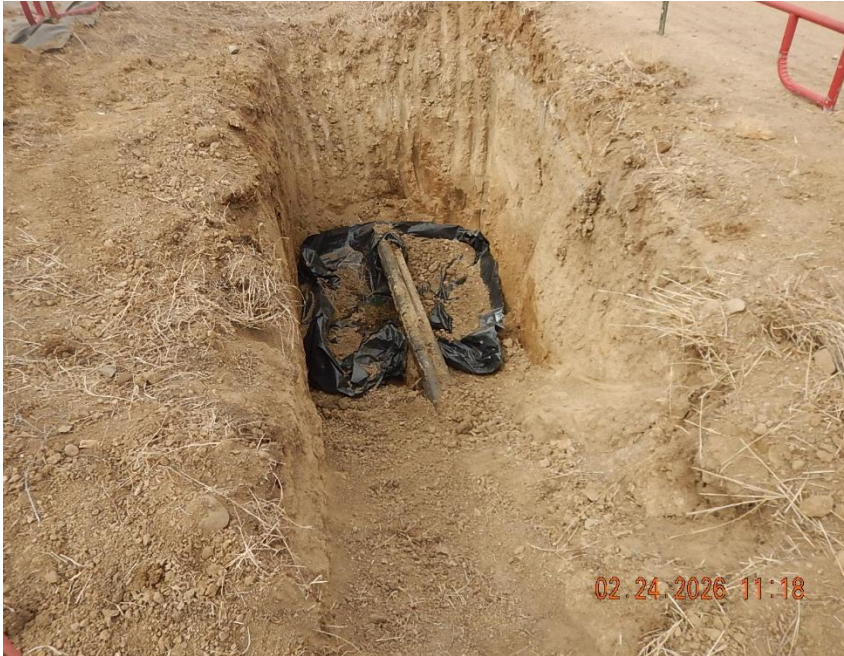
**(1) 4" CS off location flowline (Facility 8 consolidation) and (1) 2" CS gas line (OOS) exposed in excavation at point of release (40.049530, -104.866933); poly liner under pipes.**

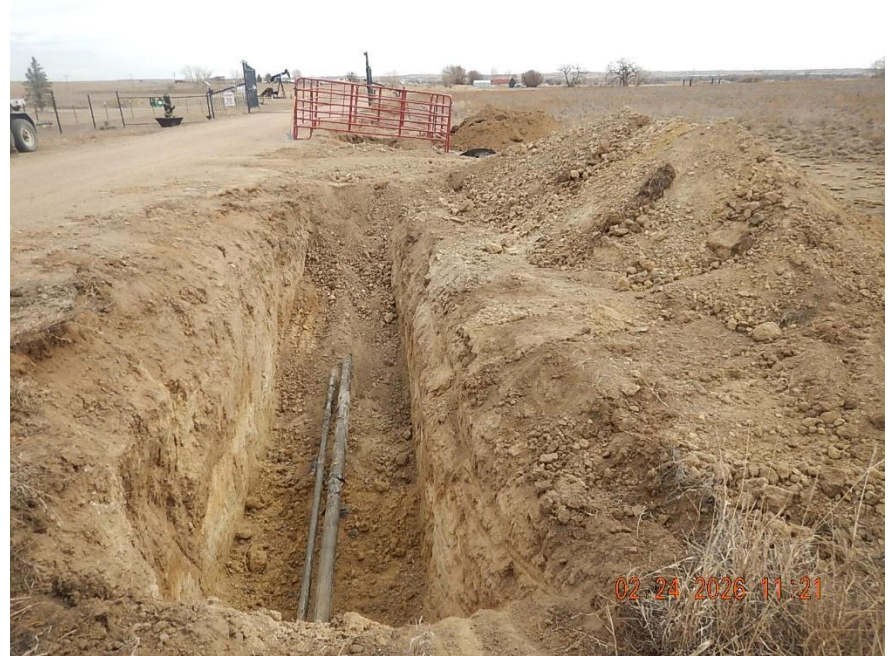
**West bell hole excavation @ 40.049530, -104.867144 and Facility 8 off location flowline(s) exposed.  
View looking east toward fenced spill/ release excavation.**

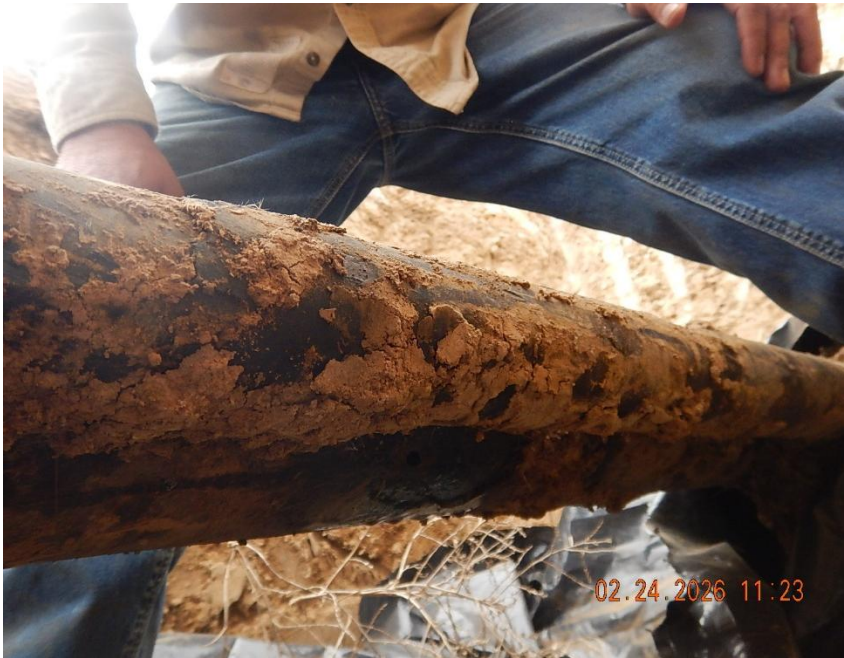
**Corrosion hole identified on the bottom of the 4" Facility 8 consolidation flowline appears to be the result of internal corrosion. External pipe coating has been blown out around hole in area of release.**

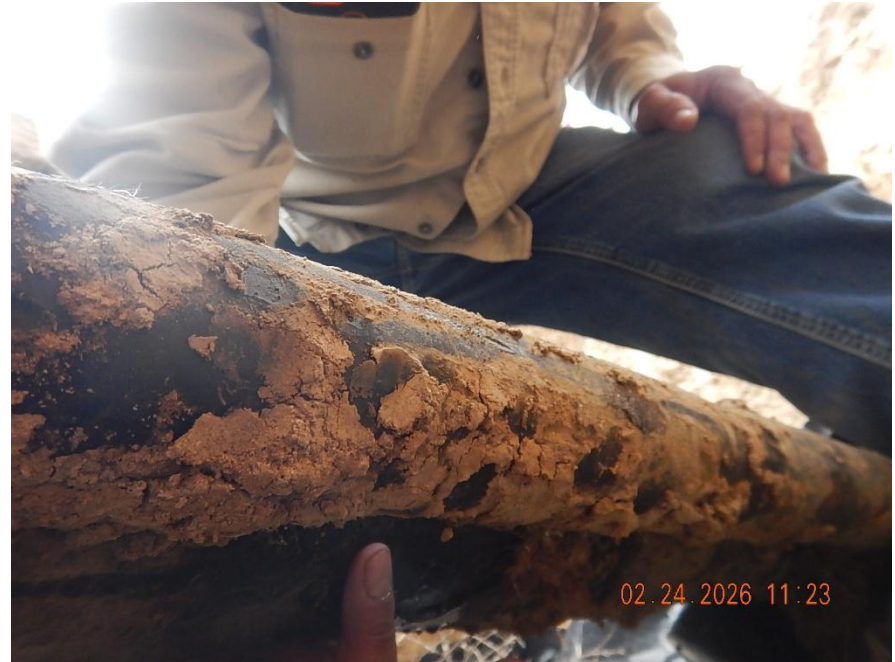
**Location of corrosion hole found on bottom of 4" Facility 8 flowline pipe is indicated with placement of finger.**

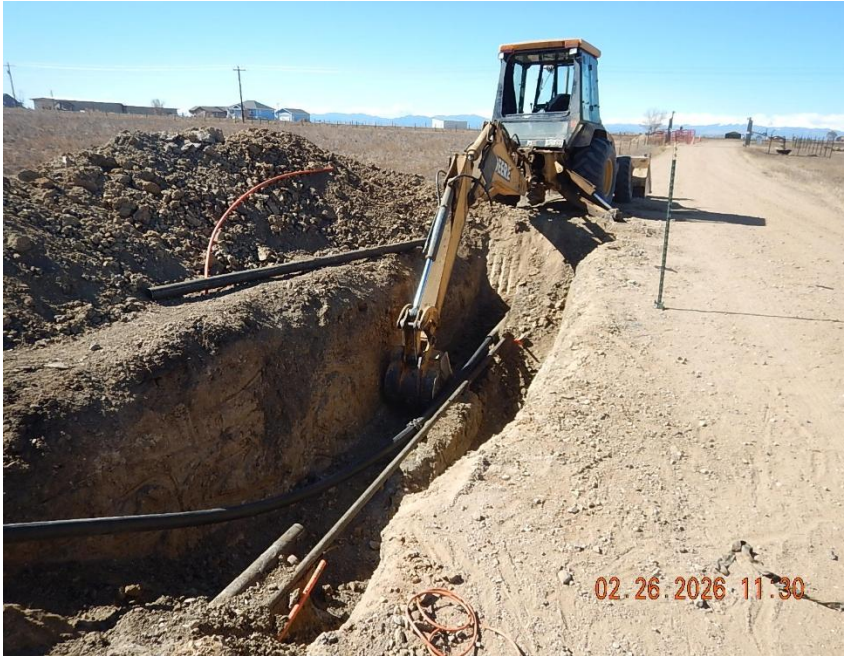
**East bell hole excavation @ 40.049530, -104.866117.**  
**Flowline pipe repair work in progress; approximately 300' of 3" SDR 11 HDPE rolled pipe being slip lined through failed section of 4" flowline pipe. View west toward spill/ release area and WCR 21.**

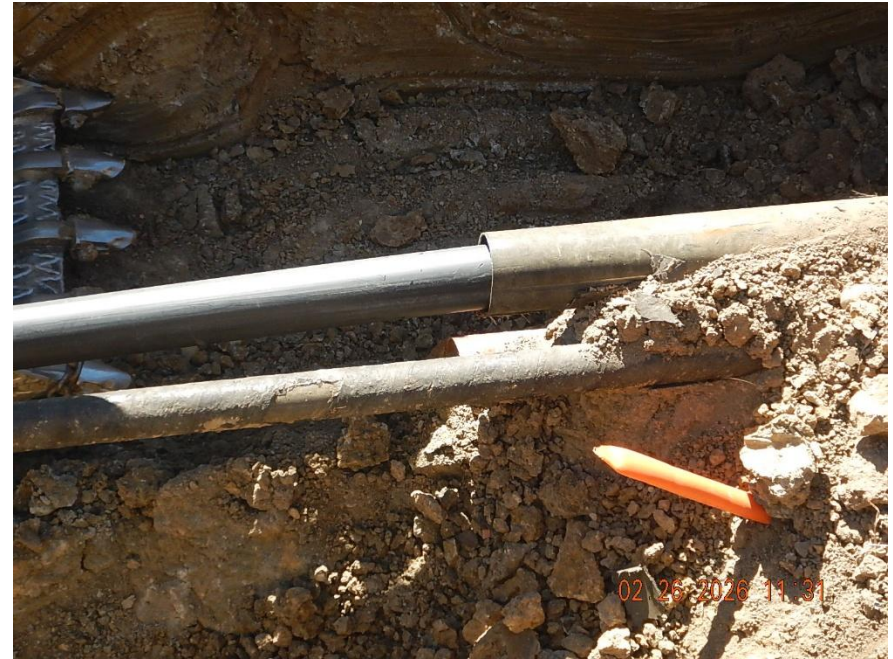
**Closer view of stinging/ slip lining flowline repair work being completed. (3) historical flowlines exposed in east bellhole excavation; (1) 2" gas line, (1) 3" fiberglass and (1) 1" orange poly line found. Per KPK field personnel historical lines found are out of service with cut ends to be capped/ sealed prior to backfill.**
