Site Specific Final Reclamation Completion Notice – Cropland Drone Imagery

Permit Closure Report – Cropland

Location ID: 322559

Location Name: FRANK-64N64W/12NENE

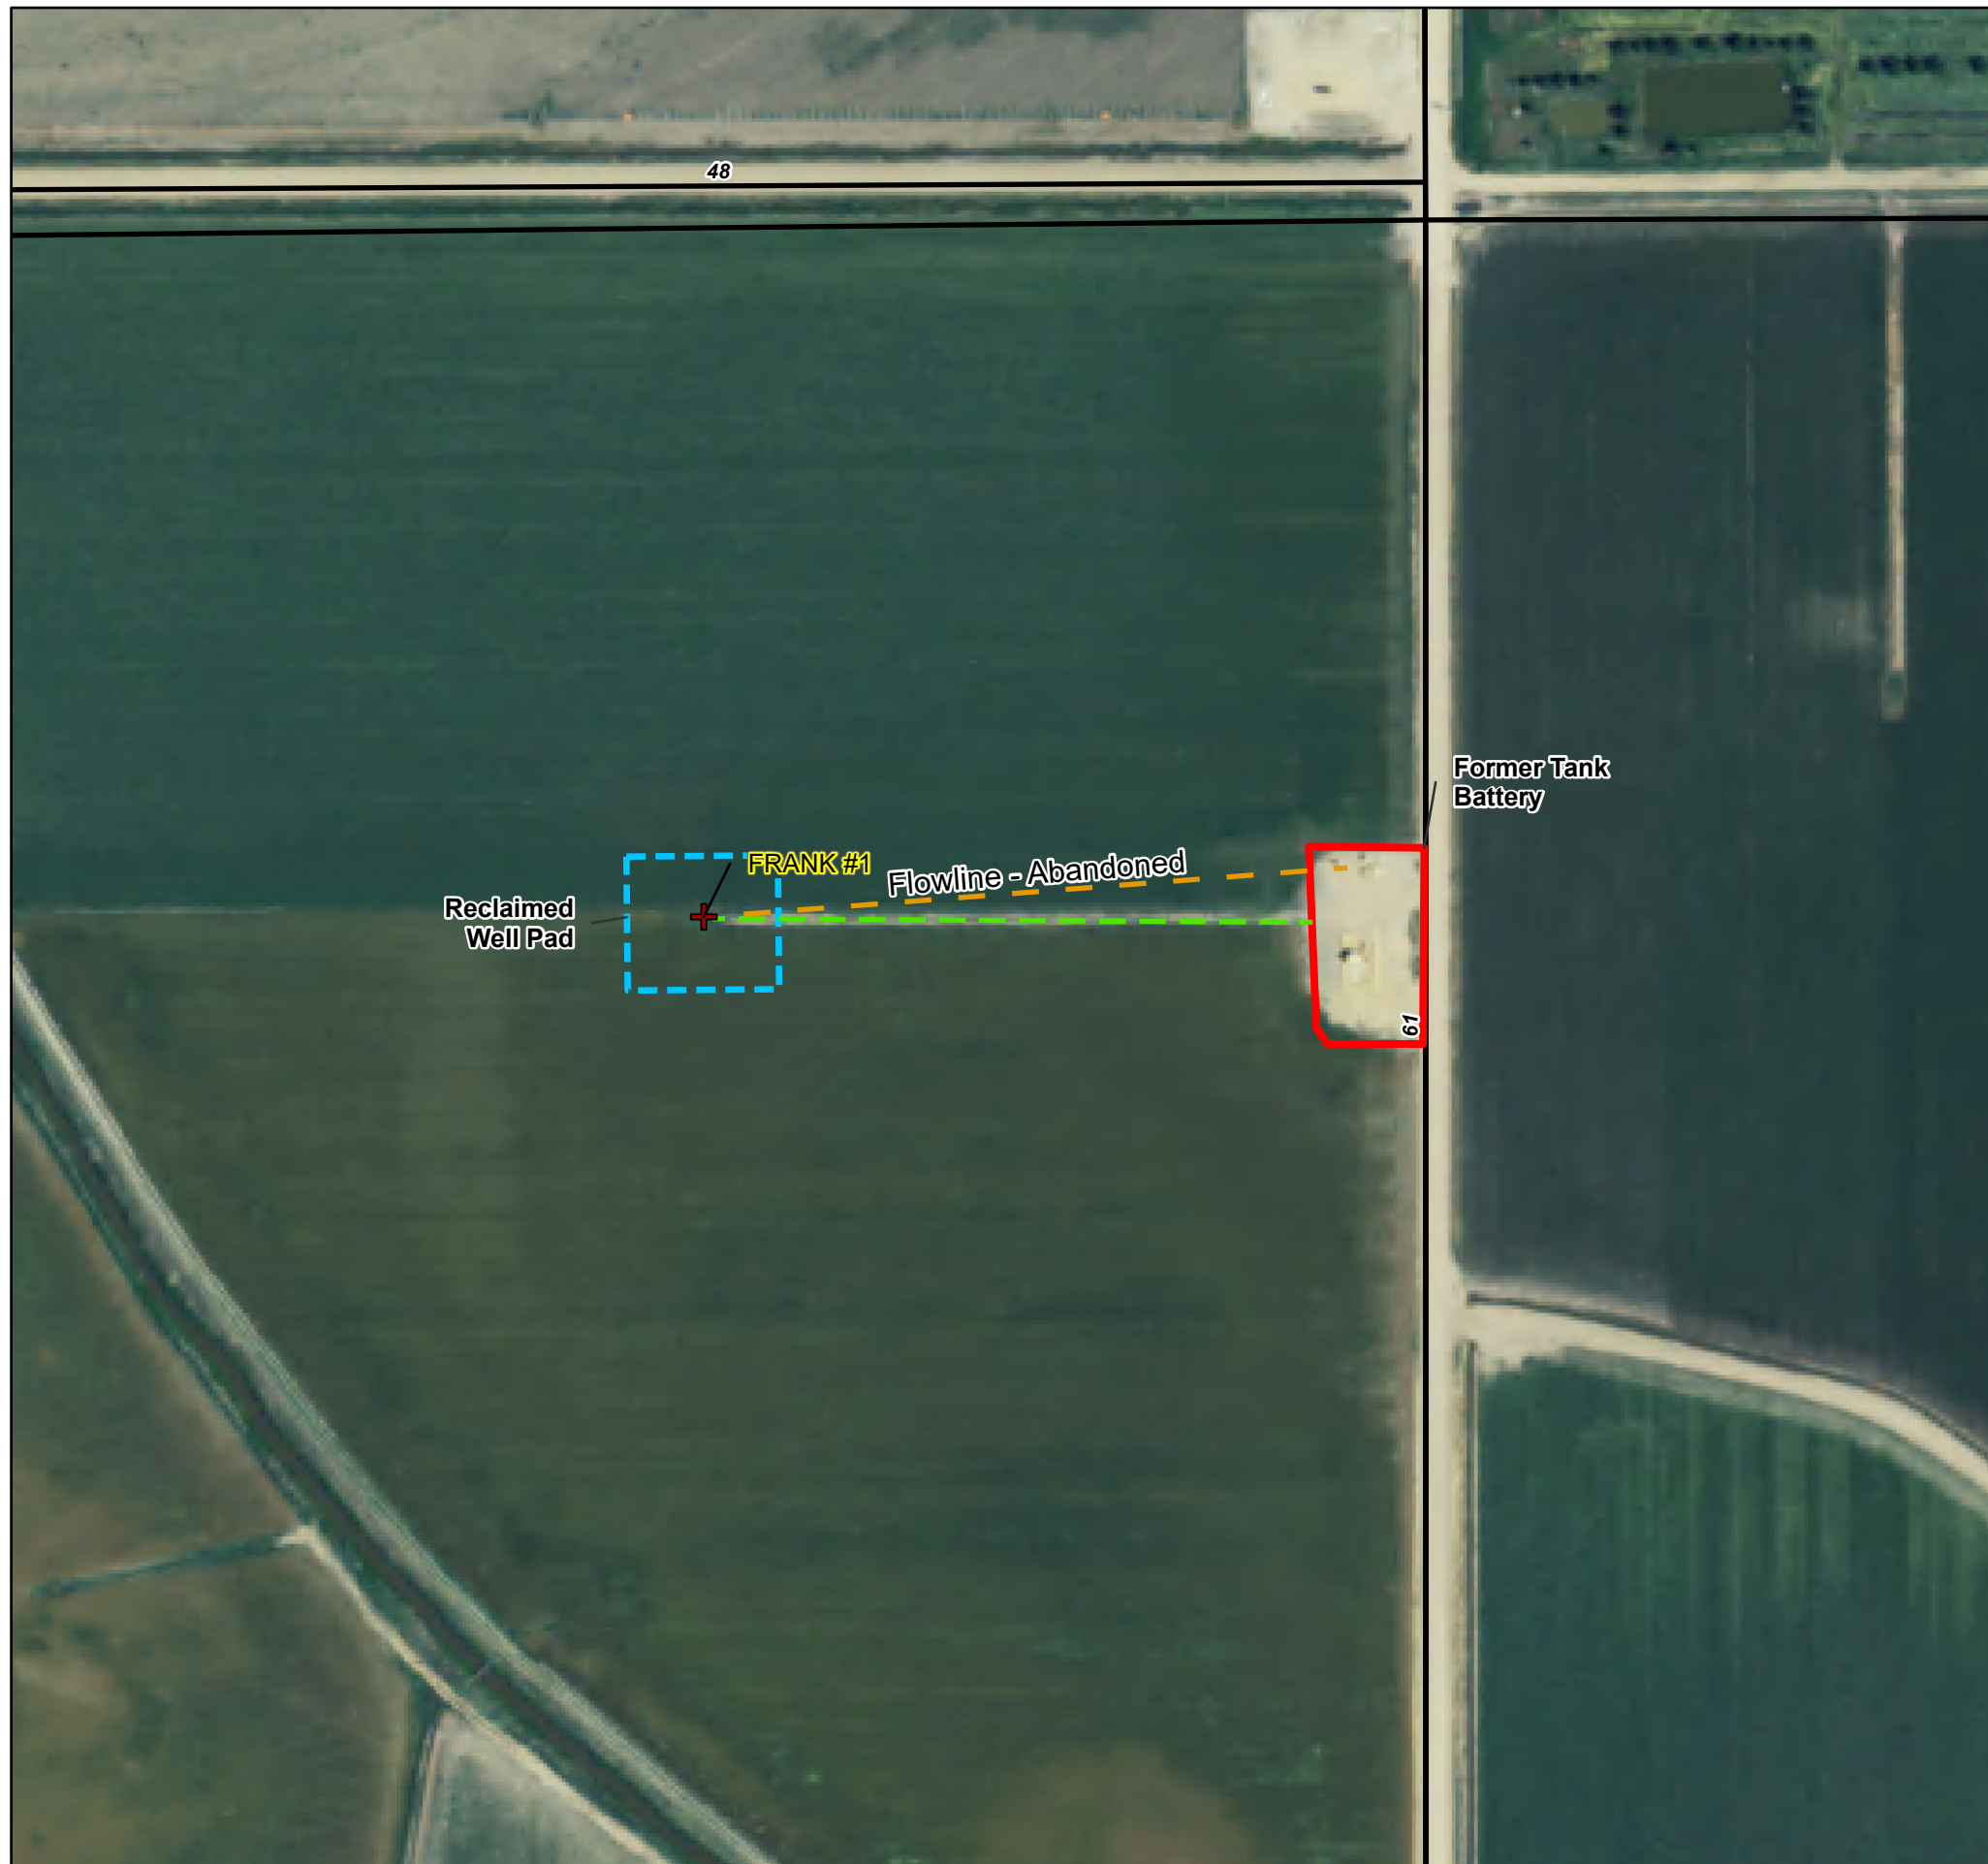
NAIP 2013 Imagery

Pre-Plugging Active Operations Location Overview

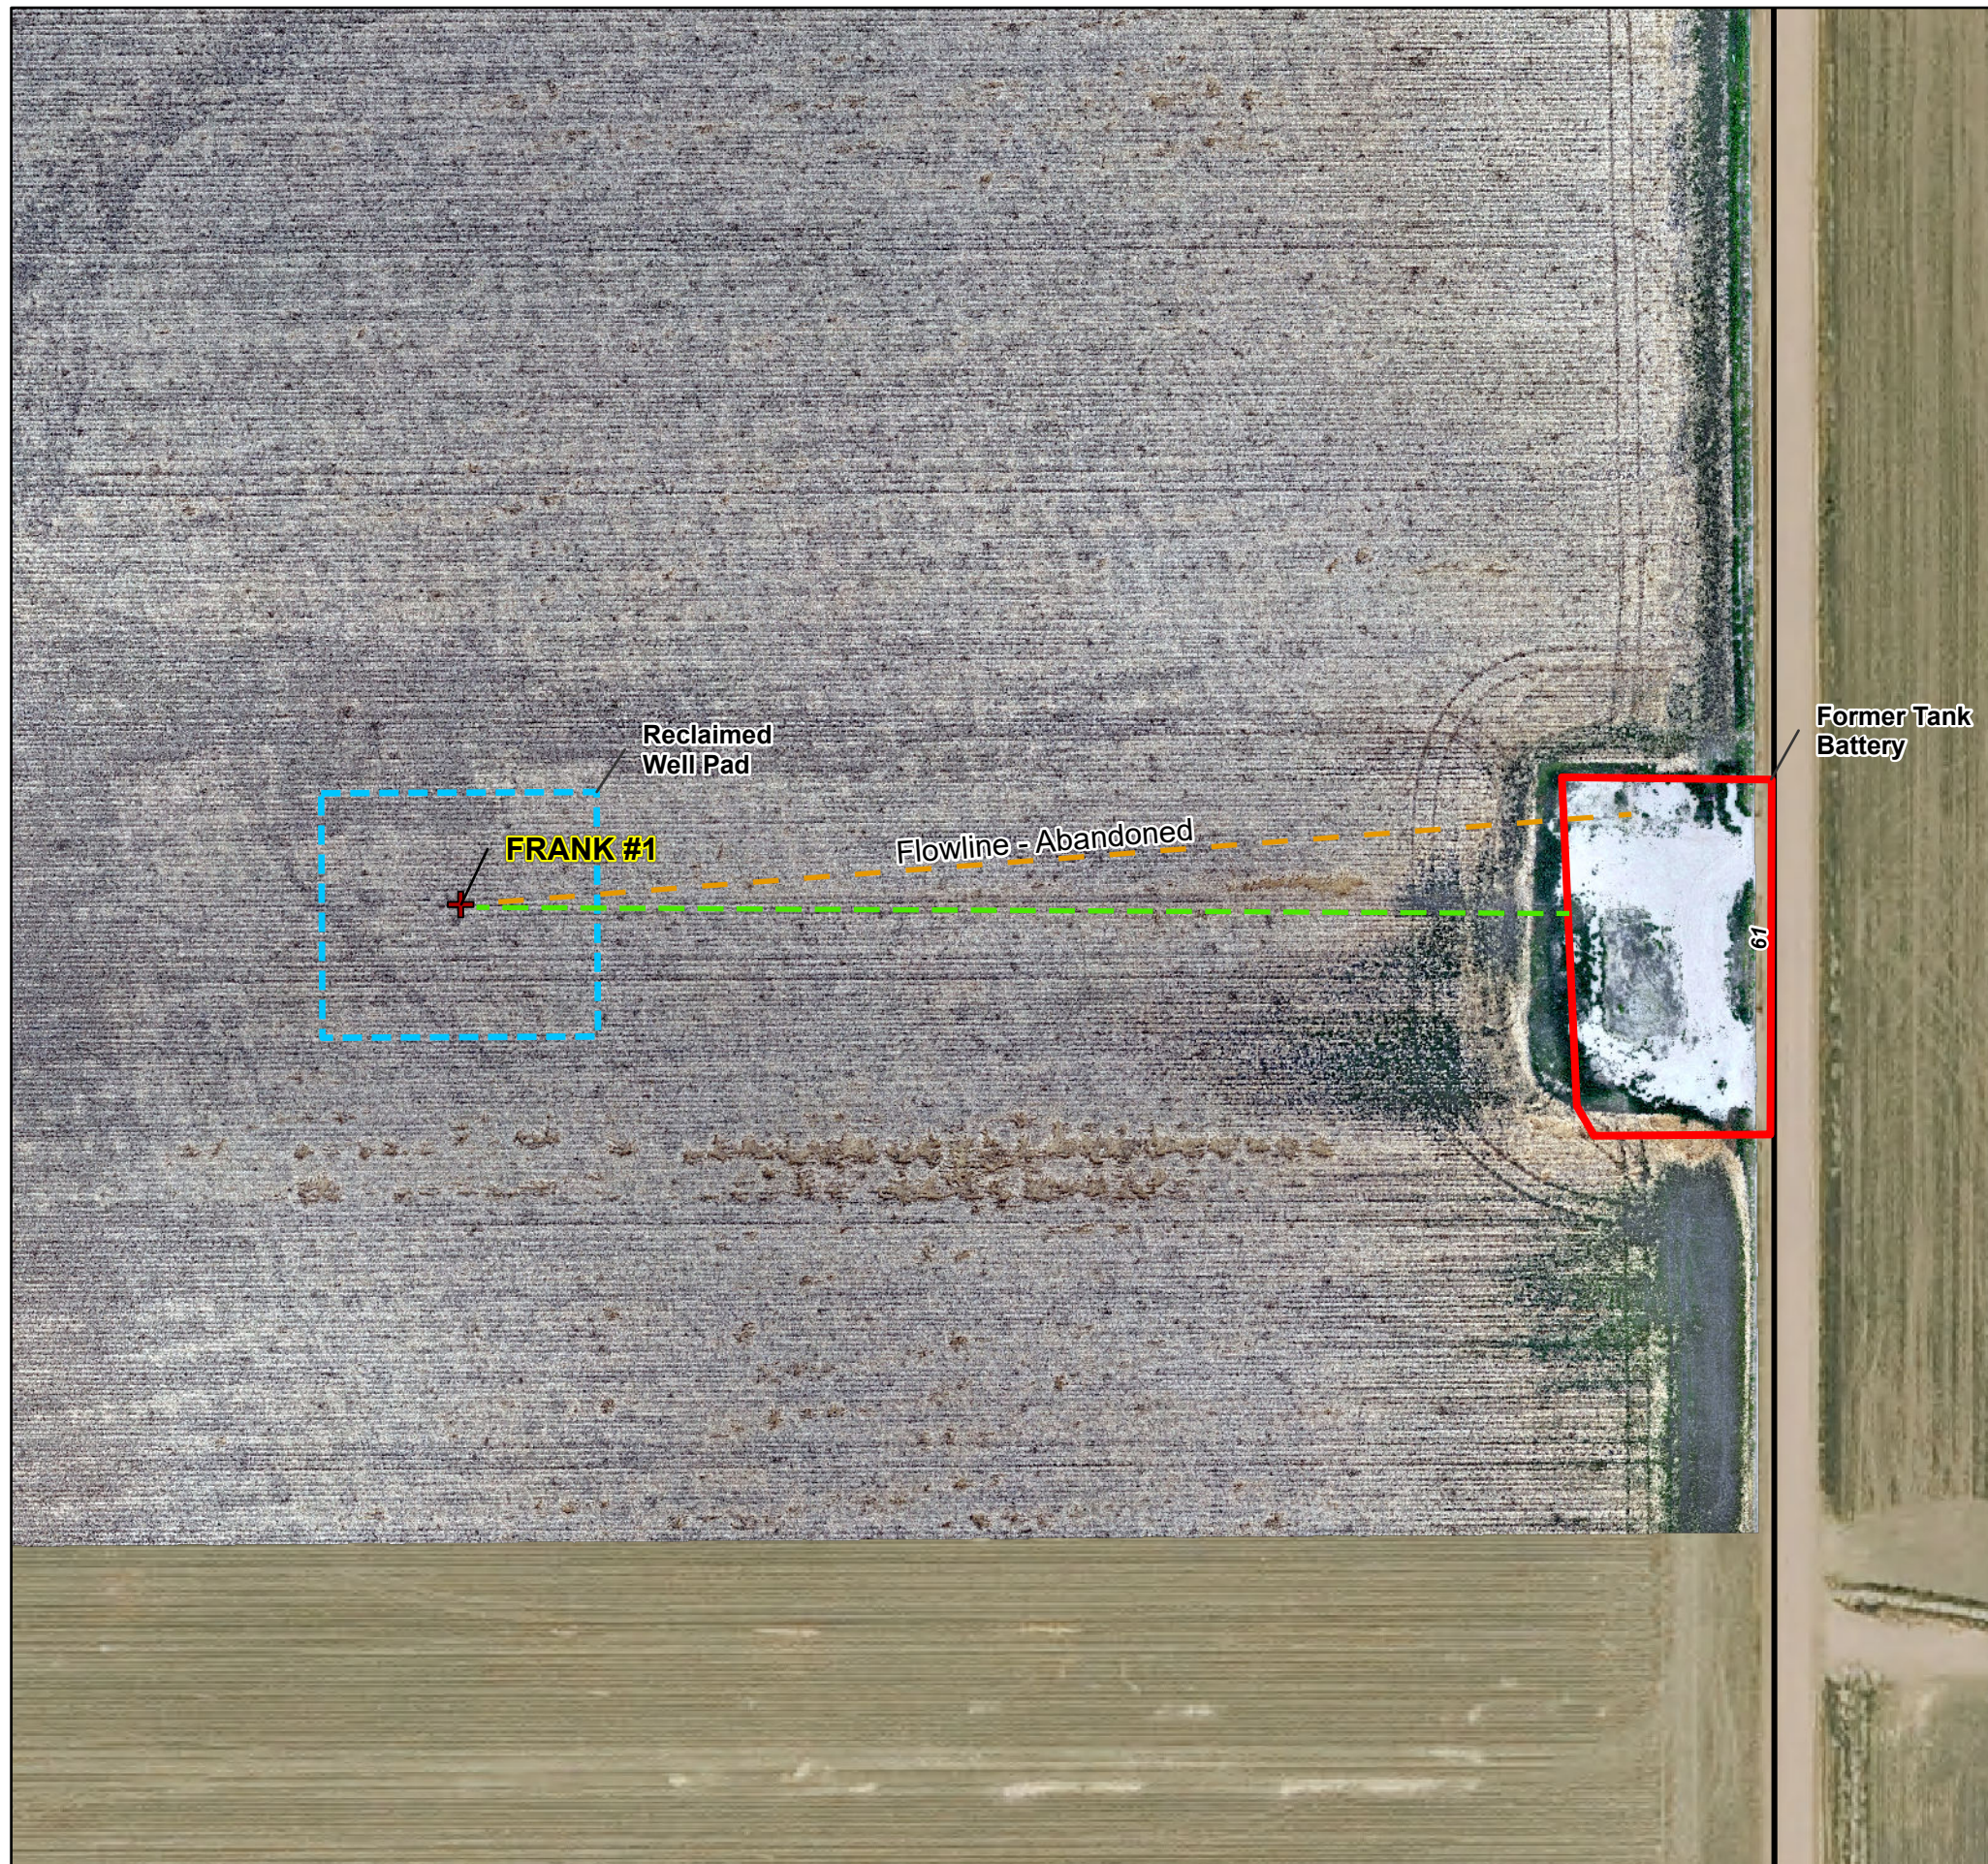
2025 Drone Imagery

Drone imagery confirms that no equipment was left on site at this location after reclamation activities occurred.

Post-Plugging and Abandonment Location Overview
