# Inspection Photos

Location Name: TEP ROCKY MOUNTAIN LLC NLW CONN CREEK 8-21D Pad

Location ID: 324442

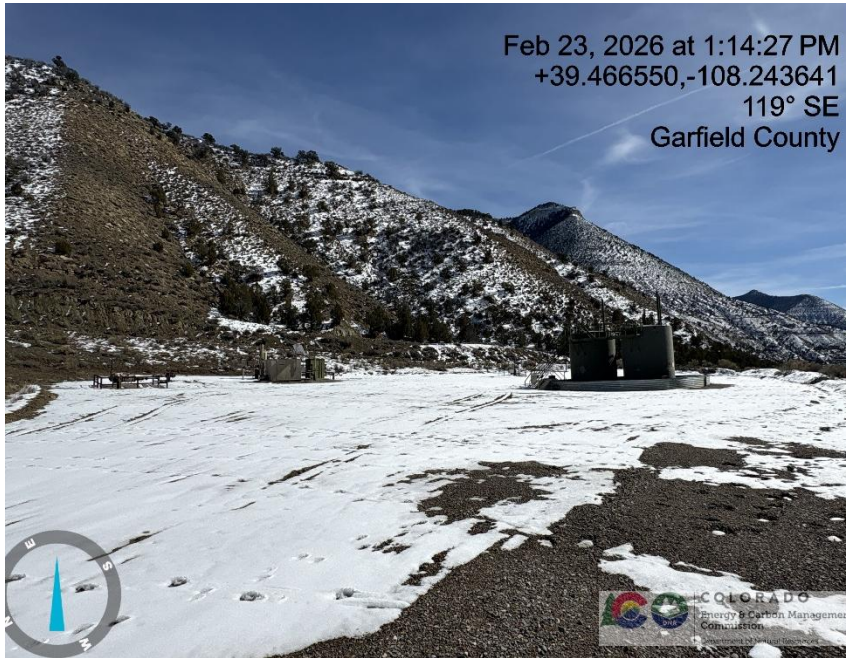
Photo # 2555 From entrance to location

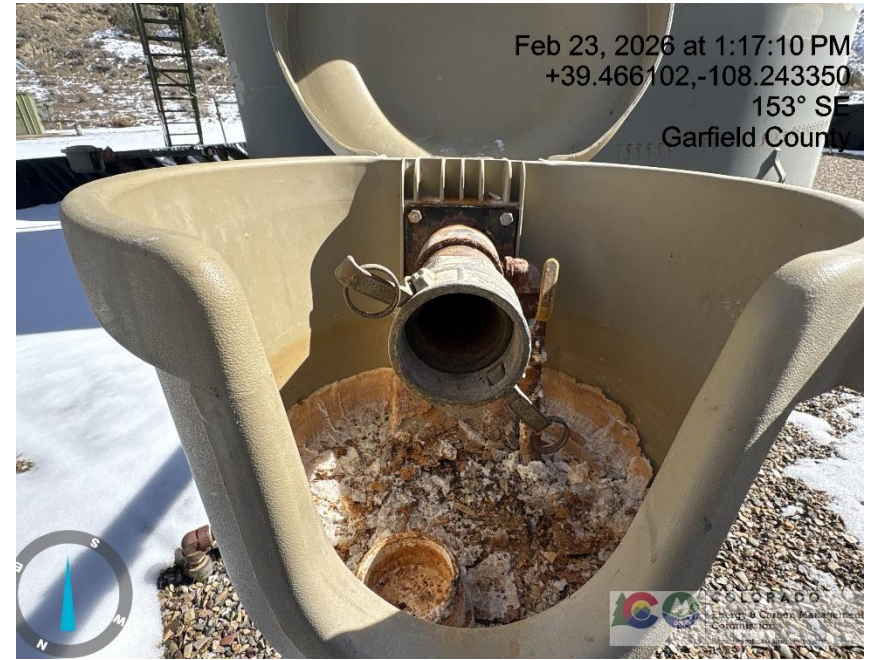
Photo # 2562 Open ended load line

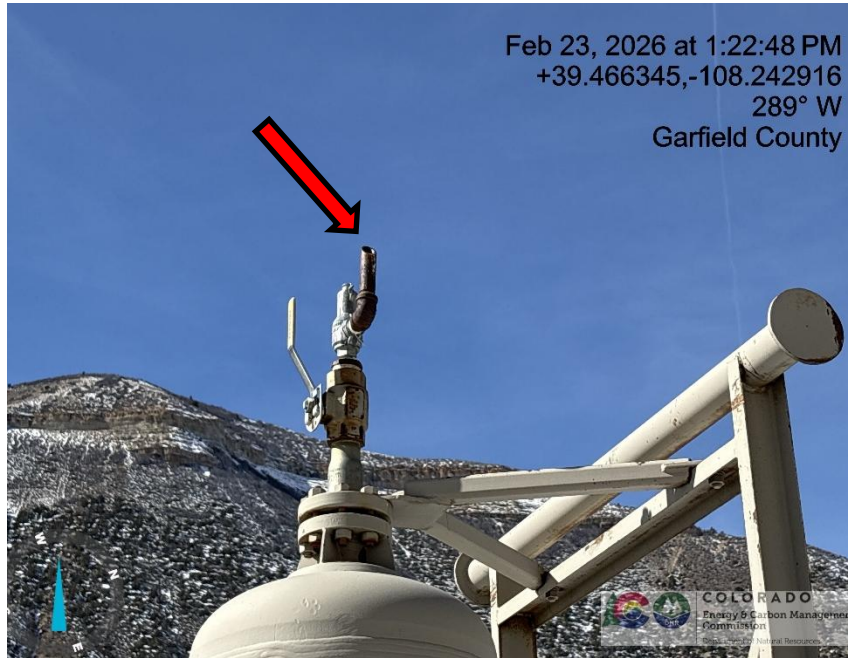
Photo # 2563 PRV vent line does not comply with CECMC pressure safety device rules

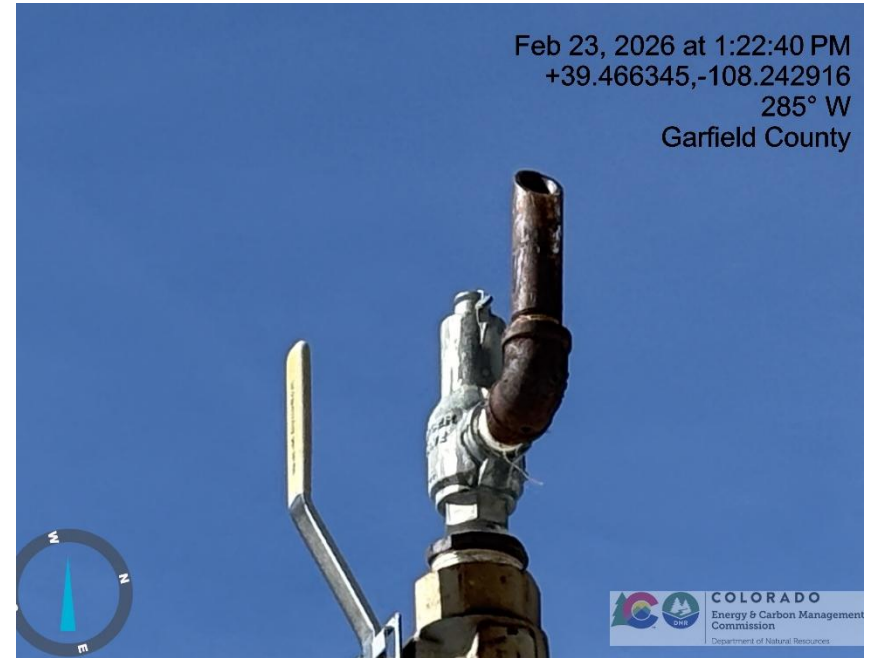
Photo # 2564 PRV vent line does not comply with CECMC pressure safety device rules
