Inspection Photos  
Simcoe – Joe Hotter 1  
API # 05-067-06964

Inspector Name: James Blair. Inspection Date: 02/25/2026  
Inspection Doc #: 721100157

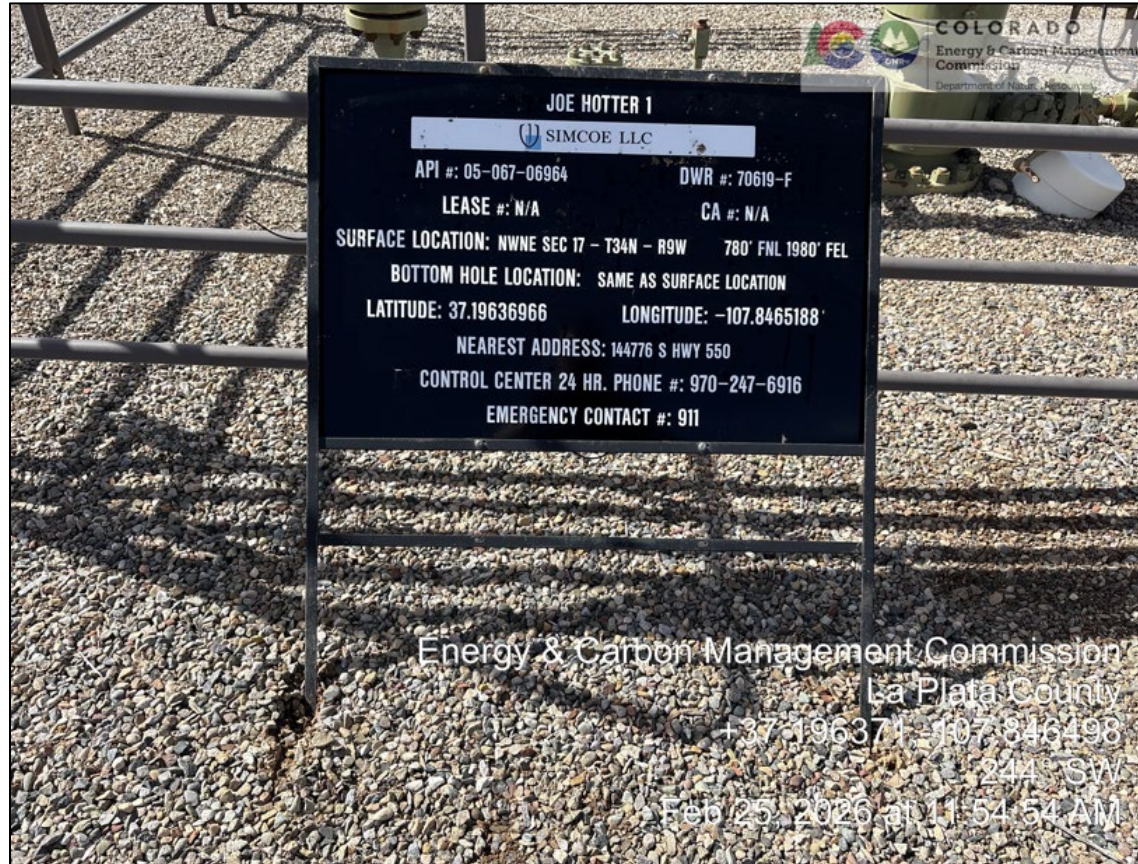
01. Well Sign was fallen over, is not secured, stood up for picture, layed back down.

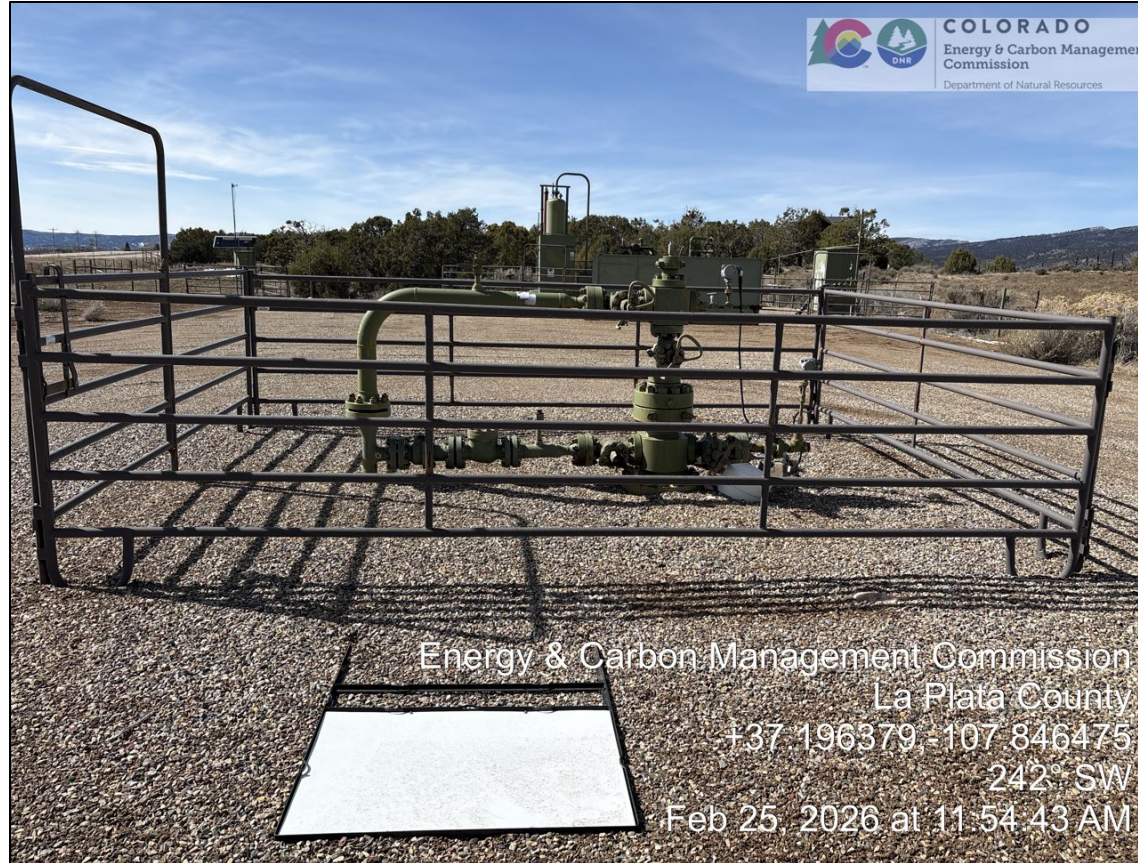
02. Wellhead is surrounded by cattle panel fence. Sign is lying face down.

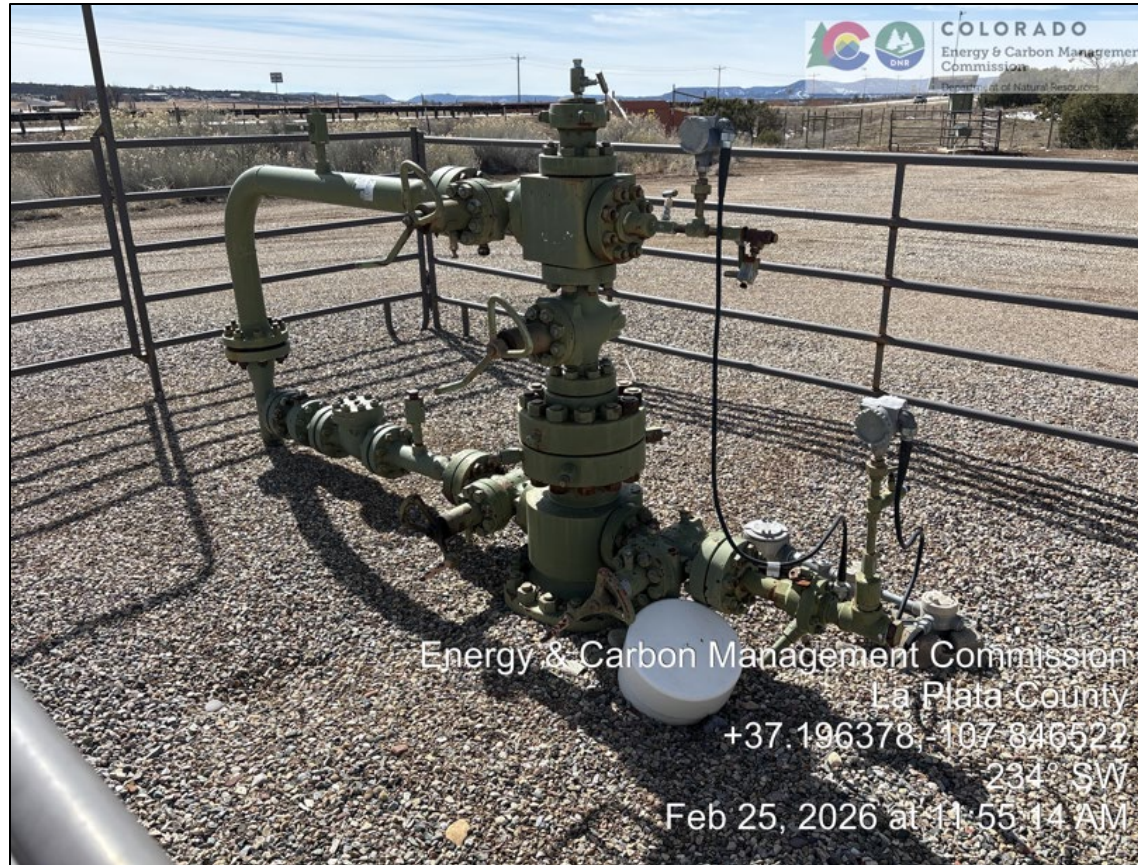
03. Wellhead. Bradenhead is accessible.

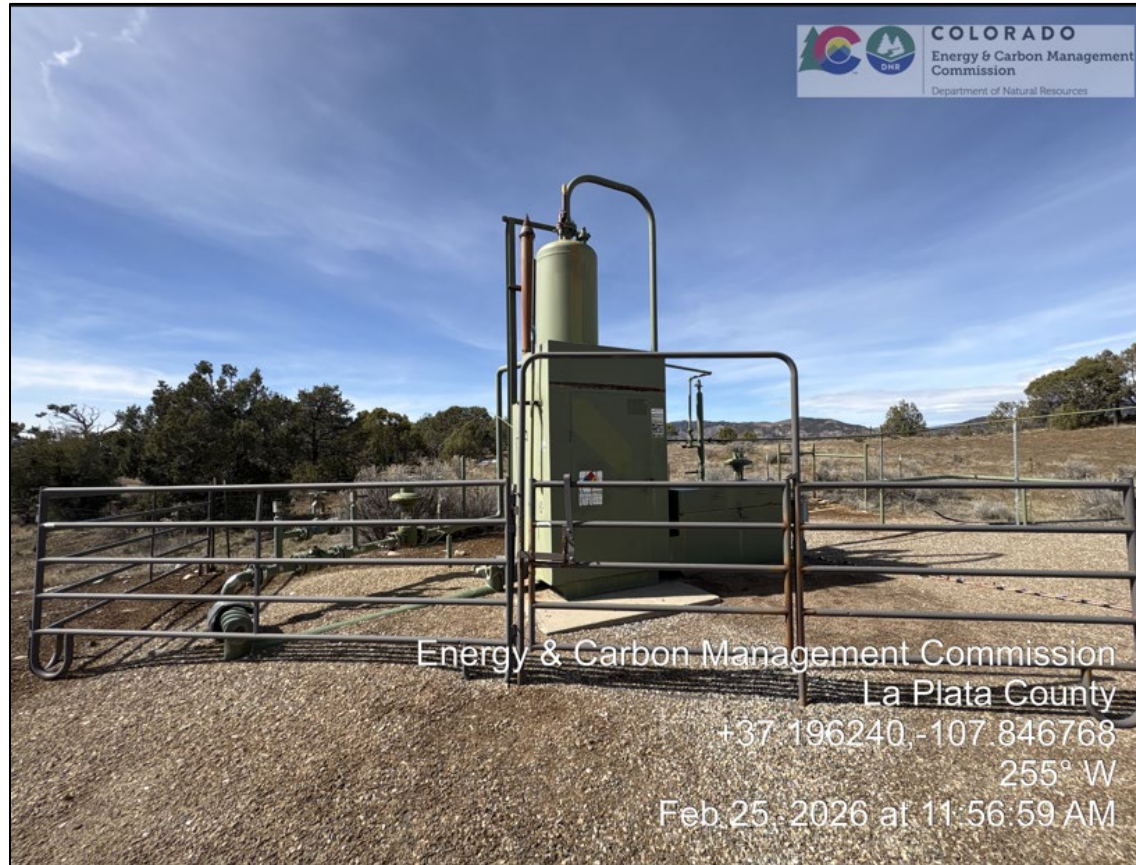
**04. Vertical heated separator. Bird protector on stack.**

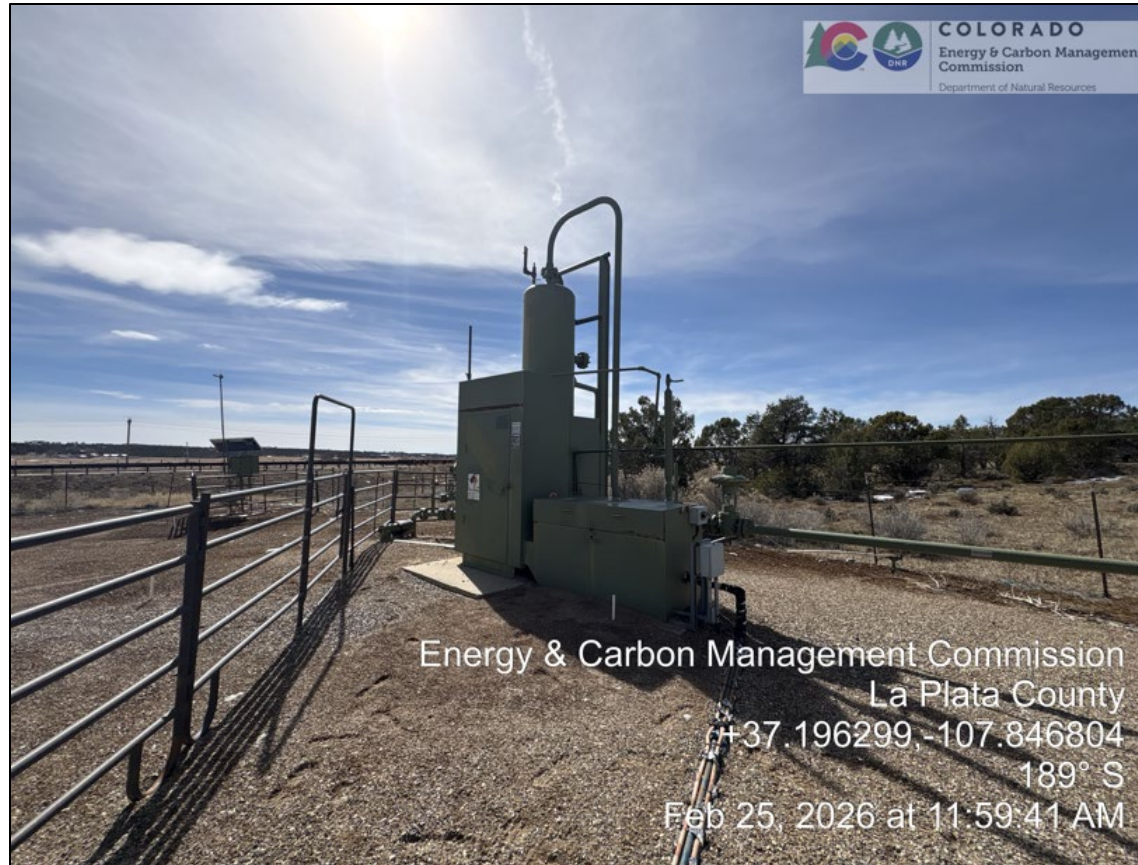
05. Vertical heated separator inside cattle panel fence. Telemetry and solar behind to left.

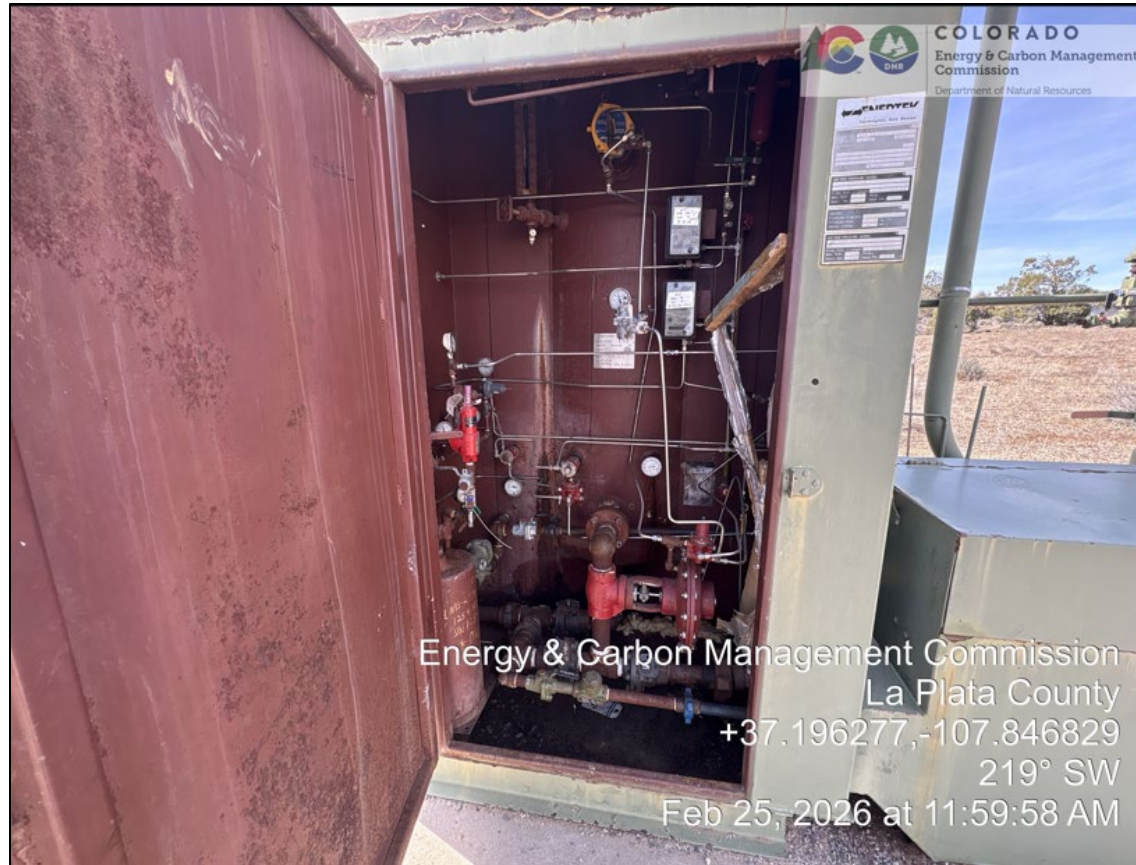
06. Inside vertical heated separator.

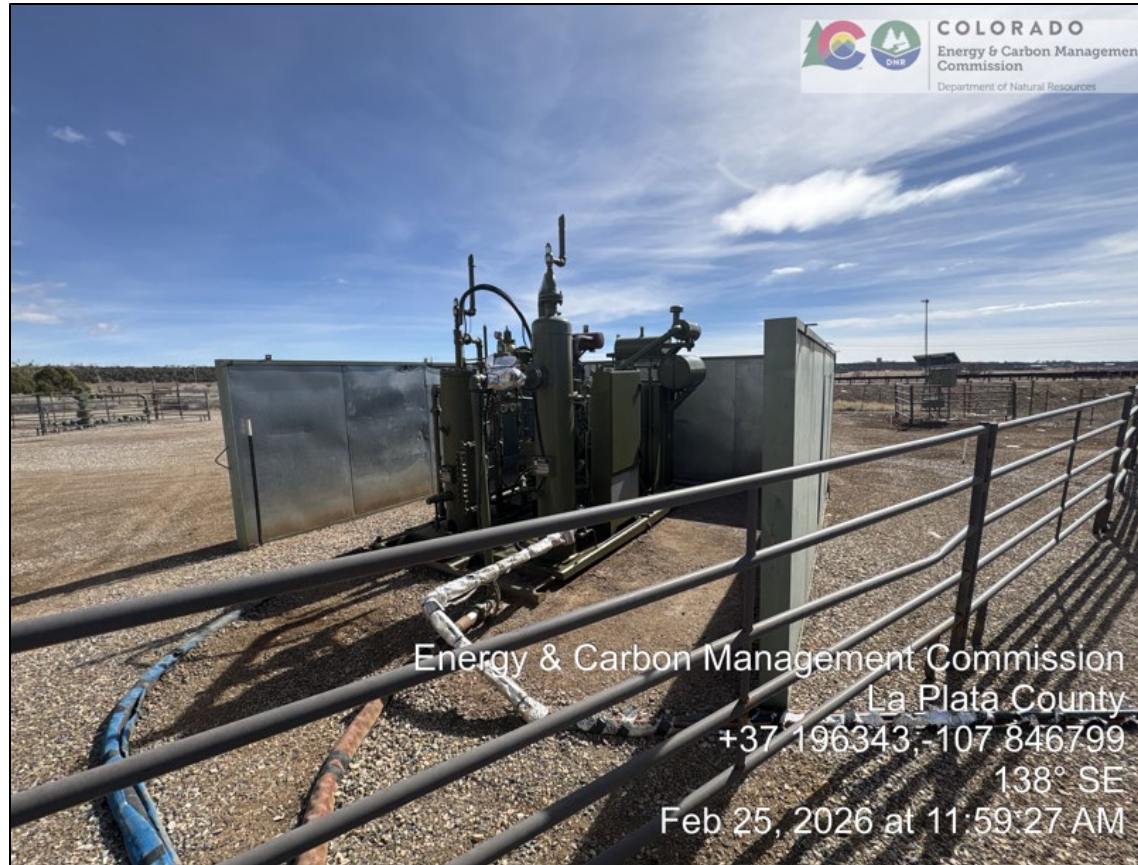
07. Compressor behind sound wall. Motor was running at time of inspection.

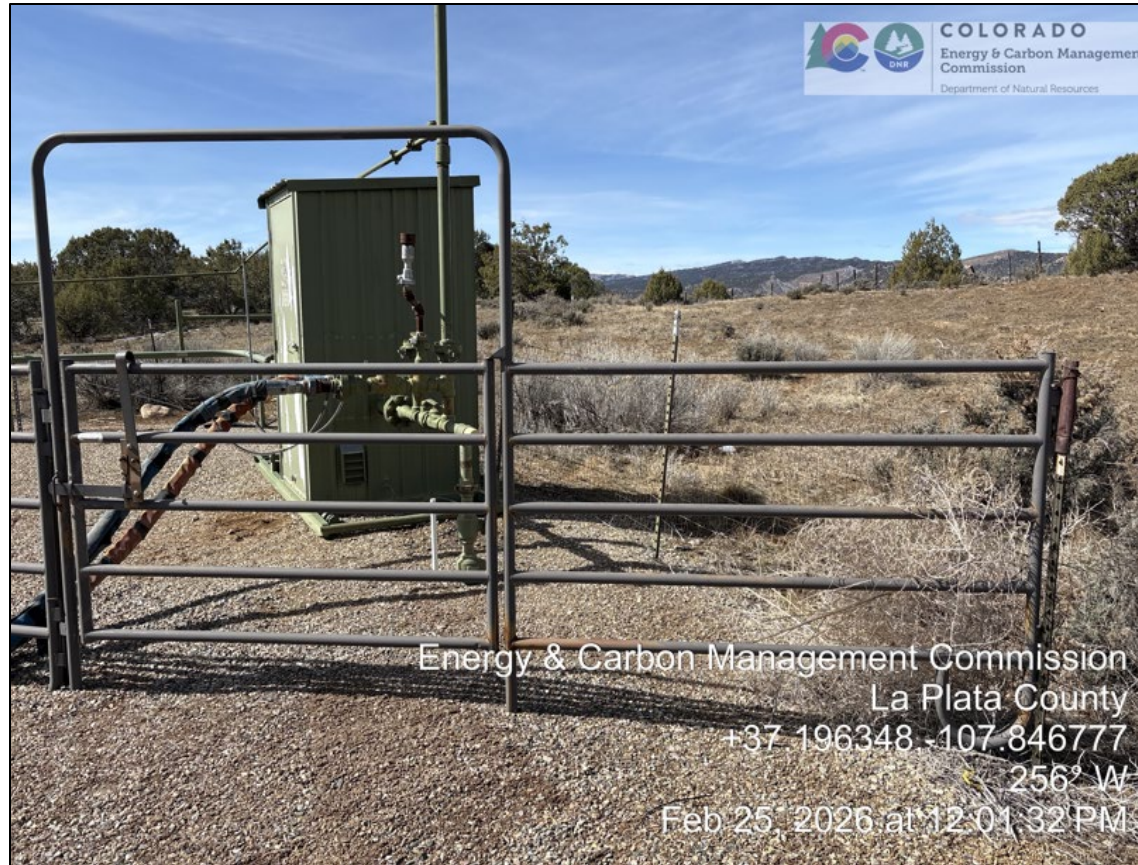
8. Meter run and 3" flow lines. Tumbleweed dead vegetative debris is accumulating in the corner of the cattle panel fence, but is more than 25 feet from fired equipment.

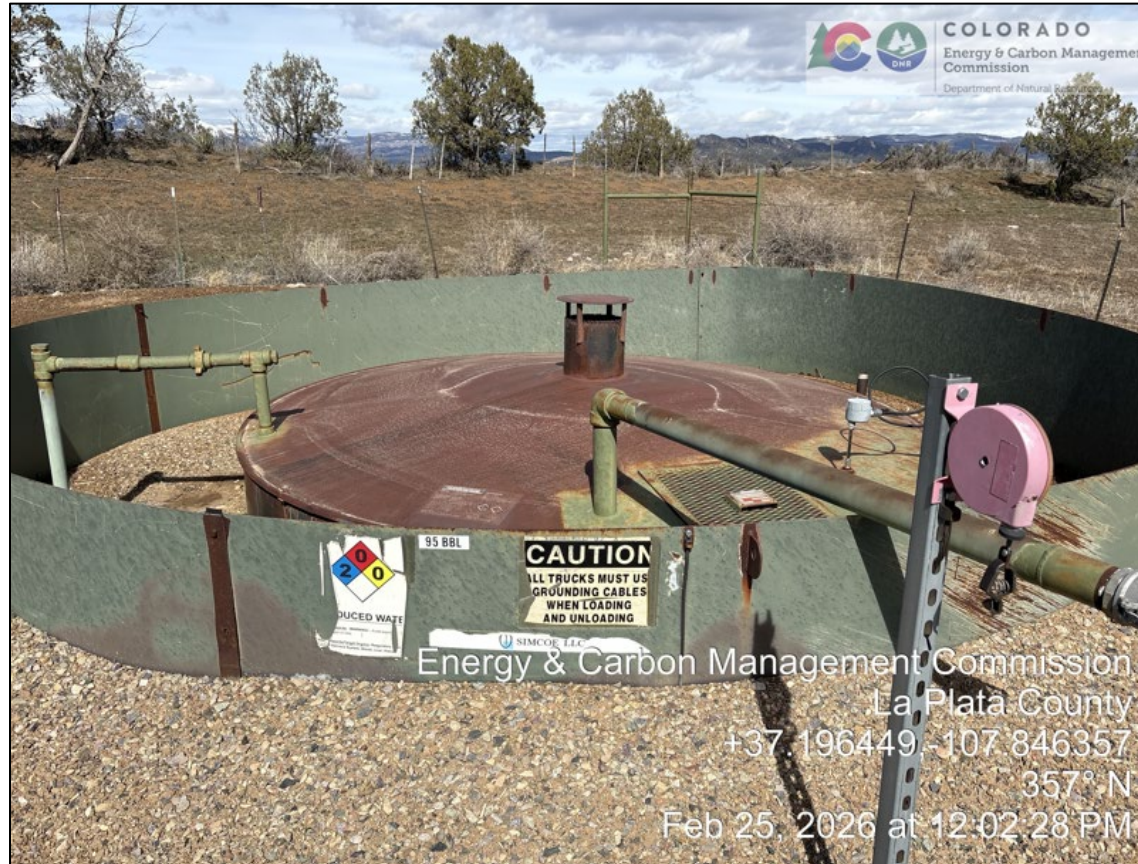
10. Produced water tank. Sign mostly peeled off and not legible and paint is inadequate.

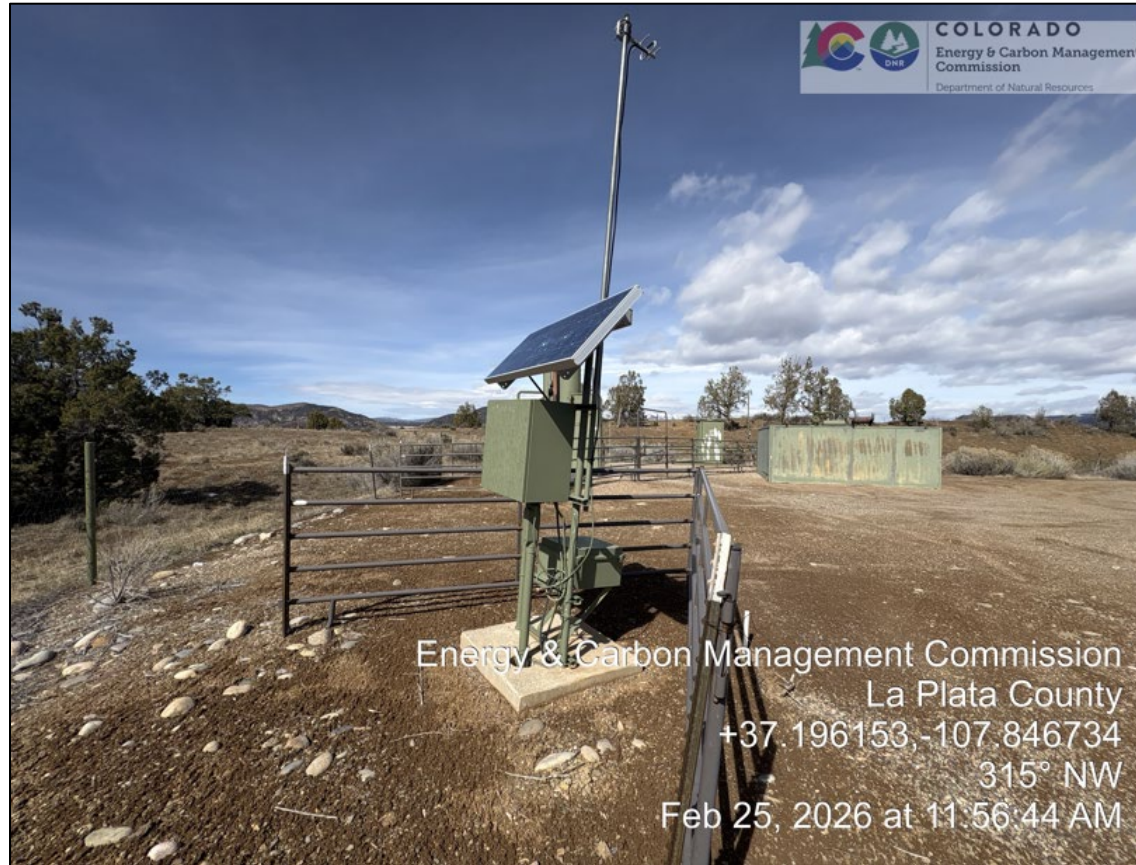
11. View looking NW along south margin of pad. Telemetry and solar in foreground. Compressor behind sound wall in background.

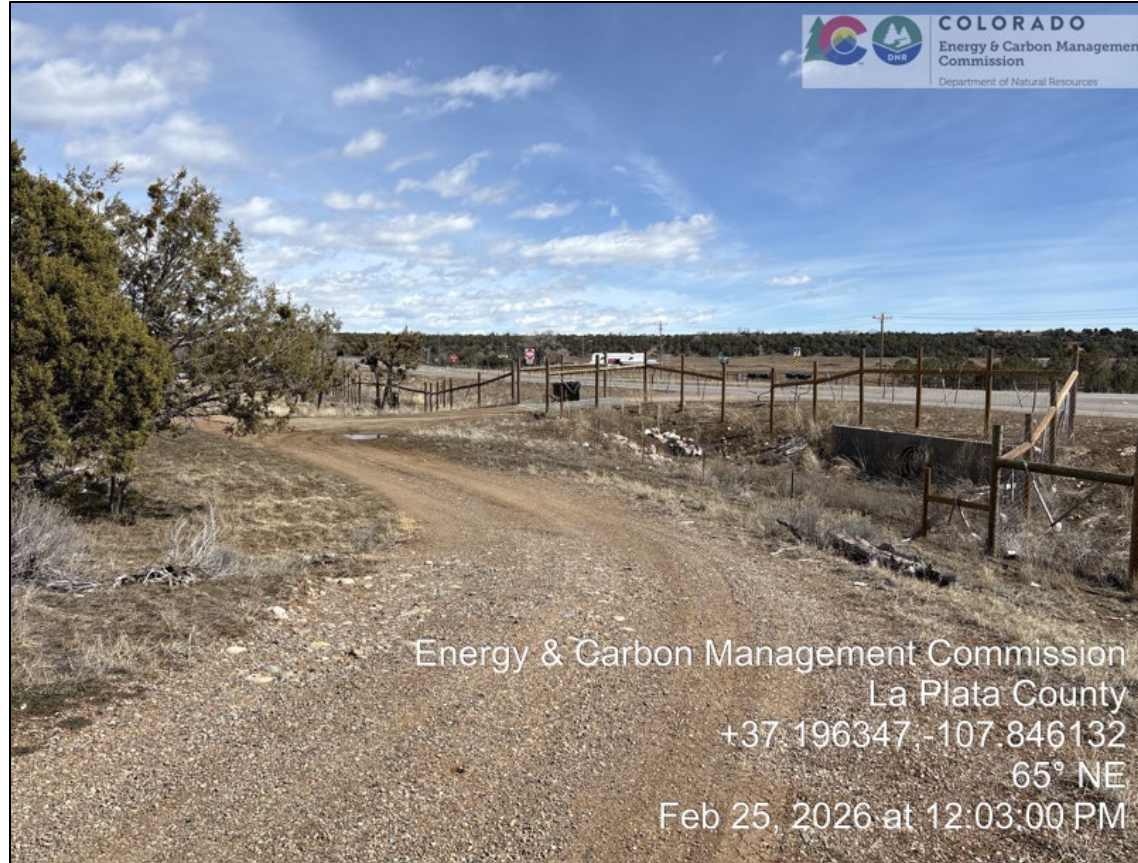
12. Access road looking to the northeast to highway 550, adjacent to site.

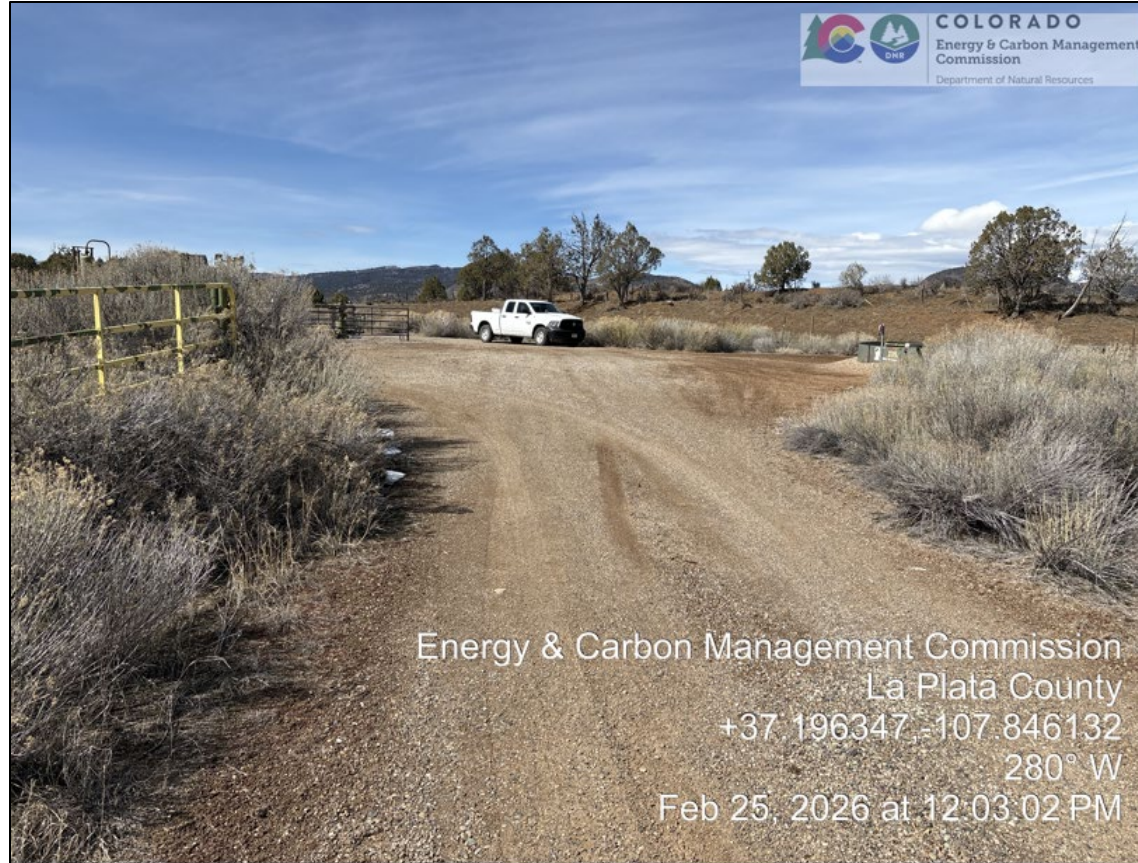
13. Access road to well pad looking west.

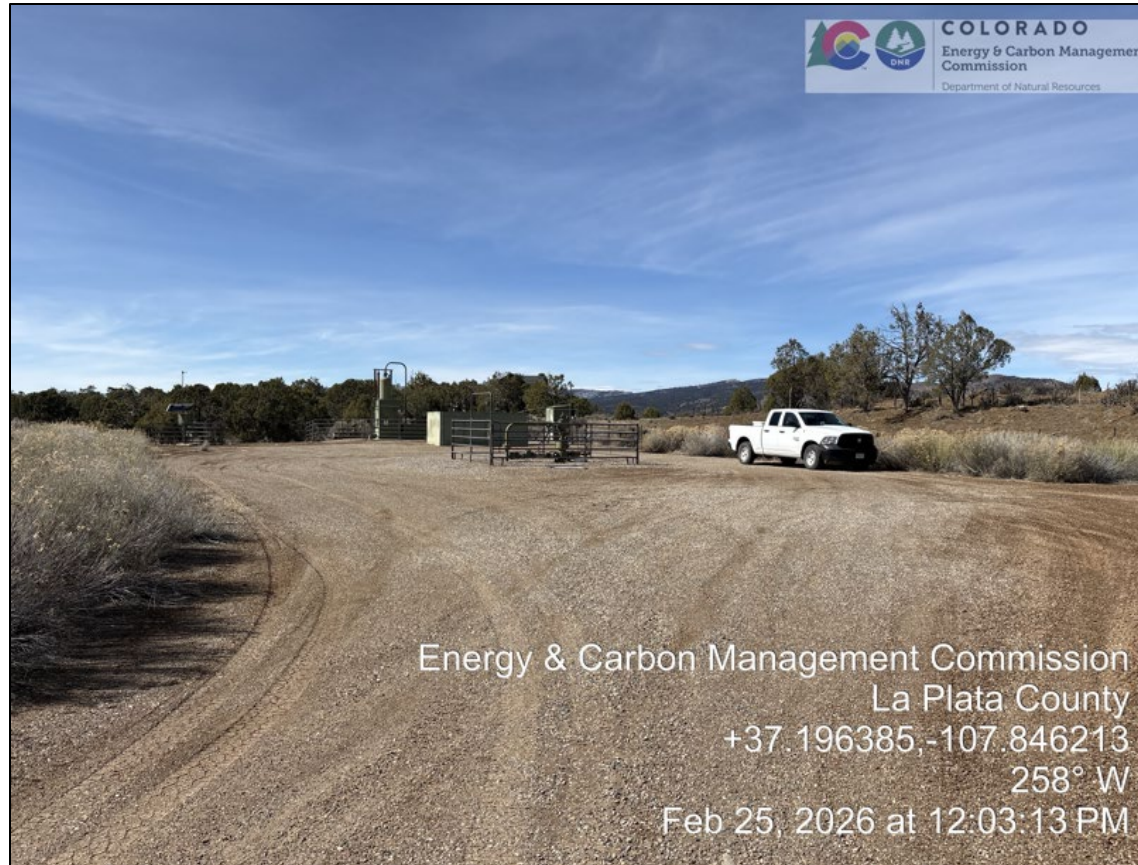
14. View of well pad from entrance gate. Gate was open at time of inspection.

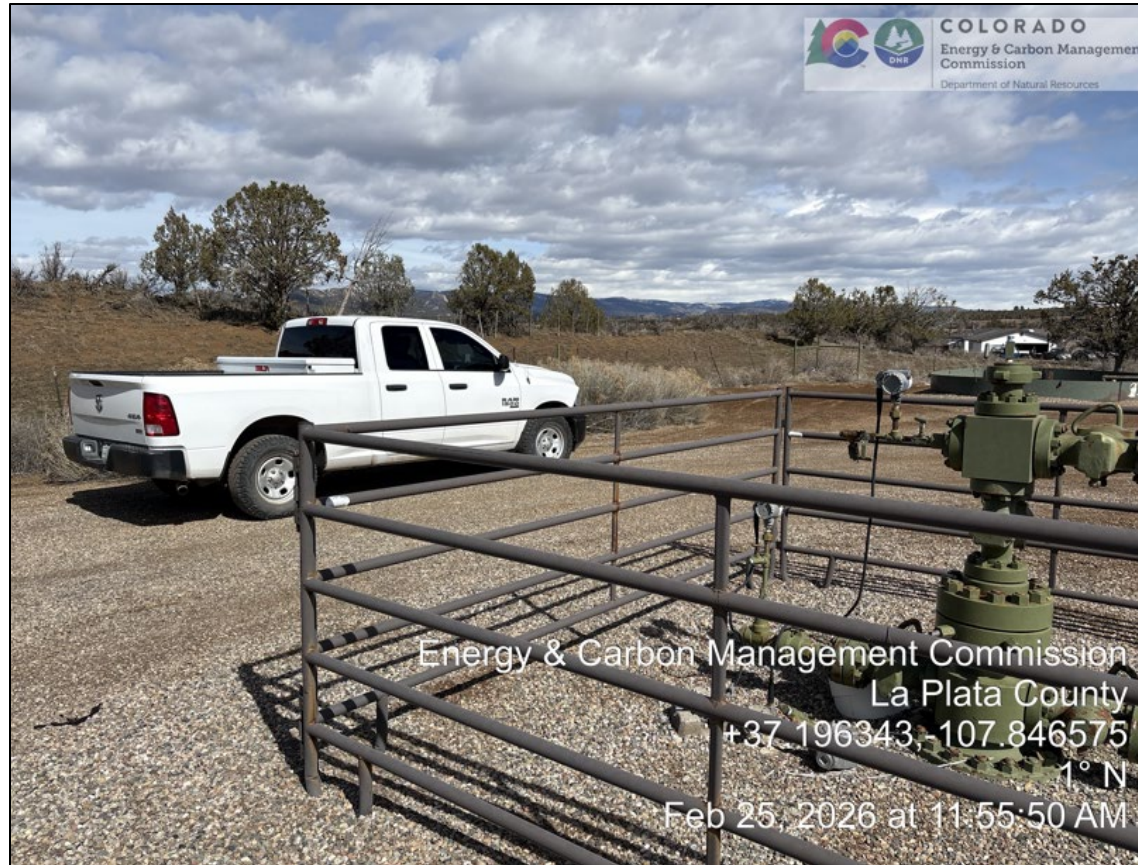
15. View of well pad looking due north from wellhead.

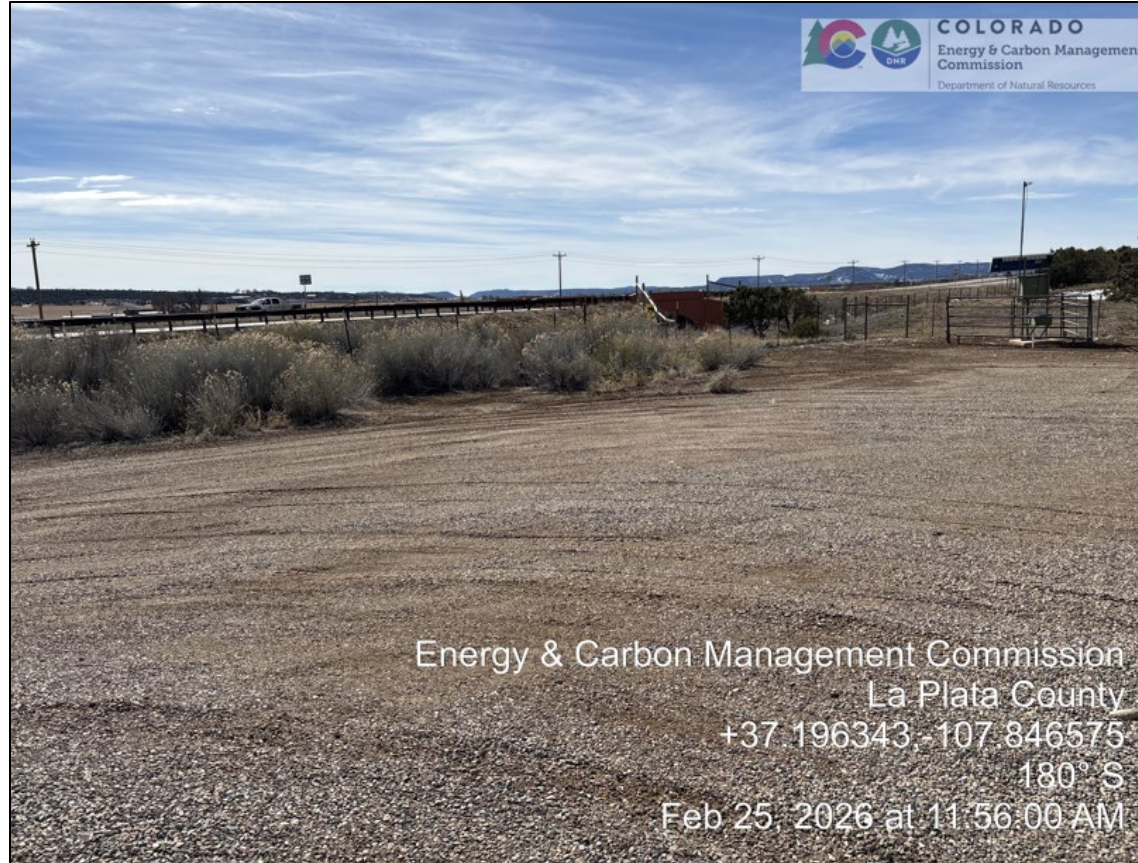
16. View looking due south from wellhead.

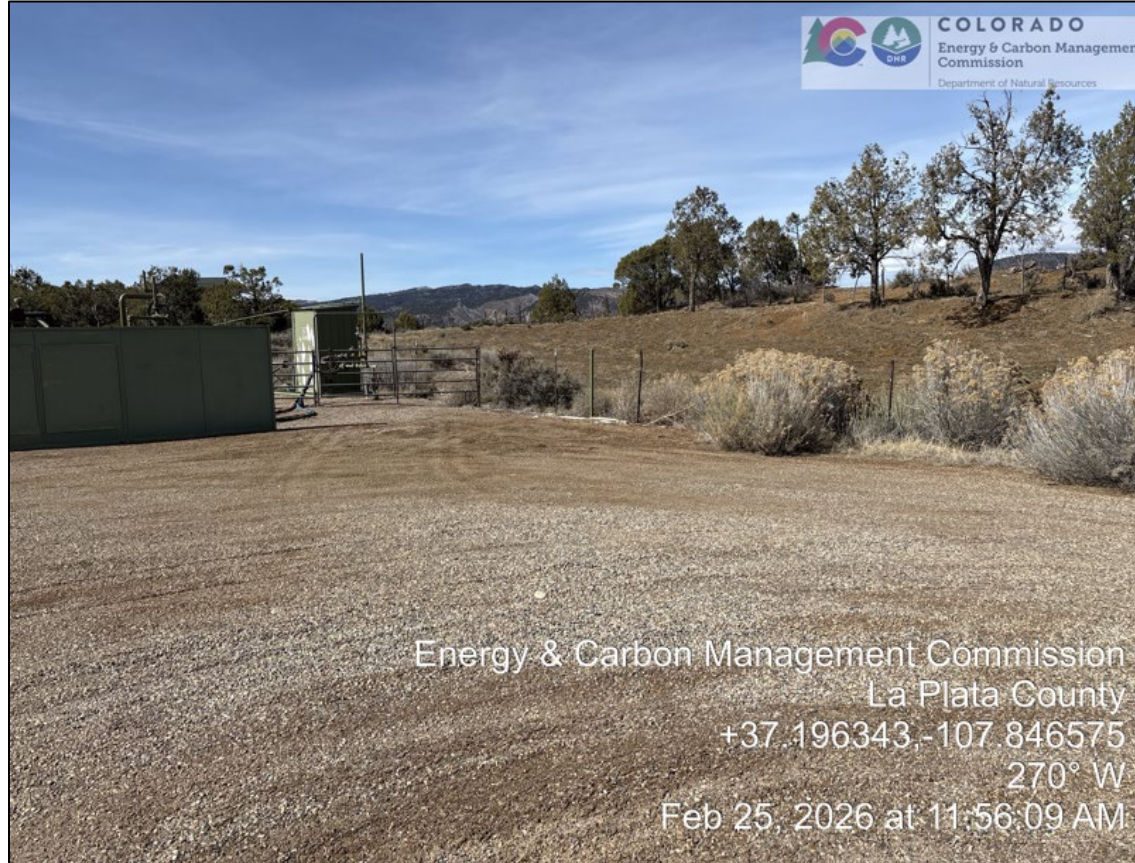
17. View looking due west from wellhead.

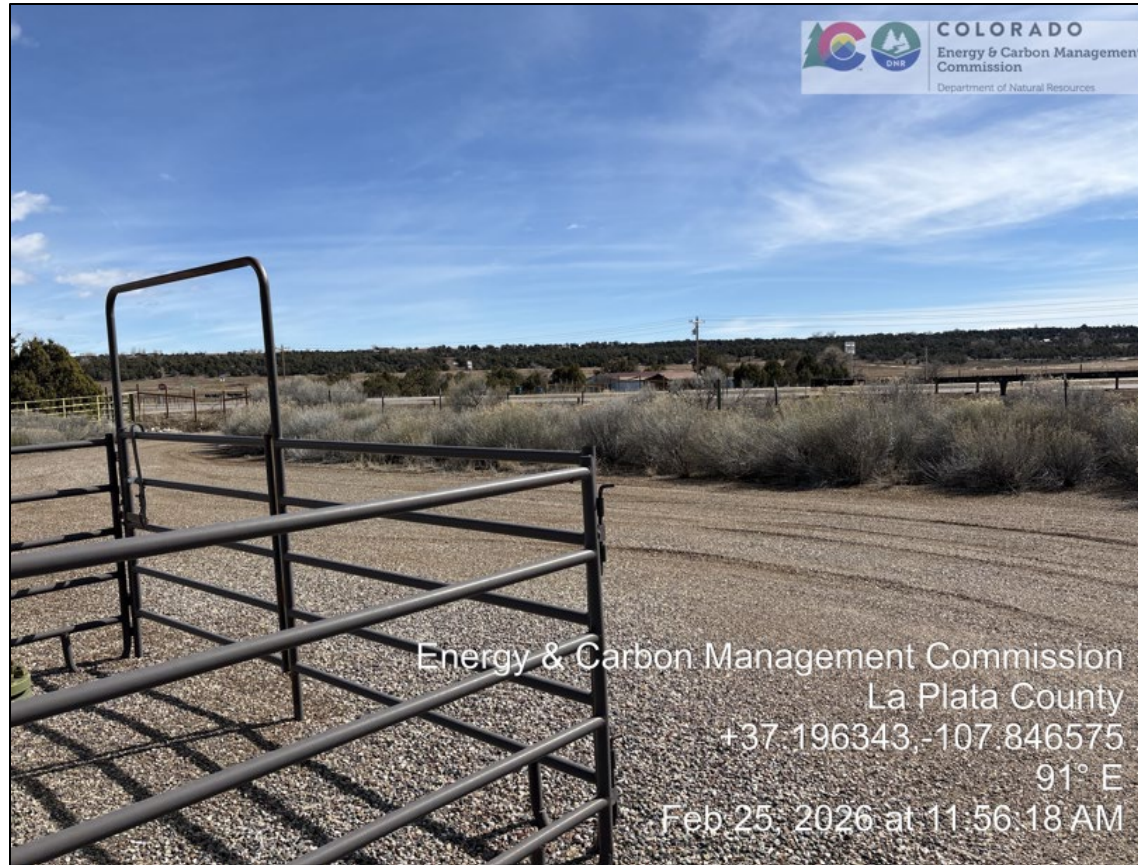
18. View looking due east from wellhead. US HWY 550 is just east of location. Barbed wire and mesh fence is visible.
