Inspection Photos
Simcoe/ Mach Natural Resources – JOE HOTTER #2
API # 05-067-08708
Inspector Name: James Blair. Inspection Date: 02/26/2026
Inspection Doc #: 721100166

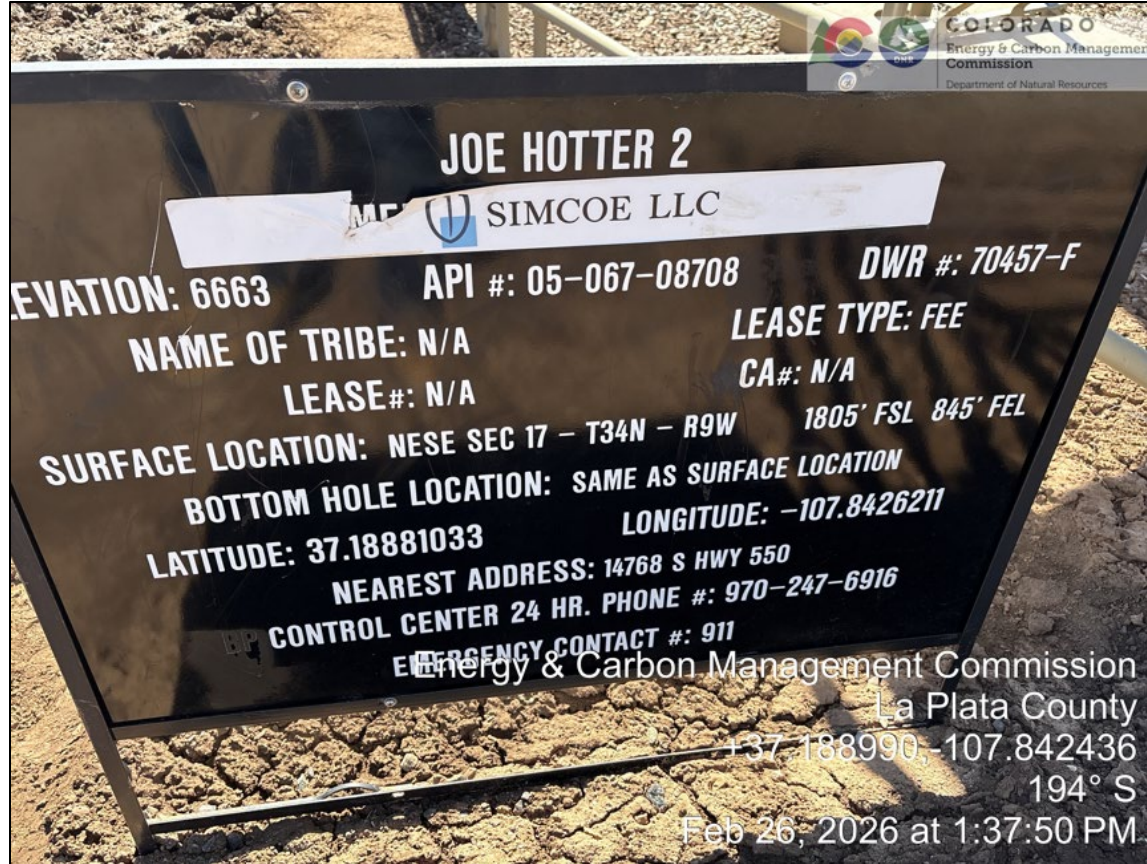
1. Well Sign. 24 Hour Contact: 970-247-6619, Emergency 911.

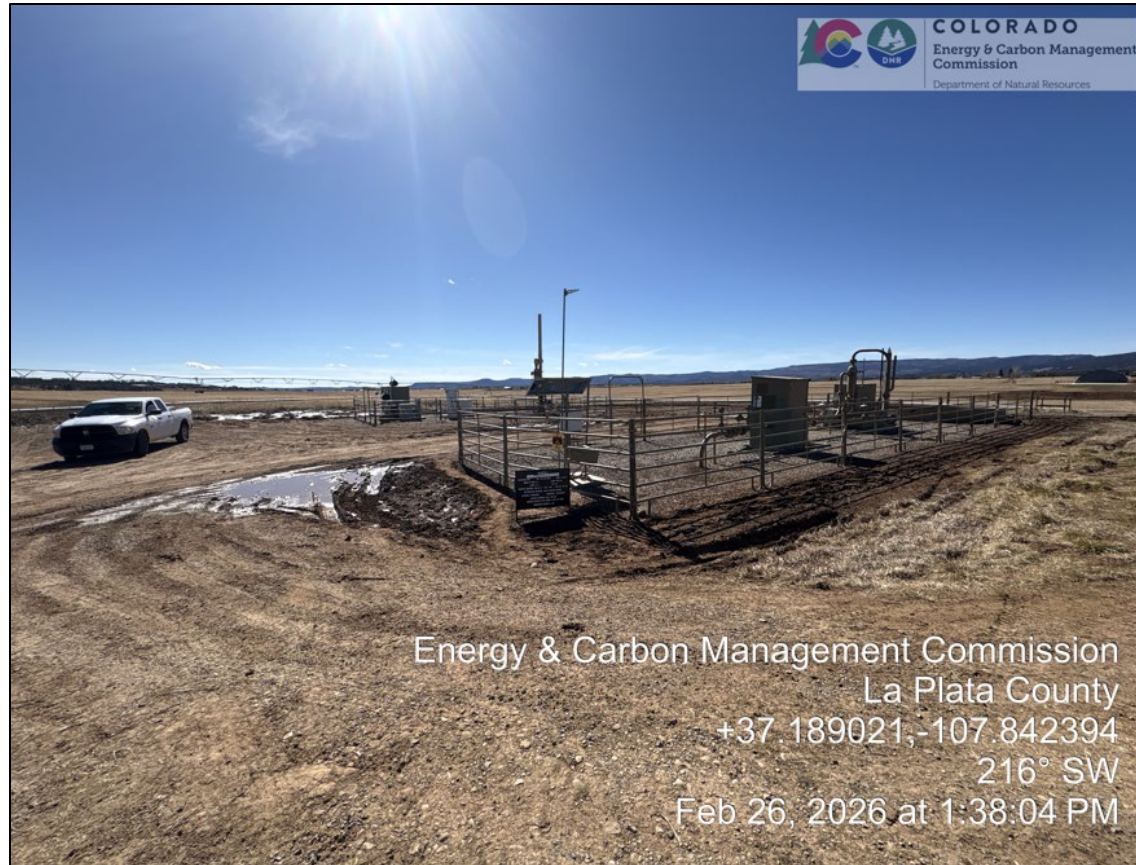
2. Well location. Mud and ruts are present from recent snowfall and warm temperatures. A workover rig was on site the day before.

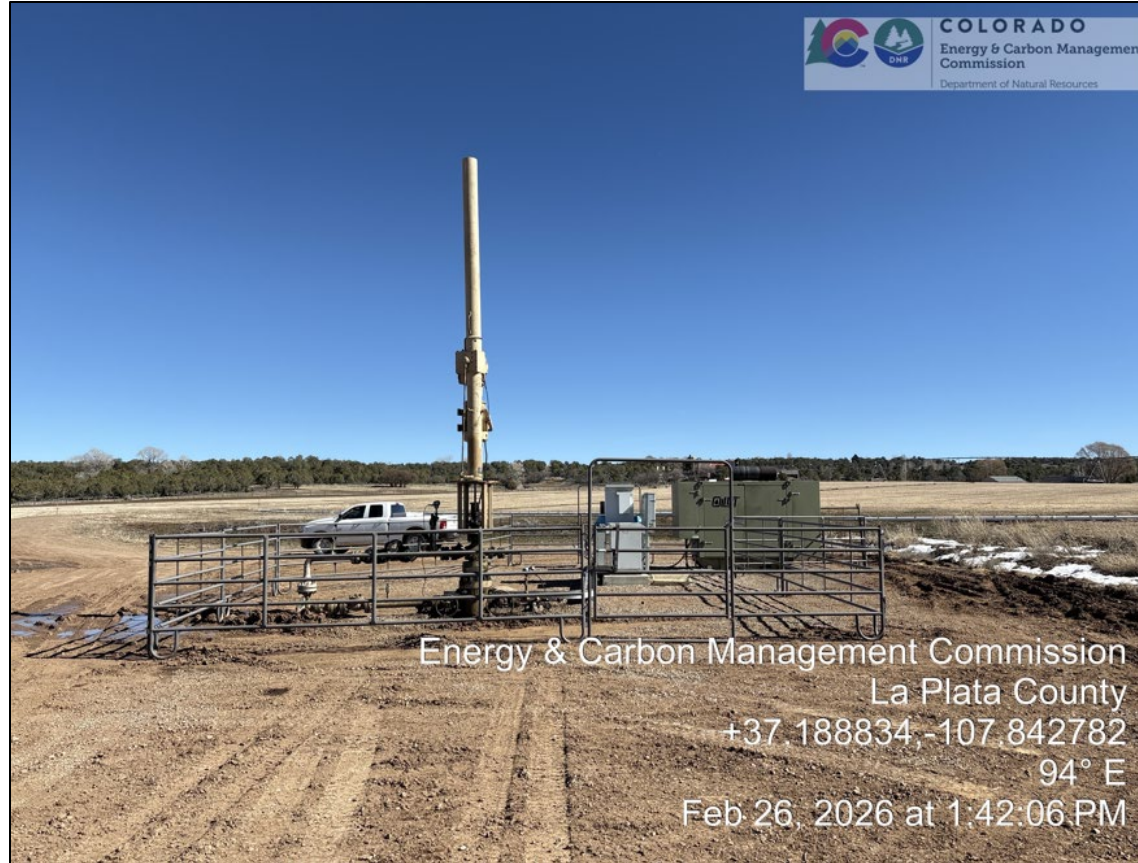
03. Wellhead and electric drive progressive cavity pump along with electrical controls.

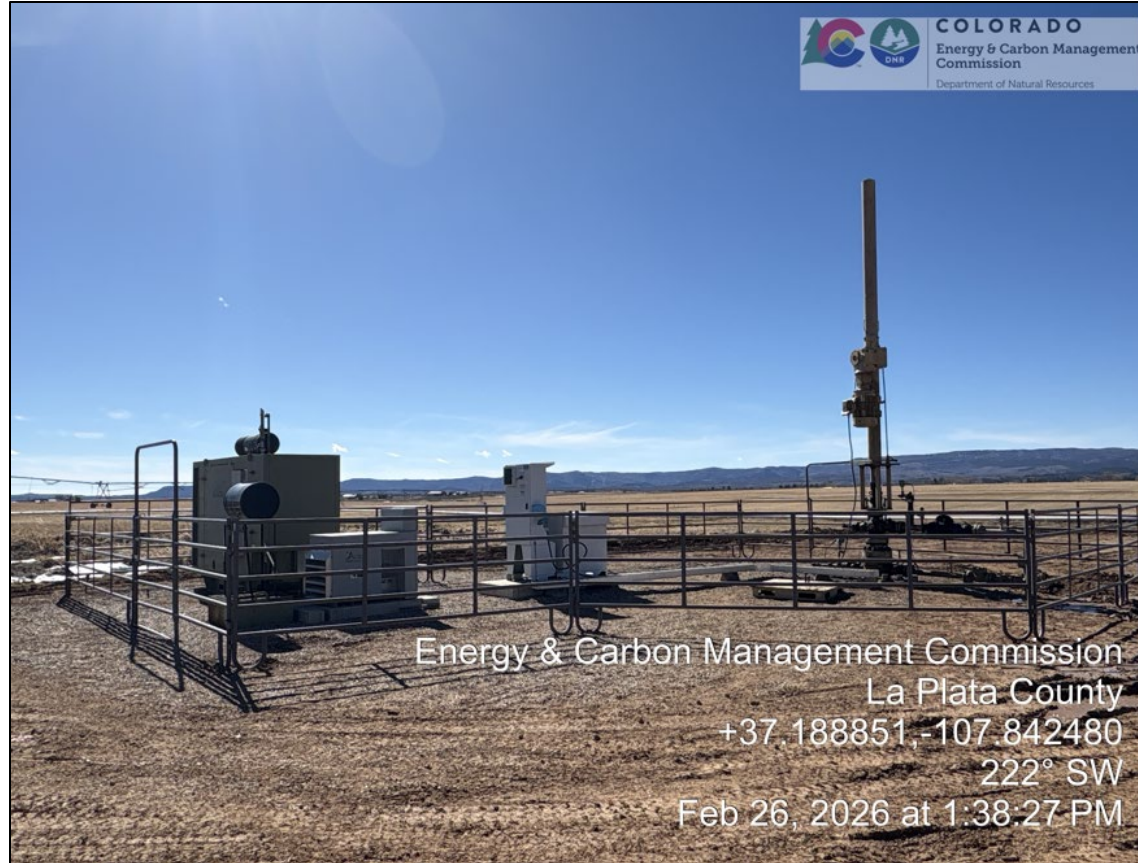
4. Wellhead, progressive cavity pump, and electrical controls behind cattle panel fence.

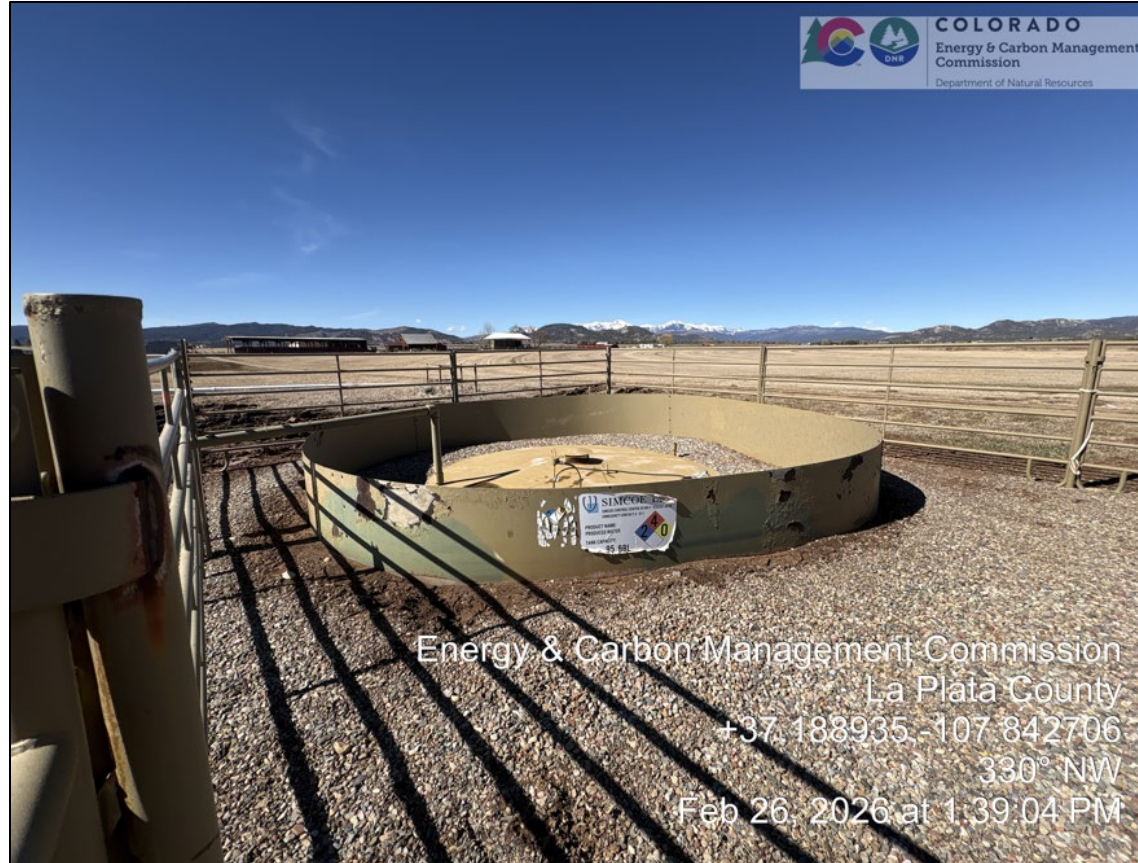
05. PBV tank and secondary containment.

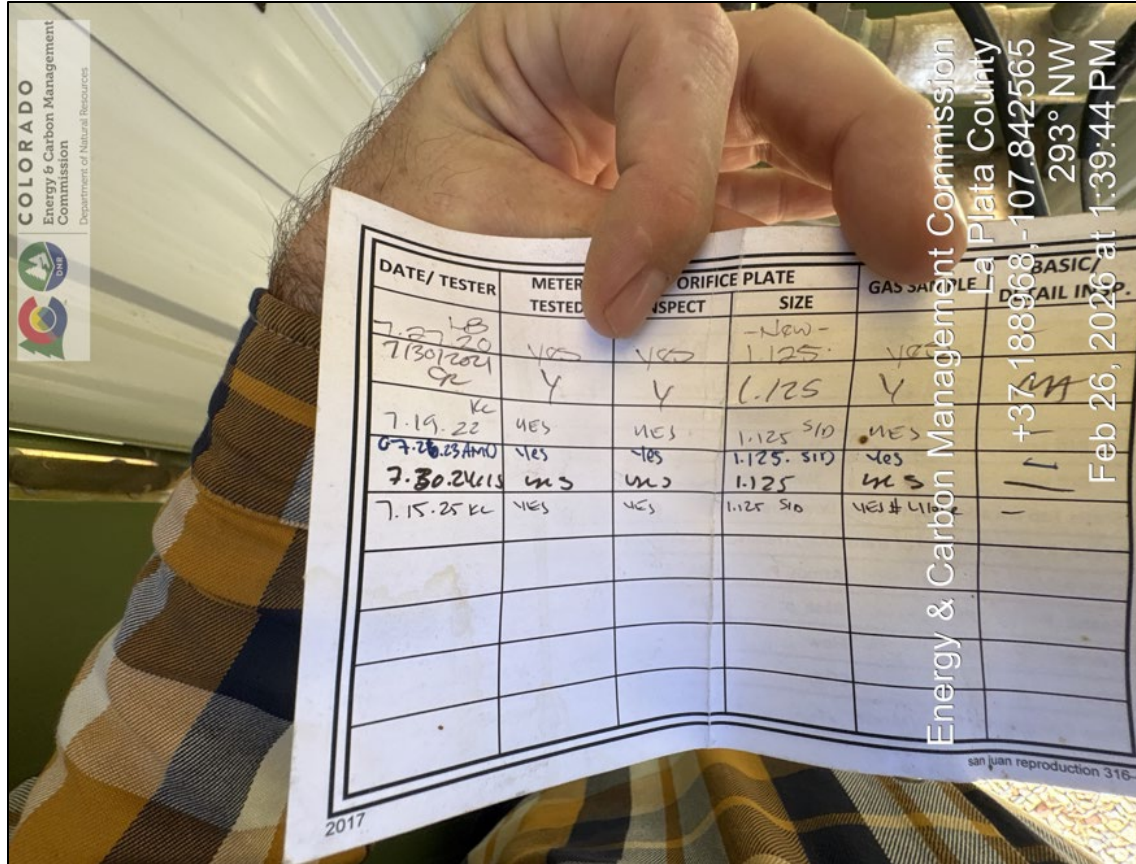
6. Meter run calibration card. 7/15/25 date.

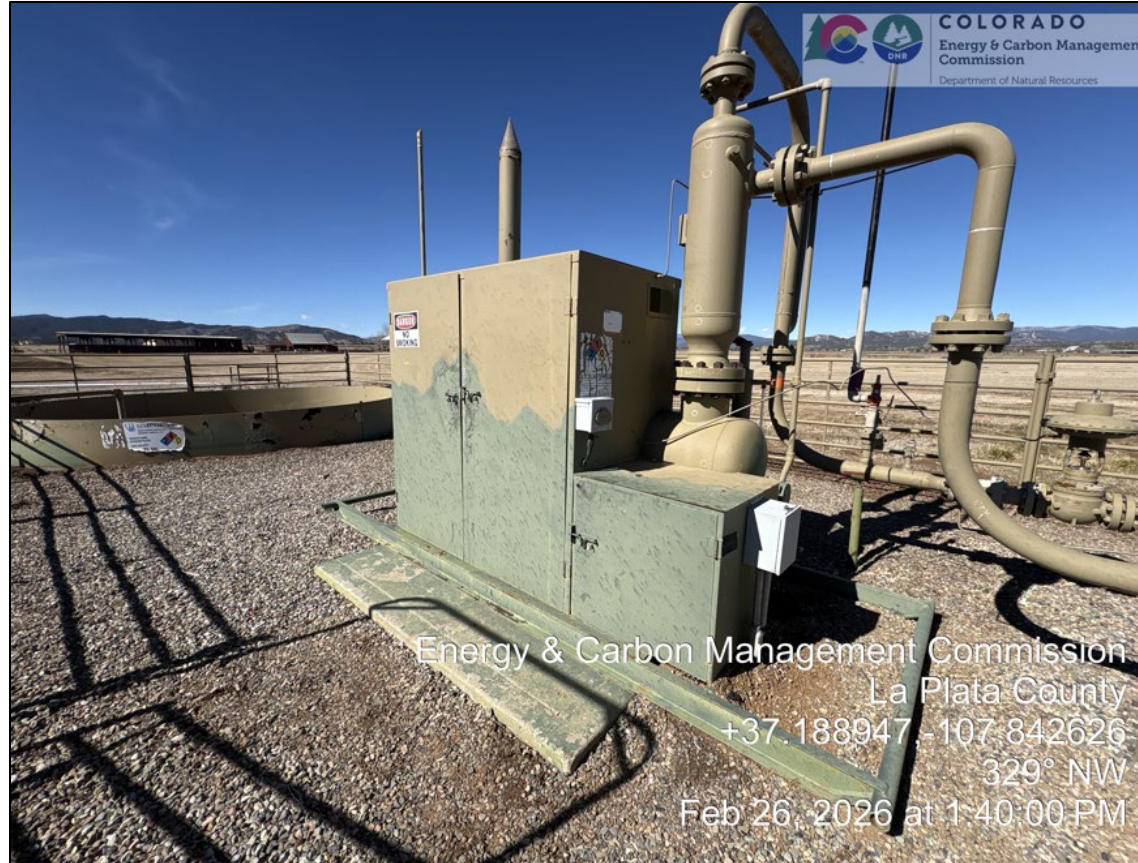
7. Horizontal heated separator.

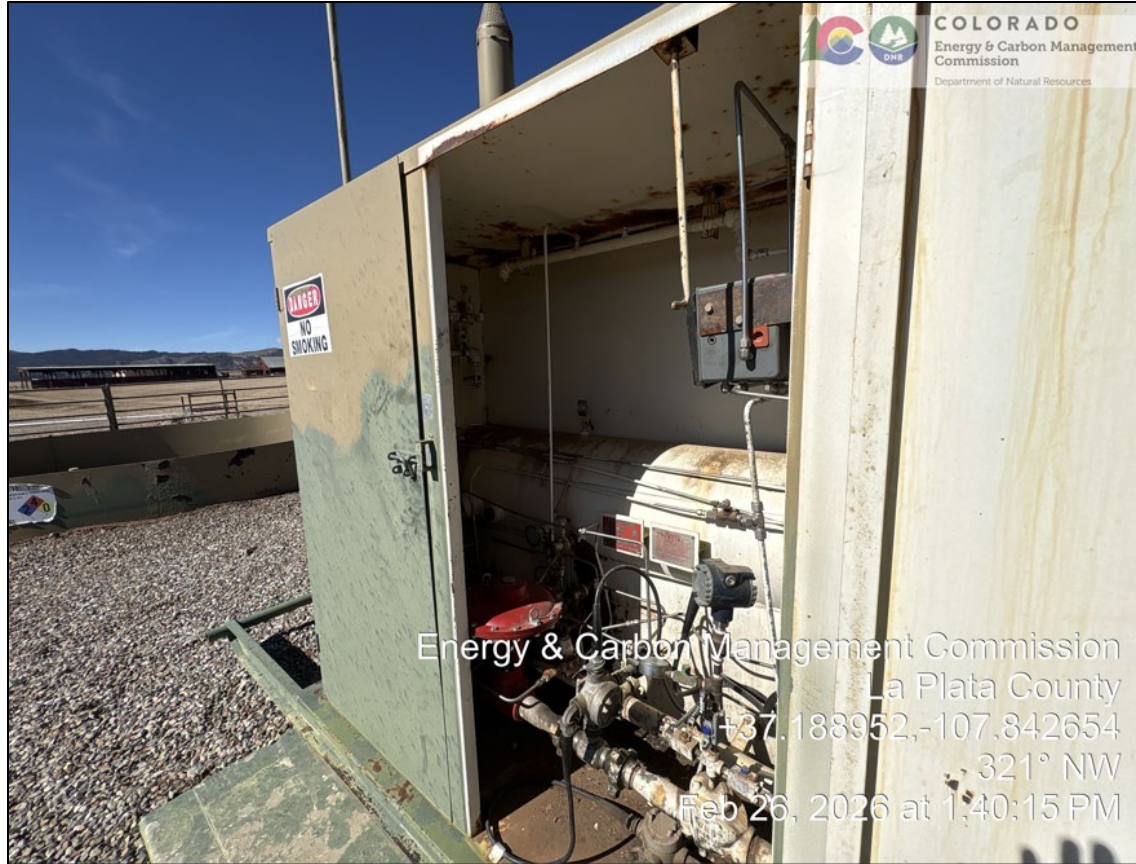
8. Inside horizontal heated separator.

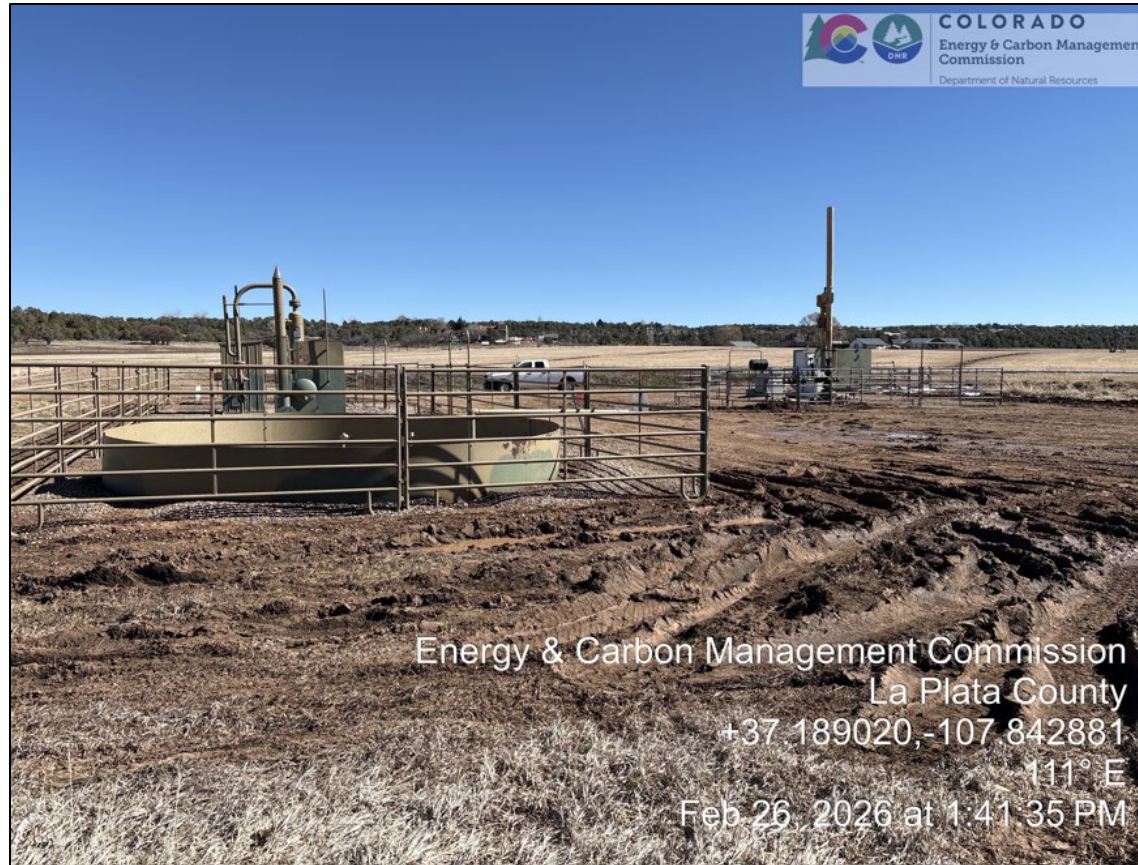
9. Location looking east. Note ruts in foreground from workover a few days prior.

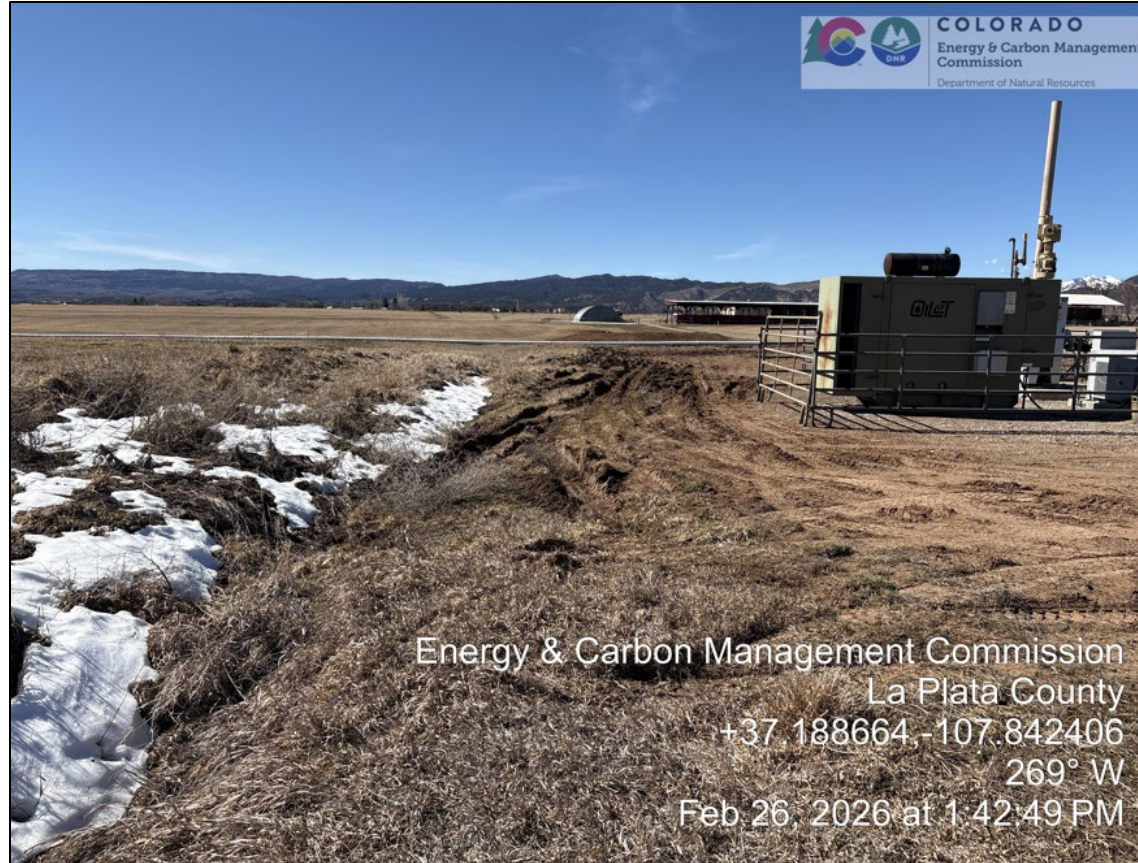
10. Drainage ditch separates location from ag field.

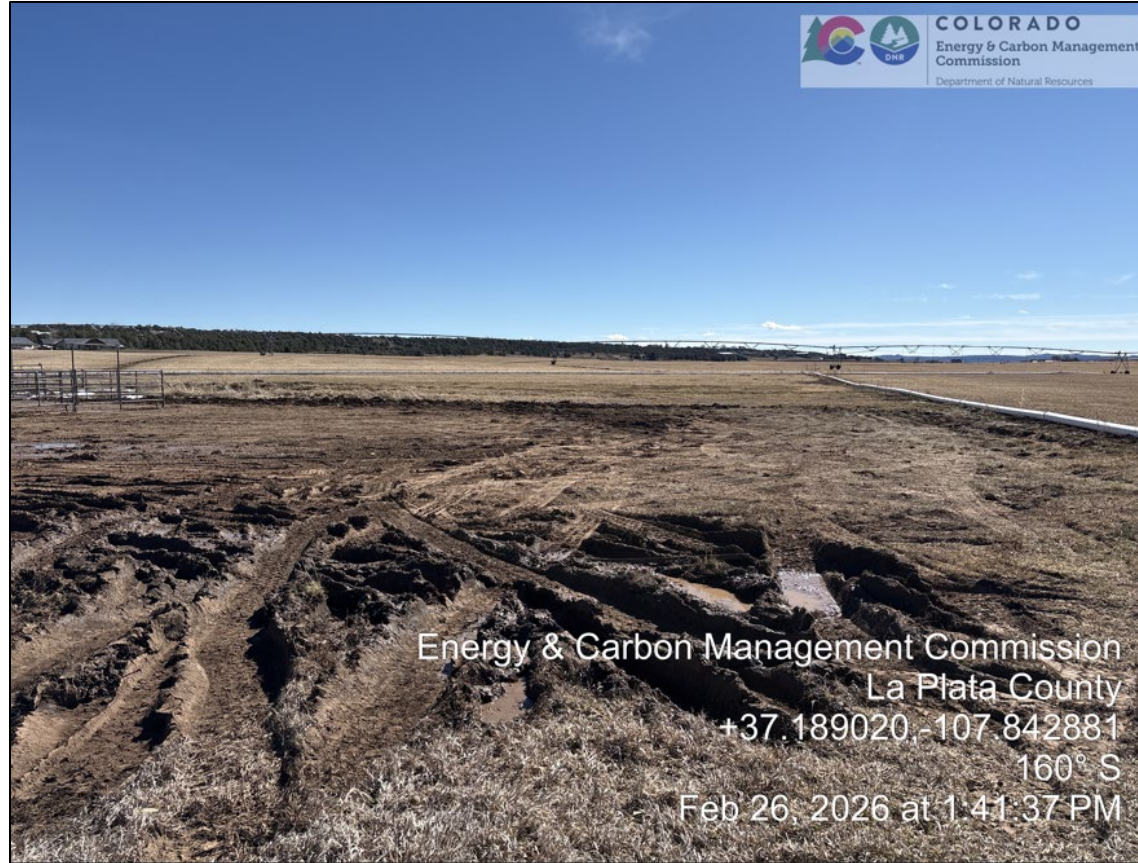
11 Ruts on pad. Ag fields immediately adjacent.

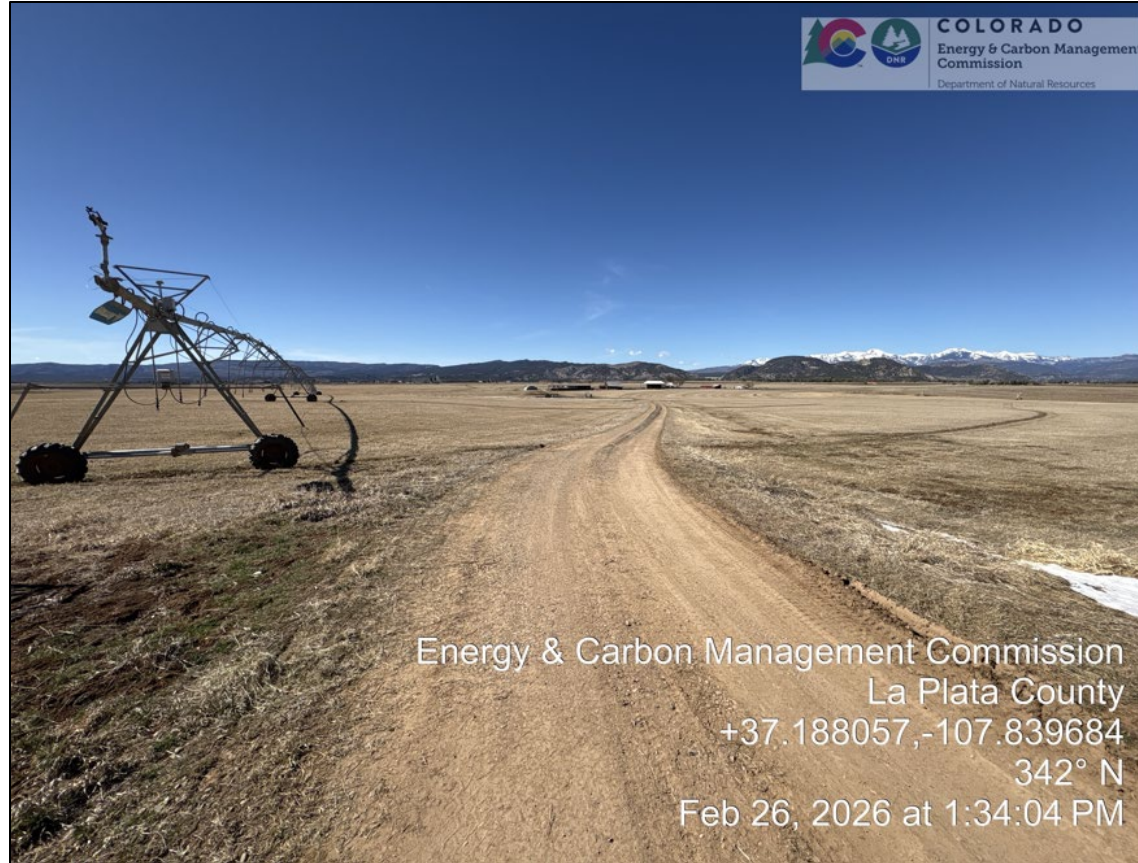
12. Access road looking towards well location.

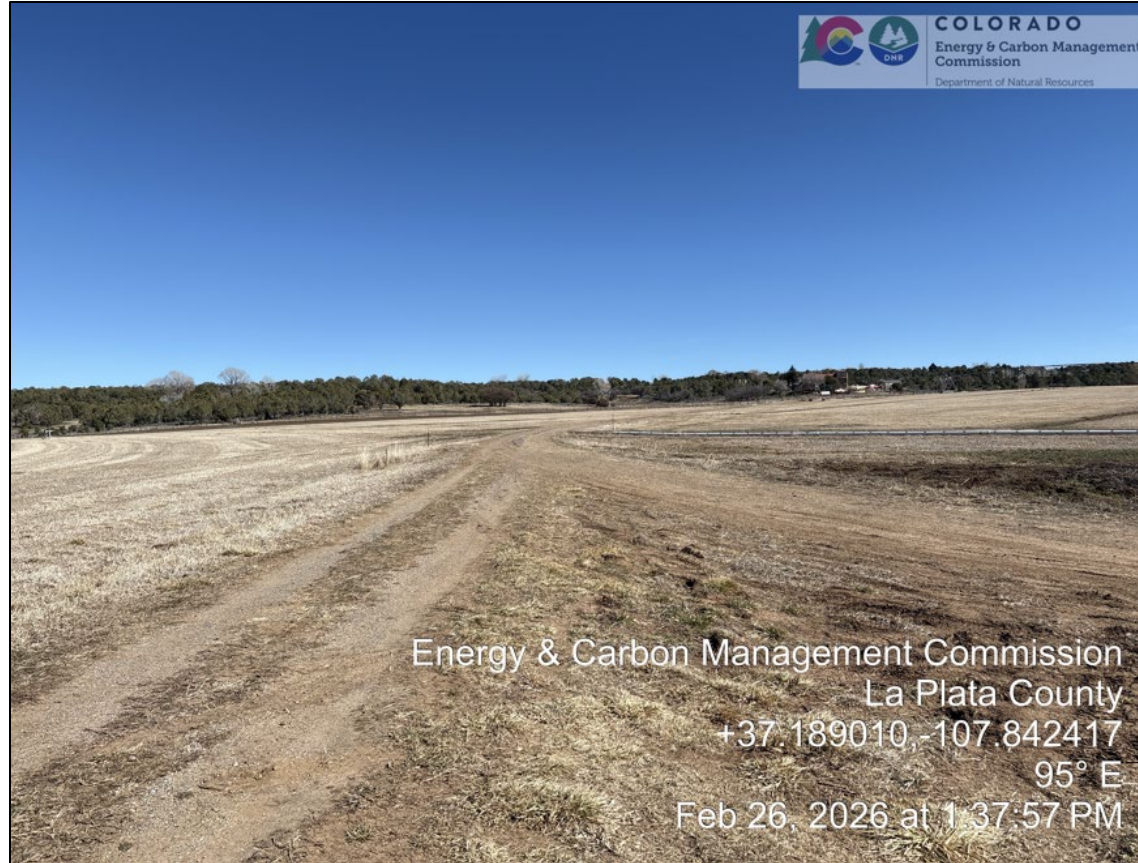
13. Access road from well location looking east.
