Site Specific Final Reclamation Completion Notice – Cropland Drone Imagery

Permit Closure Report – Cropland

Location ID: 305601

Location Name: MILLAGE C-64N64W/11NENE

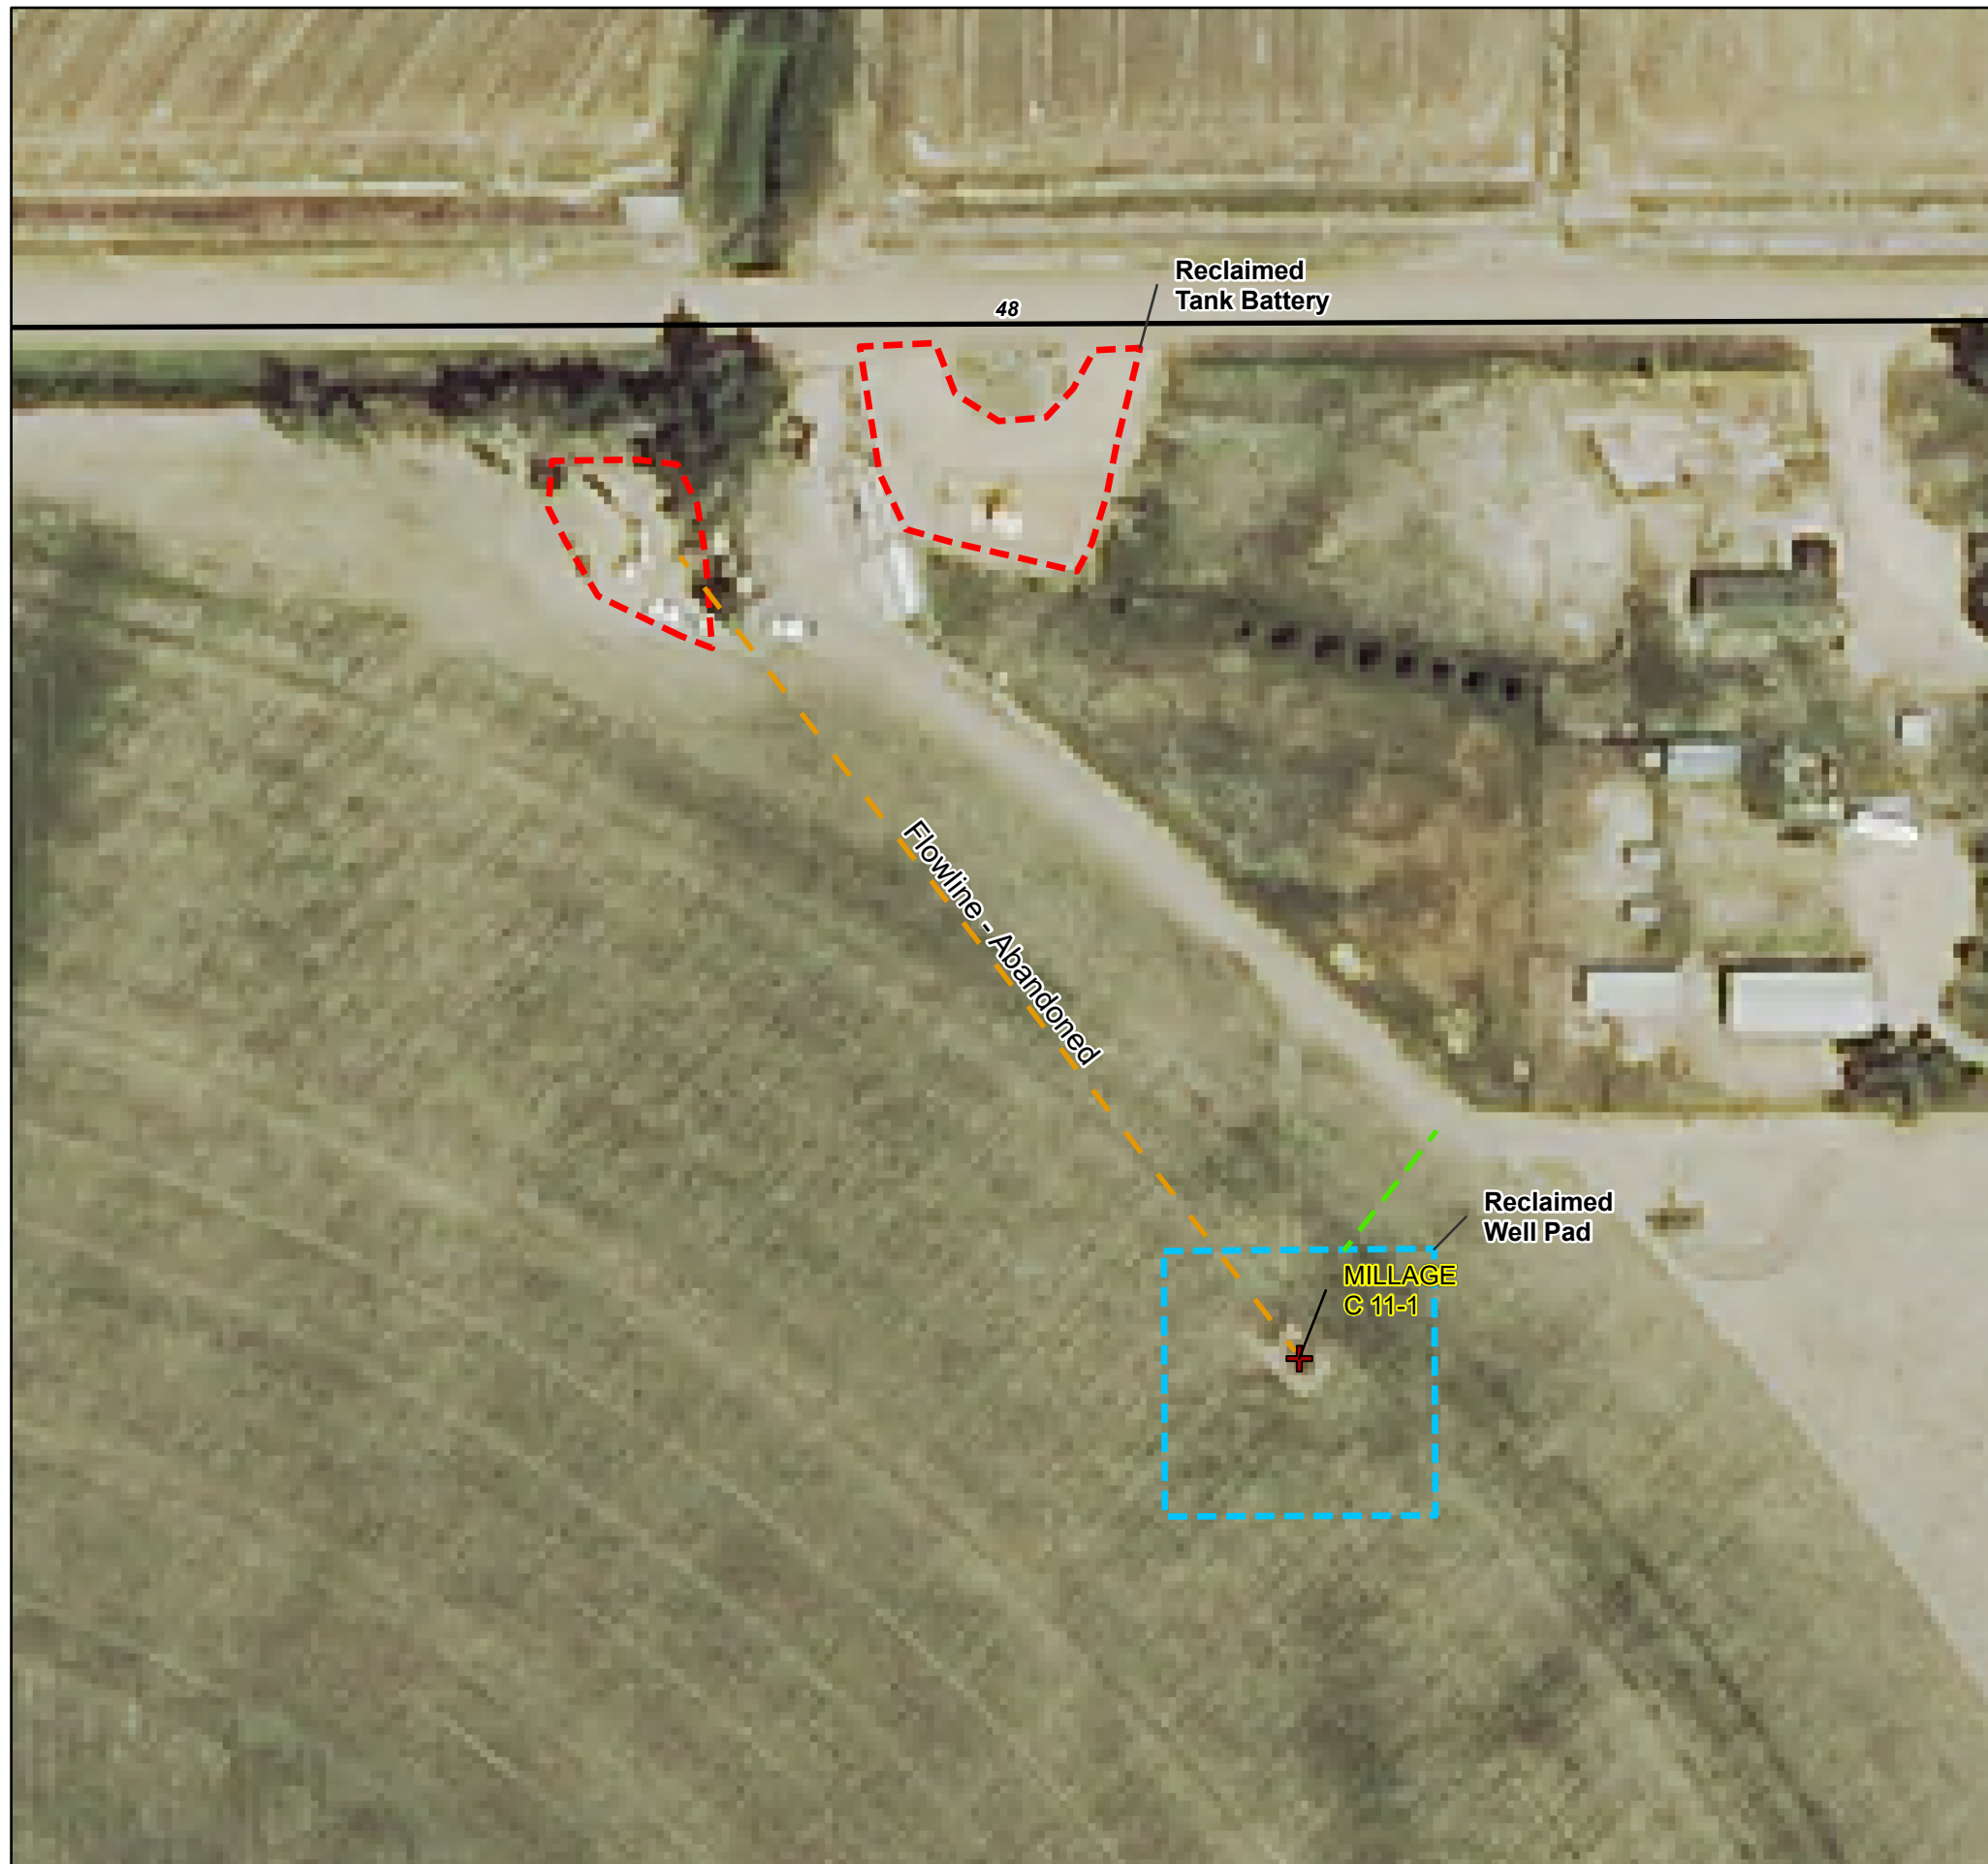
Chevron Form 4 Final Reclamation - Post Plugging Overview

Drone imagery confirms that no equipment was left on site at this location after reclamation activities occurred.

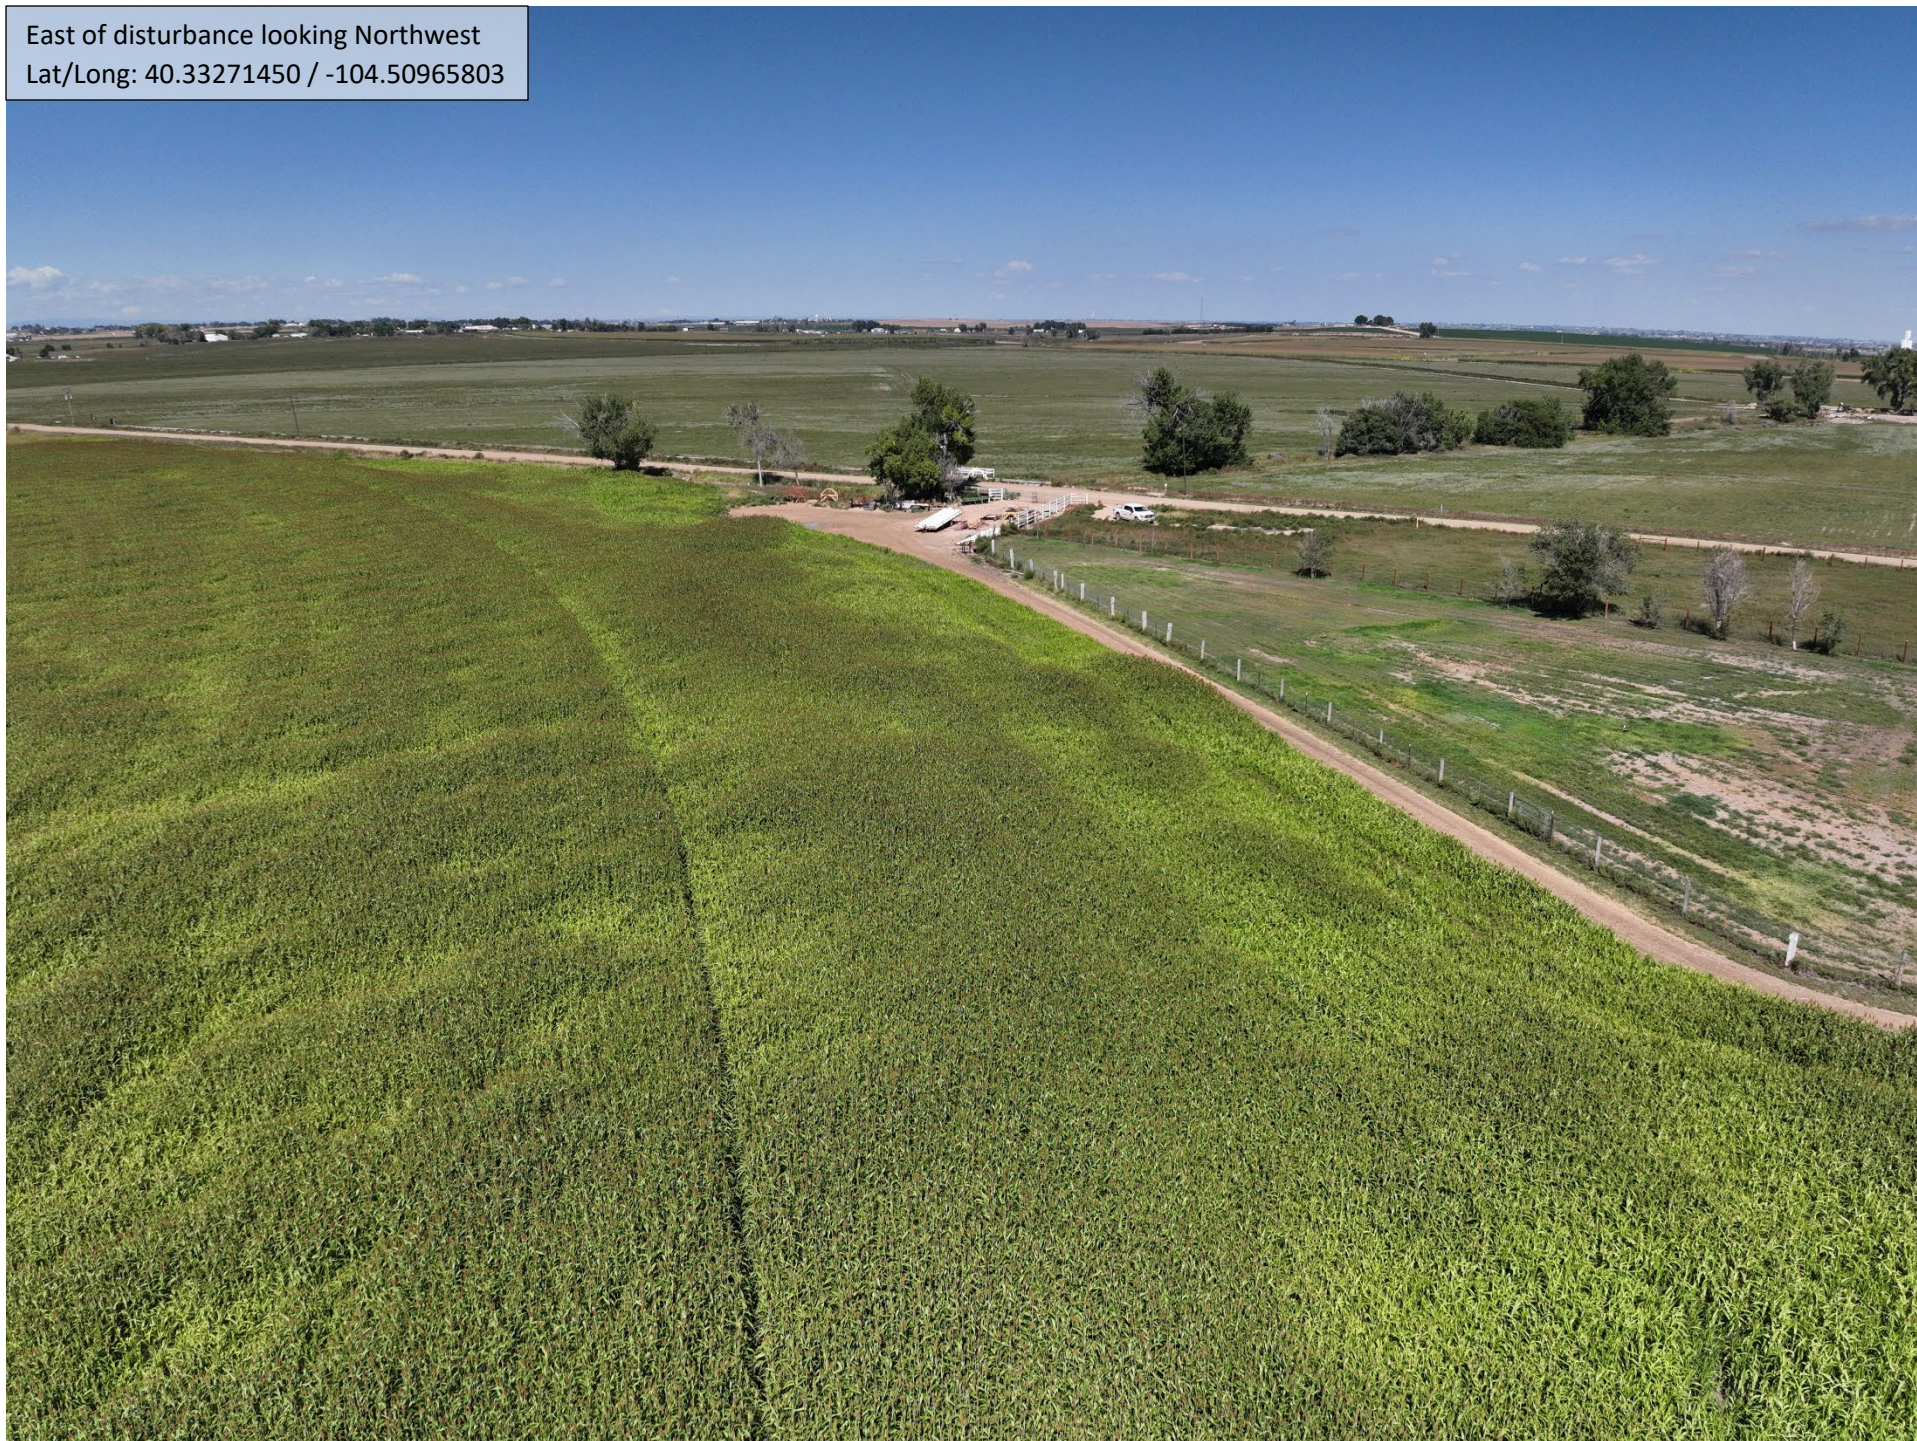
East of disturbance looking Northwest
Lat/Long: 40.33271450 / -104.50965803

MILLAGE C #11-1 was reclaimed and returned to the landowner for agricultural use in 2020. The wellhead was accessed from an unpaved access road that originated at an existing agricultural service road off of County Road 59. The access road was reclaimed and returned to agriculture in conjunction with the reclamation of the well location.
