Final Reclamation Inspection

Operator: KERR MCGEE OIL & GAS ONSHORE LP

Location ID: 330415

Location Name: HSR-KNOX-65N67W 3NWNW

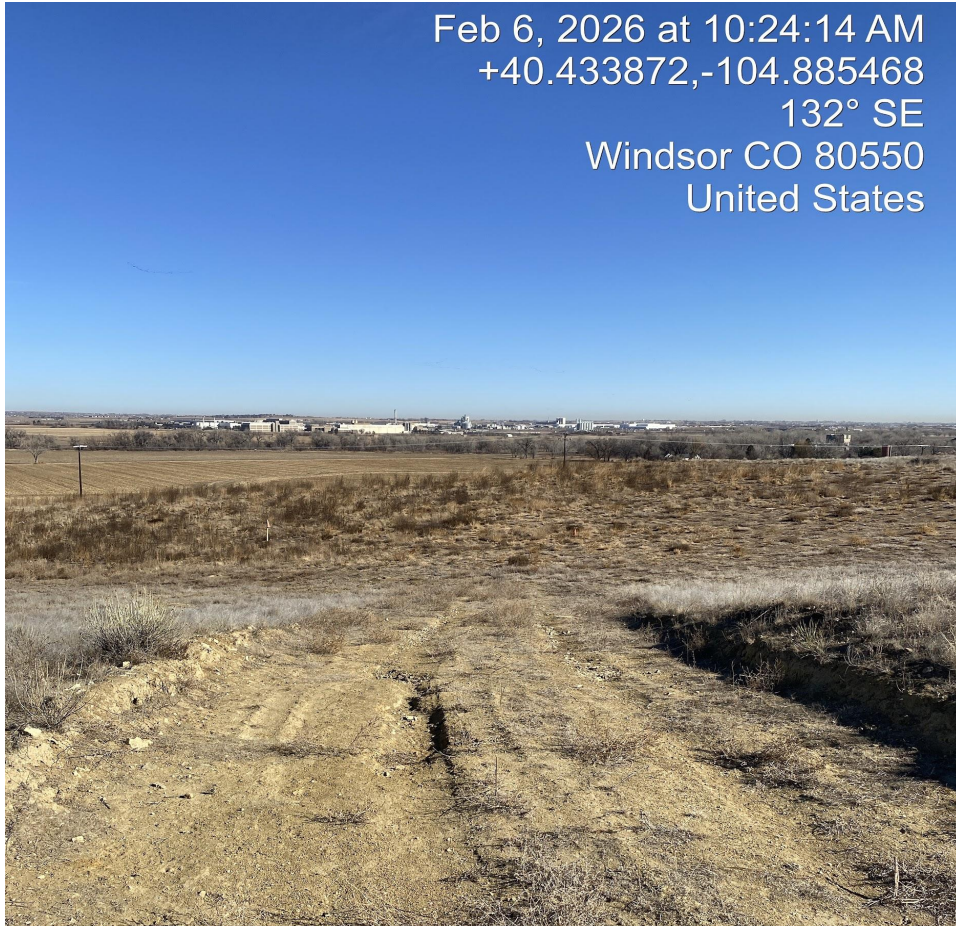
Photo 1. Photo taken from access road looking down on location. Access road has not been reclaimed and remains bare. Due to this there is a high risk stormwater erosion.

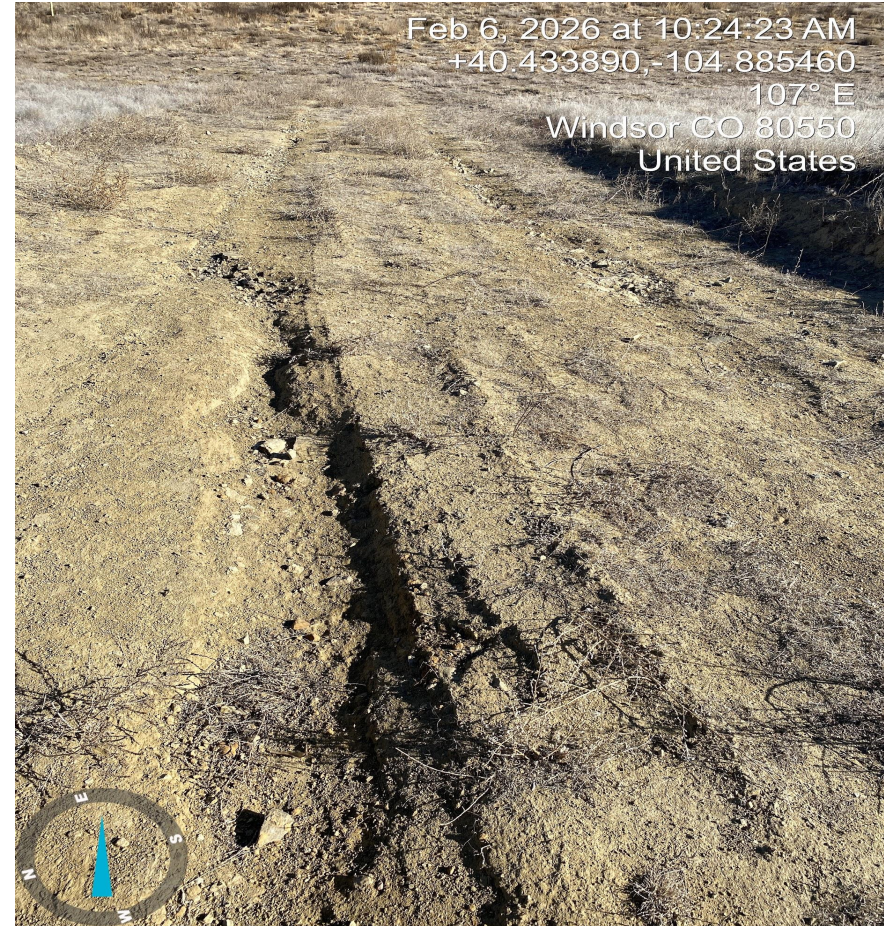
Photo 2. Photo taken on access road going to location showing evidence of stormwater rill erosion and bare soil.

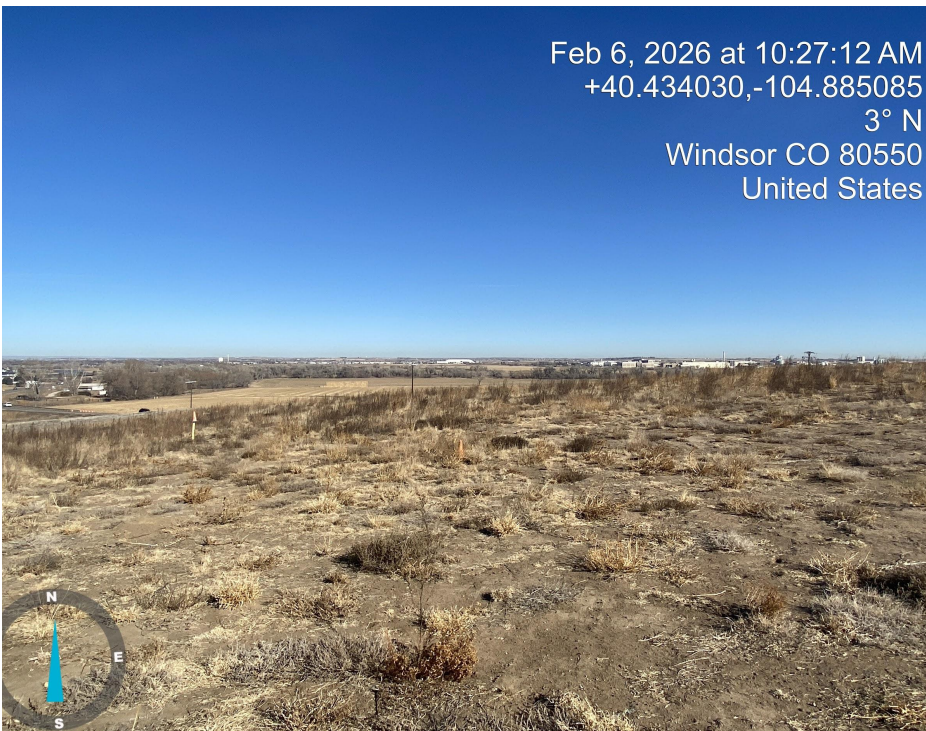
Photo 3. Photo taken from location facing north, shows overview of the location. Location does not meet final reclamation standards significant area is bare and large number of weeds are present on location.

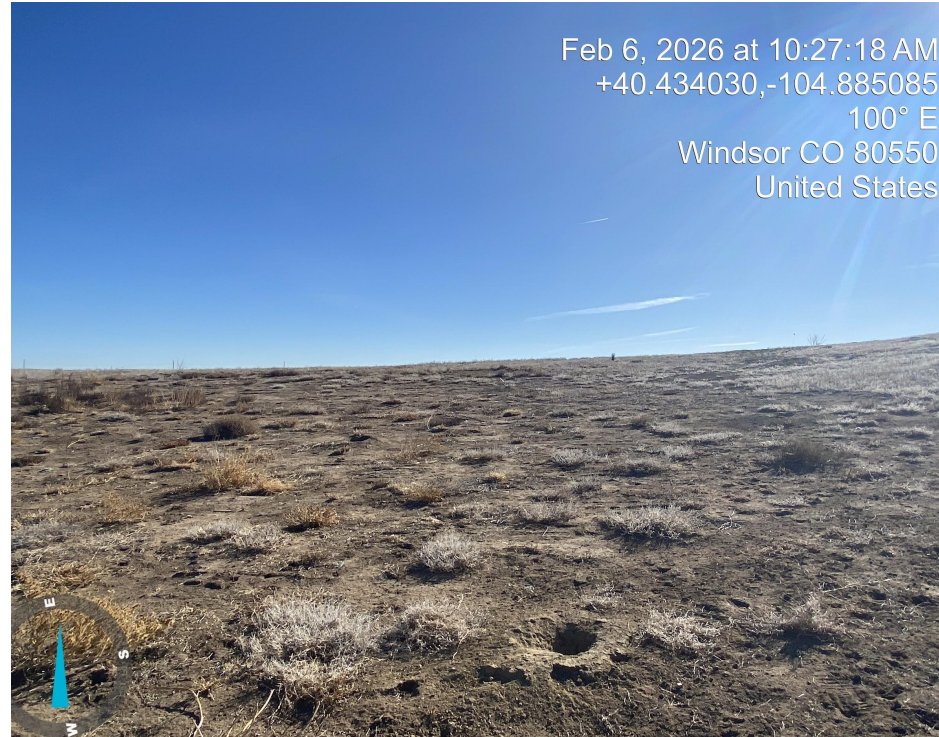
Photo 4. Photo taken from location facing east. See comments under photo 3.

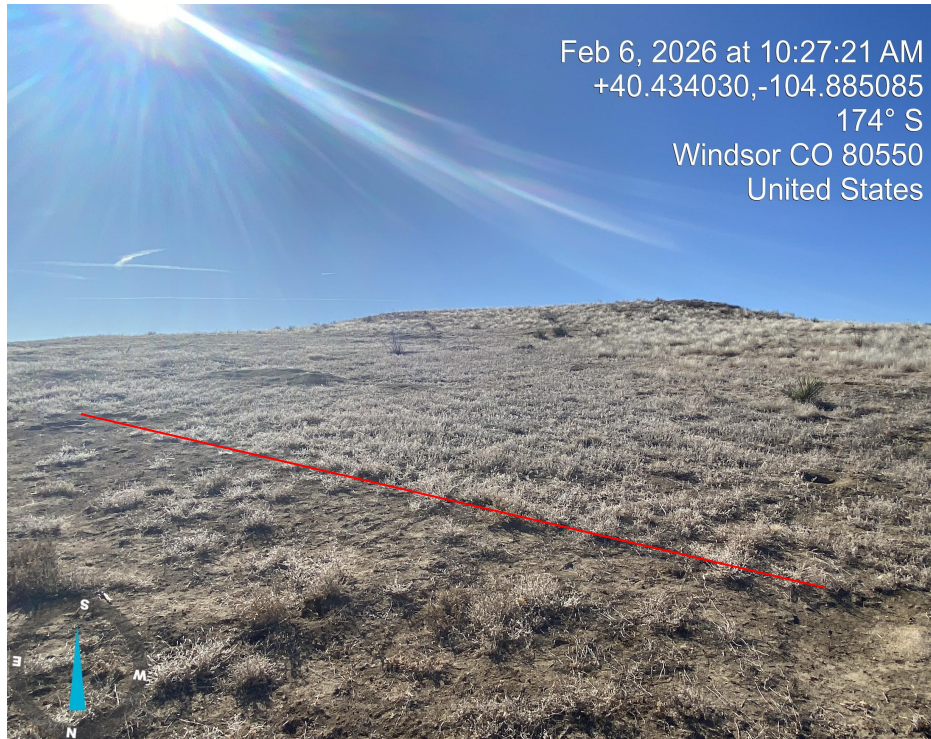
Photo 5. Photo taken from southern end of location facing south. Clear line is present where disturbance occurred and vegetation is lacking. Above redline is undisturbed and below was disturbed.

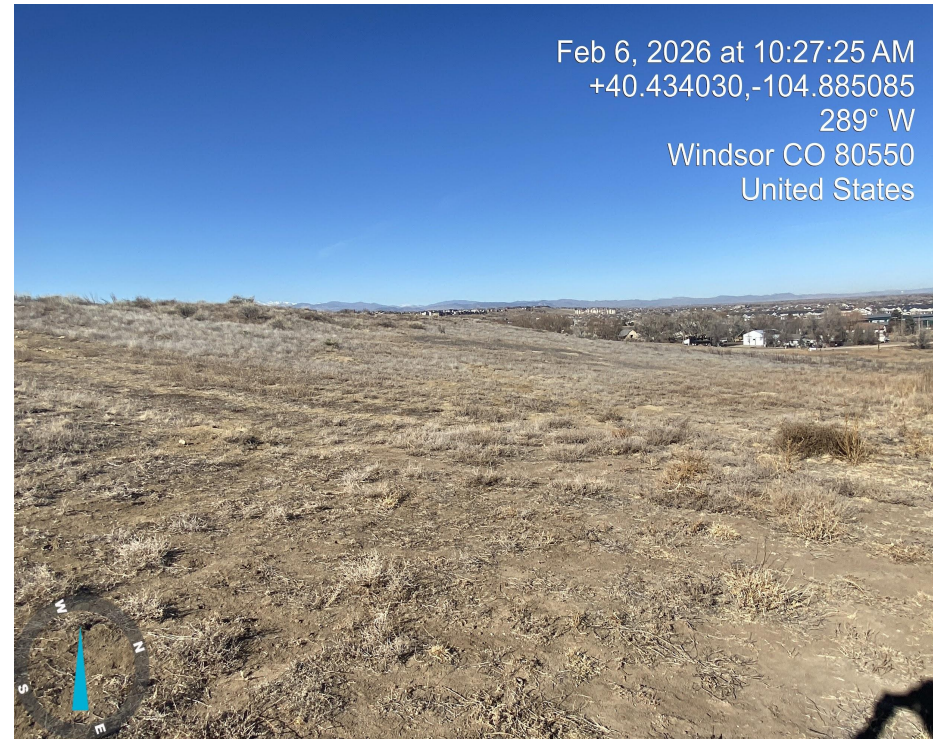
Photo 6. Photo taken from location facing north west, on the north west corner of the well pad. See comment in photo 3.

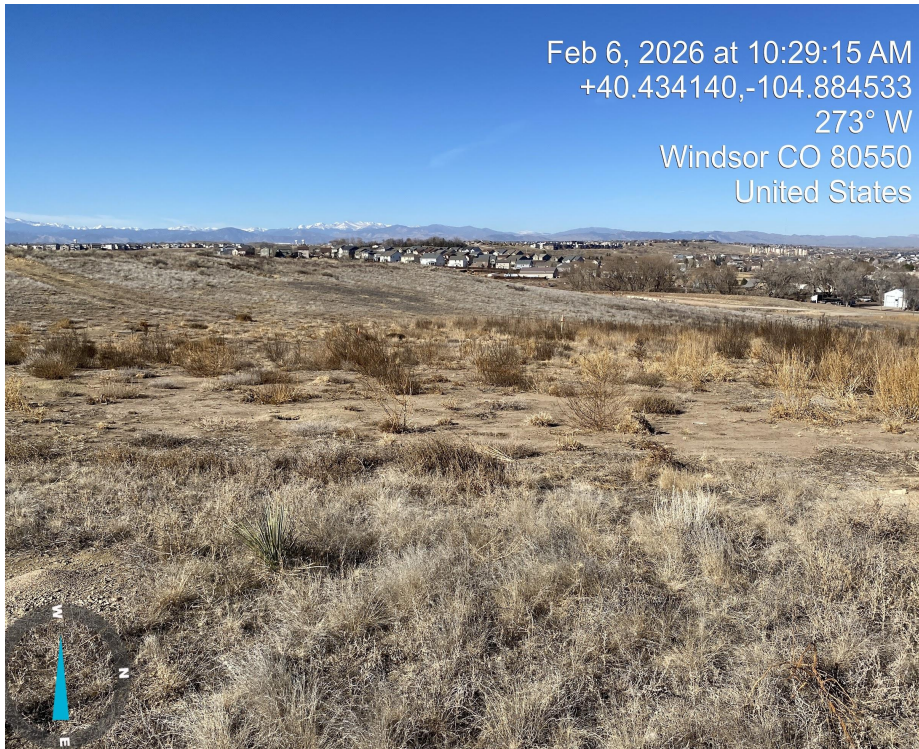
Photo 7. Photo taken from southeastern edge of location facing west. There is a clear line where well pad was. Where well pad was weeds are present and significant bare areas are present throughout the location.

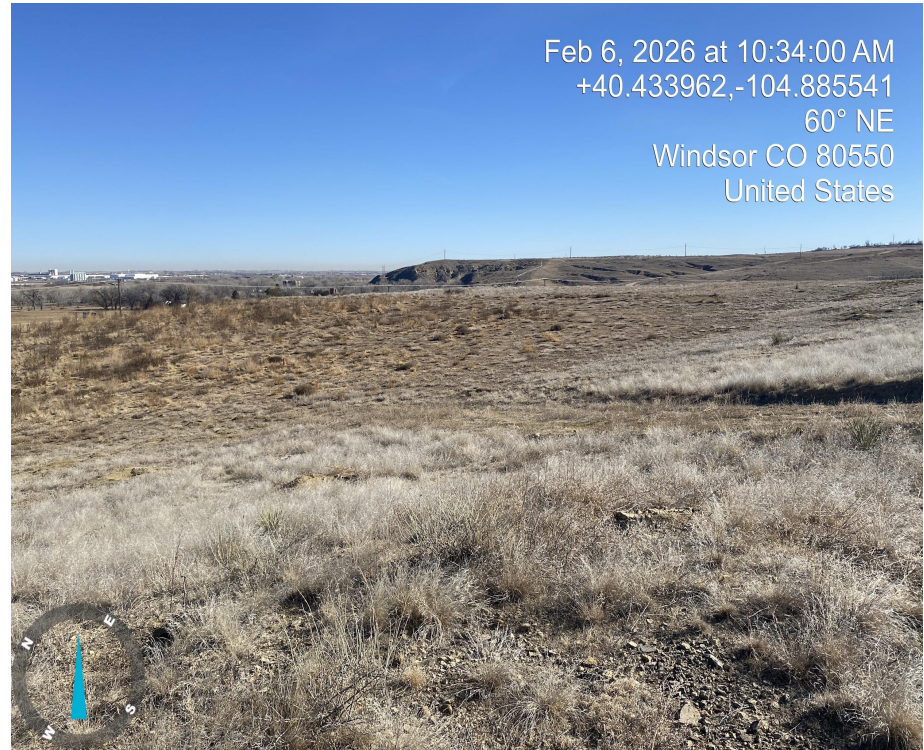
Photo 8. Photo taken from the south western side of well pad demonstrating a clear outline of where the well pad was and where the road enters.

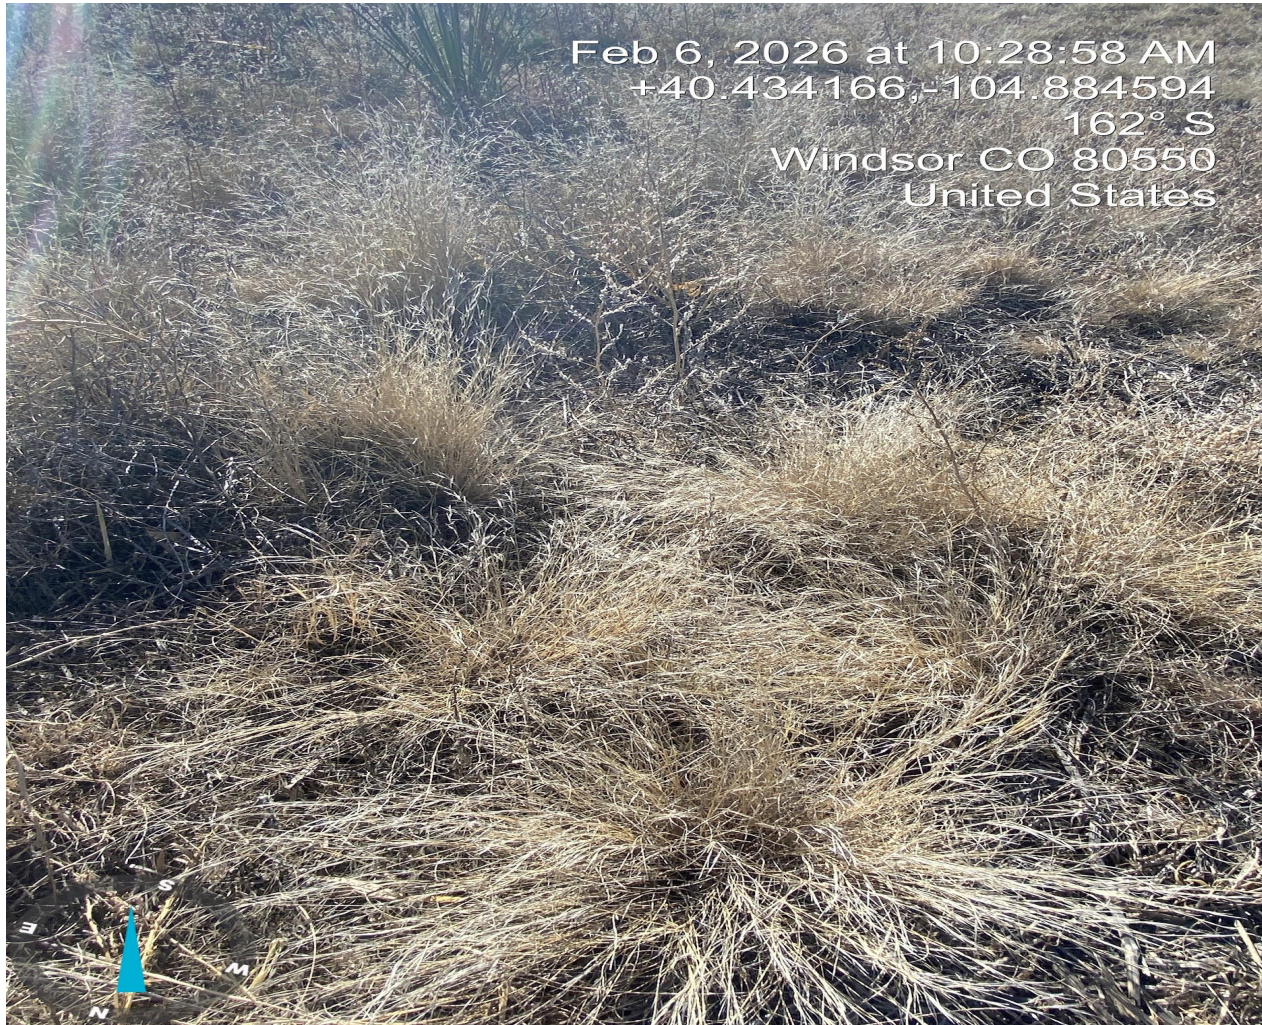
Photo 9. Photo shows native desirable grass species just off of location on the south eastern side of well head.

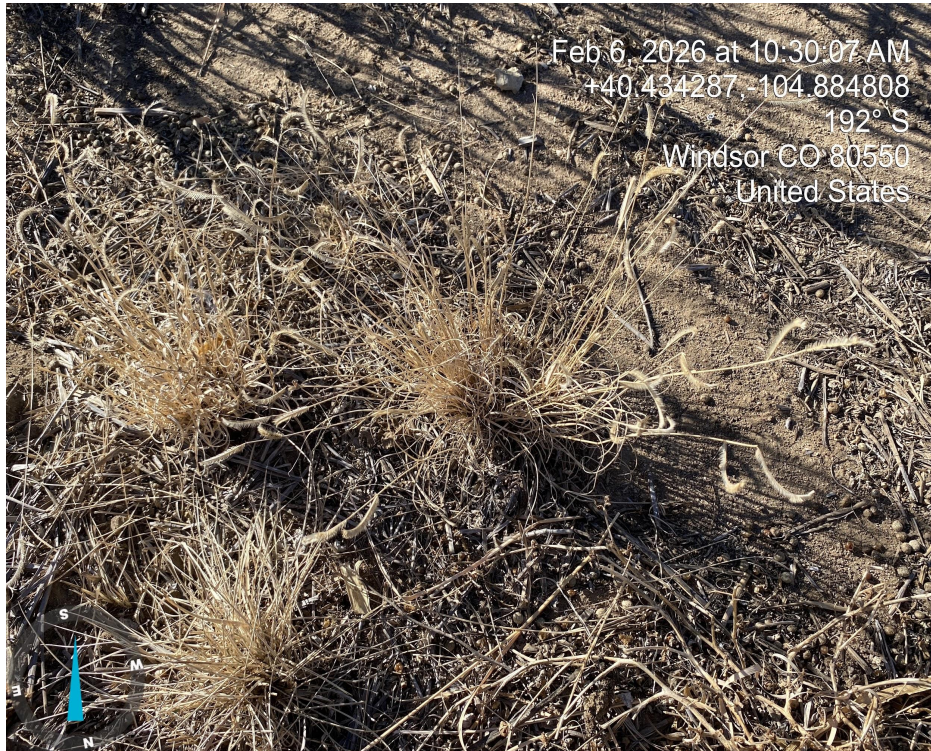
Photo 10. Photo shows desirable grass species that was present on location giving some evidence of previous reclamation work however undesirable plants outnumber natives significantly.

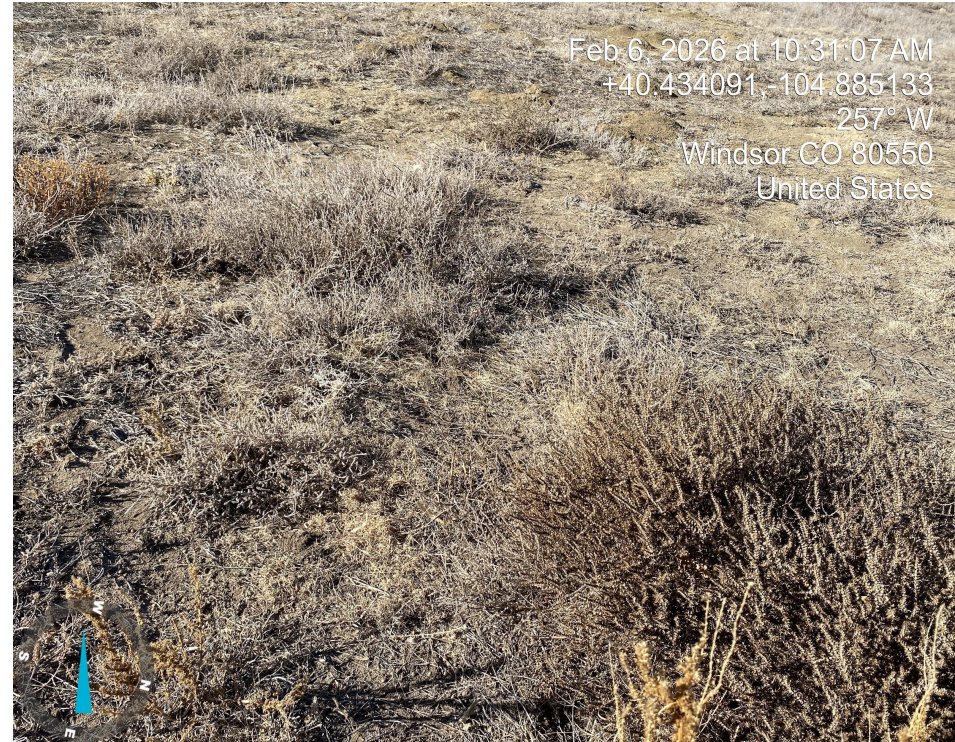
Photo 11. Photo shows undesirable plant species russian thistle present on location

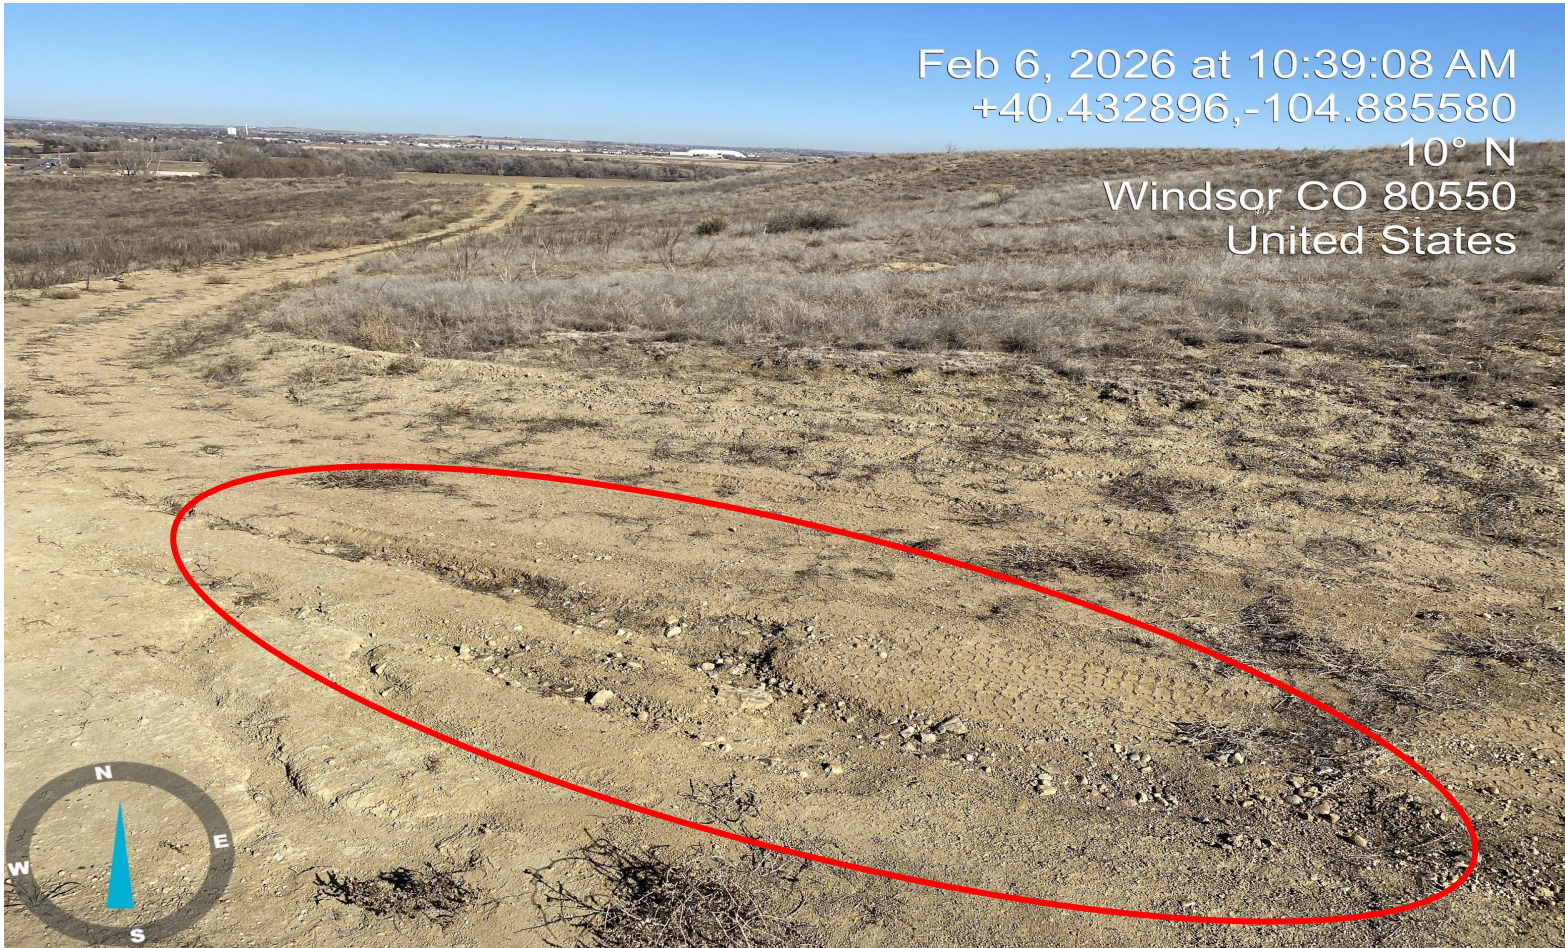
Photo 12. Photo shows location access road has not been reclaimed, is mostly bare and there is evidence of stormwater erosion (red circle) .

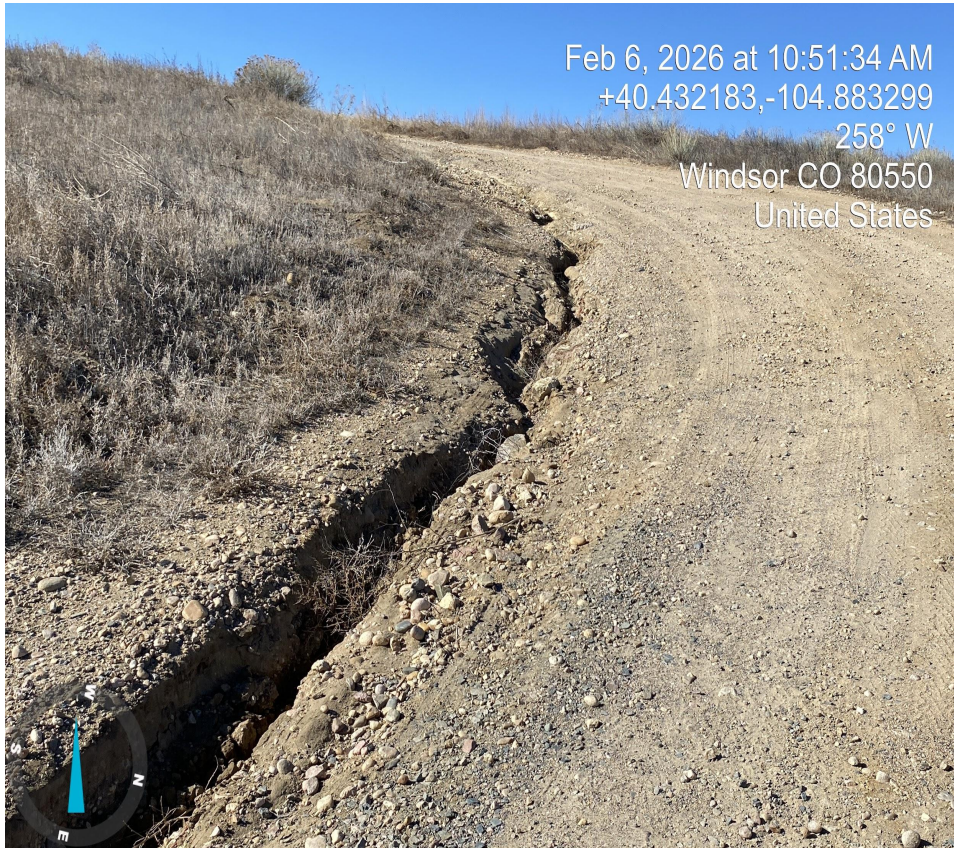
Photo 13. Photo shows erosion on main access road.

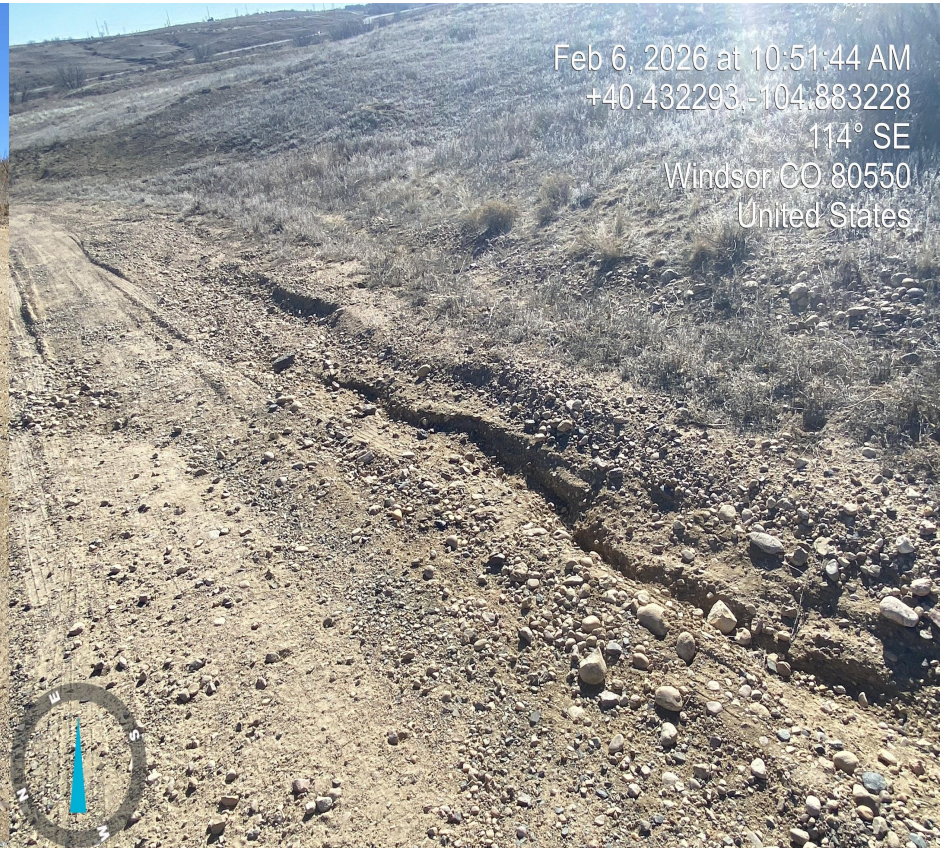
Photo 14. Photo shows erosion on main access road.

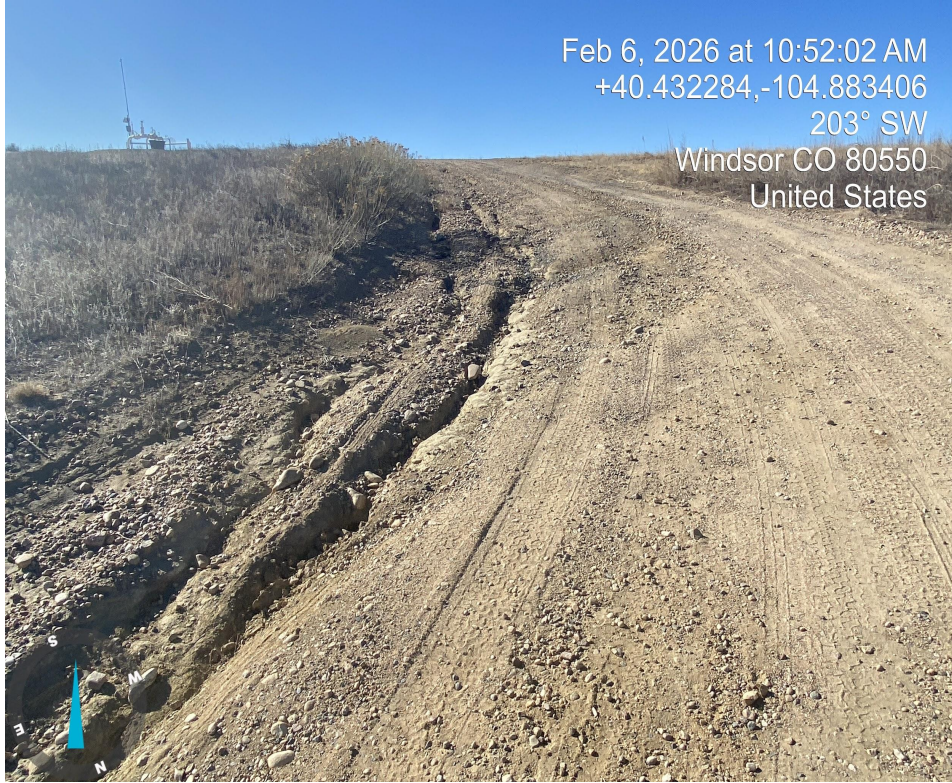
Photo 15. Photo shows erosion on main access road.

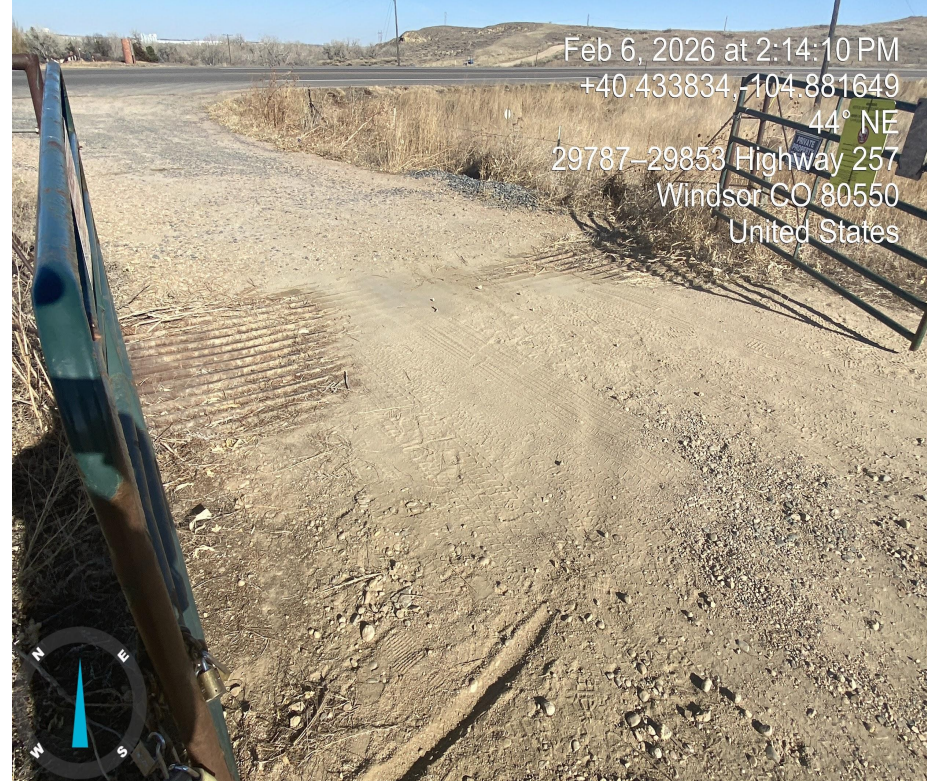
Photo 16. Photo shows soil from main access road filling cattle guard at the access gate to SH 257.
