Inspection Photos  
Kinder Morgan – HE #3  
API # 05-083-06458

Inspector Name: James Blair. Inspection Date: 02/27/2026  
Inspection Doc #: 721100180

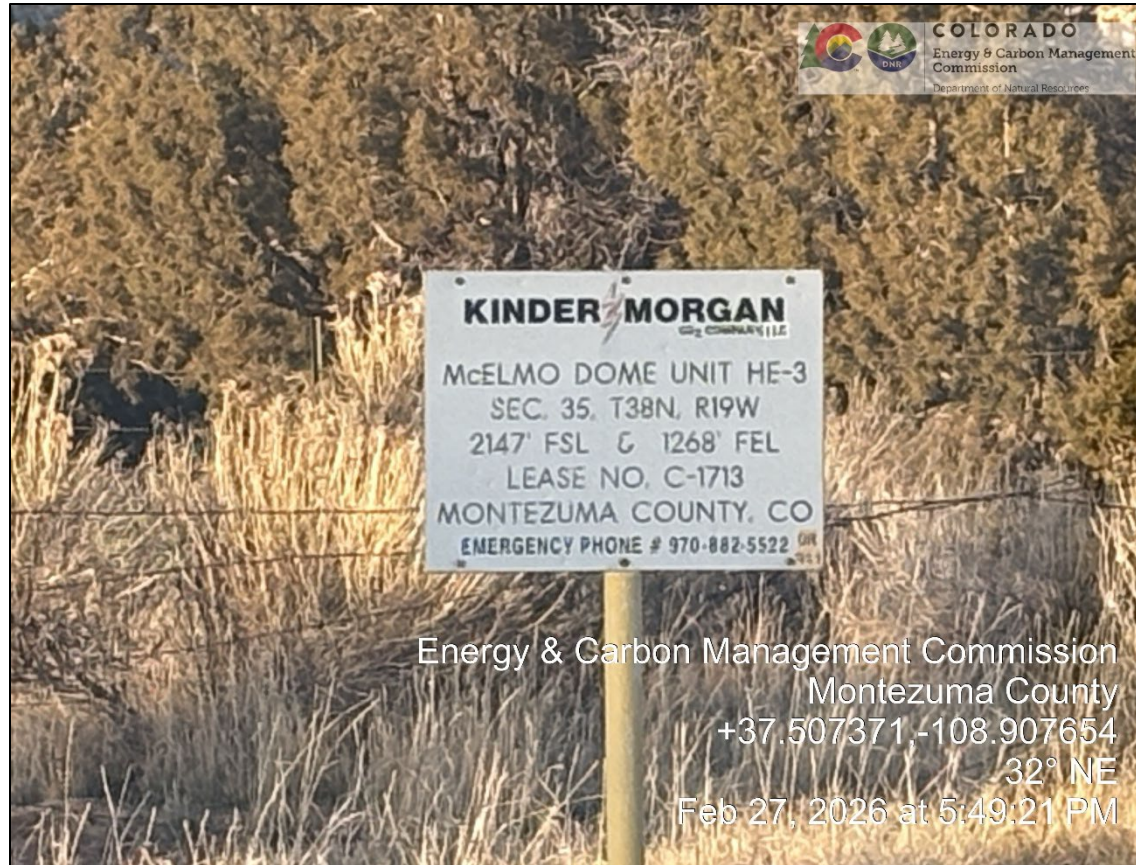
1. Well sign

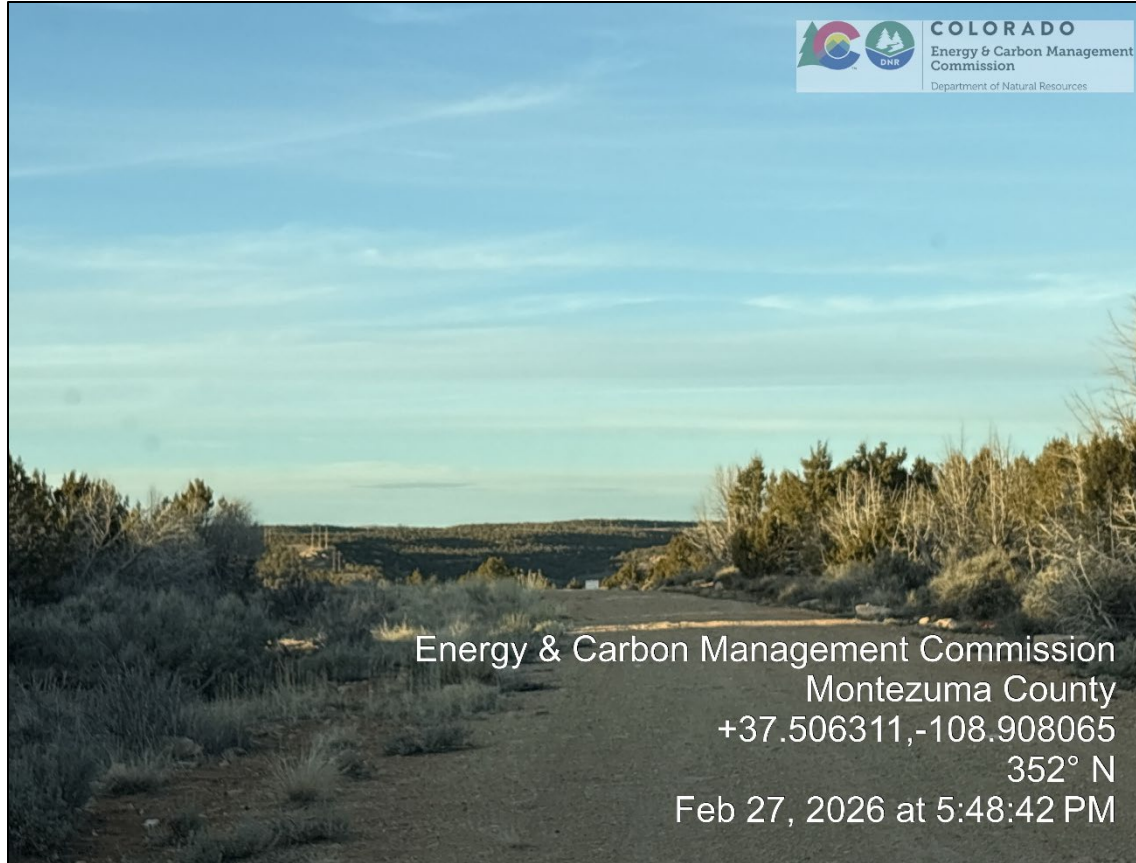
2. Access road.

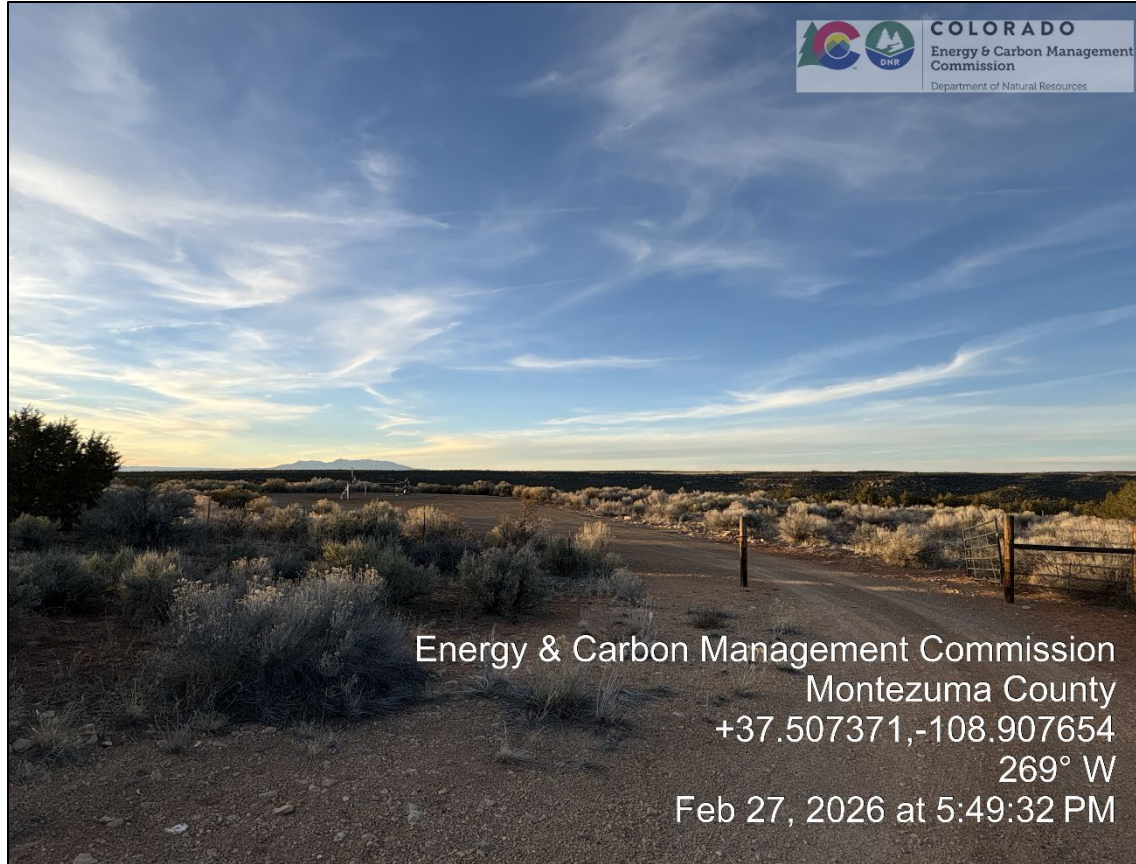
3. Pad entrance and gate.

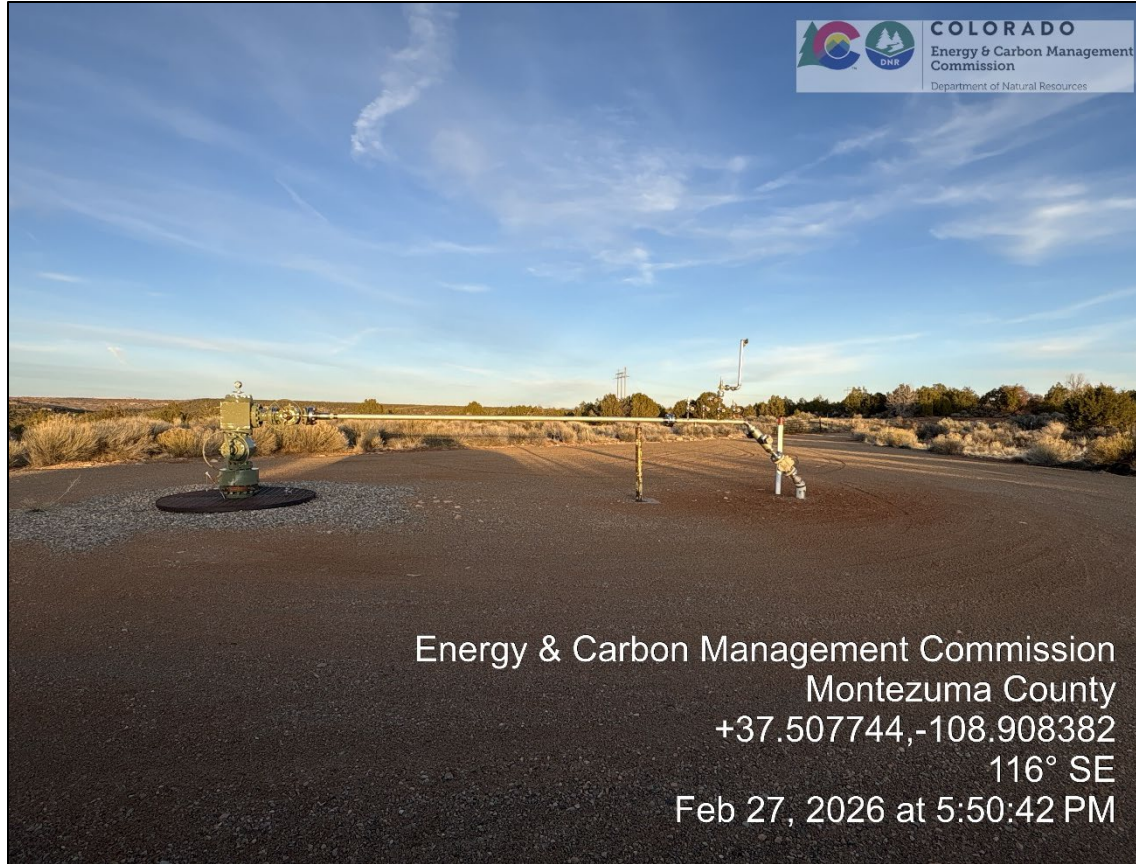
4. Wellhead and flow line.

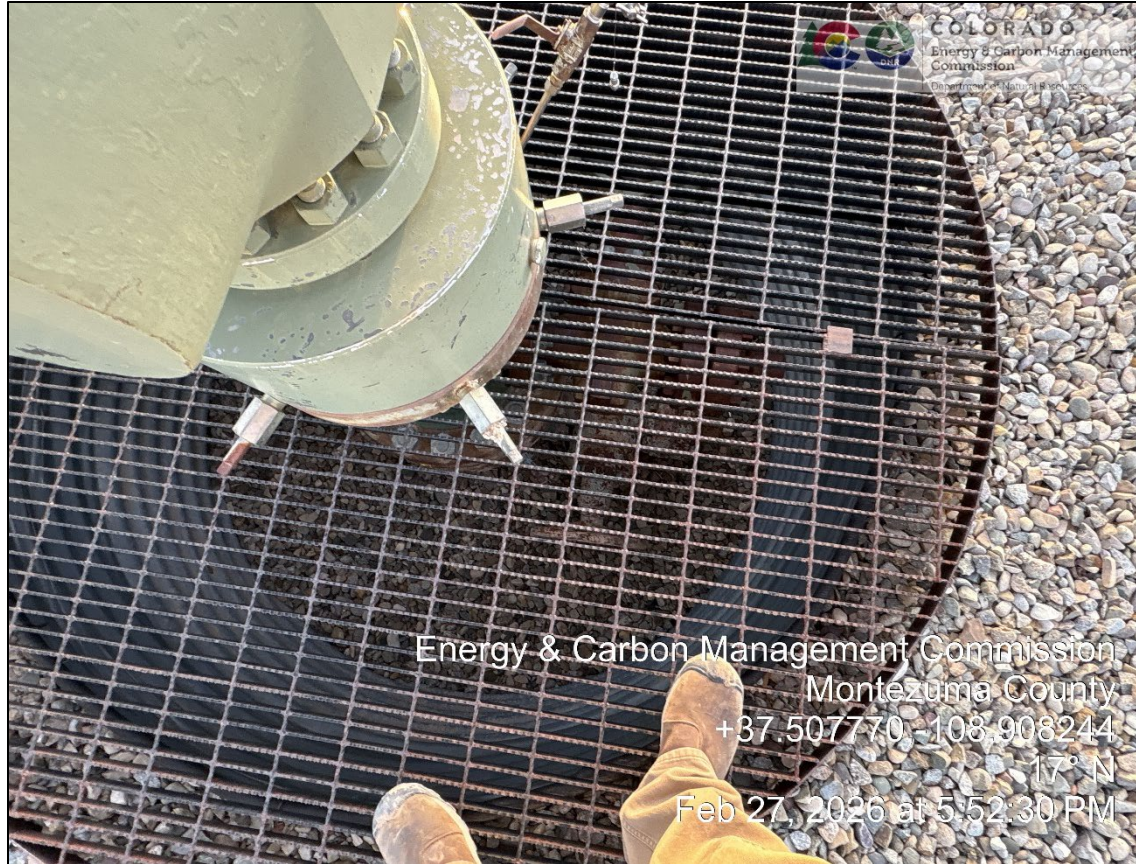
5. Well cellar and bradenhead.

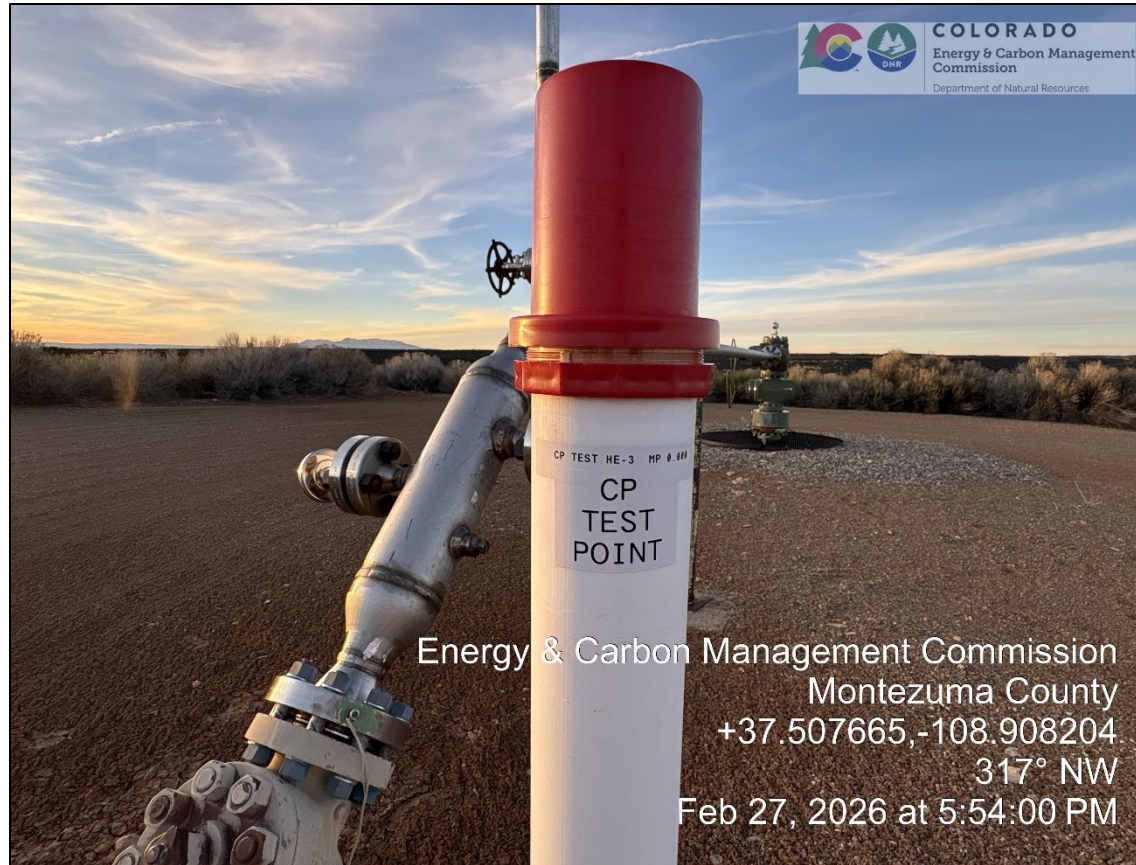
6. CP test point.

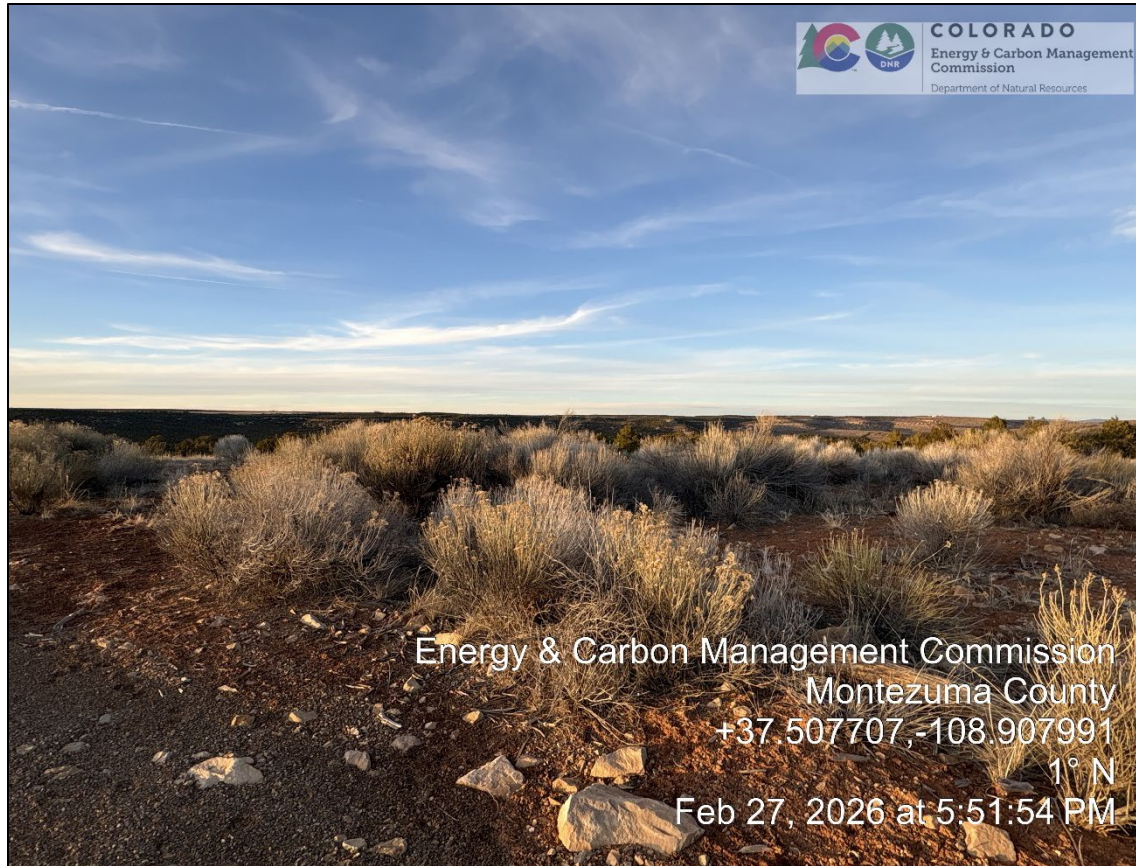
7. Reclamation vegetation.

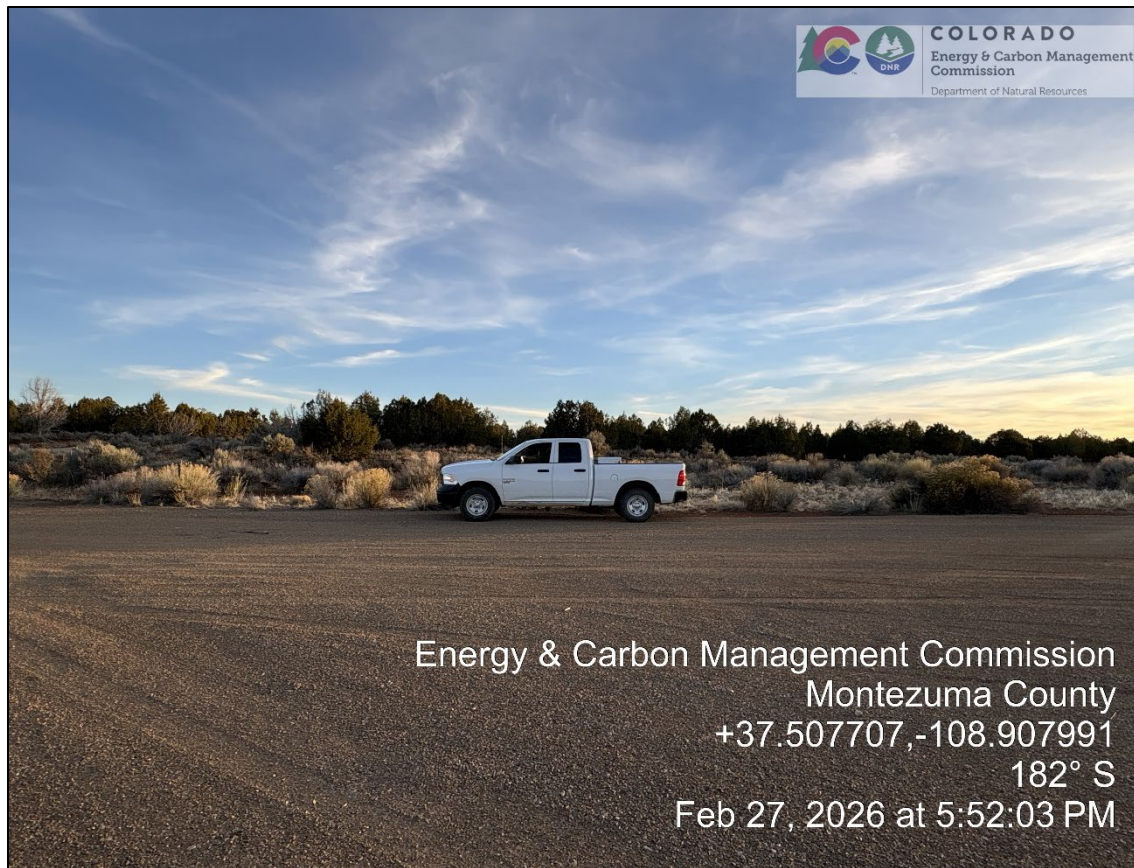
8. Well pad and reclamation vegetaion looking south.

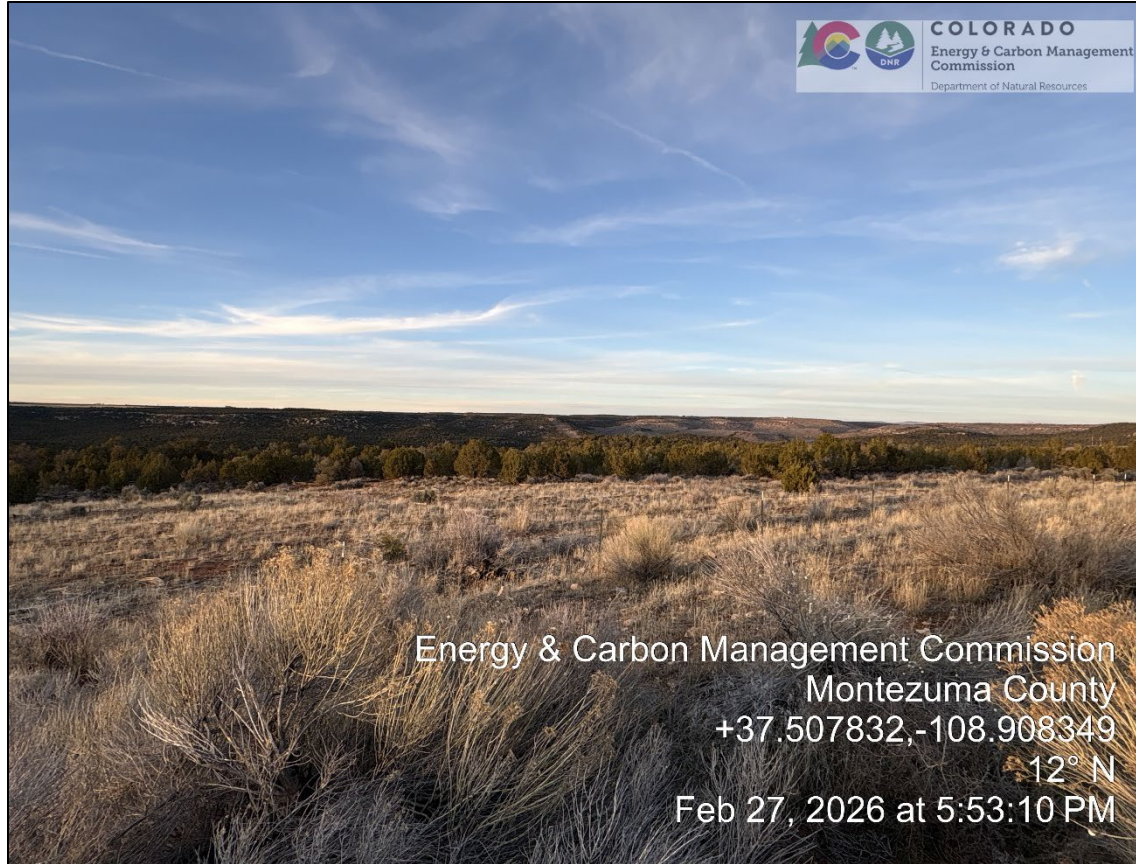
9. Interim reclamation and location fence.

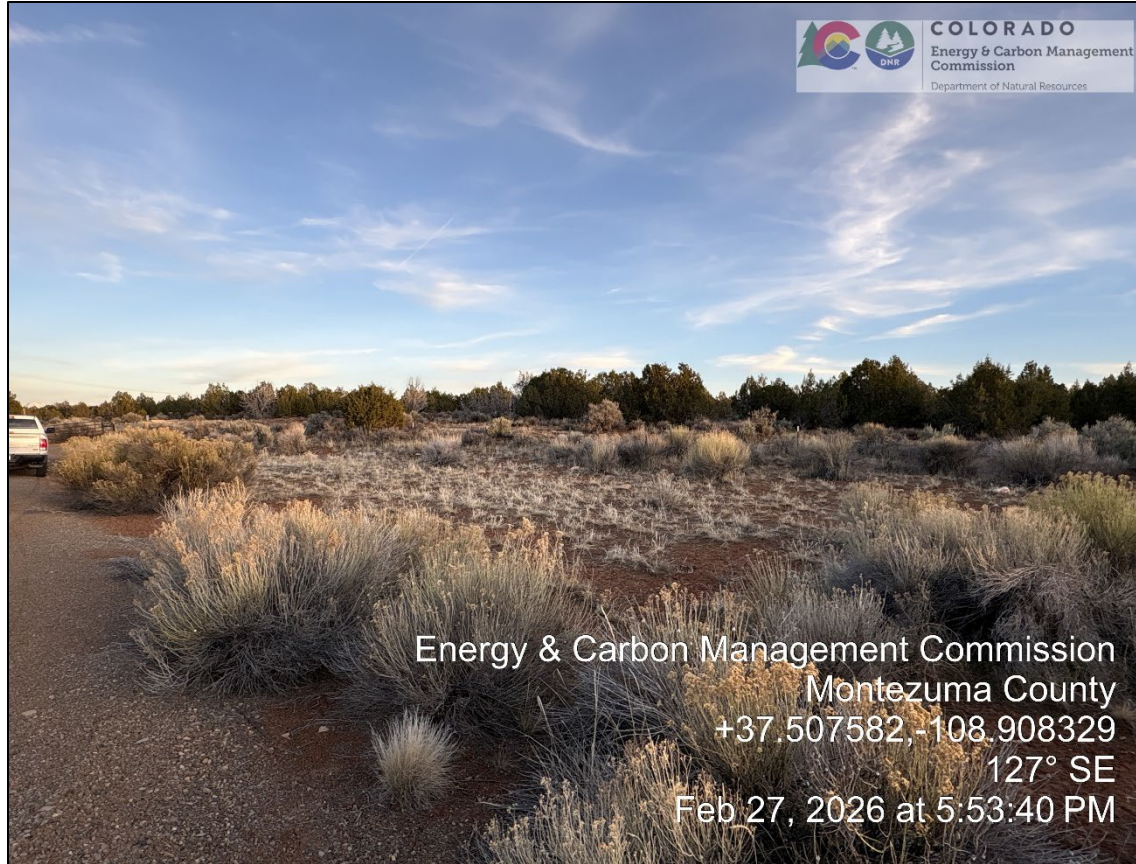
10. Reclamation vegetaion.
