Inspection Photos

API: 017-06389

Operator: MURFIN DRILLING COMPANY

Inspection Date: 3/3/2026

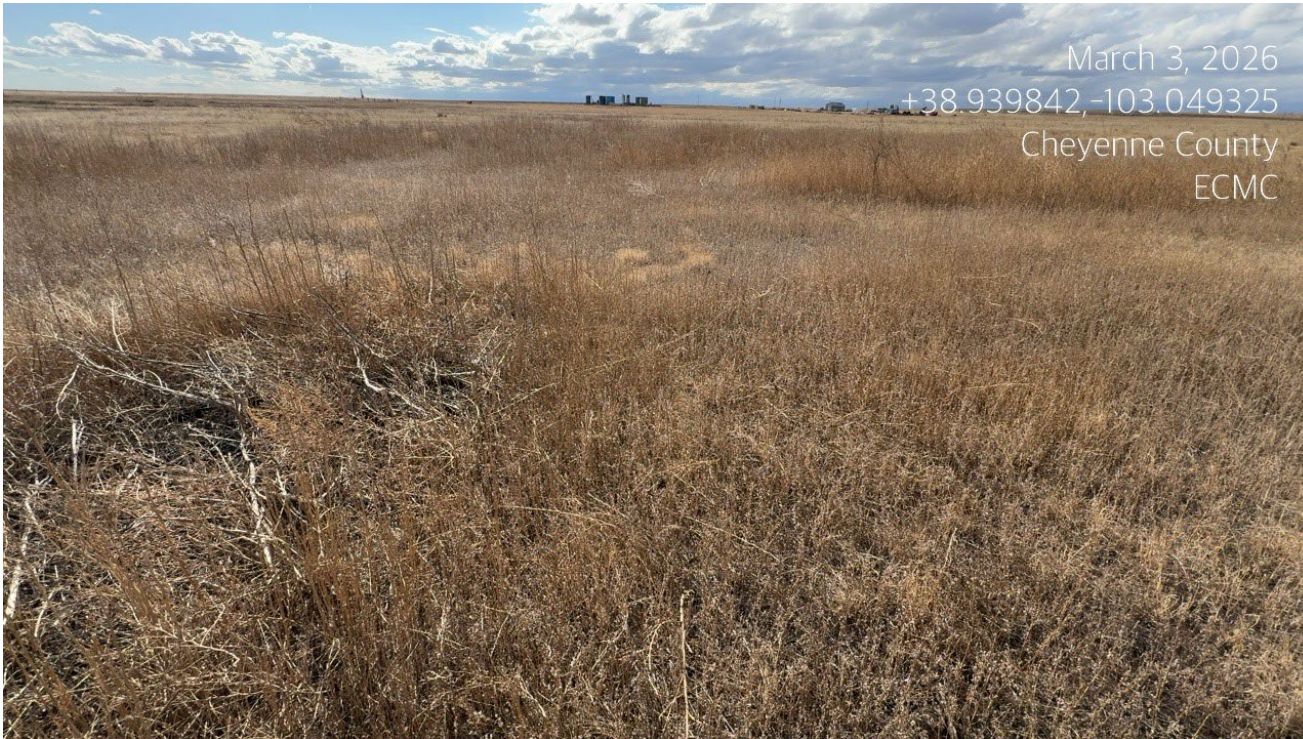
Photo 1. Facing south at the east side of the location. This area consist of undesirable weeds (Kochia).

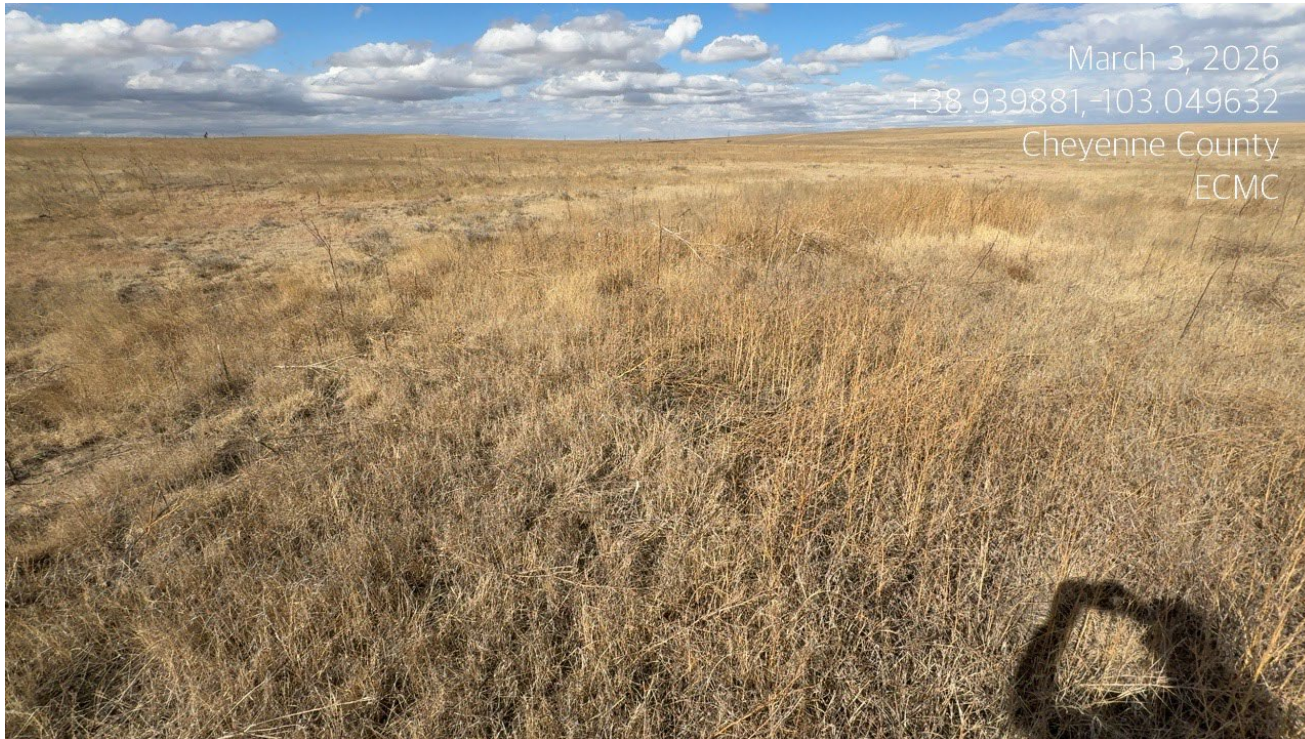
Photo 2. Center of the location facing north.

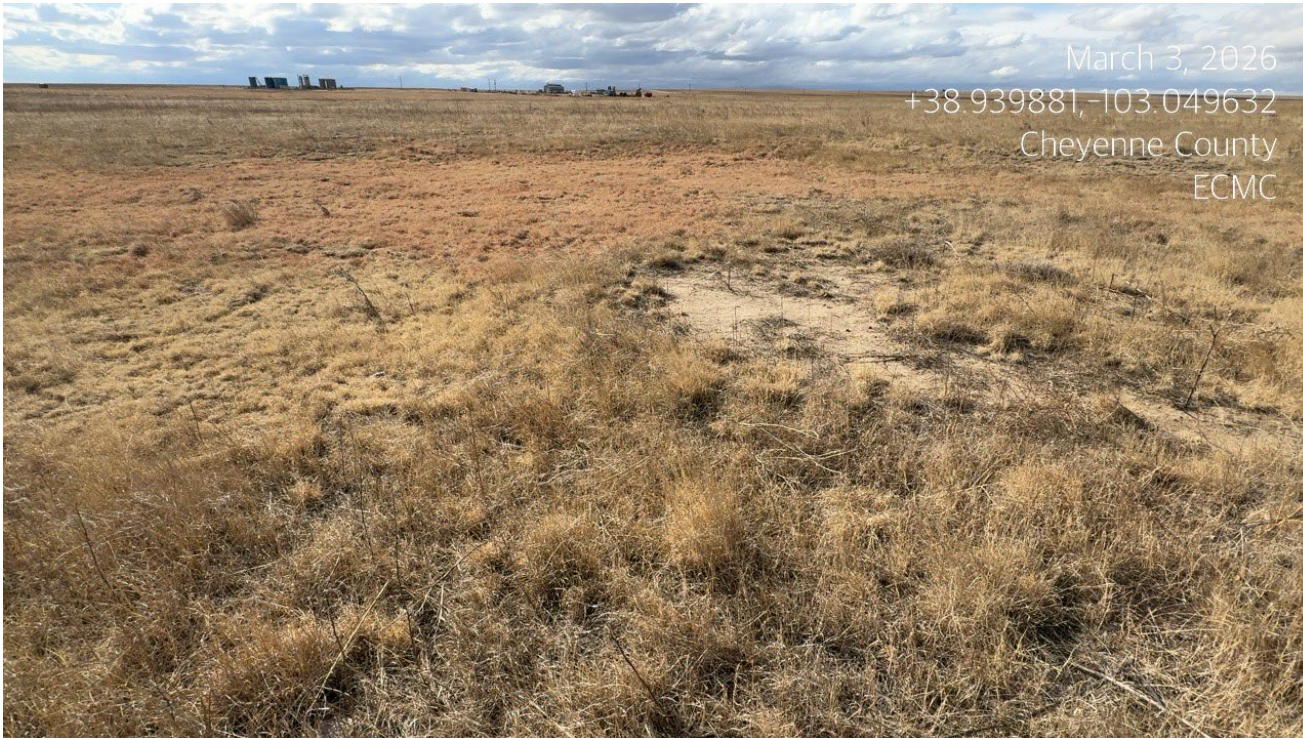
Photo 3. Center of the location facing west. The west side of the location has desirable vegetation with minimal weeds.

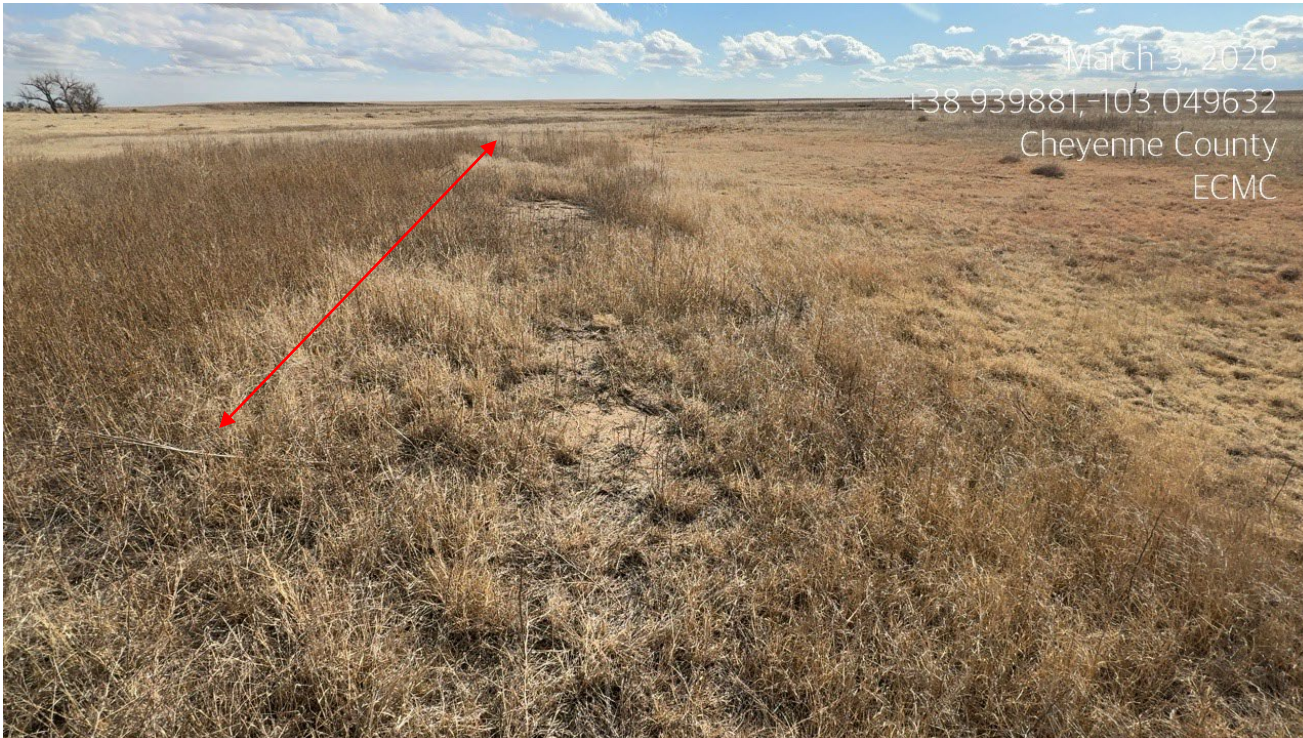
Photo 4. Center of the location facing south. The left side of the line is dominantly undesirable weeds.

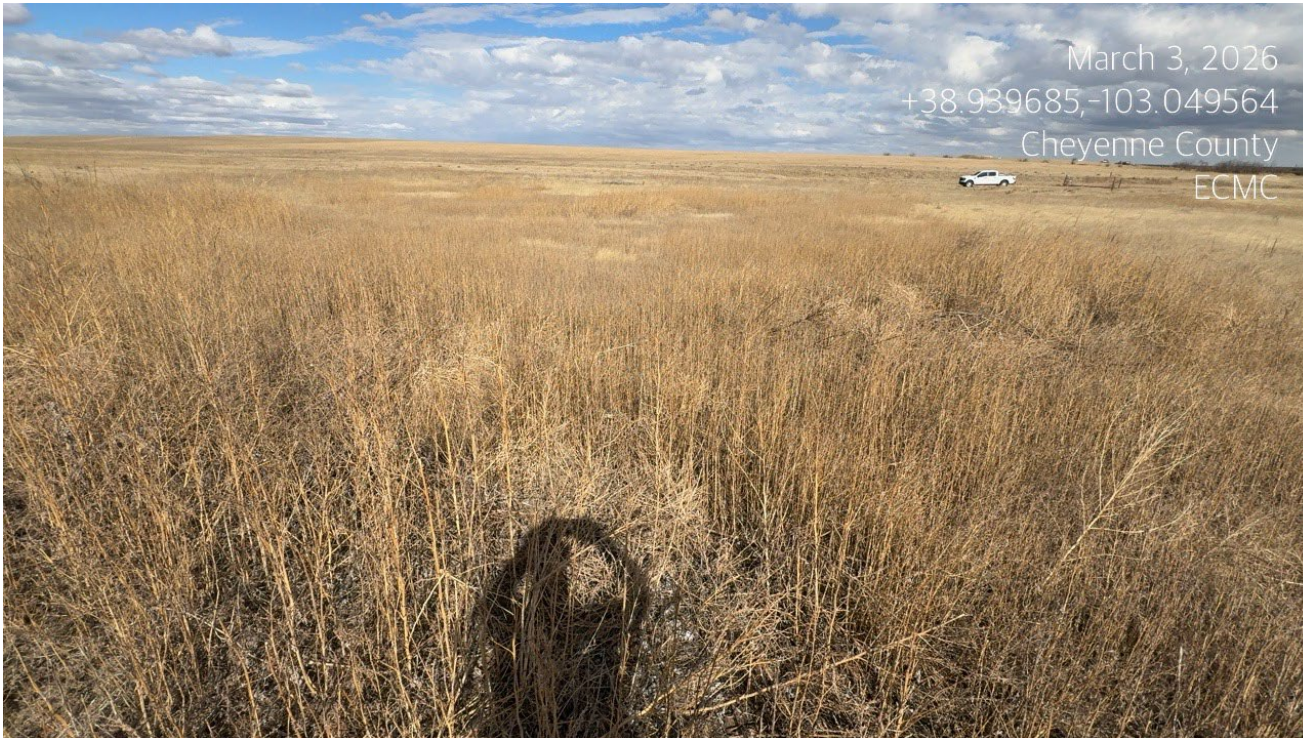
Photo 5. Center of the location facing east. The east side of the location consists mostly of undesirable weeds (Kochia).
