Inspection Photos

API: 017-06519

Operator: OGRIS OPERATING LLC

Inspection Date: 3/3/2026

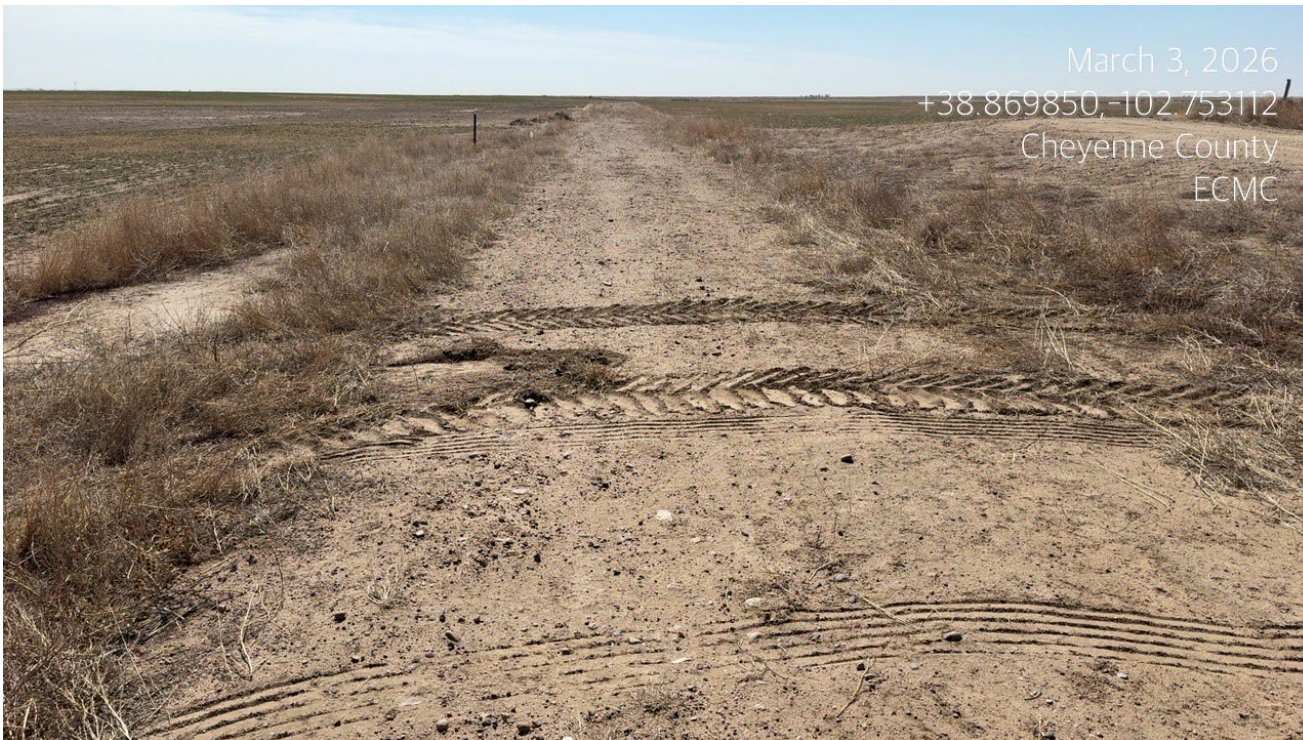
Photo 1. Facing south toward the access road which has not been reclaimed. The gravel road base needs to be removed and soils need to be decompacted by cross ripping to 18 inches.

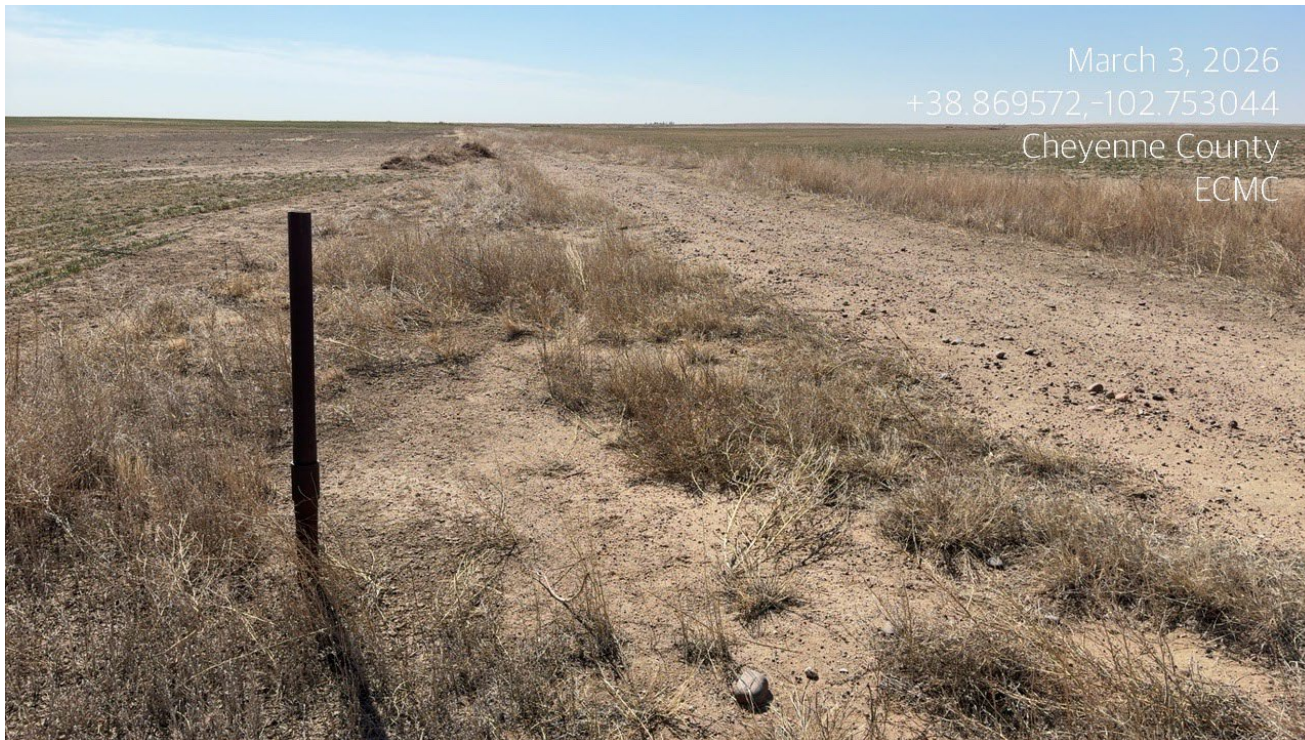
Photo 2. There is a metal pipe that remains along the access road that needs to be removed if associated with the wellsite.

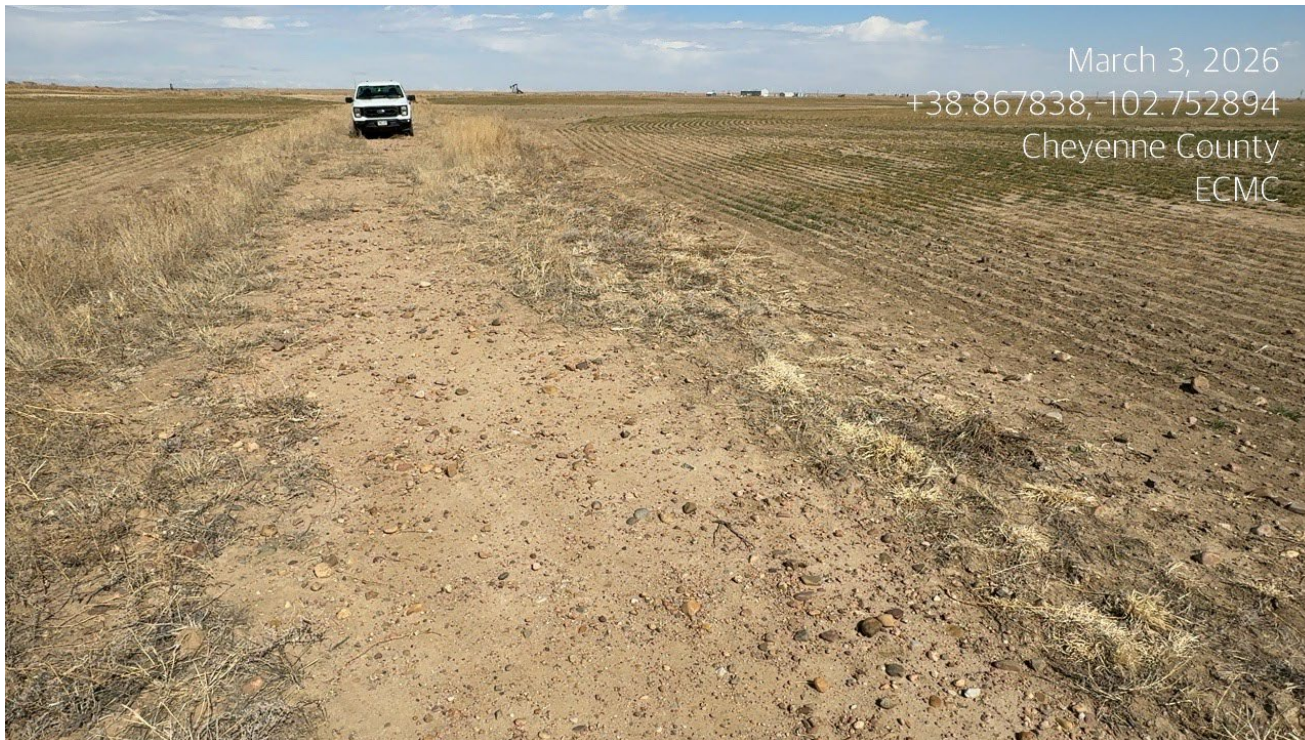
Photo 3. End of the access road facing north. The access road needs to be decompacted and reclaimed back to cropland.

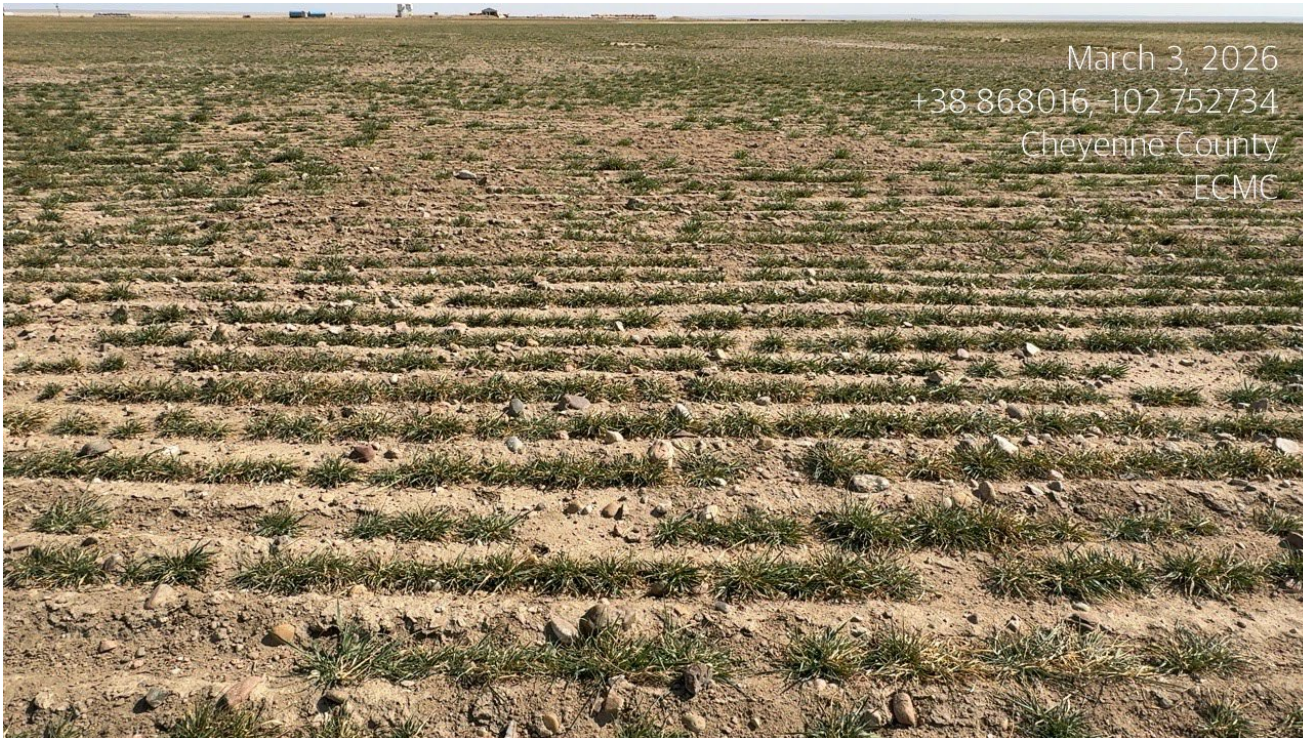
Photo 4. Facing east toward the location.

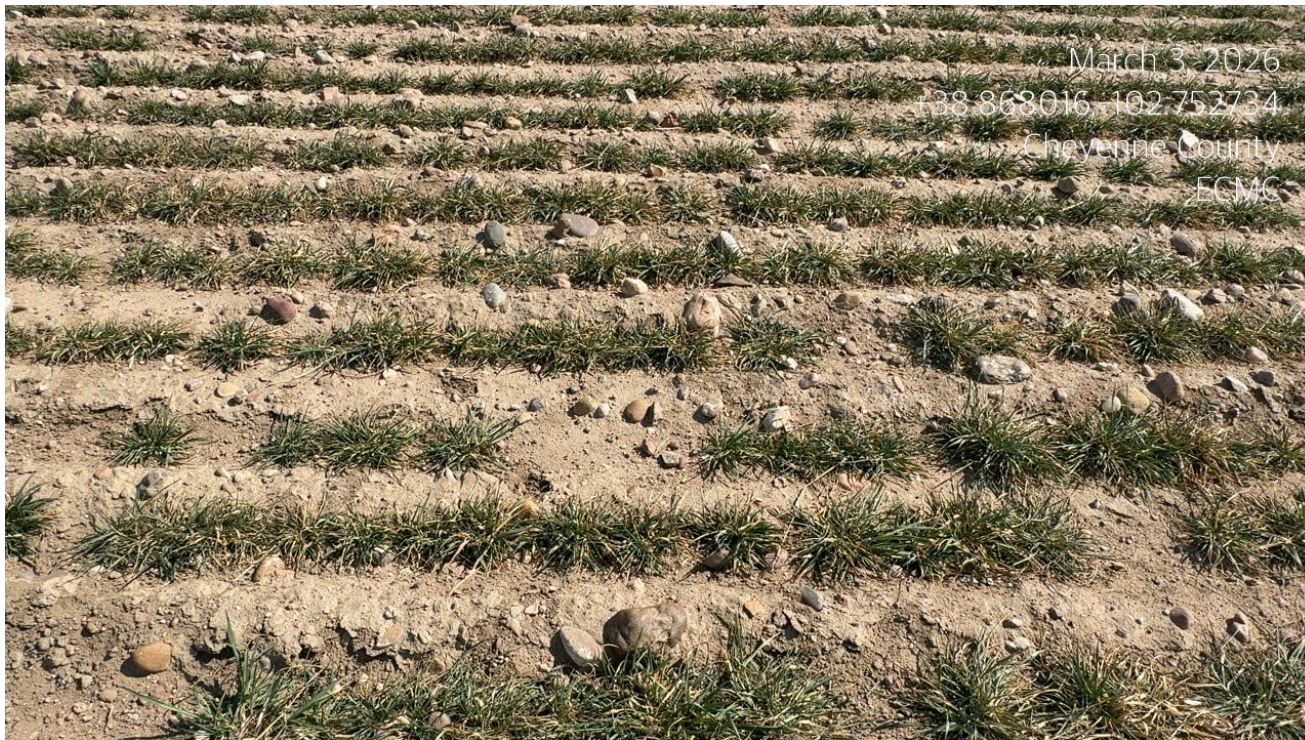
Photo 5. View of ground cover showing rocks at the location. Bigger rock will need to be picked up.

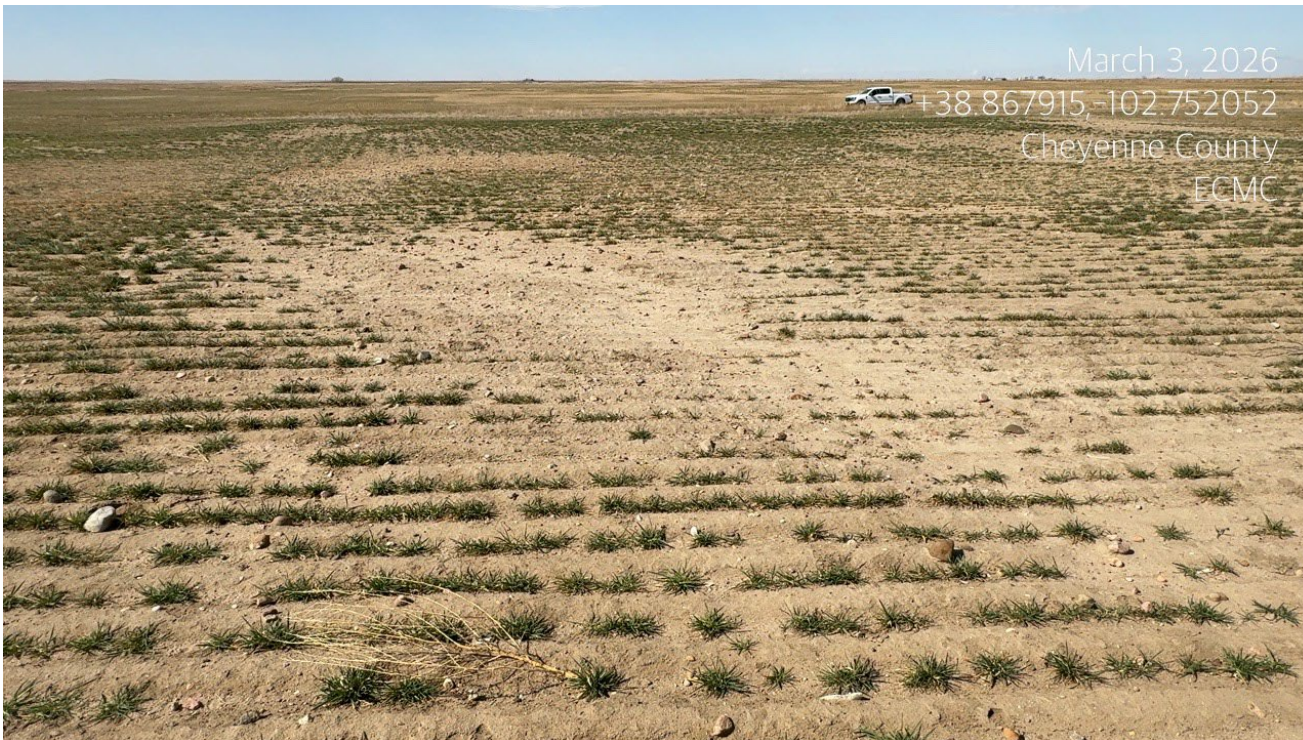
Photo 6. East side of the location facing west. There are areas of the location that don't show signs of crop growth.

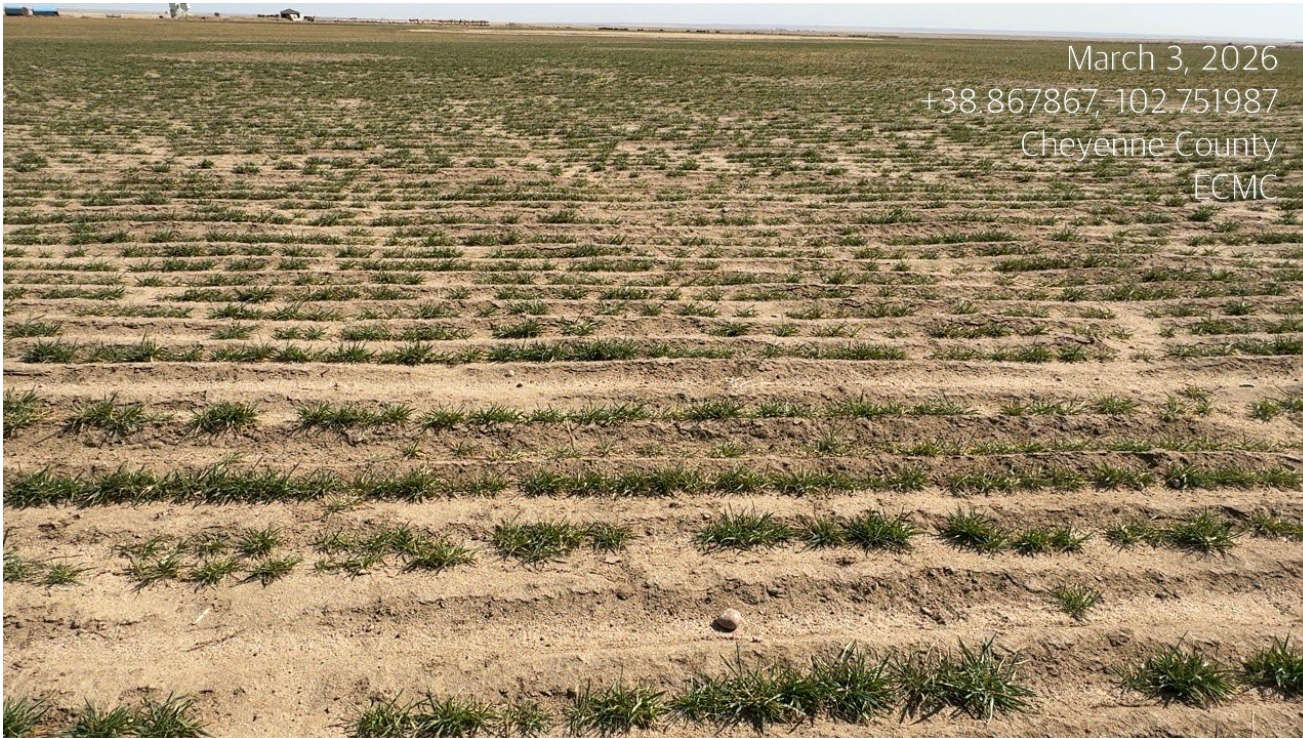
Photo 7. Facing east toward the surrounding undisturbed crop. There are very few rocks observed outside of the location.
