Lat 40.181834, Long -104.677815
03/03/2026 15:00 GMT-07:00
ECMC : Environmental Inspection

KerrMcGee
CANNON & UPRC 33-1121215
NW/4 SW/4 SEC.33-T3N-R65W
RD 28 & RD 41, S 1/2, E INTO
WELD CO., COLORADO
IN CASE OF EMERGENCY CALL
360-444-4444 OR 373-2811
IN CASE OF FIRE OR MEDICAL EMERGENCY CALL 911

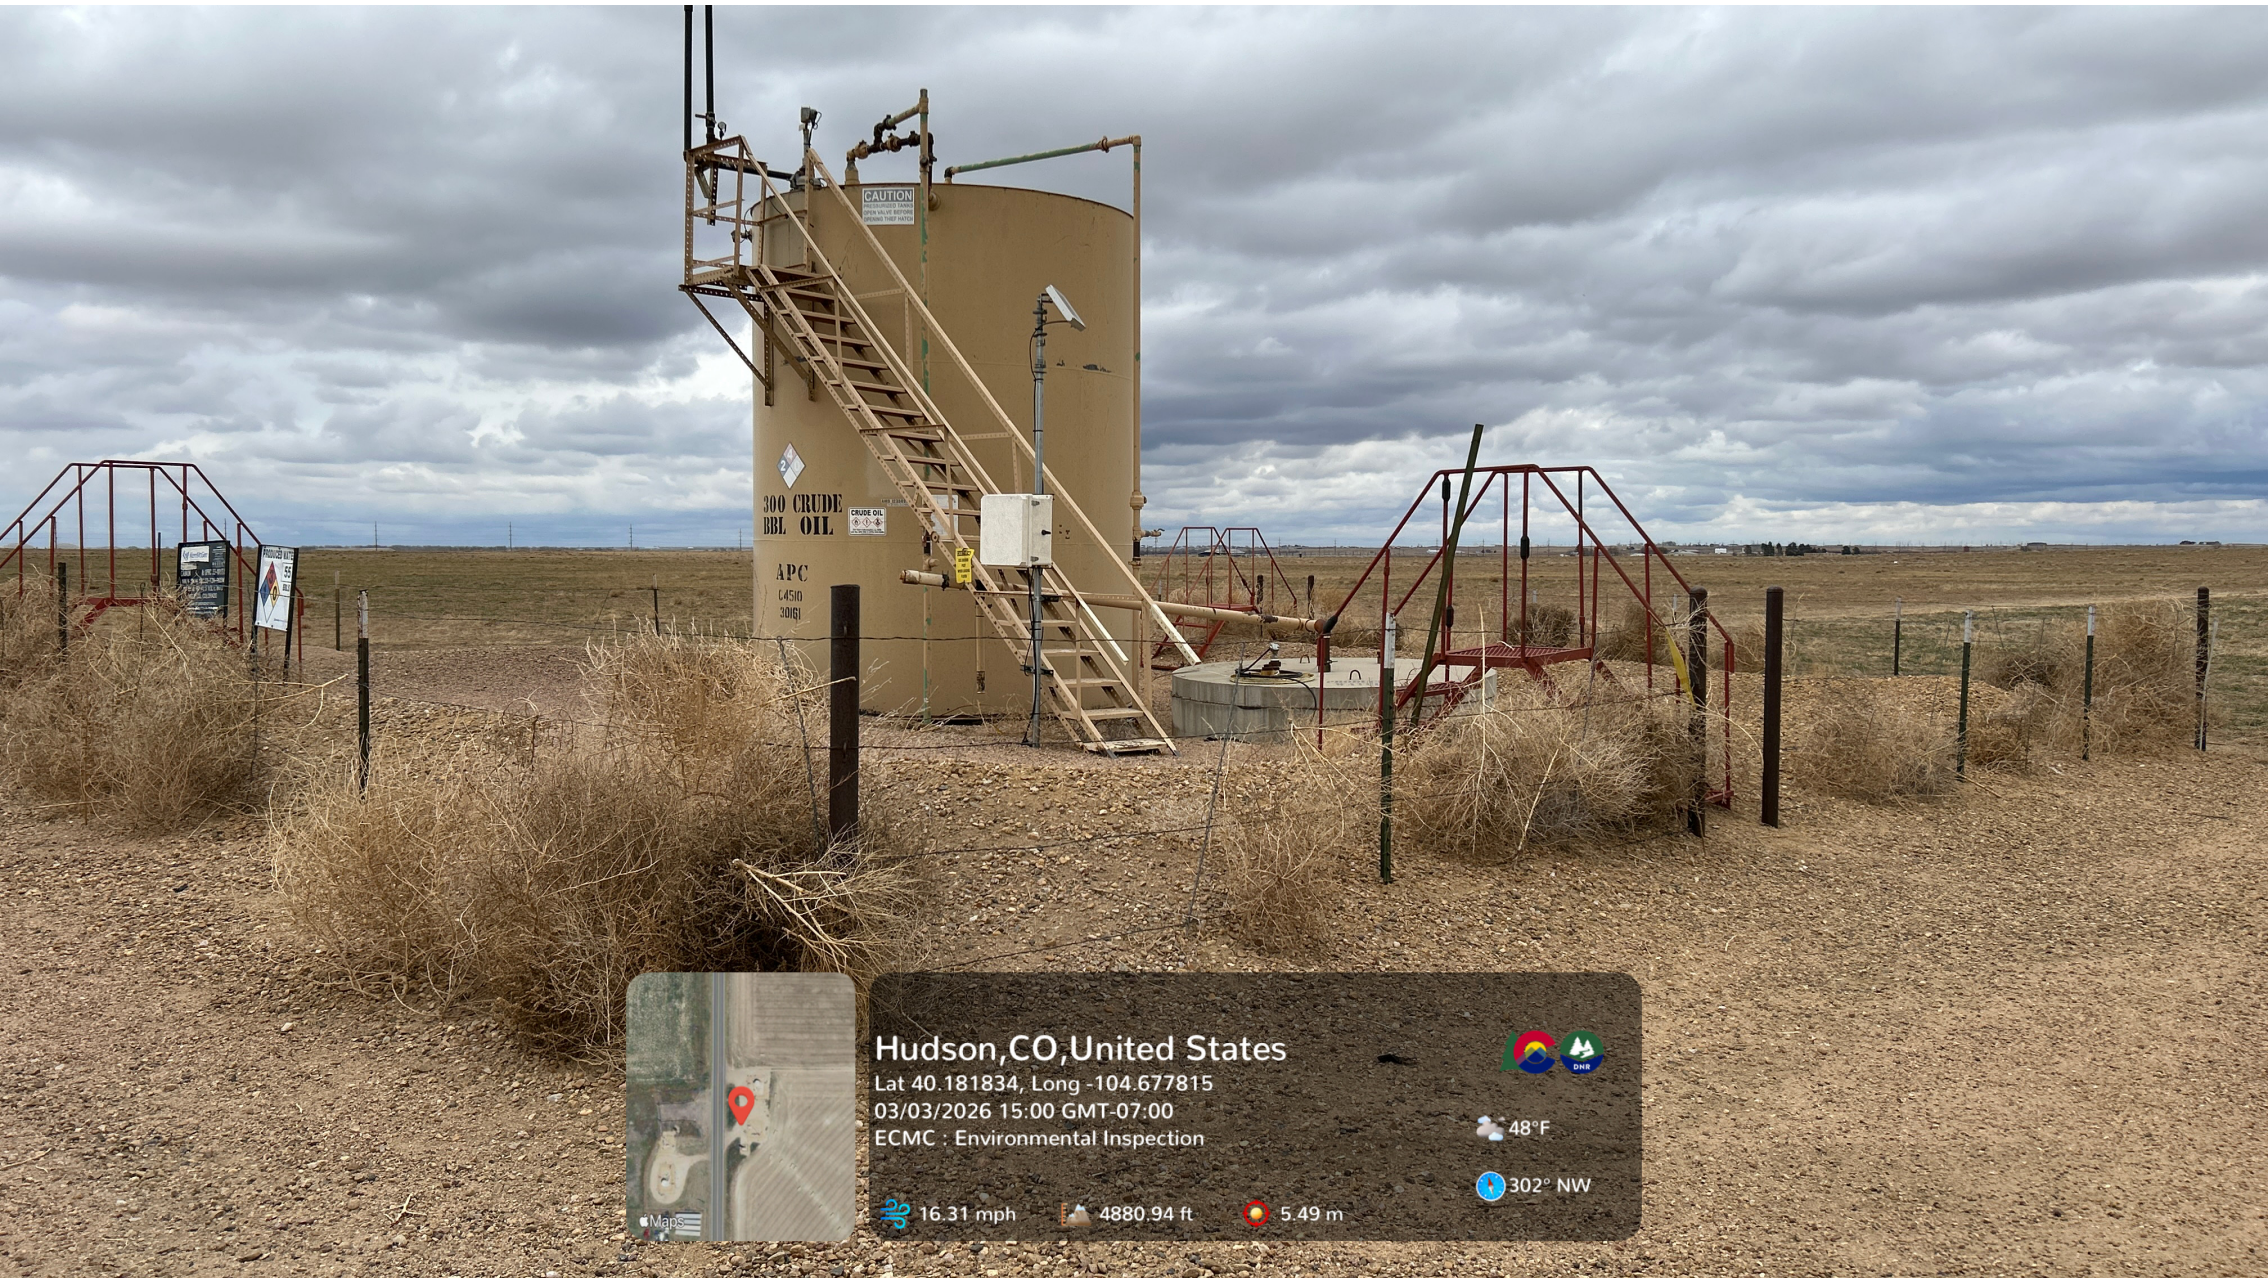
Looking at production tank and produced water vessel containment. Debris is visible around the metal wire fence.

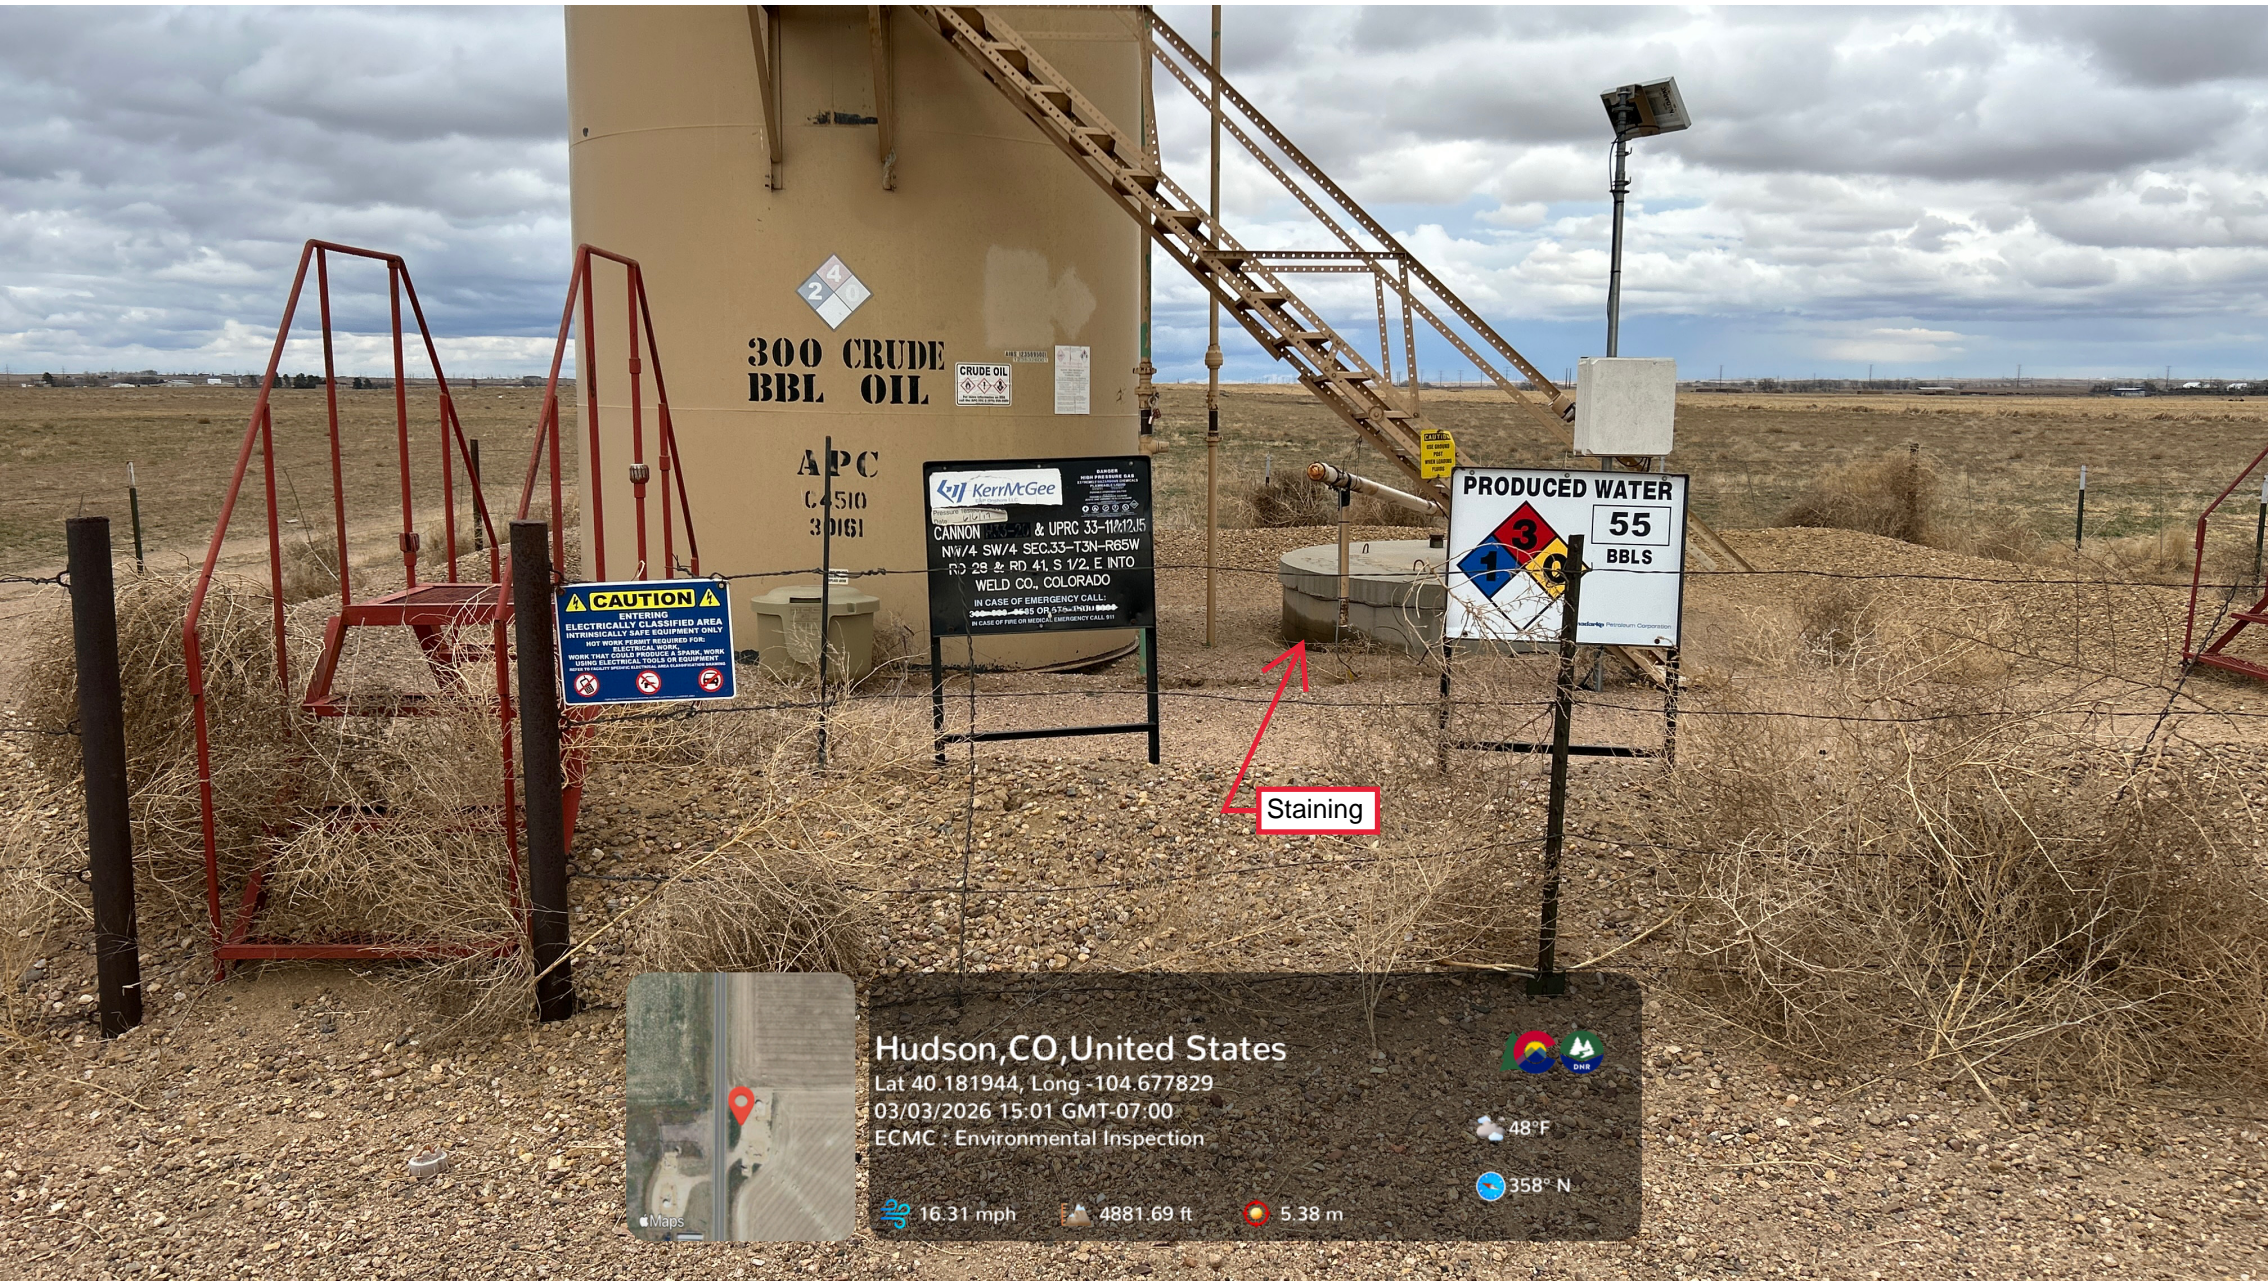
Production tank labels are legible; placards are fading. Signage with emergency contact number is illegible. Produced water vessel signage and placard are visible. Staining is visible on the sides of the partially buried produced water vessel.

Staining

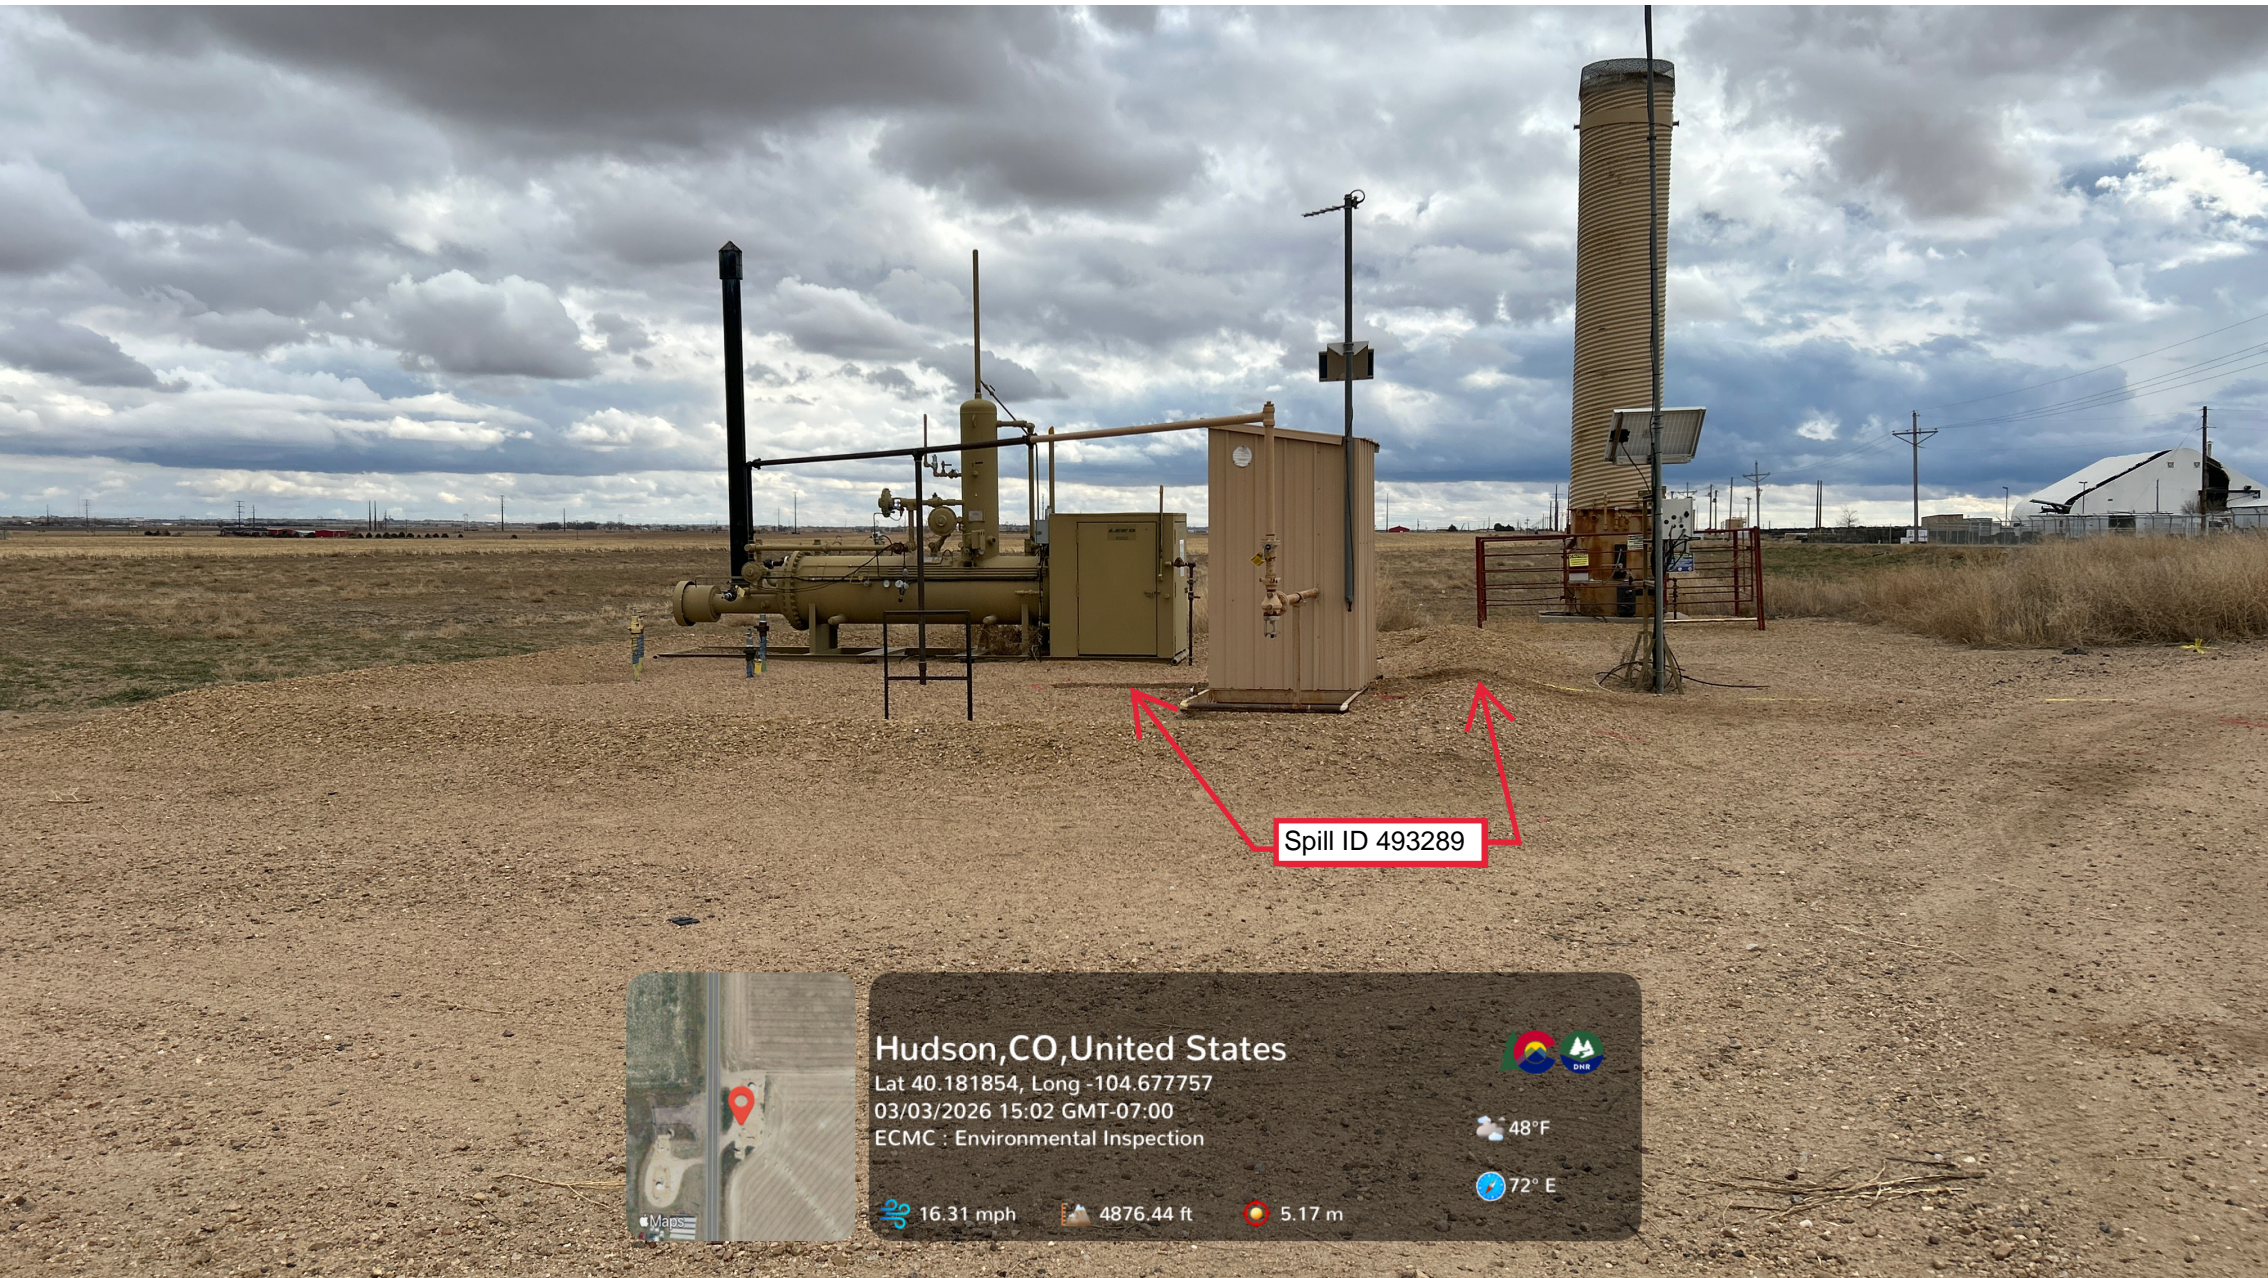
Looking at horizontal separator, emission control device, and third party owned meter house.
Note: Spill ID 493289 was reported by another Operator on the south side of the meter house and will be addressed in a separate Field Inspection Report.

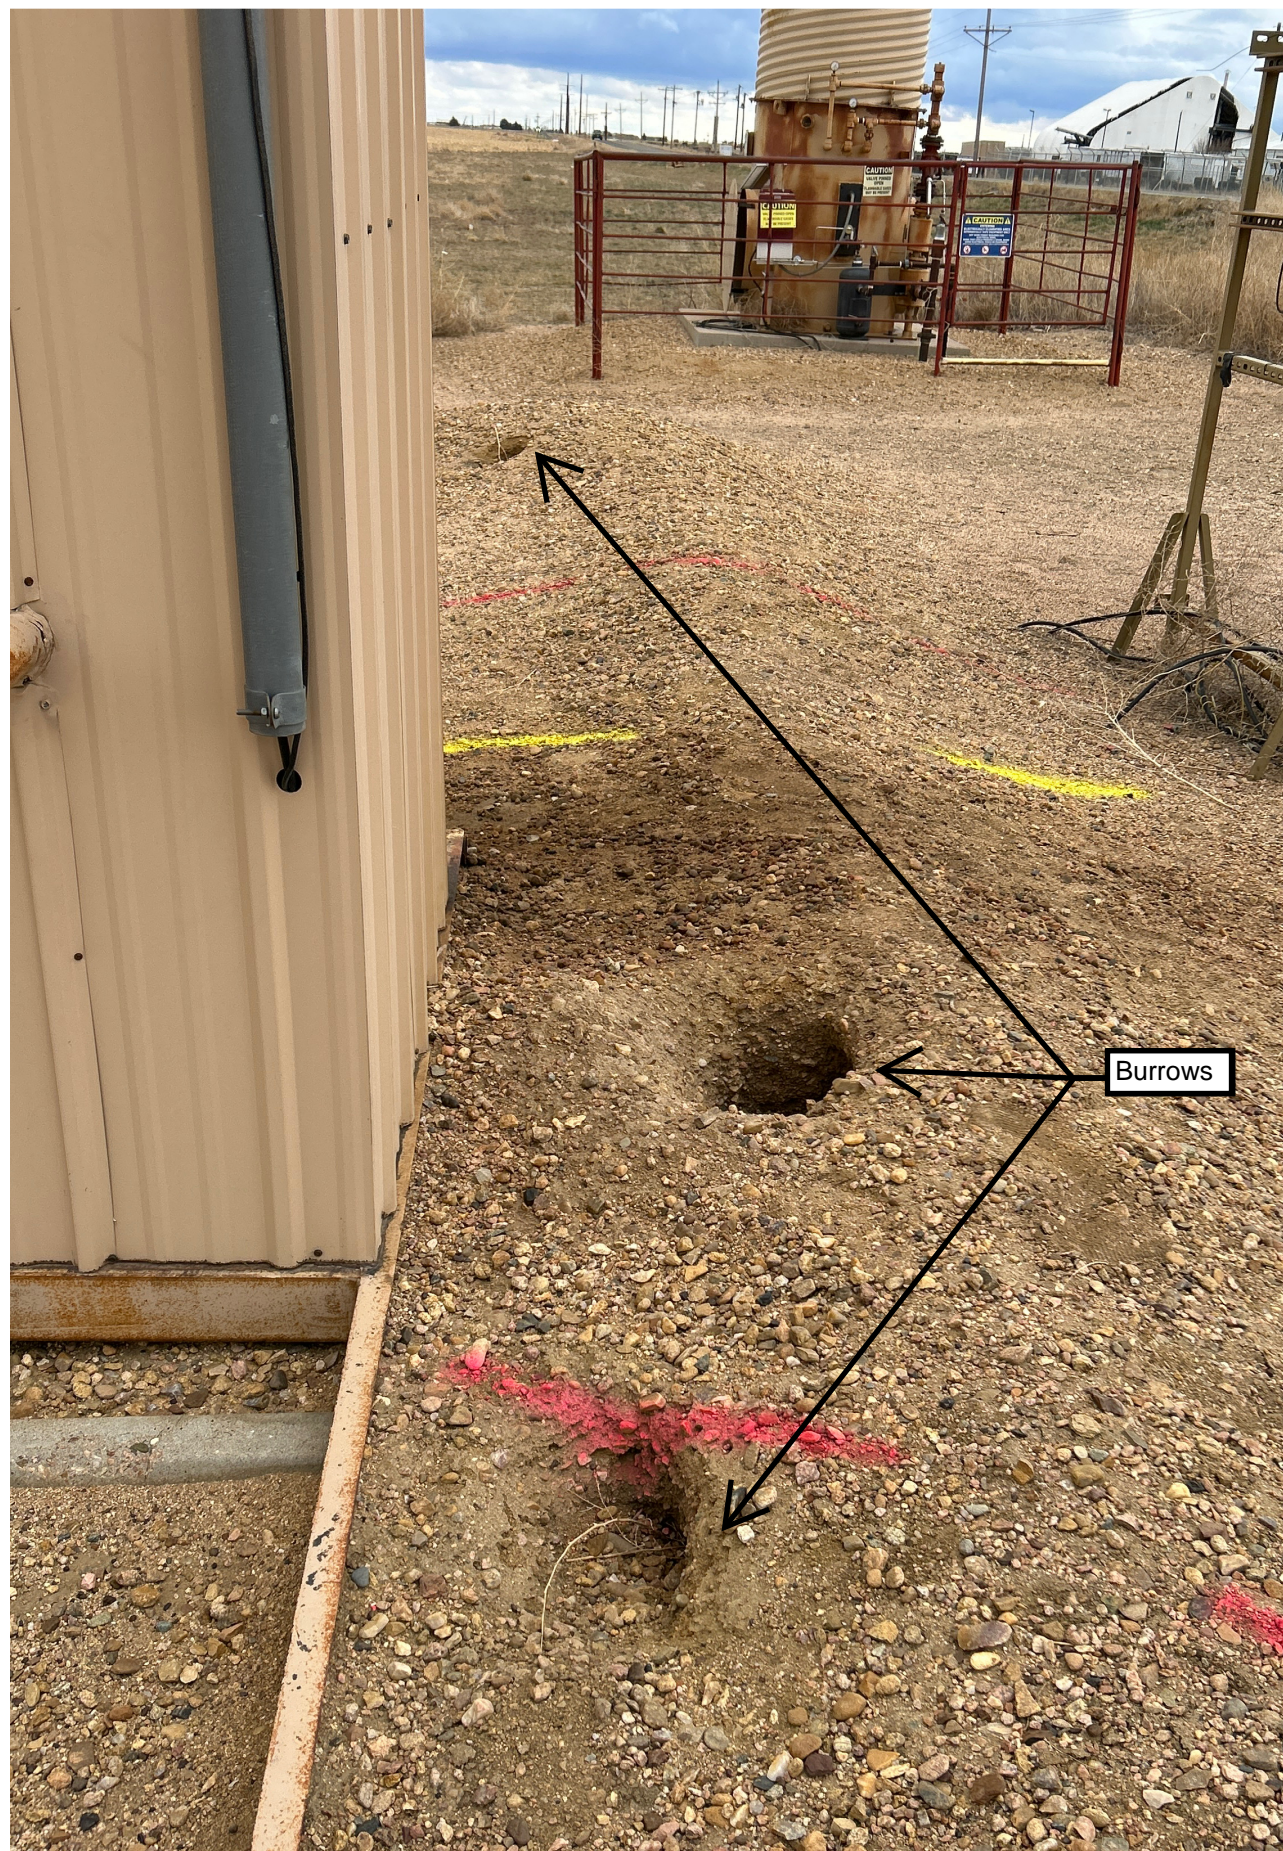
Rodent burrows are visible in the separator containment berm.

Burrows
