# Inspection Photos

API: 017-06378

Operator: CITATION OIL & GAS CORP

Inspection Date: 3/3/2026

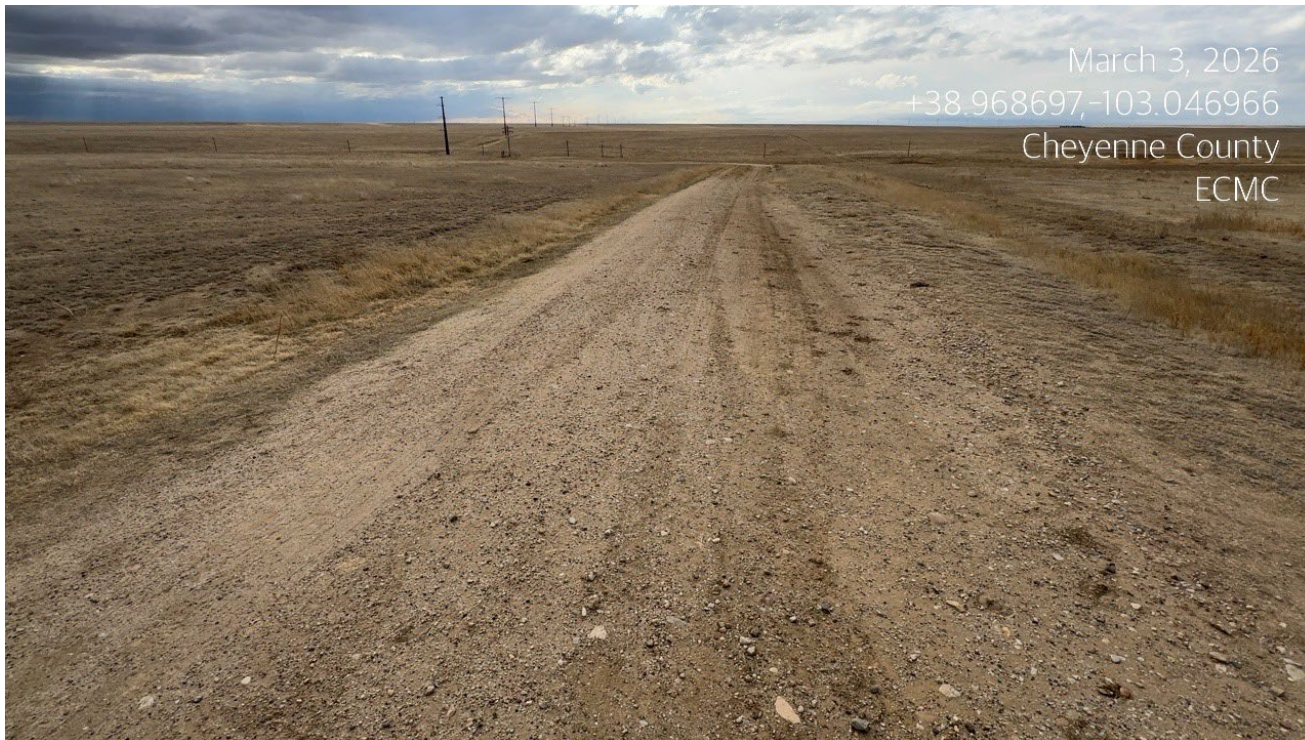
**Photo 1.** Facing west along the access road. Gravel remains along the road.

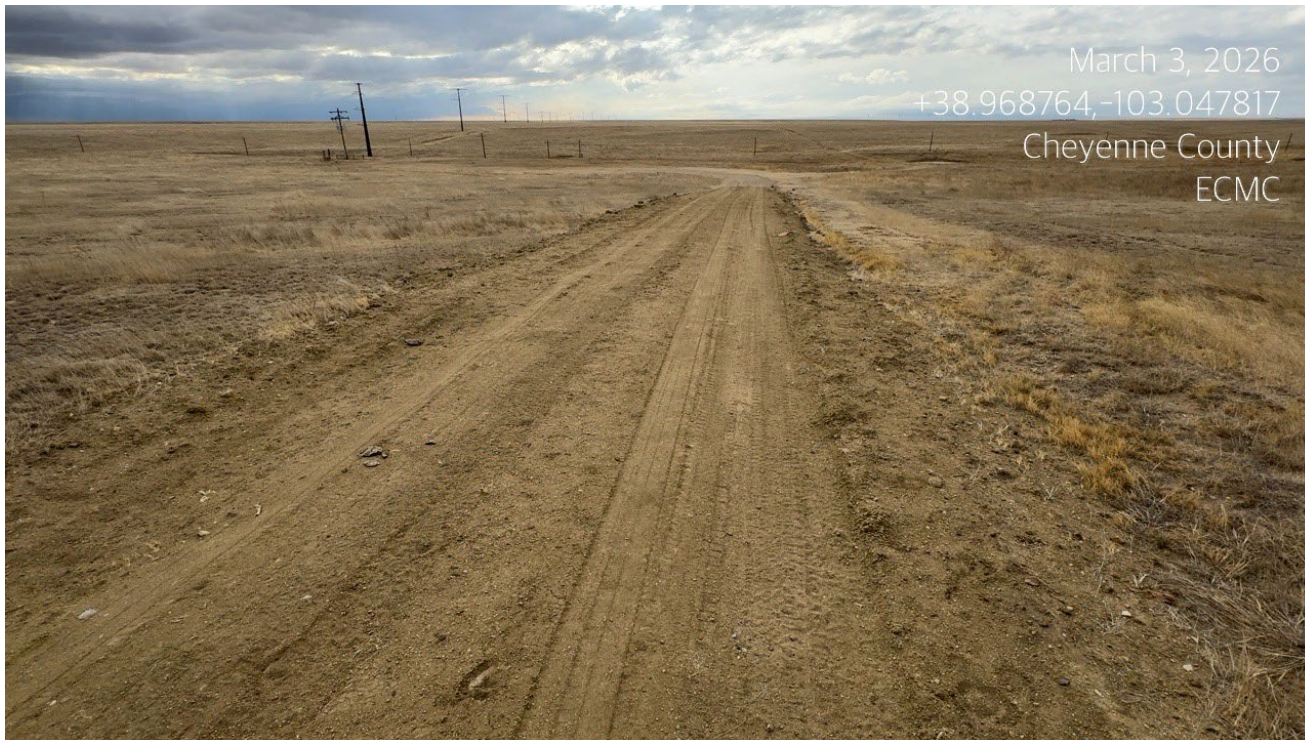
**Photo 2.** Facing west further along the road. Soil has been placed on this portion of the road.

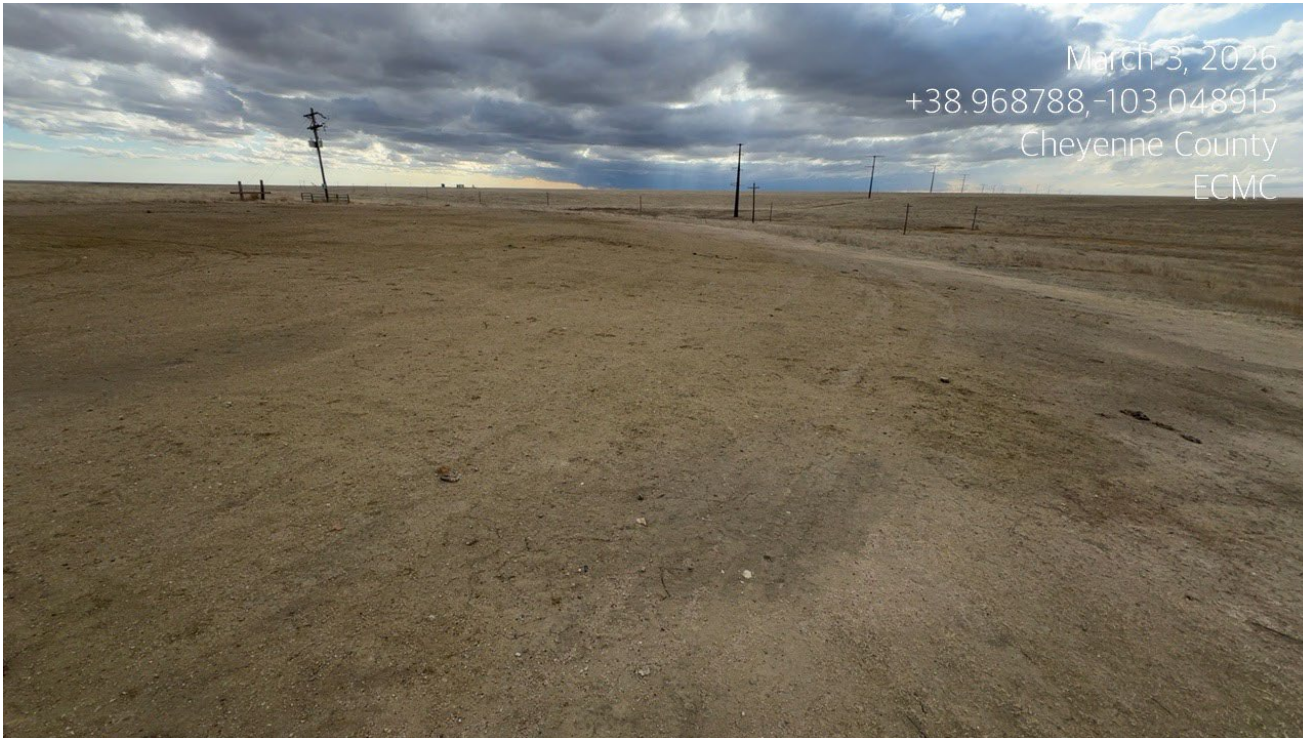
**Photo 3.** Facing southwest at the location. It appears soil was placed on the location however the location was not recontoured and soils underneath the soil may not have been decompacted..

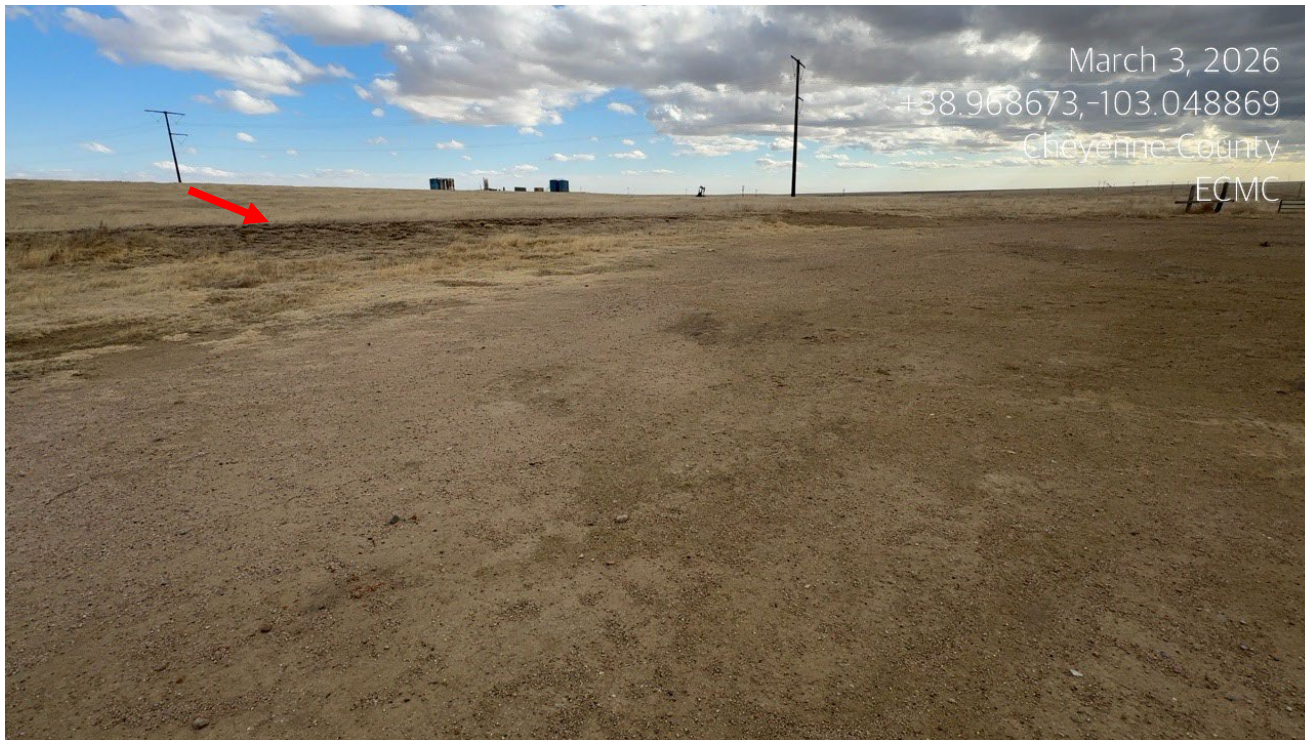
**Photo 4.** Facing southeast at the location. There is a cut slope at the red arrow where soil needs to be recontoured back to the terrain.

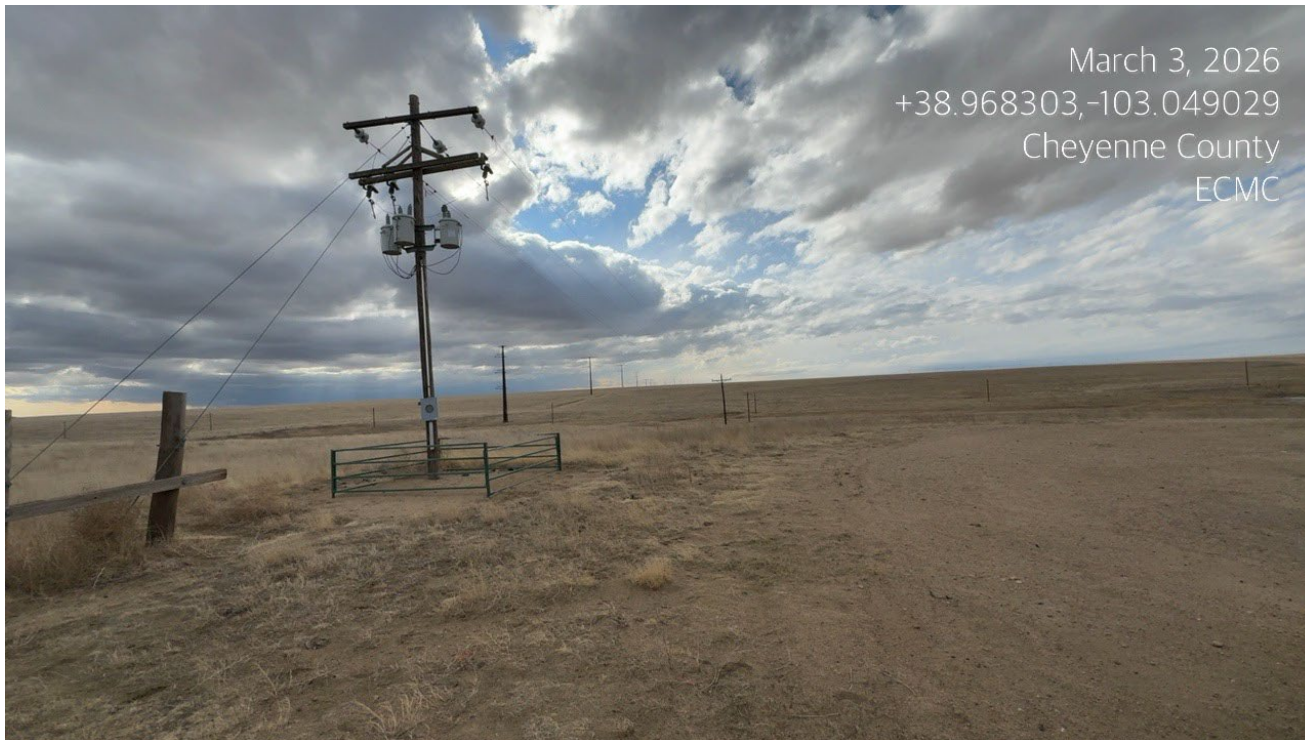
**Photo 5.** The powerline servicing the former wellsite needs to be removed

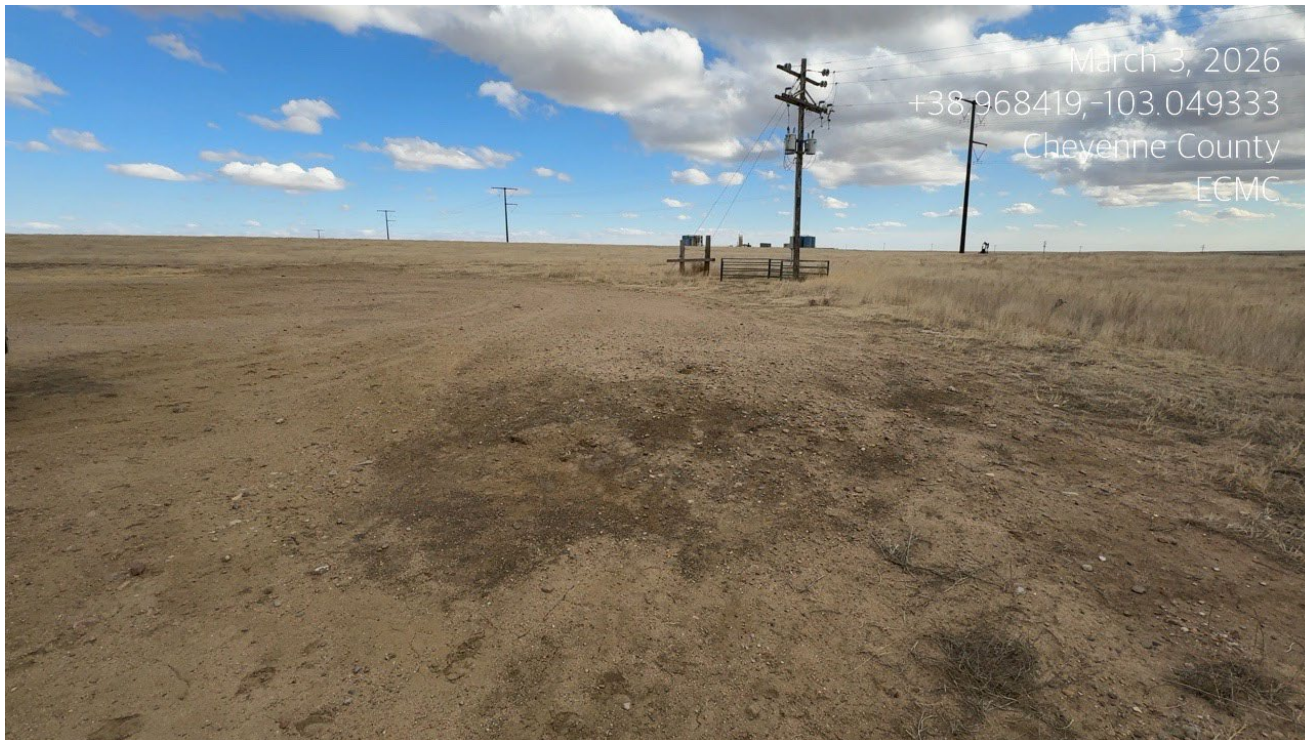
**Photo 6.** Facing east at the south side of the location.

**Photo 7.** The soils in the area shown in the previous photo has very compacted soils that a shovel could not penetrate. Soils also appear to be discolored in this area.
