ECMC
Environmental
Field Inspection

Hale #1,2 &3 Signage at tank battery (HALE-65N68W31SWSE Location/Location ID: 307132)

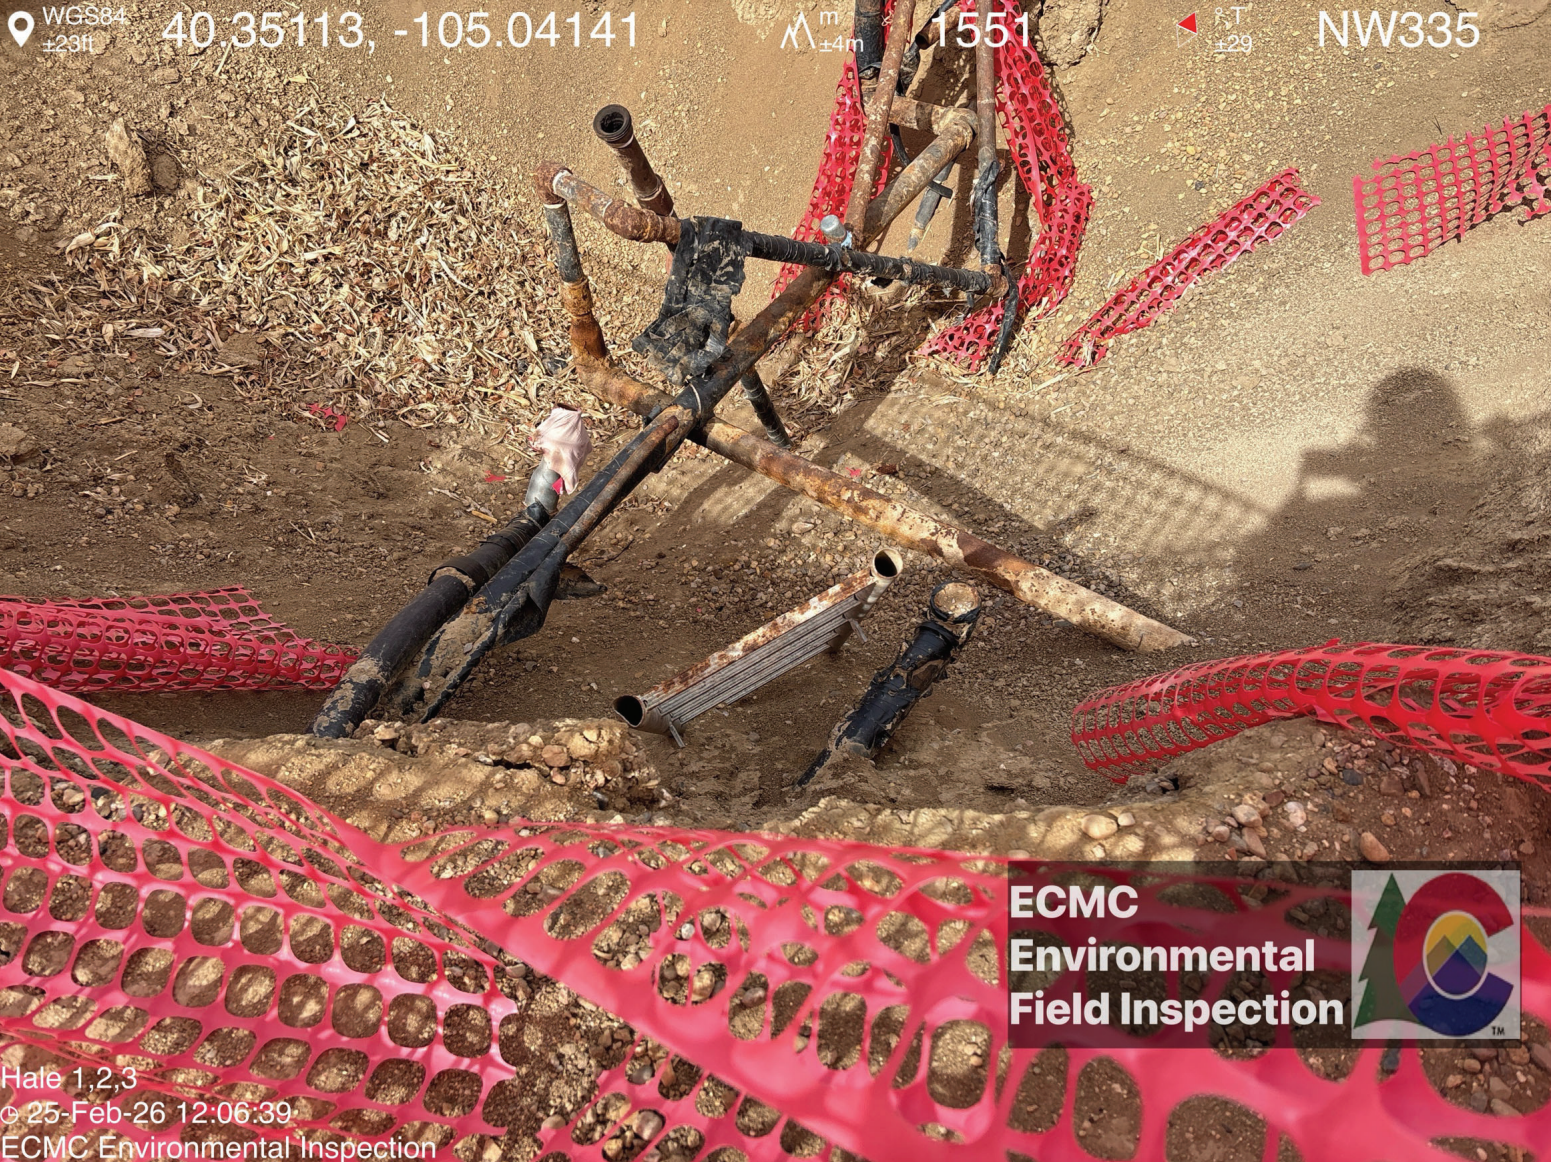
Inadequate fencing, debris (pieces of torn fence), multiple flowlines of unknown status visible within the open excavation at the Hale 3 Separator Spill (Spill ID 488488).

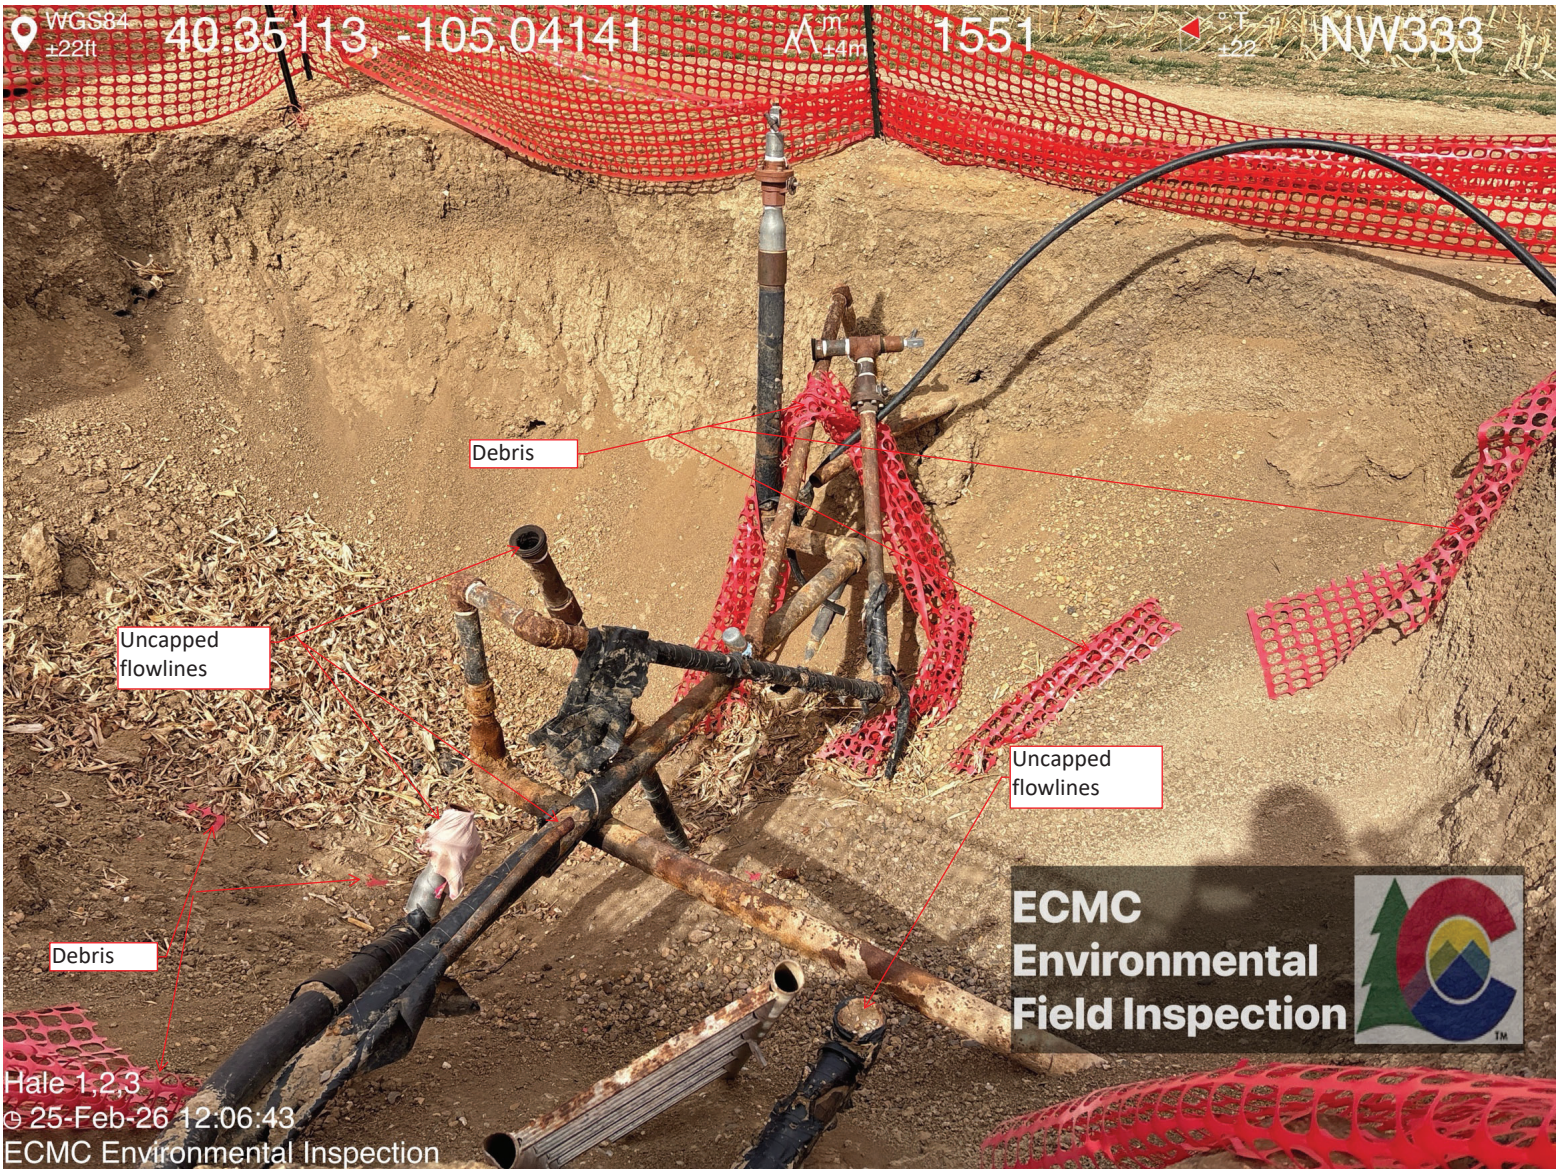
Inadequate fencing, debris (pieces of torn fence), multiple flowlines of unknown status visible within the open excavation at the Hale 3 Separator Spill (Spill ID 488488).

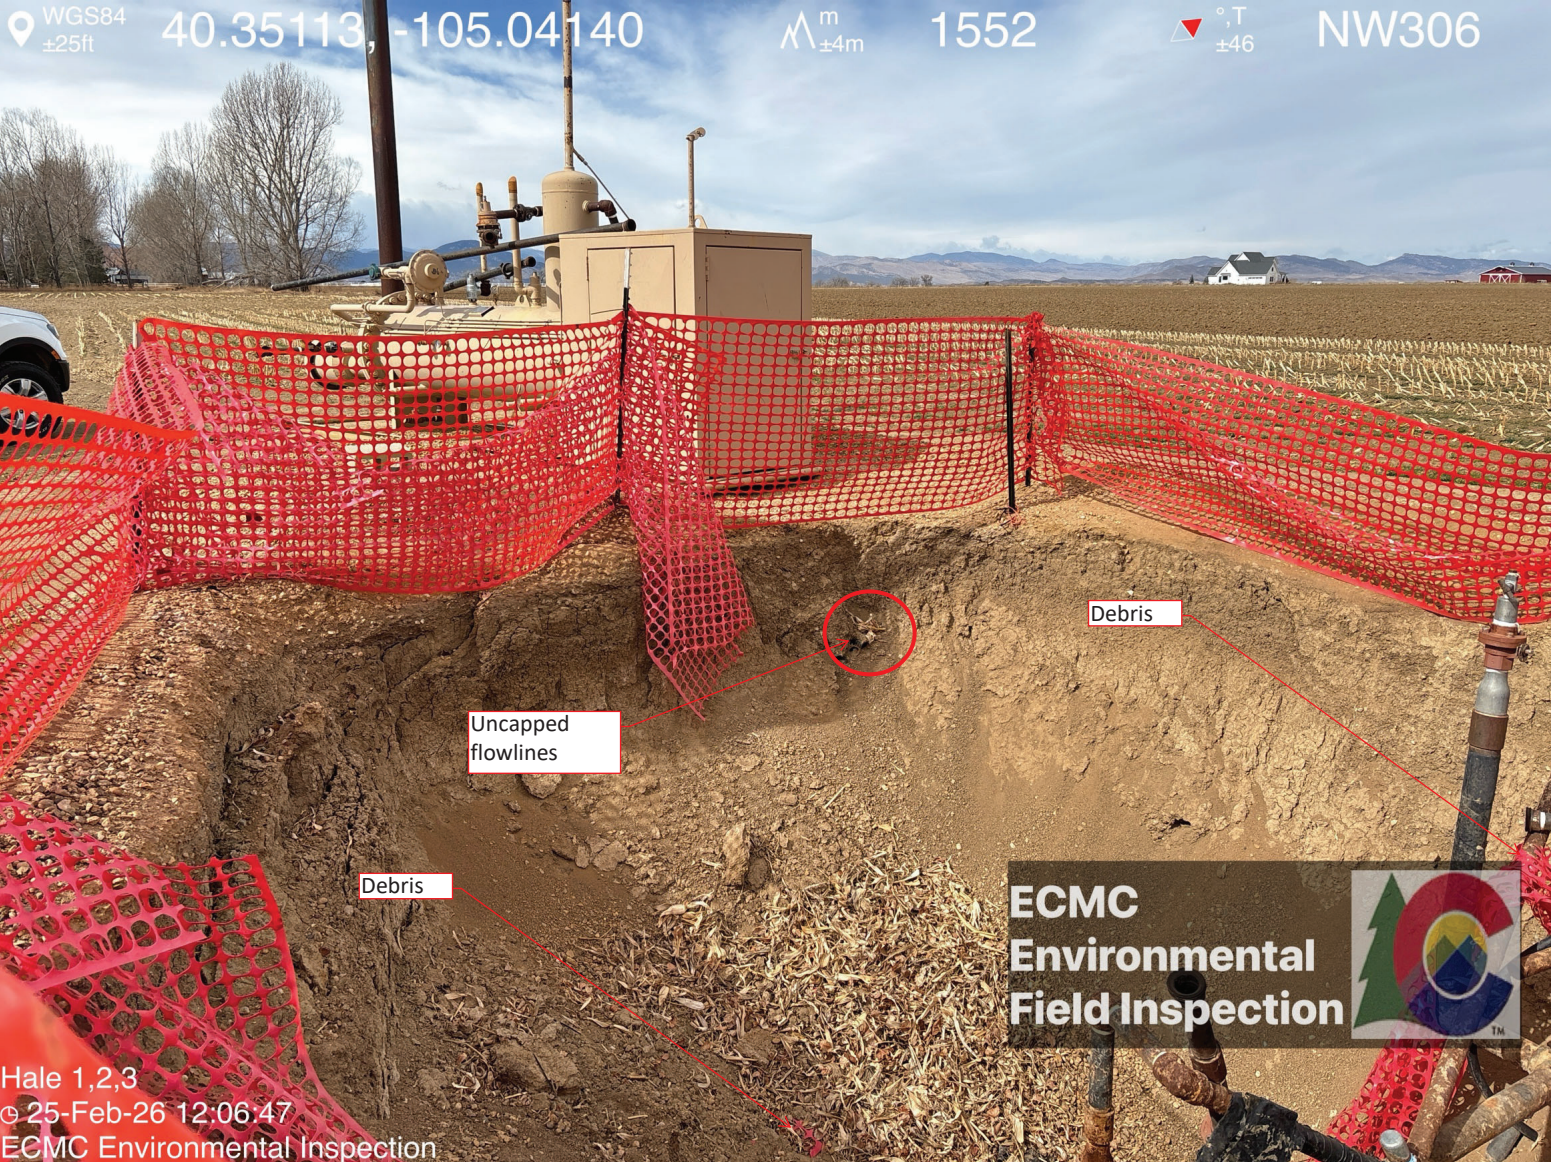
Inadequate fencing, debris (pieces of torn fence), multiple flowlines of unknown status visible within the open excavation at the Hale 3 Separator Spill (Spill ID 488488).

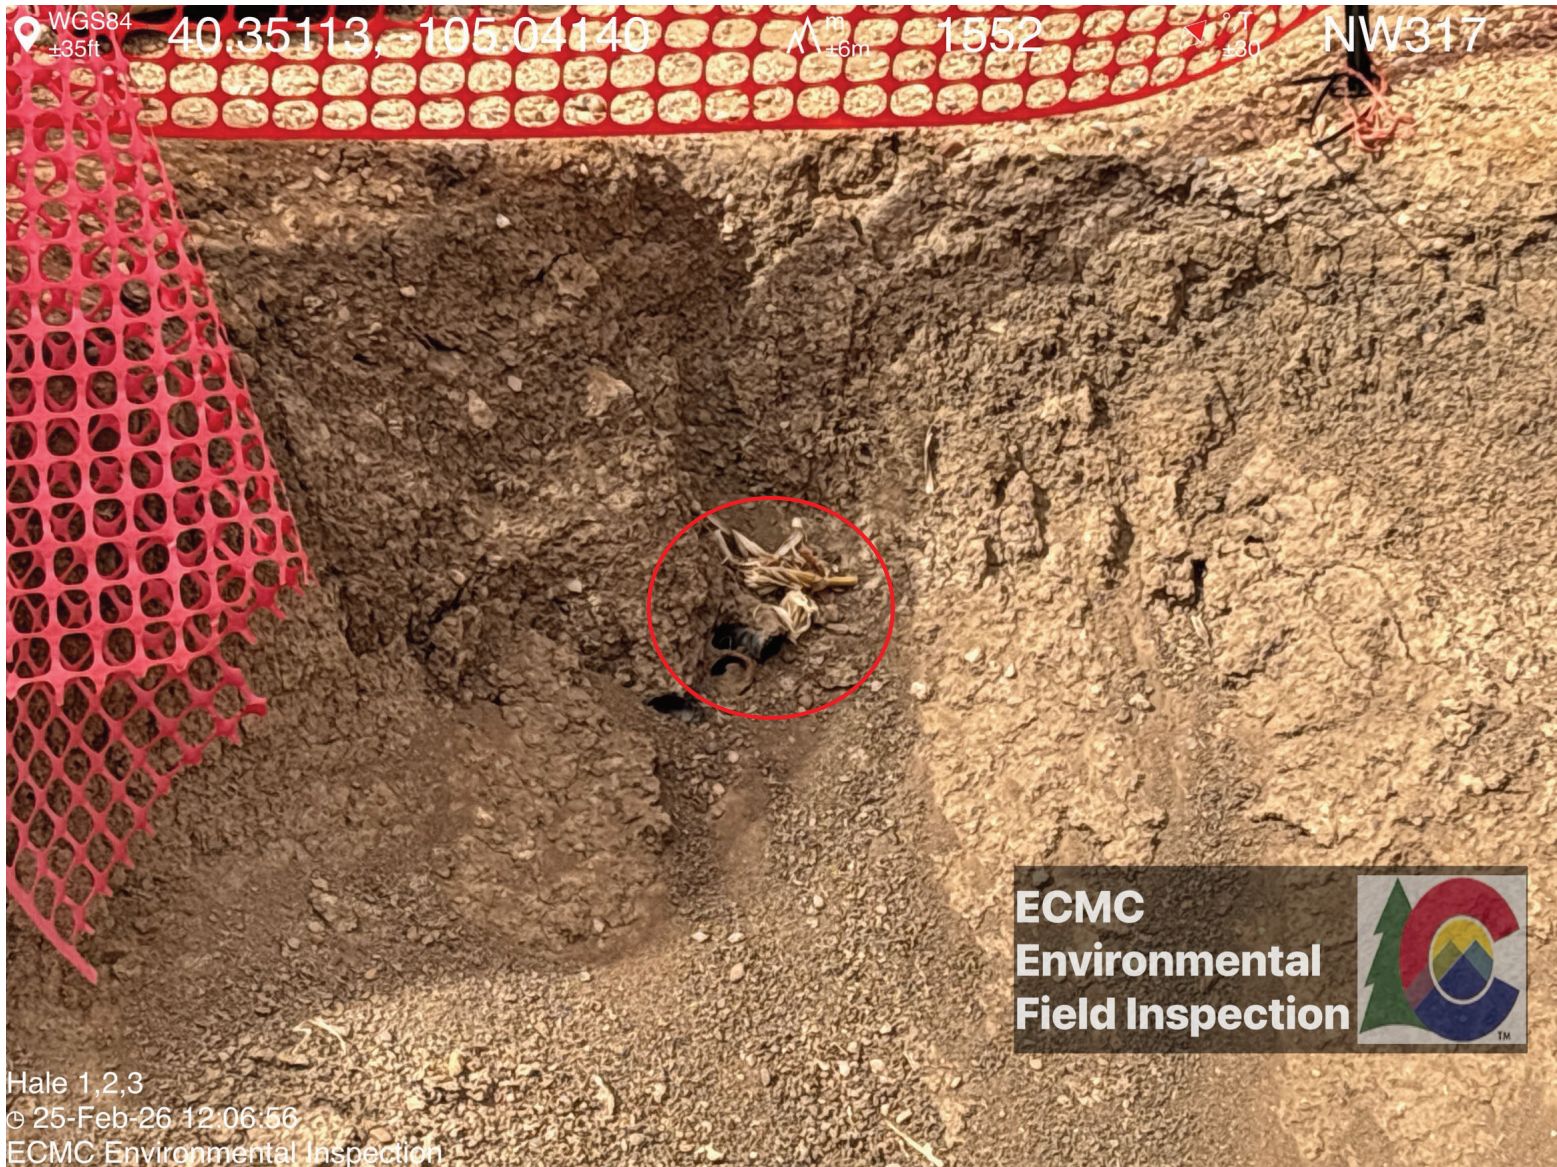
Uncapped flowlines visible in sidewall of the northwest corner of the open excavation

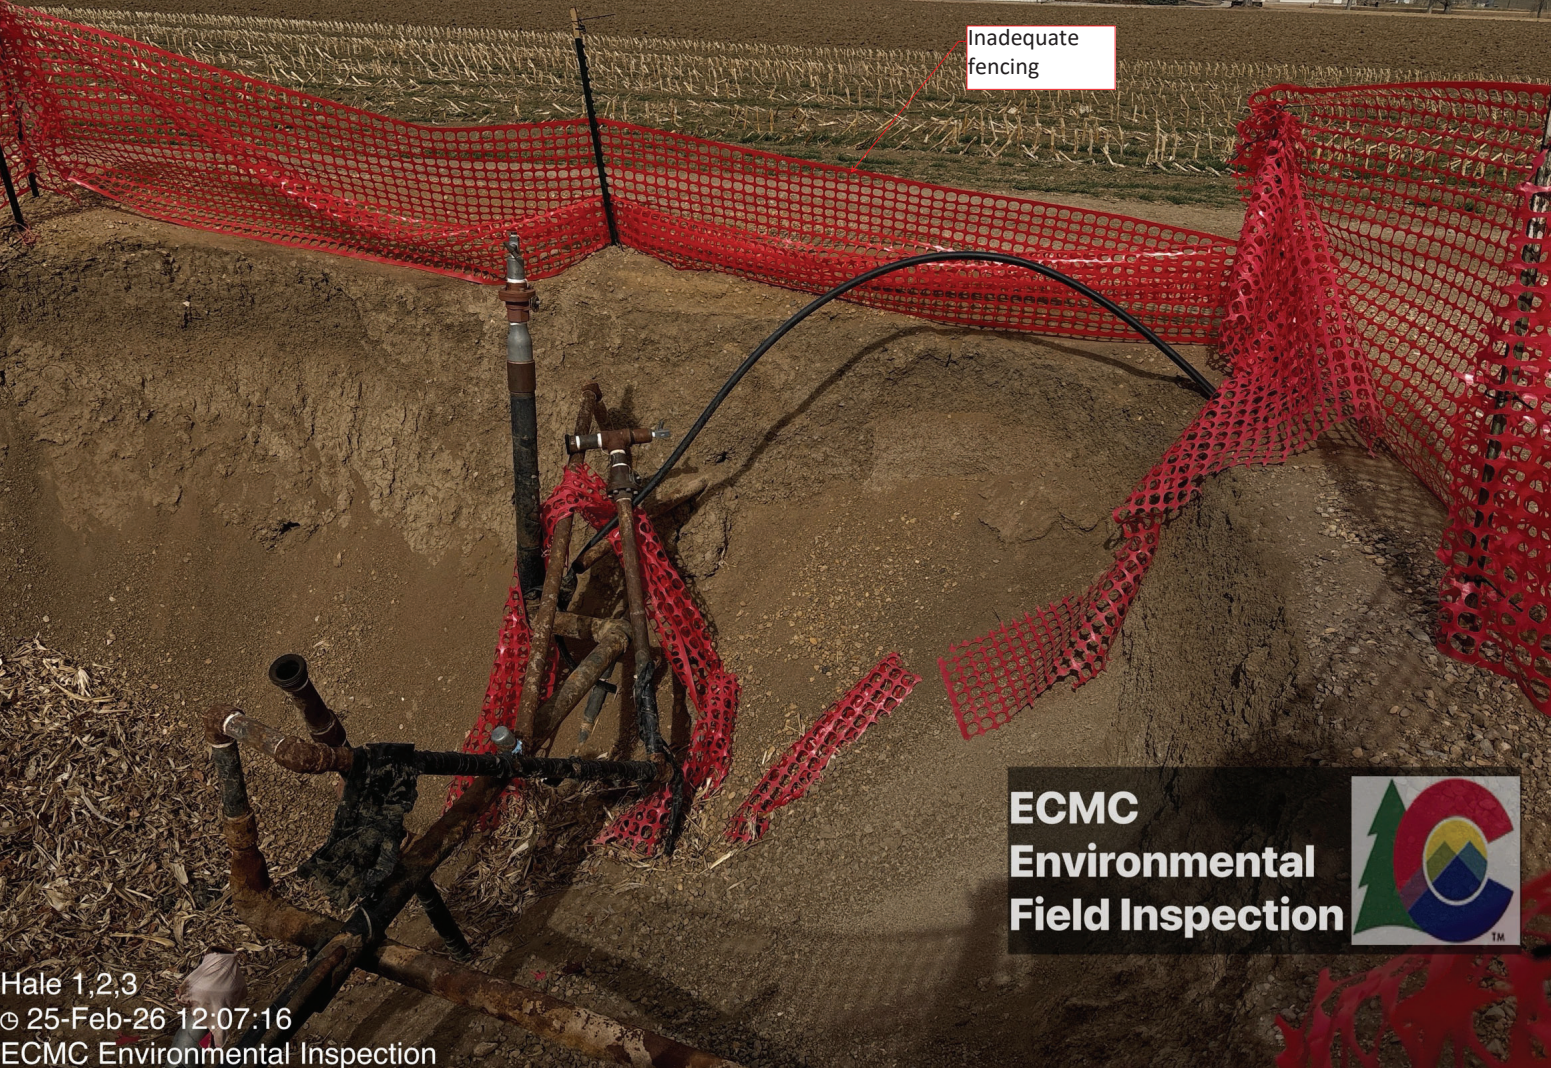
Inadequate
fencing

Inadequate fencing, debris (pieces of torn fence), multiple flowlines of unknown status visible within the open excavation at the Hale 3 Separator Spill (Spill ID 488488).
