Final Reclamation Inspection

Operator: KERR MCGEE OIL & GAS ONSHORE LP

Location ID: 329657

Location Name: HSR-KNOX-65N67W 3SEW

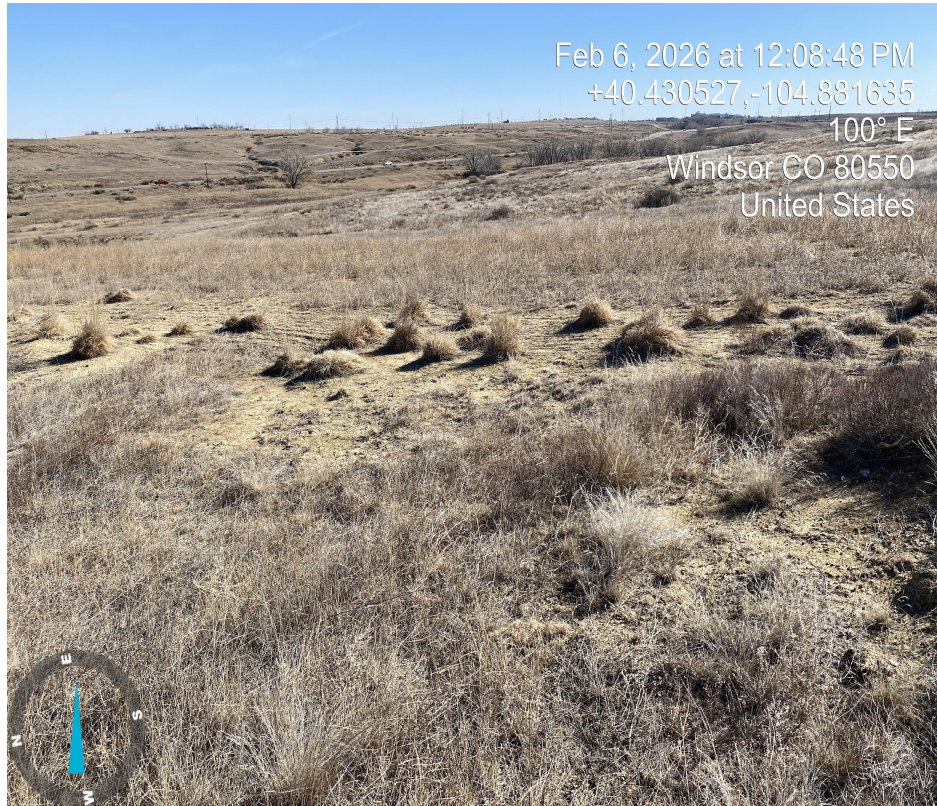
Photo 1. Photo taken from access road showing bare spoil and some growth of desirable grass species.

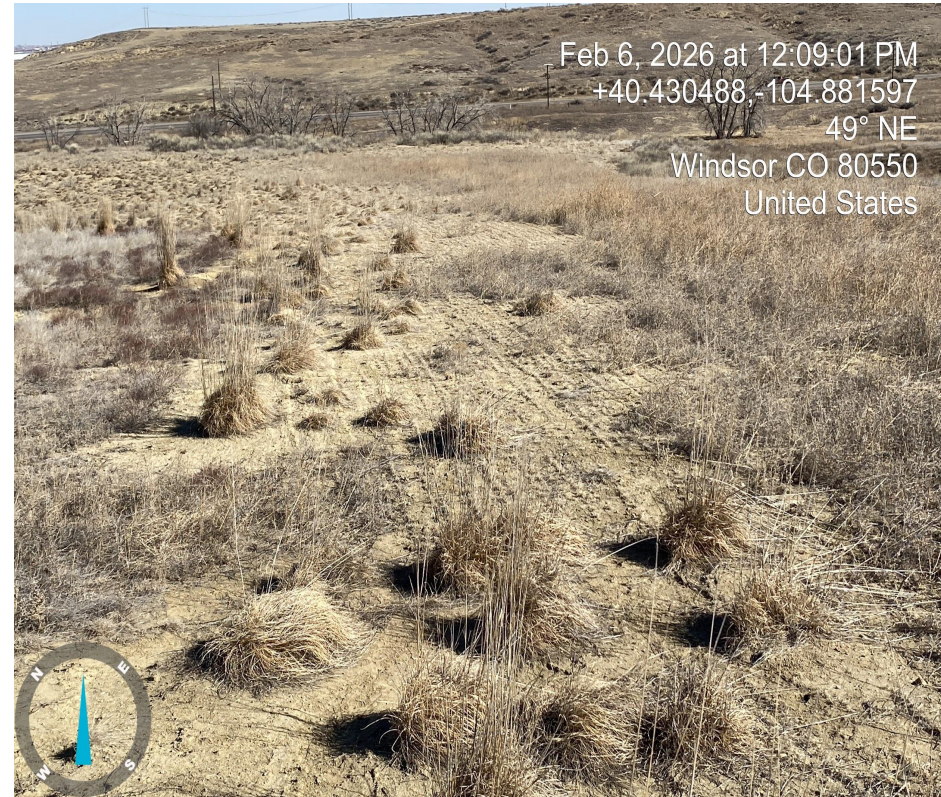
Photo 2. Photo taken on the access road looking down on the location. Areas with bare soil and also large numbers of annual weeds are present on the south side of the access road and on the site. Bunch grass is present on the north side of the site and along the access road.

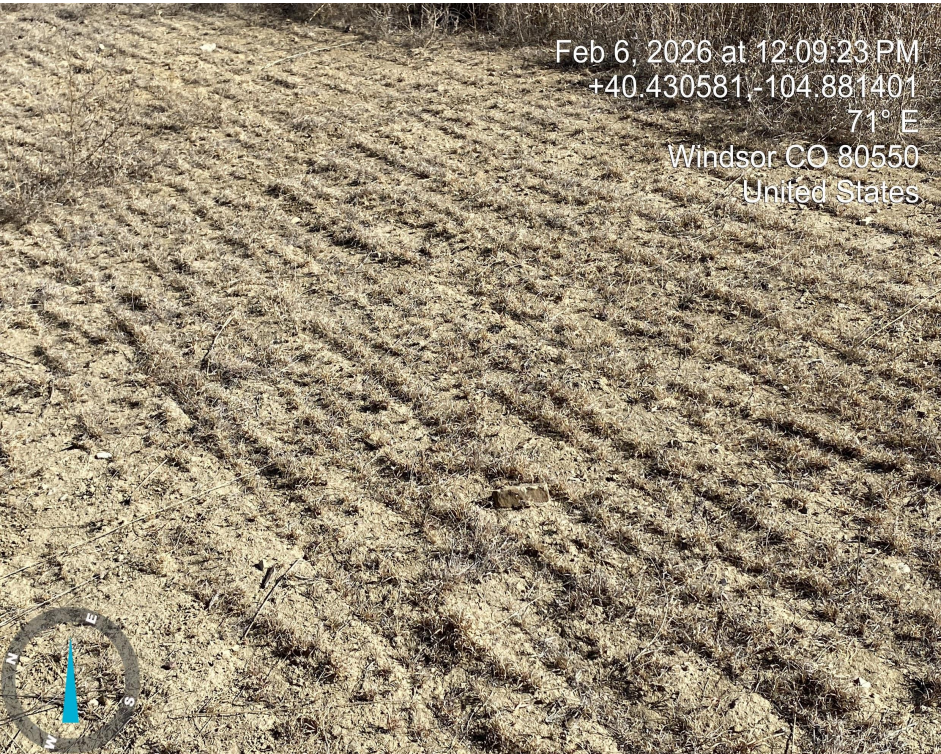
Photo 3. Photo taken from access road showing drill seeding rows that have stunted vegetation growth.

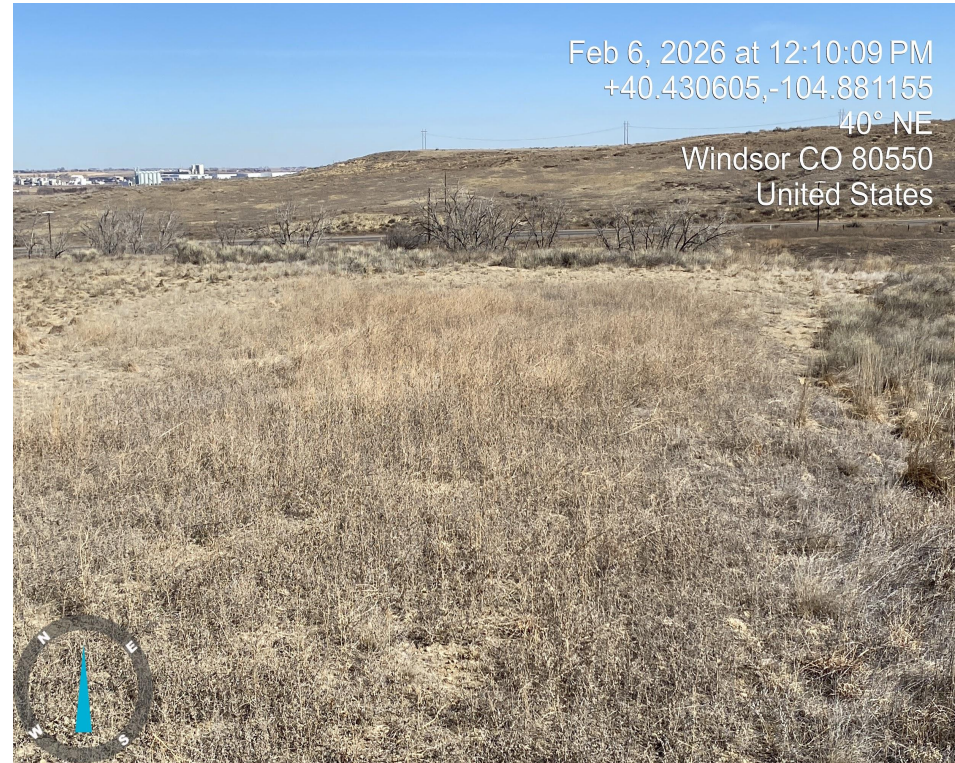
Photo 4. Photo taken from the west edge of the location facing north. See comment under photo 3. The majority of vegetation growth is undesirable annual weeds.

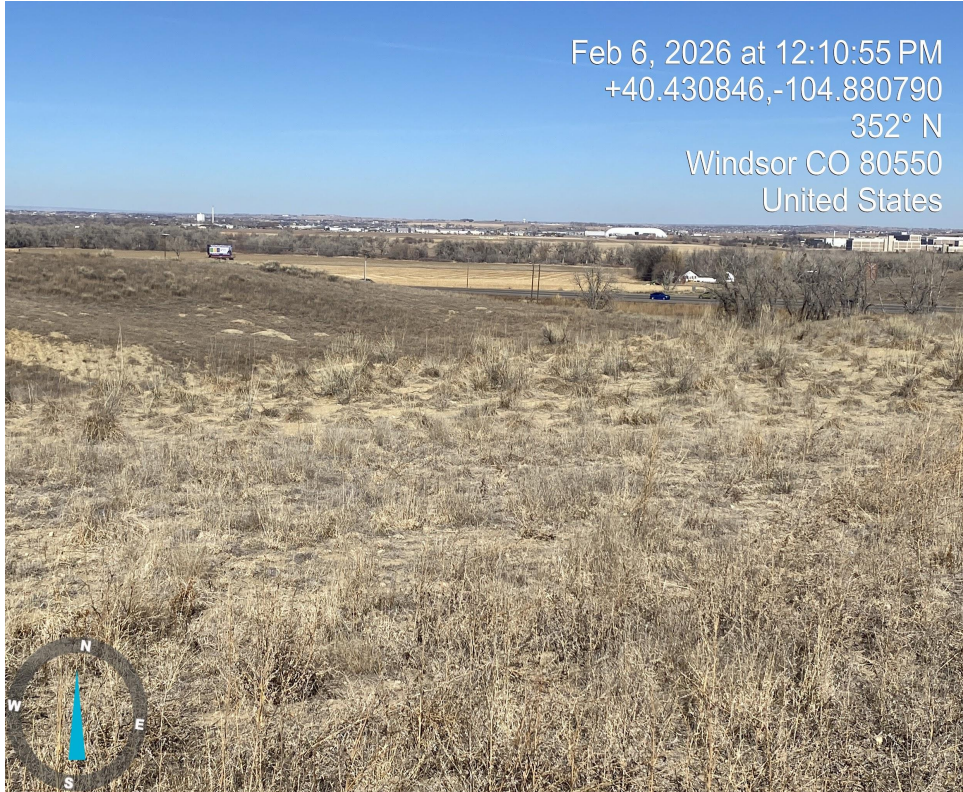
Photo 5. Photo taken from location facing north showing a significant area covered by undesirable vegetation and areas with bare soil.

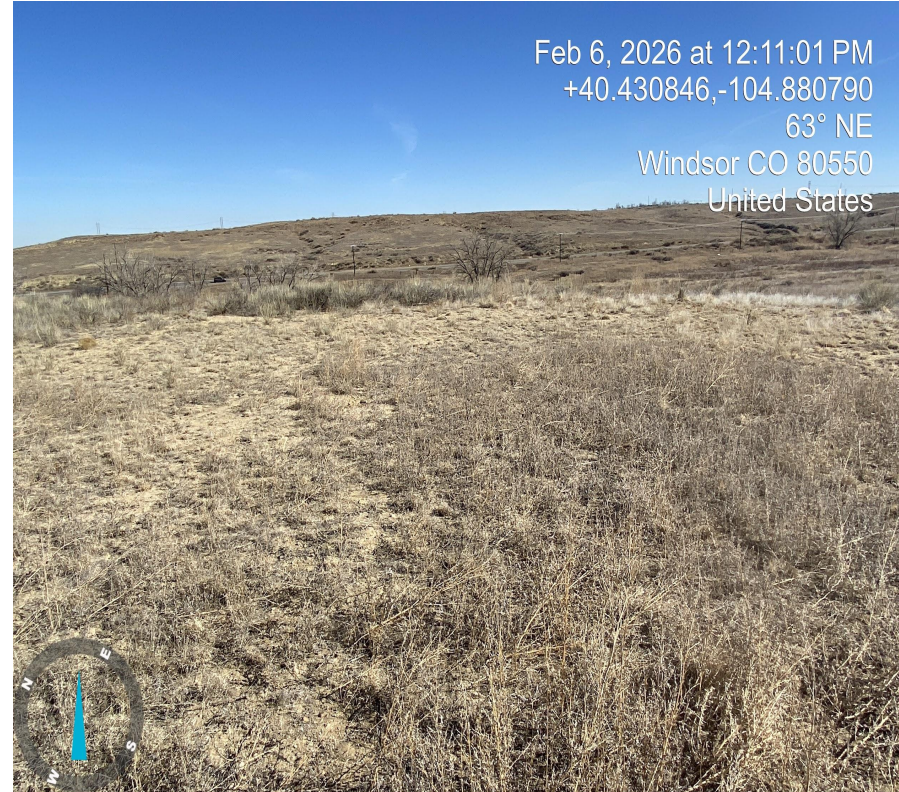
Photo 6. Photo taken from location facing east. See comment under photo 5.

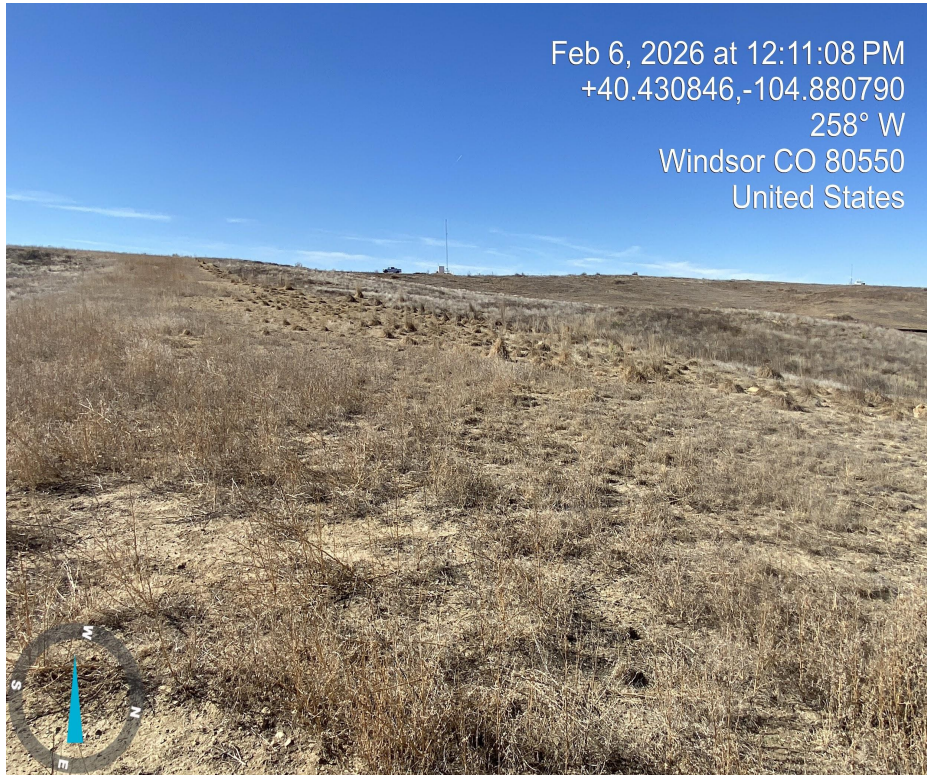
Photo 7. Photo taken from the location facing west. Some desirable grasses are present; however, there are also bare areas and undesirable vegetation.

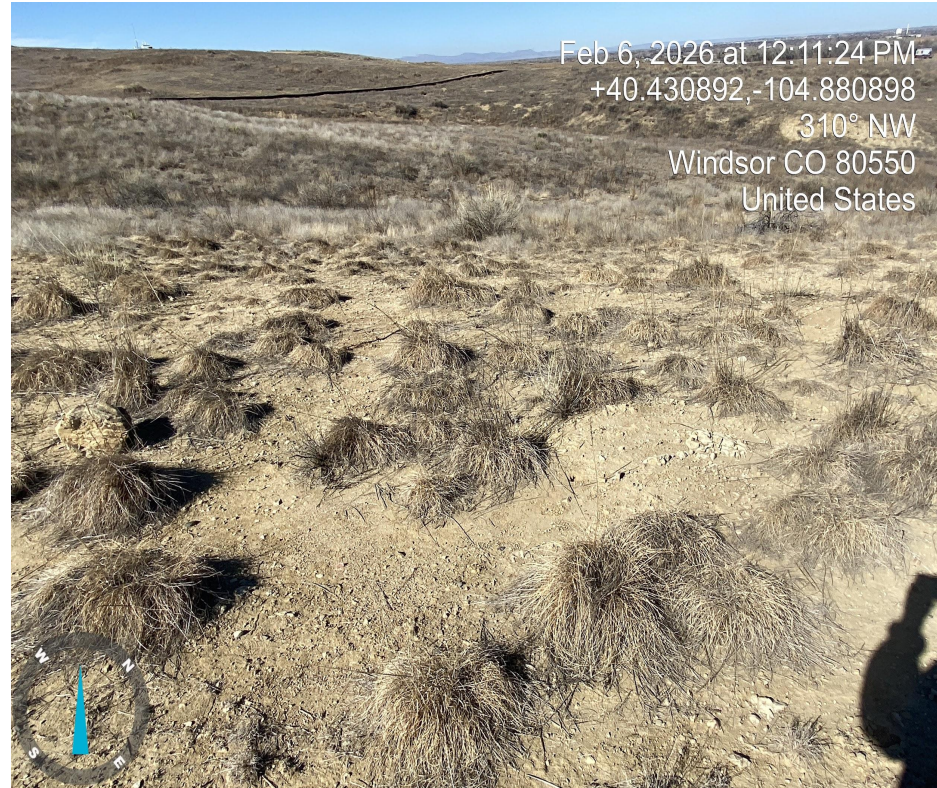
Photo 8. Photo taken on location of bare soil between bunch grass that is conserving for stormwater erosion.

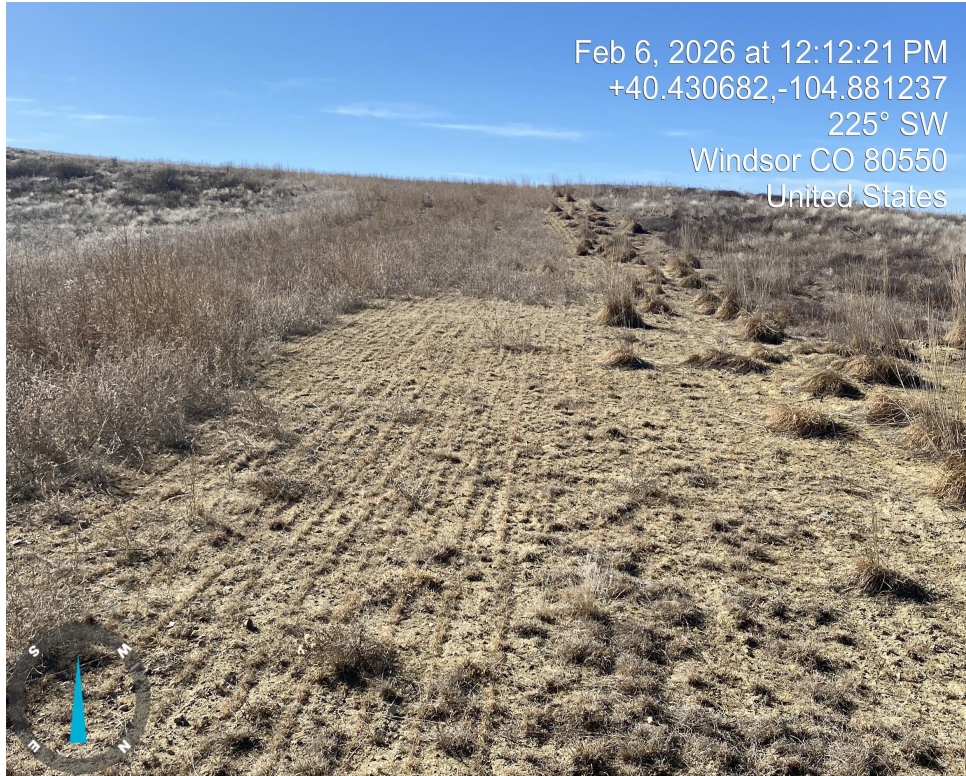
Photo 9. Photo taken of access road facing up slope showing stunted vegetation, areas of bare soil and undesirable annual weeds.

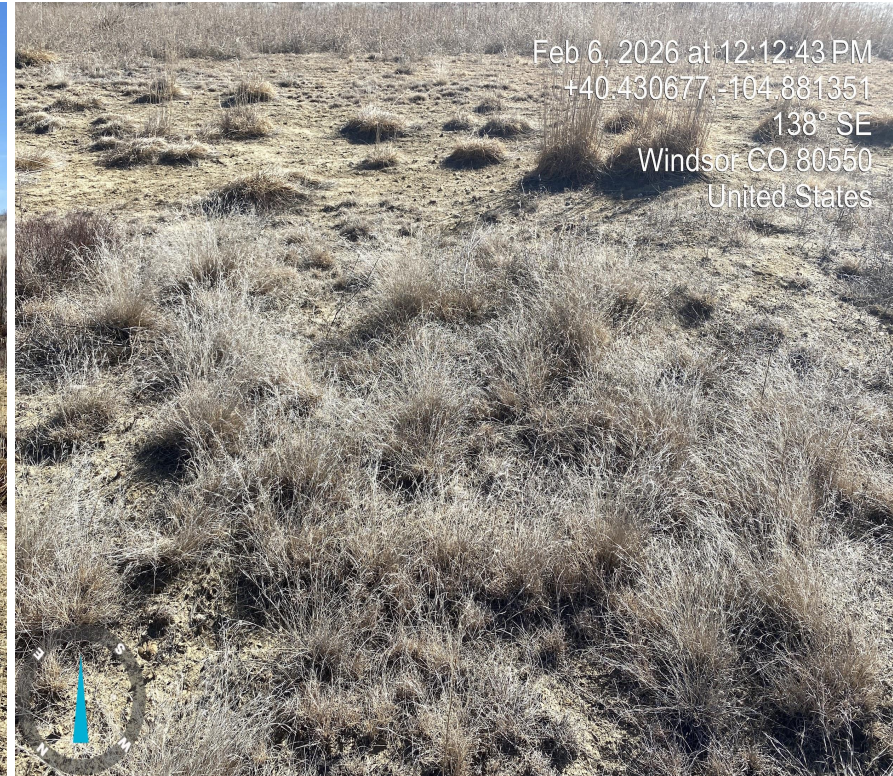
Photo 10. The photo shows a clear line where the access road was present, and the area was disturbed, and the adjacent reference area that was not impacted.
