Final Reclamation Inspection

Operator: KERR MCGEE OIL & GAS ONSHORE LP

Location ID: 330418

Location Name: HSR-KNOX-65N67W 3SESW

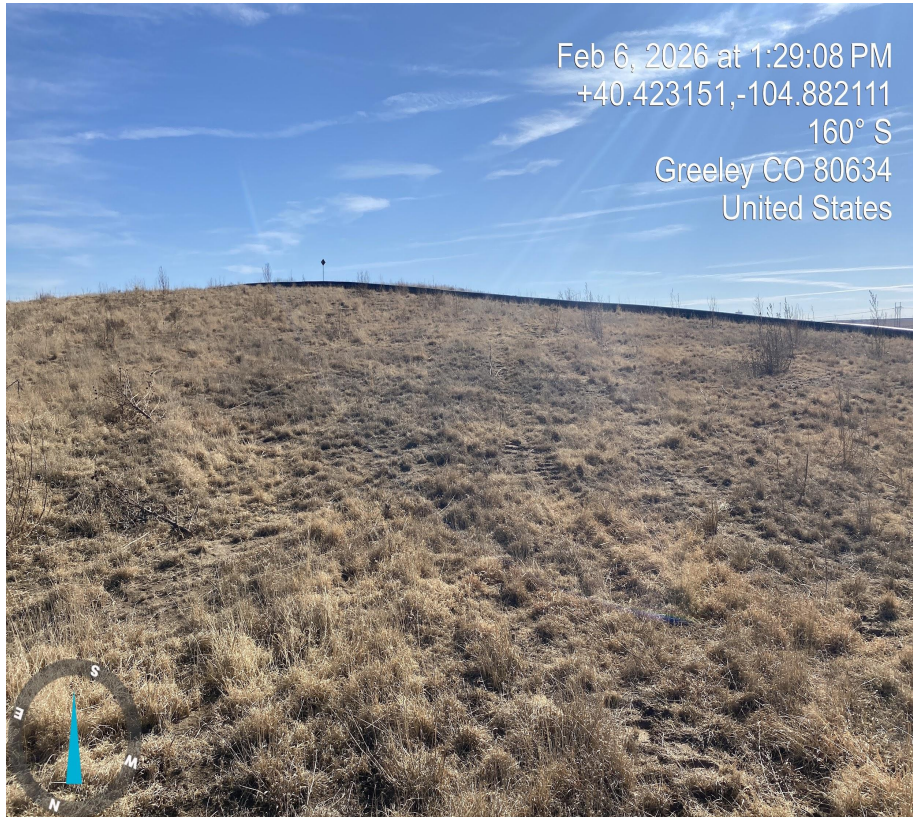
Photo 1. Photo taken from center of location facing south, showing desirable forb and grass species establishment as well as some undesirable weeds on the location.

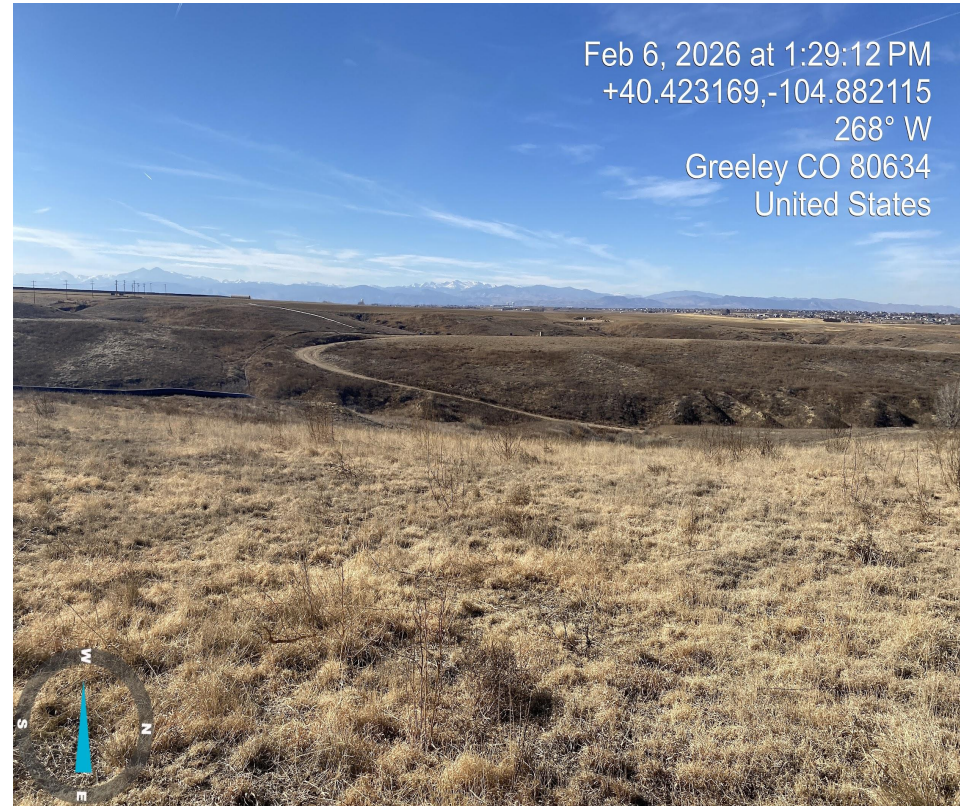
Photo 2. Photo taken from center of location facing west. See comment under photo 1.

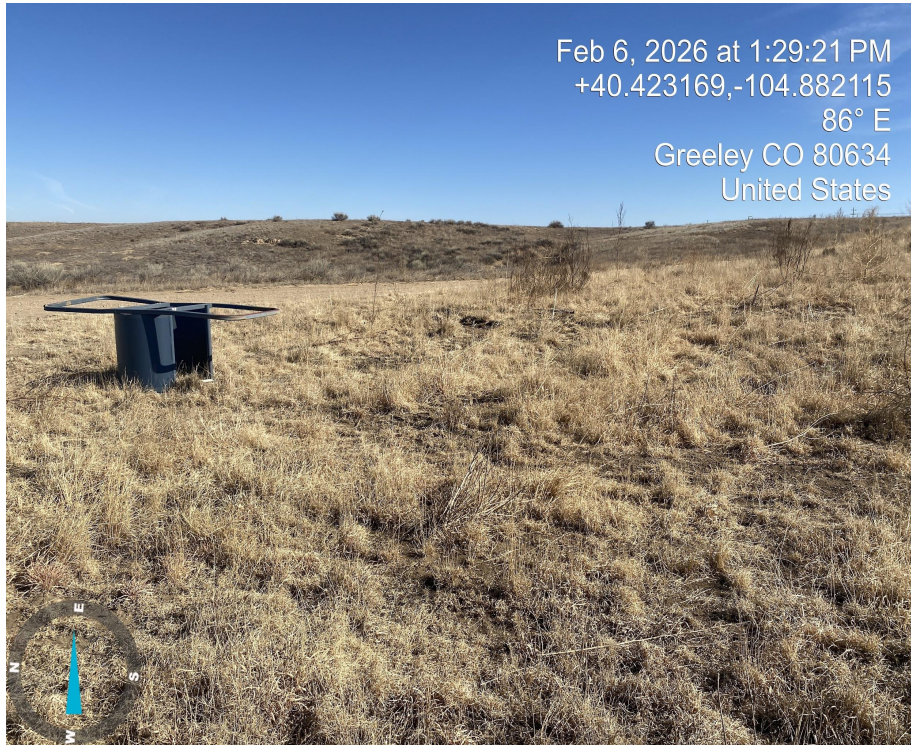
Photo 3. Photo taken from center of location facing east. See comment under photo 1.

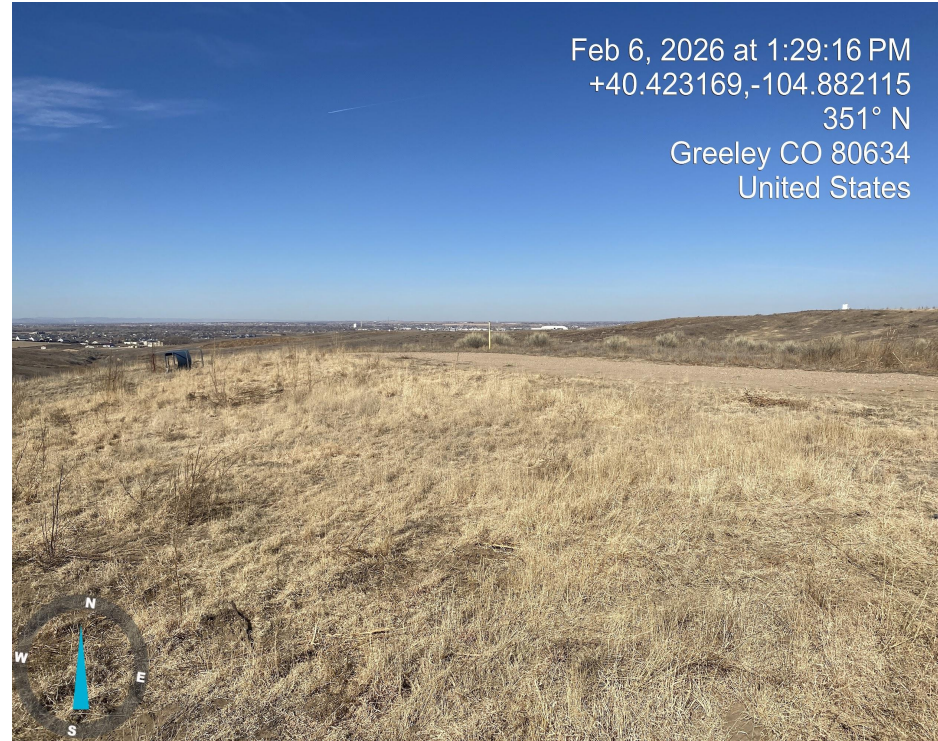
Photo 4. Photo taken from center of location facing north. See comment under photo 1.

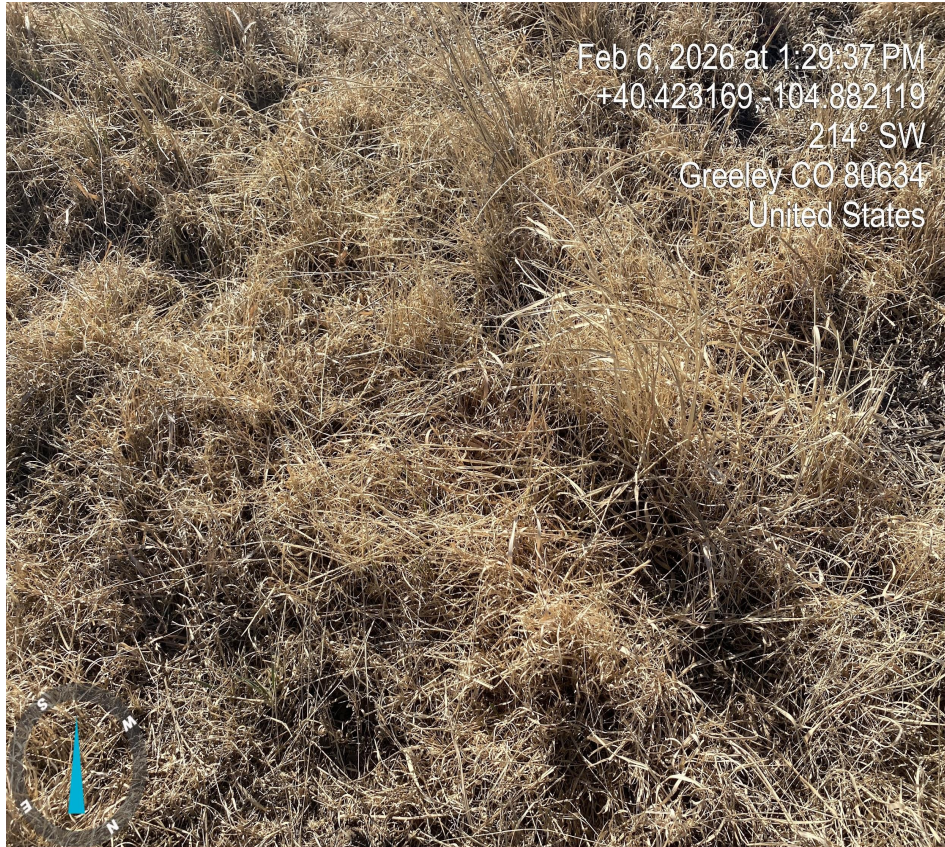
Photo 5. Photo taken from location showing desirable vegetation growing on location.

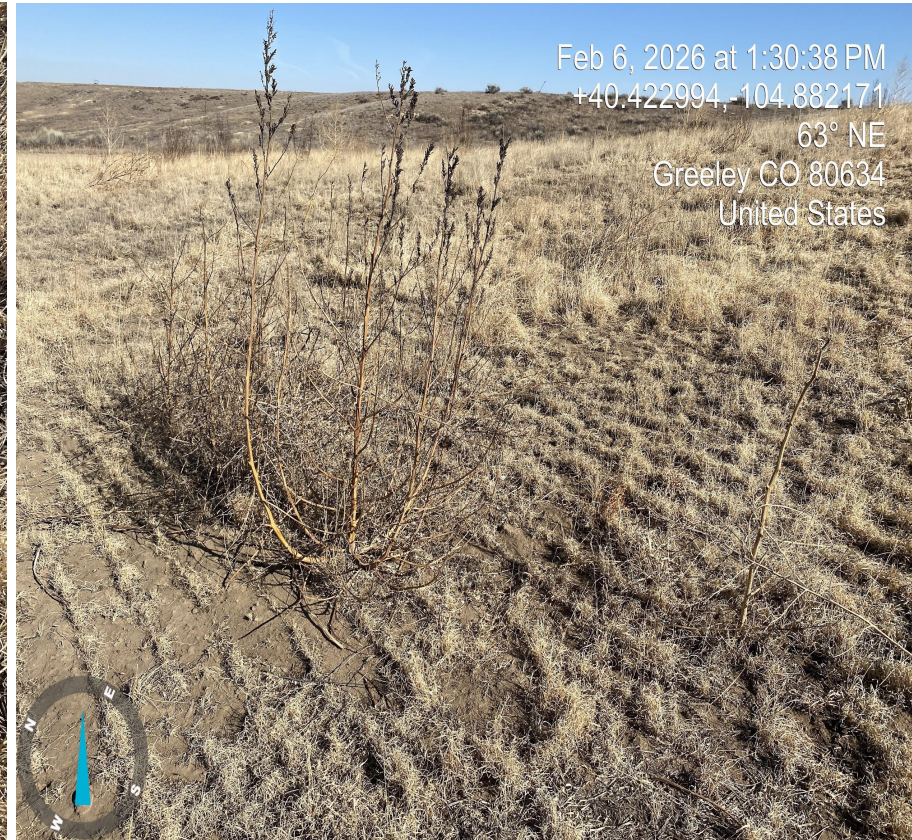
Photo 6. Photo shows some weeds growing on location with drill seed rows showing evidence of reclamation activity. Growth of desirable vegetation on location.

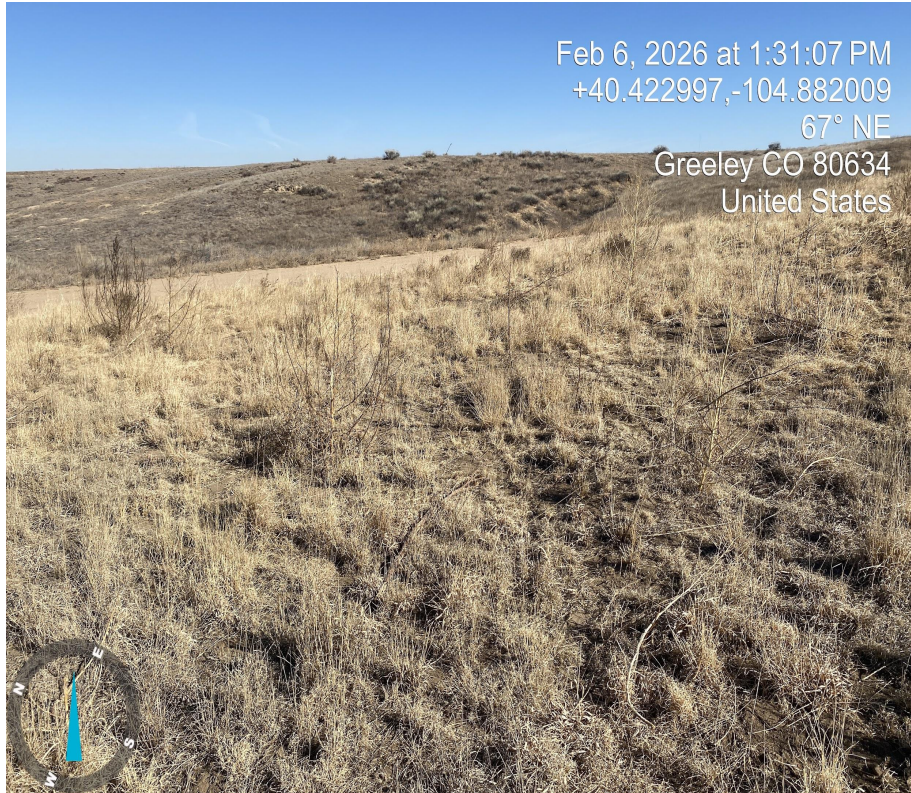
Photo 7. Photo shows desirable vegetation as well as some weeds present on well pad.

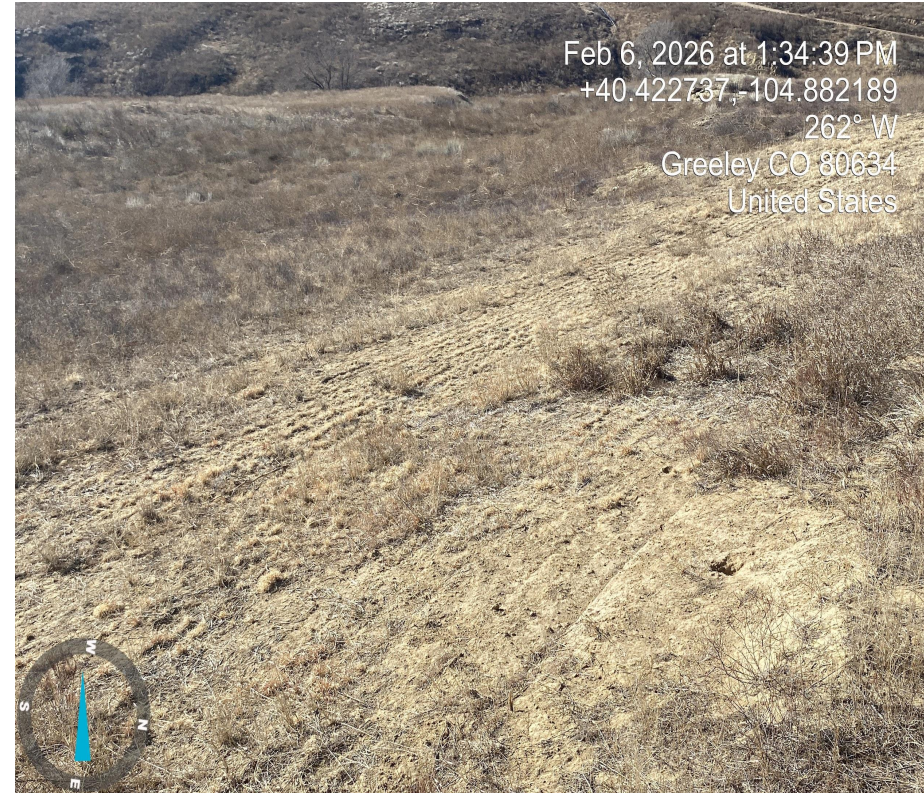
Photo 8. Photo taken on north west corner of location showing bare earth and evidence of drill seeing rows.

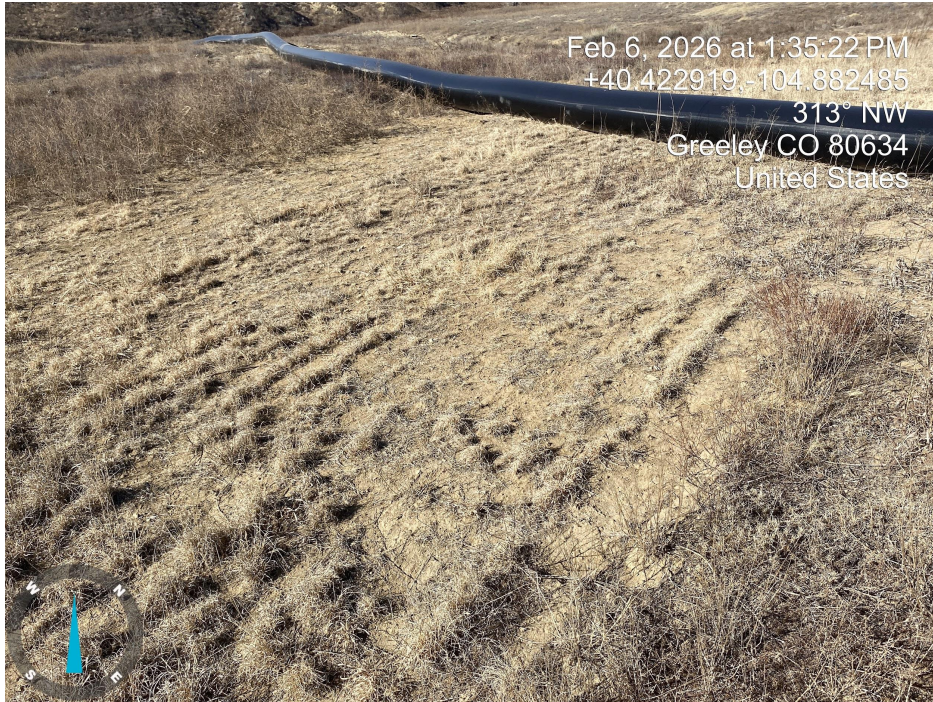
Photo 9. Photo taken from western side of location facing north west. See comment under photo 8.

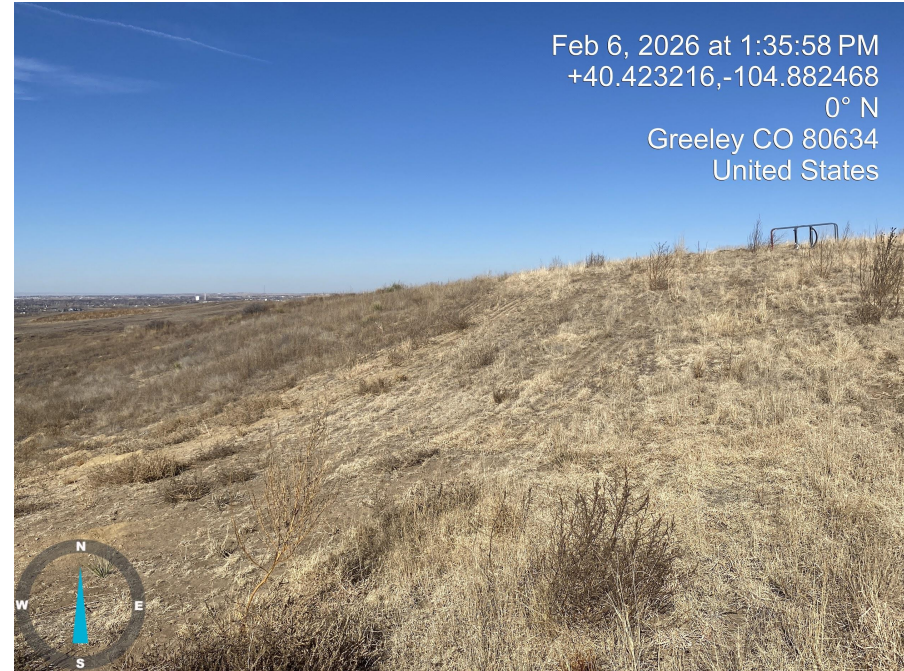
Photo 10. Photo taken from western side of location facing north. See comment under photo 8.

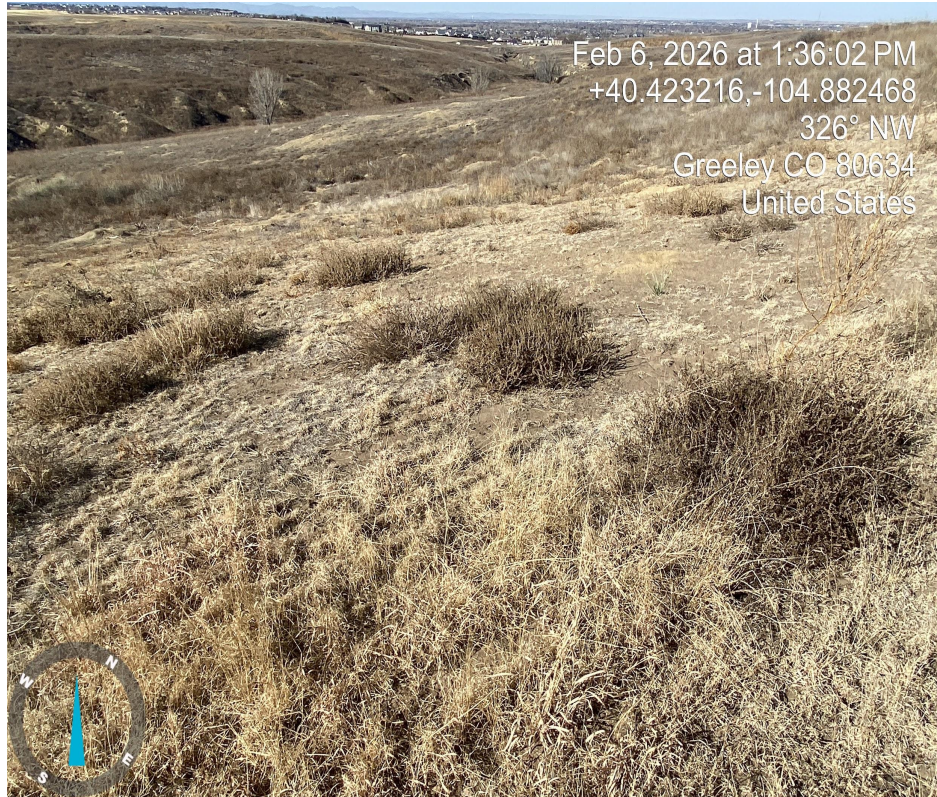
Photo 11. Photo taken on western side of location undesirable vegetation and some patches bare soil. There is also growth of desirable grass species.

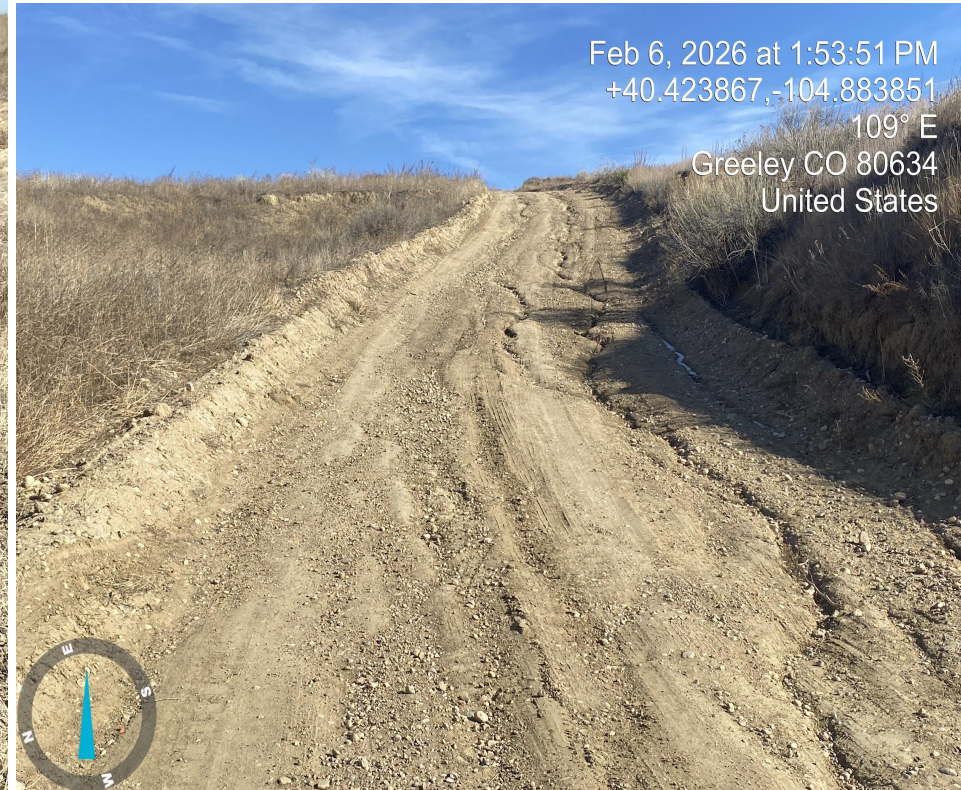
Photo 12. Photo taken from main access road northwest past location showing erosion on main road.

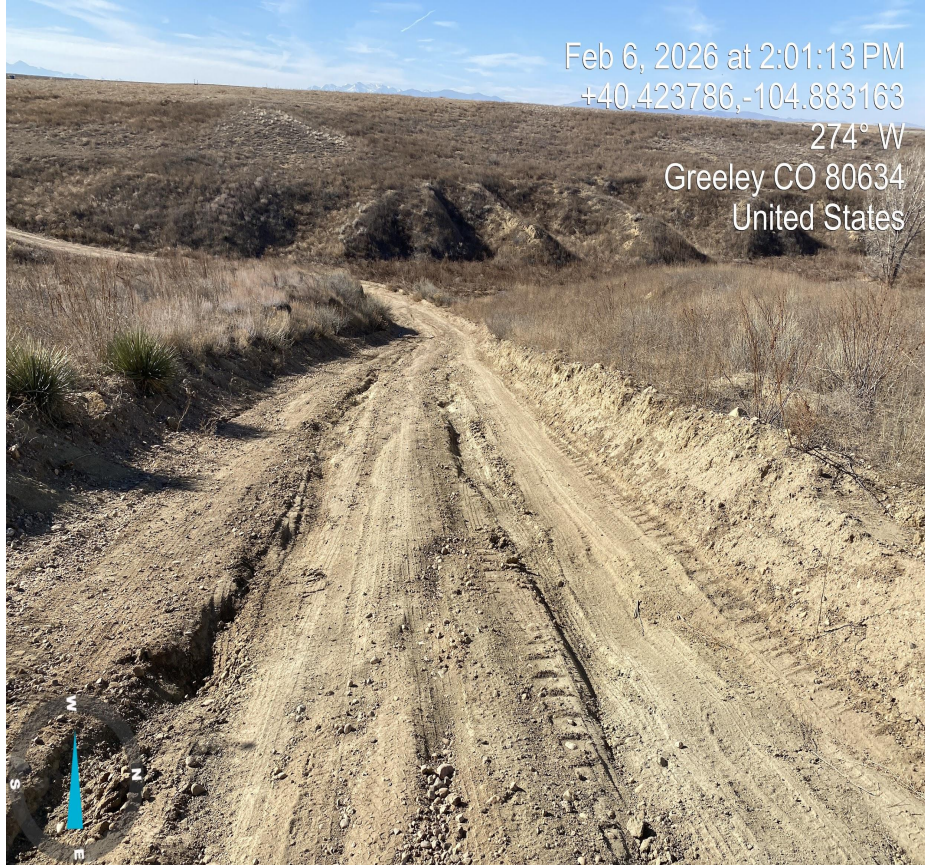
Photo 13. Photo taken from main access road north west past location showing erosion on main road.

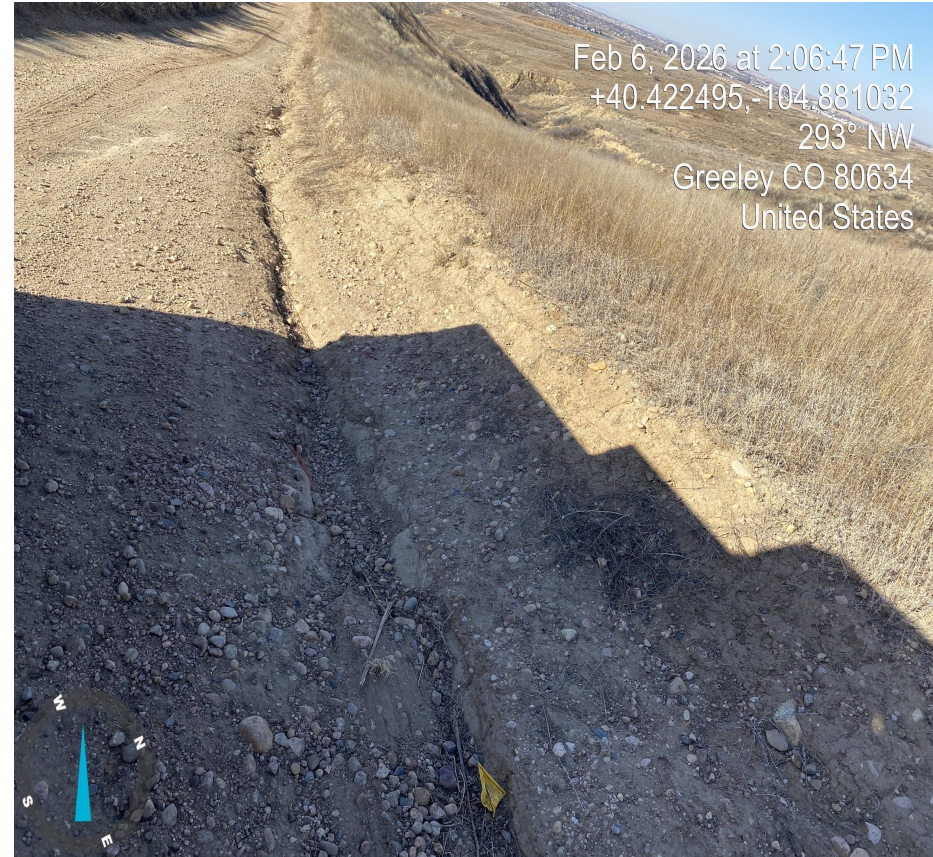
Photo 14. Photo taken from main access road north west past location showing erosion on main road.

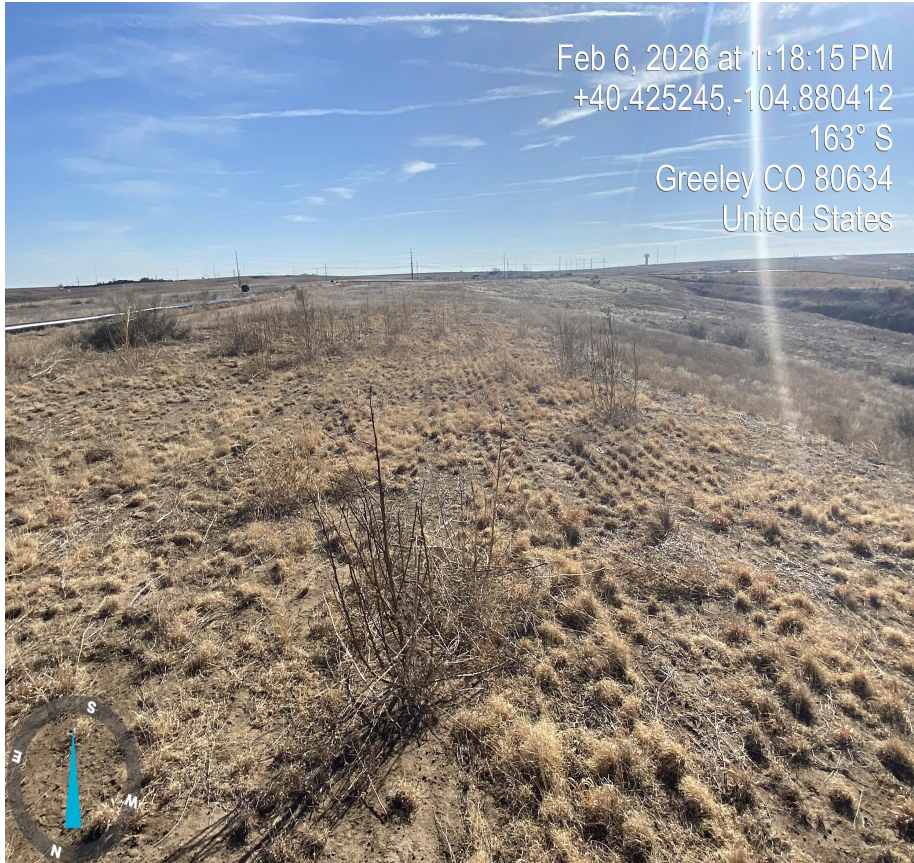
Photo 15. Photo taken from the tank battery location showing drill-seeded rows of desirable grass species; also present are a large amount of bare area and some undesirable annual weed species.

Photo 17. Photo taken from tank battery location. See comment under photo 15.

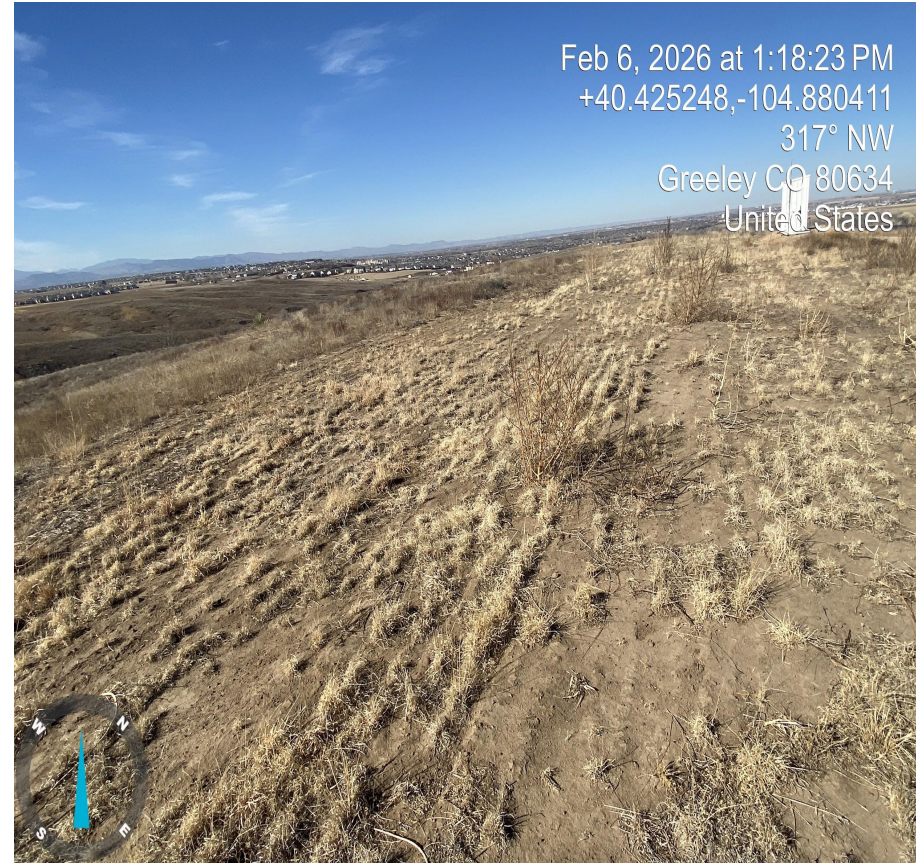
Photo 18. Photo taken from tank battery location. See comment under photo 15.

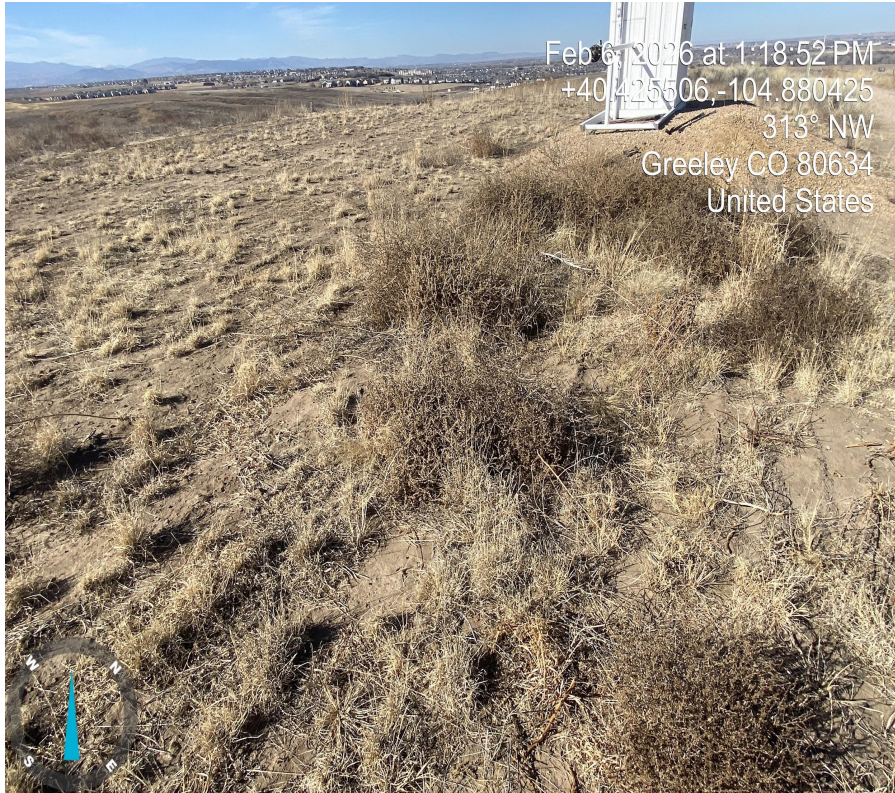
Photo 19. Photo taken from the tank battery location. Showing Russian thistle and desirable grass species. Also, bare spoil present.

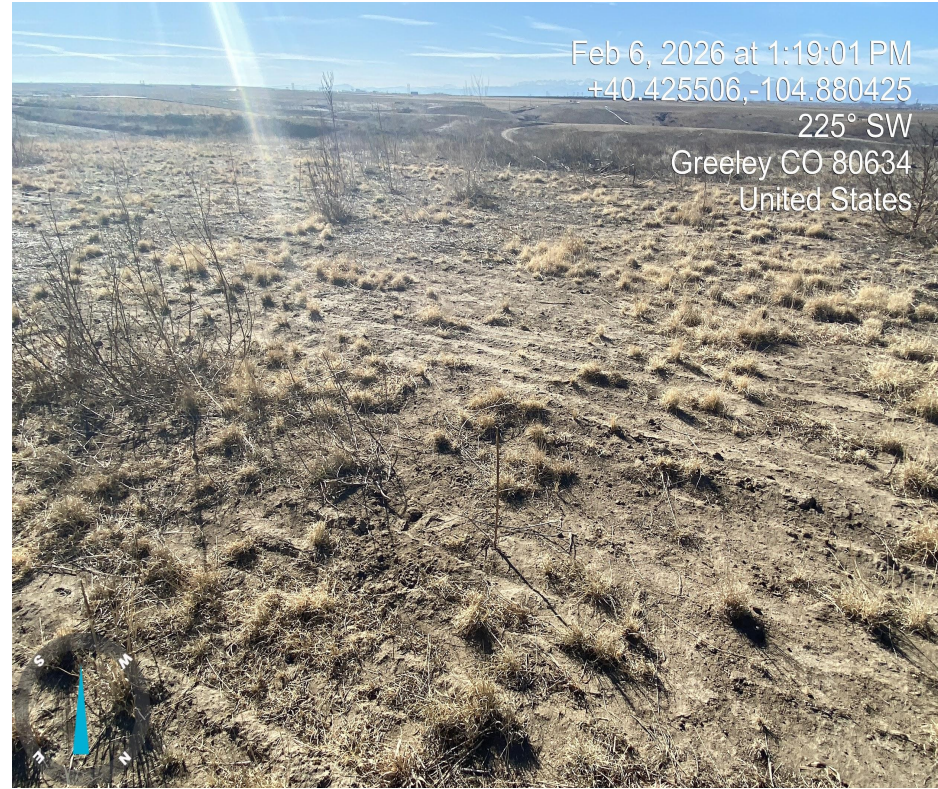
Photo 20. Photo taken from tank battery location. See comment under photo 15.

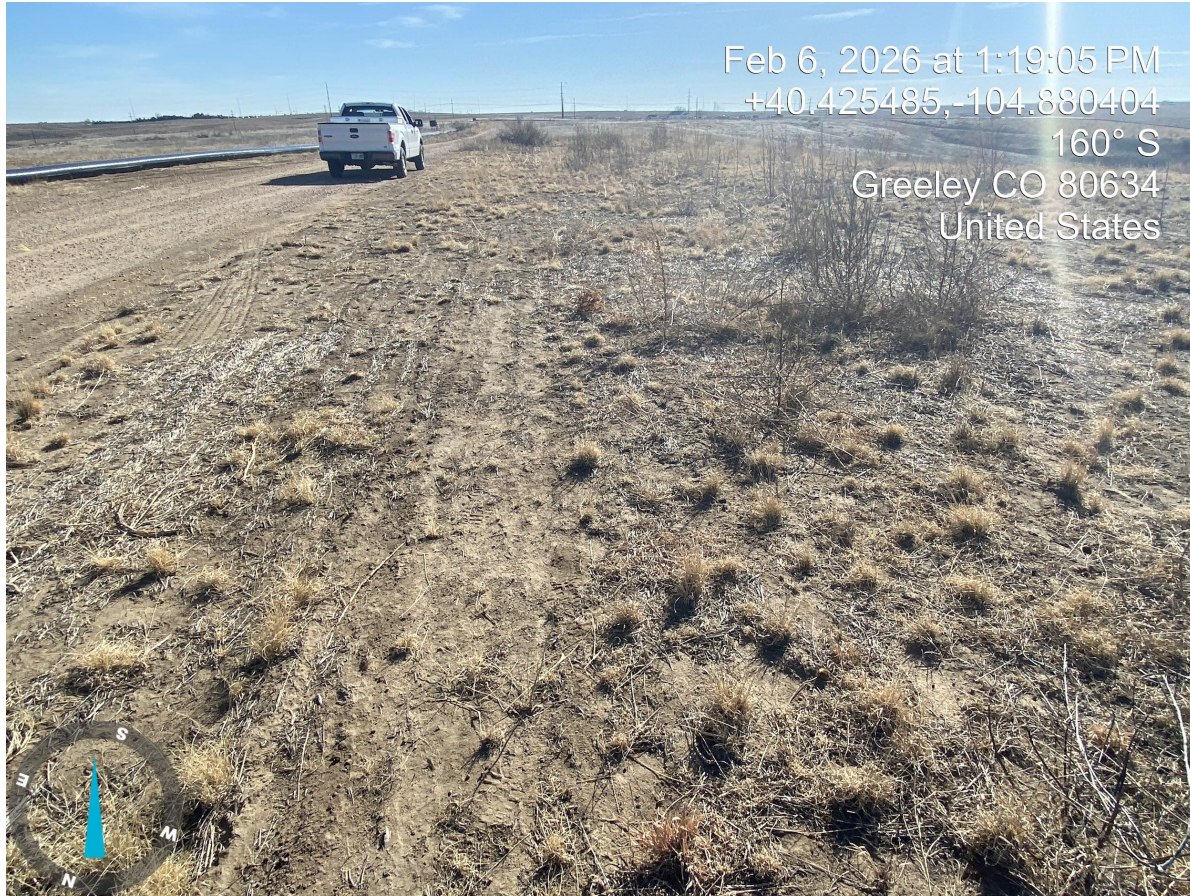
Photo 21. Photo taken from tank battery location. See comment under photo 15.
