Final Reclamation Inspection

Operator: KERR MCGEE OIL & GAS ONSHORE LP

Location ID: 464085

Inspection Document #: 720300123

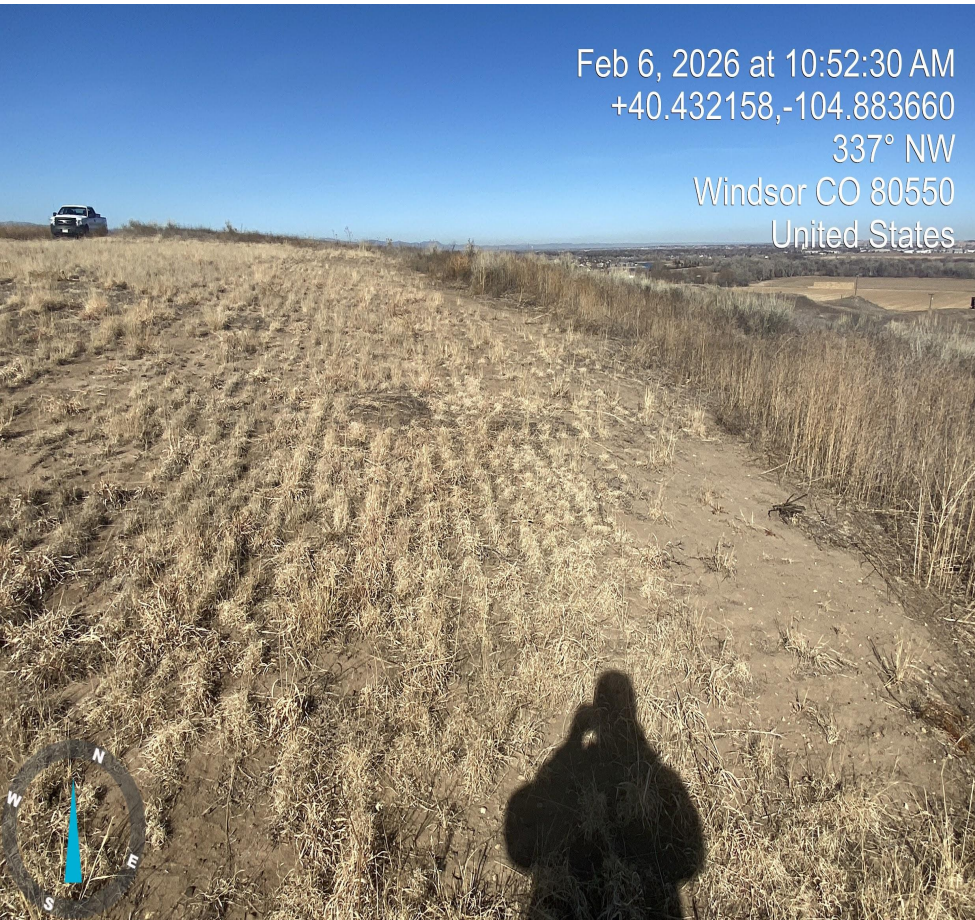
Photo 1. Photo taken from the southeastern corner of the location. It appears that an attempt to revegetate the location was made based on evidence of drill seed rows; however, vegetation cover has not achieved 80% cover compared to a

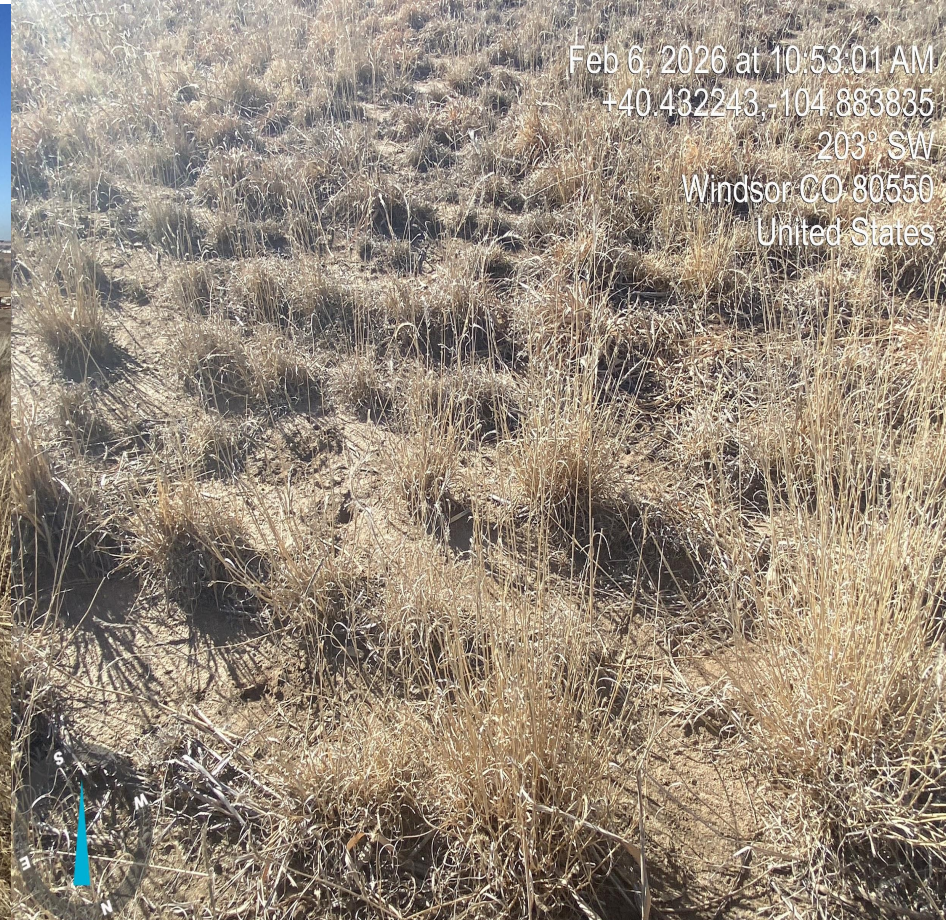
Photo 2. Photo of desirable grass species present on location.

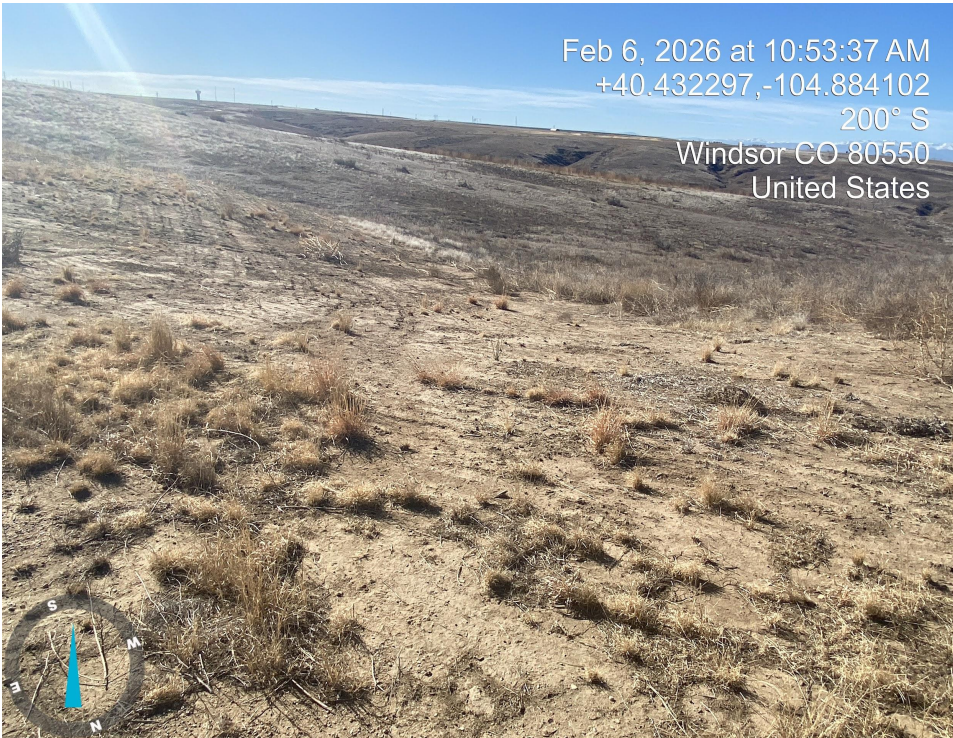
Photo 3. Photo taken from location facing south showing a large amount of bare areas. The location needs to be vegetated to prevent erosion. Downslope west is sensitive riparian habitat.

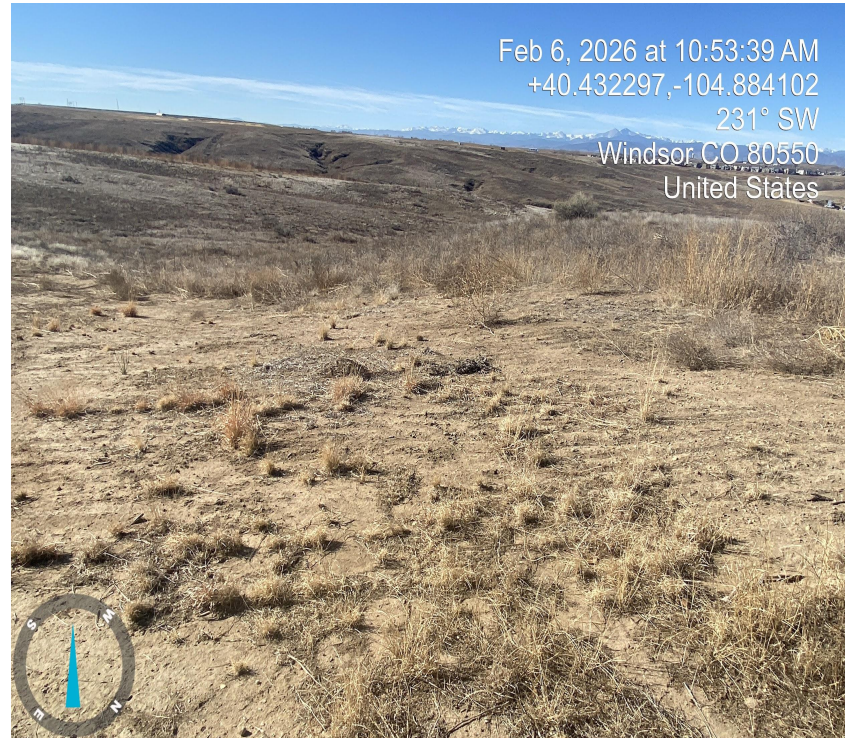
Photo 4. Photo taken from location facing south west. see comment under photo 3

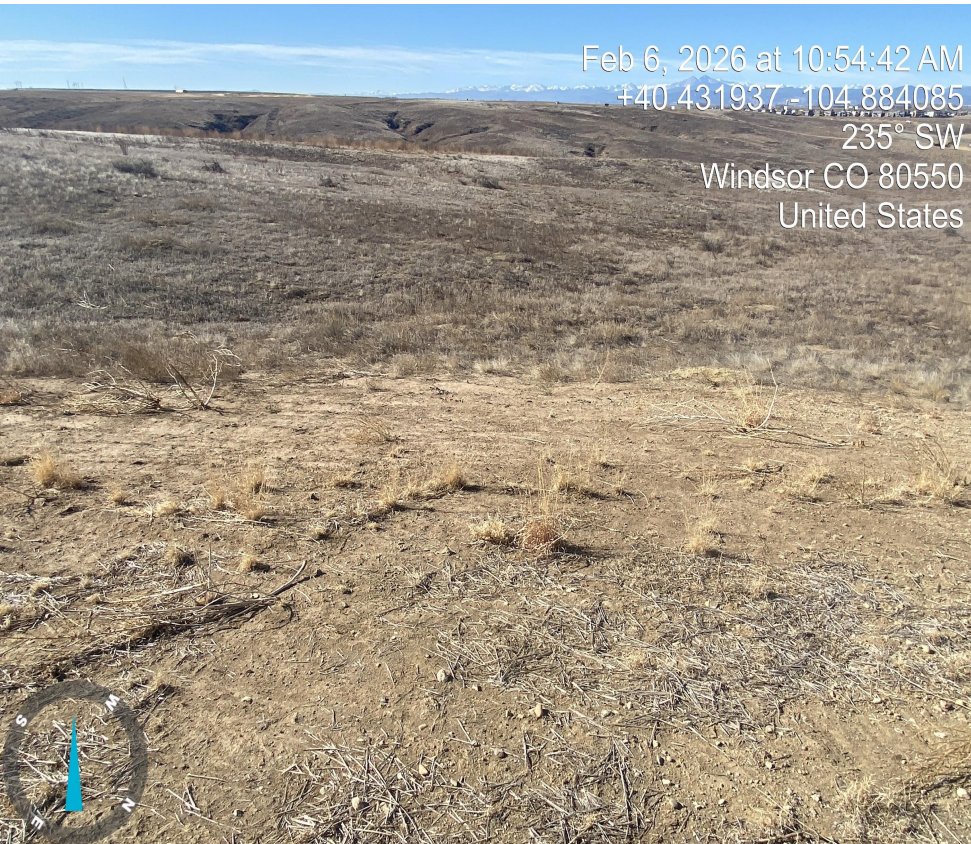
Photo 5. Photo taken from a location on the southern portion of the location facing southwest, showing a significant bare area.

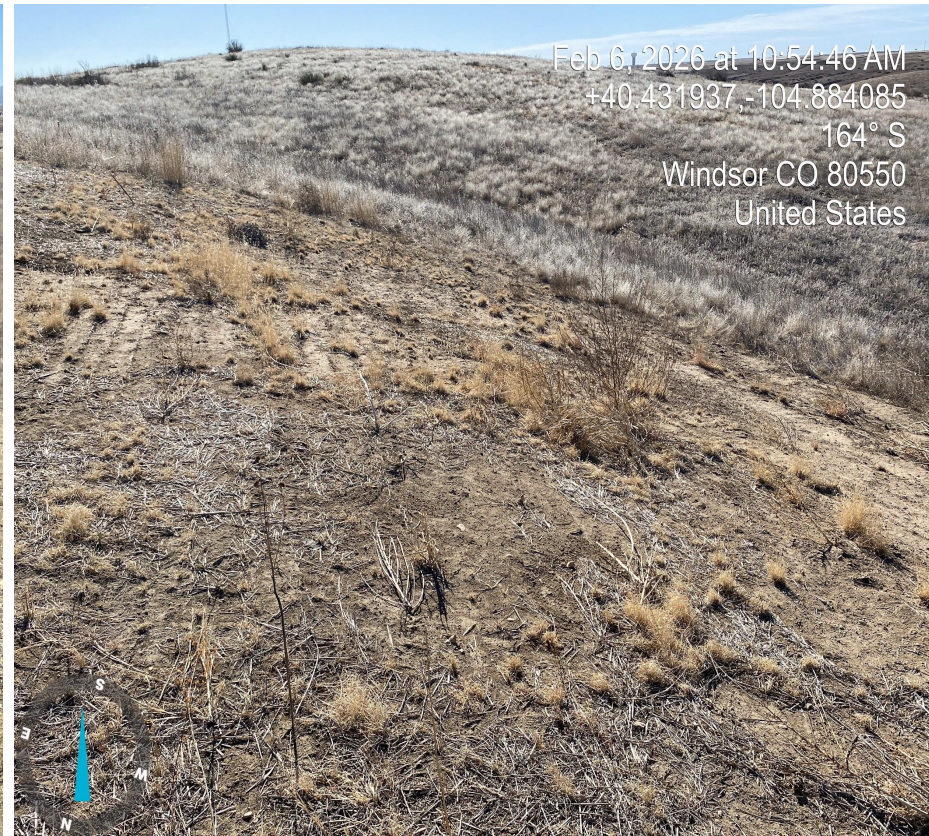
Photo 6. Photo taken from a location in the southwestern portion of the site, facing south, showing bare earth and undesirable weeds.

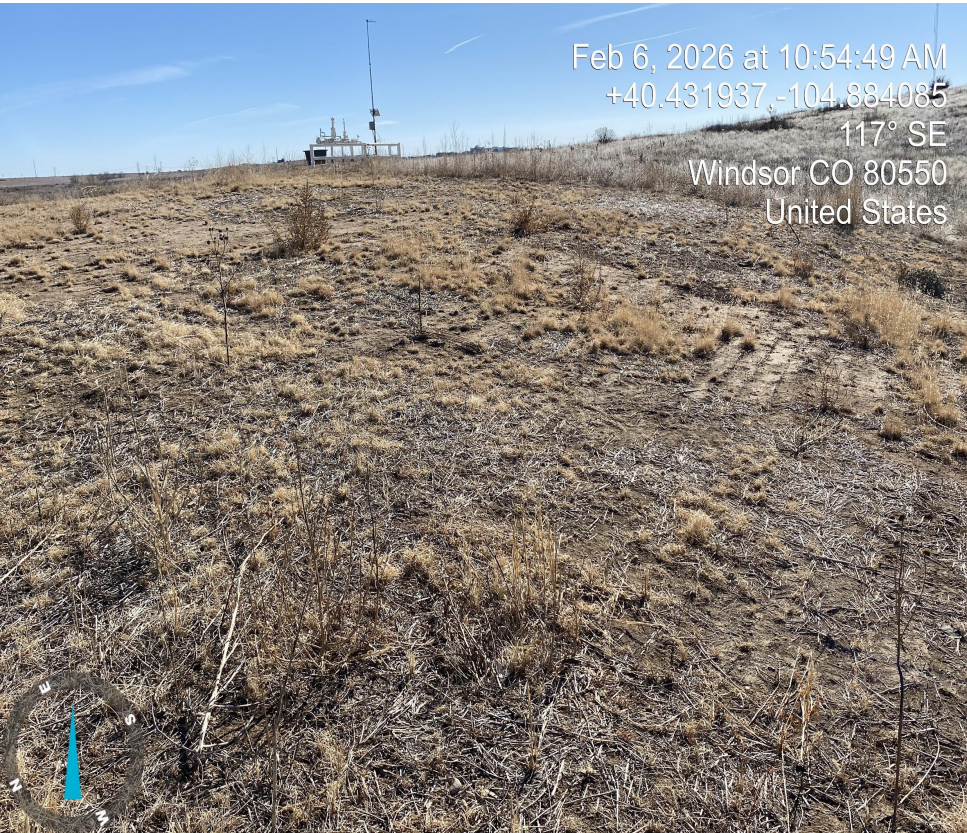
Photo 7. Photo taken from the southwestern portion of location facing south east. Some desirable grasses are present however there are bare areas as well as undesirable weeds growing.

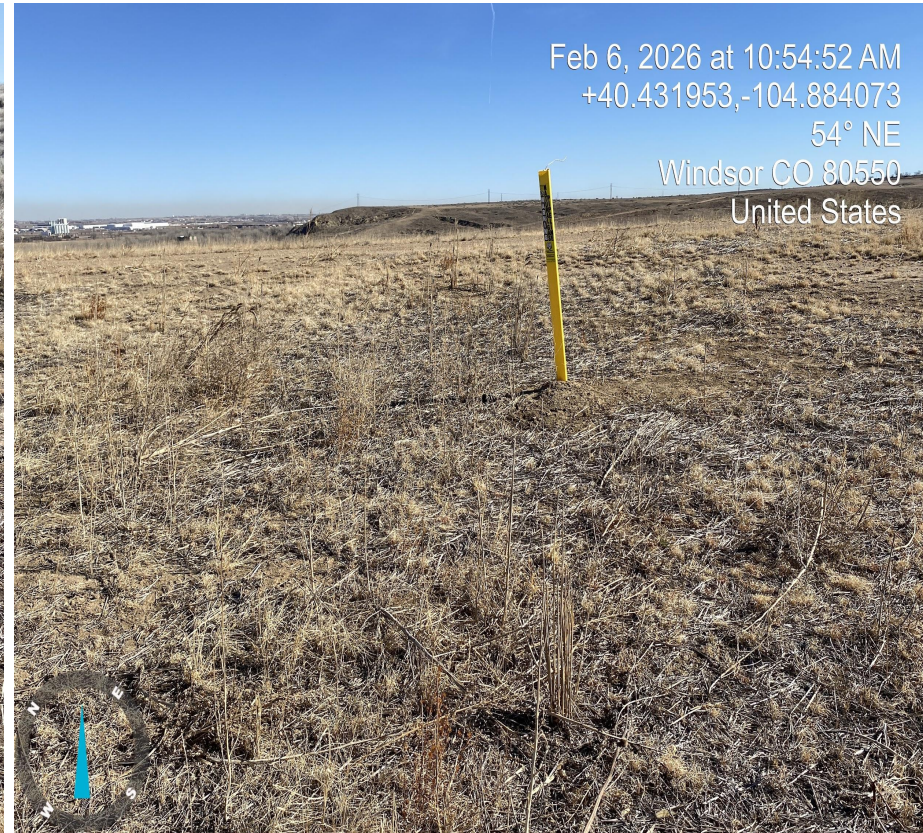
Photo 8. Photo taken on location facing northeast showing growth of desirable grasses however some undesirable weeds are also present.

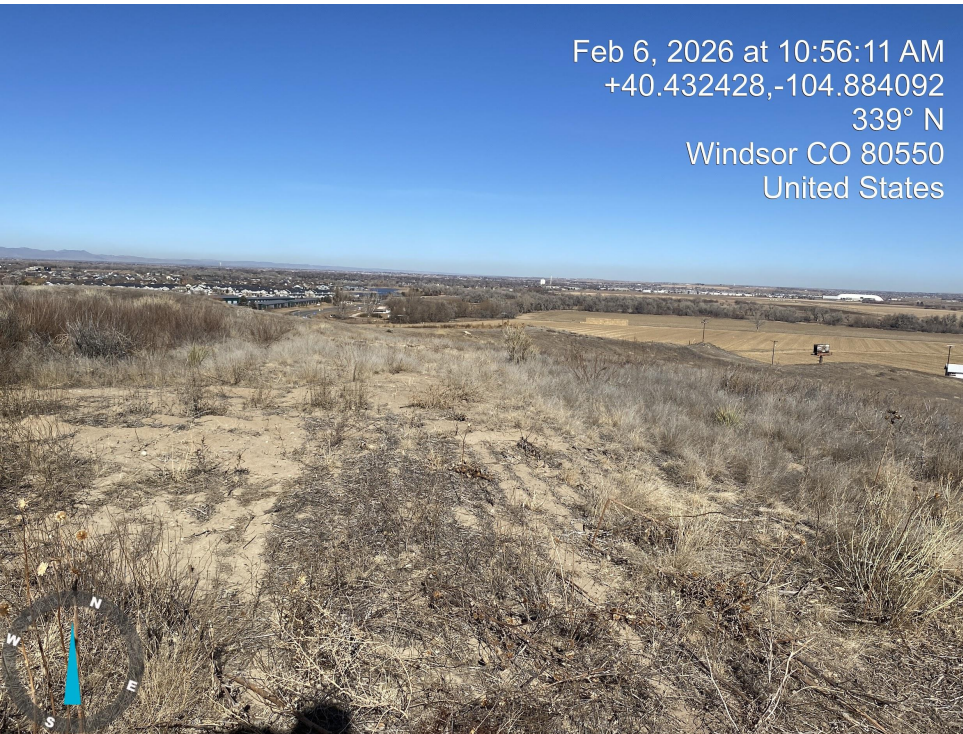
Photo 9. Photo taken at the location where the flowline was removed, heading to location 330415. The area appears to have stalled for reclamation, and the bare area needs to be seeded.

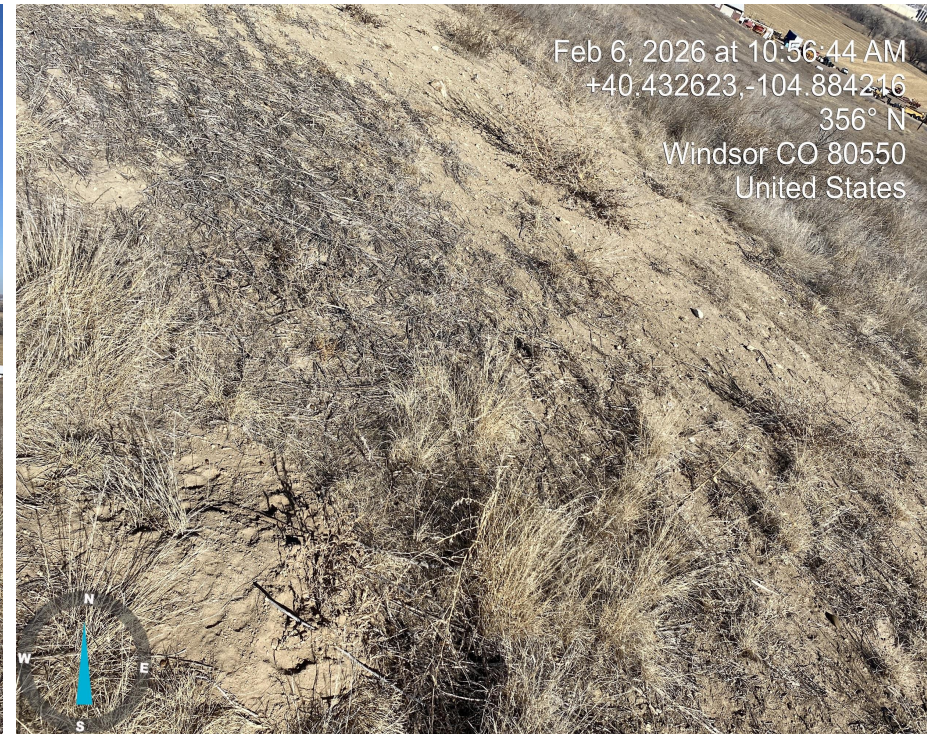
Photo 10. Photo shows undesirable plant species present on flowline scare.
