# Final Reclamation Inspection

Operator: KIMBARK OIL & GAS COMPANY

Location ID: 395521

Inspection Document #: 720300115

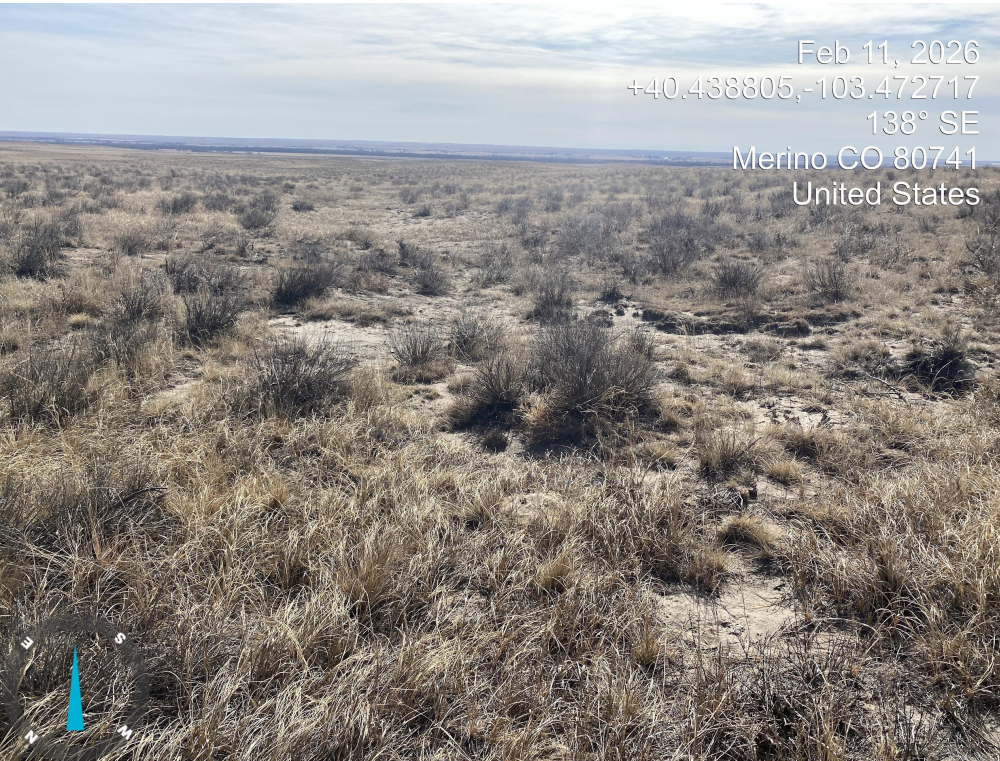
**Photo 1.** Photo taken from south of the location where the historic access road was facing southeast. The area has evidence of stormwater erosion. Road appears to have been installed in a depression between two hills, making it susceptible to stormwater erosion. Vegetation present is native perennial.

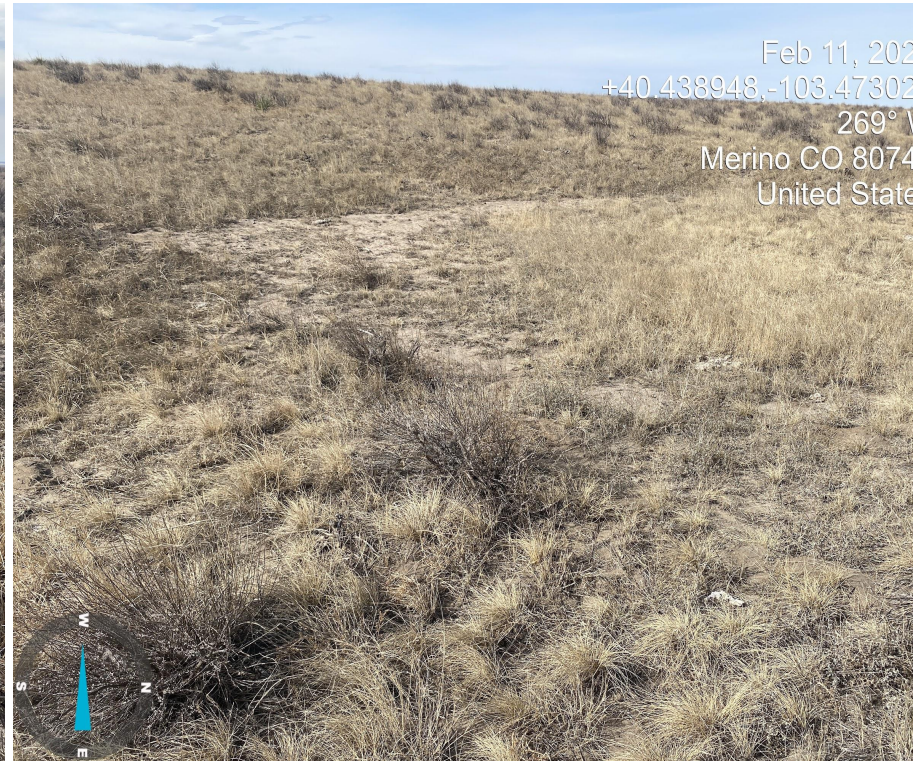
**Photo 2.** Photo taken from location facing west showing where water accumulates and area of bare soil.

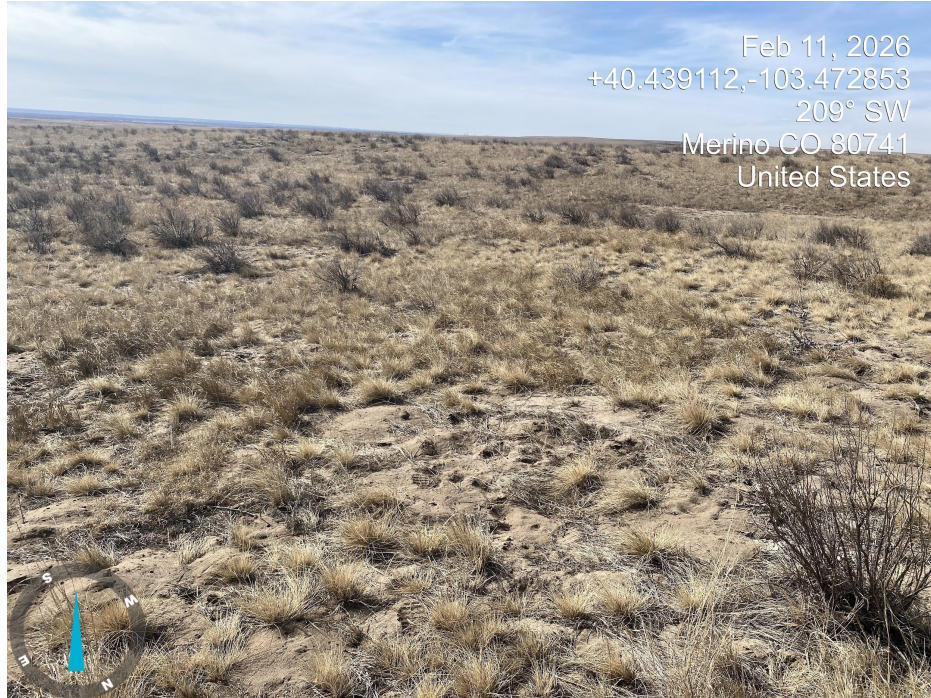
**Photo 3.** Photo taken from location facing south, showing some bare soil as well as native vegetation present on location.

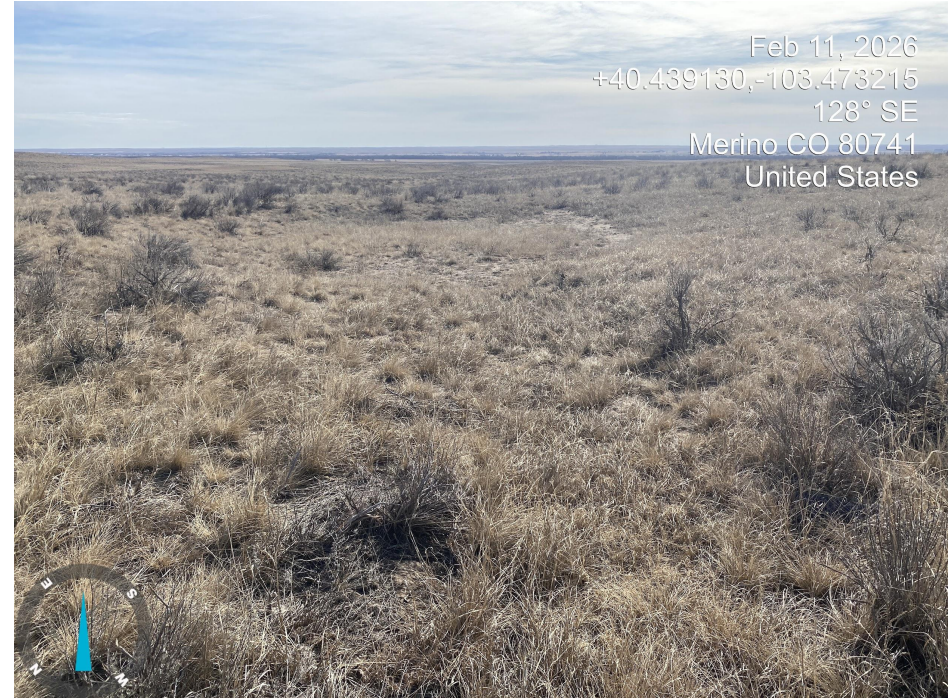
**Photo 4.** Photo taken from the above location facing southeast. Showing growth of desirable grass and forb species. The area where water has accumulated can also be seen towards the top of the photo.

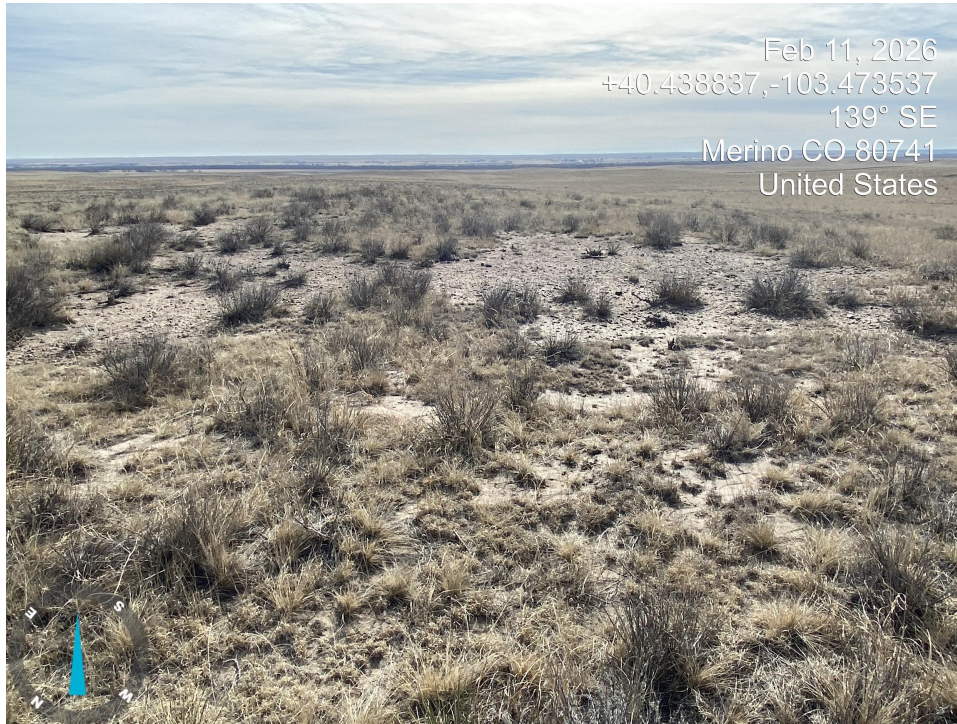
**Photo 5.** Photo taken from west of location at the top of the showing bare soil areas that are concerning for stormwater erosion.

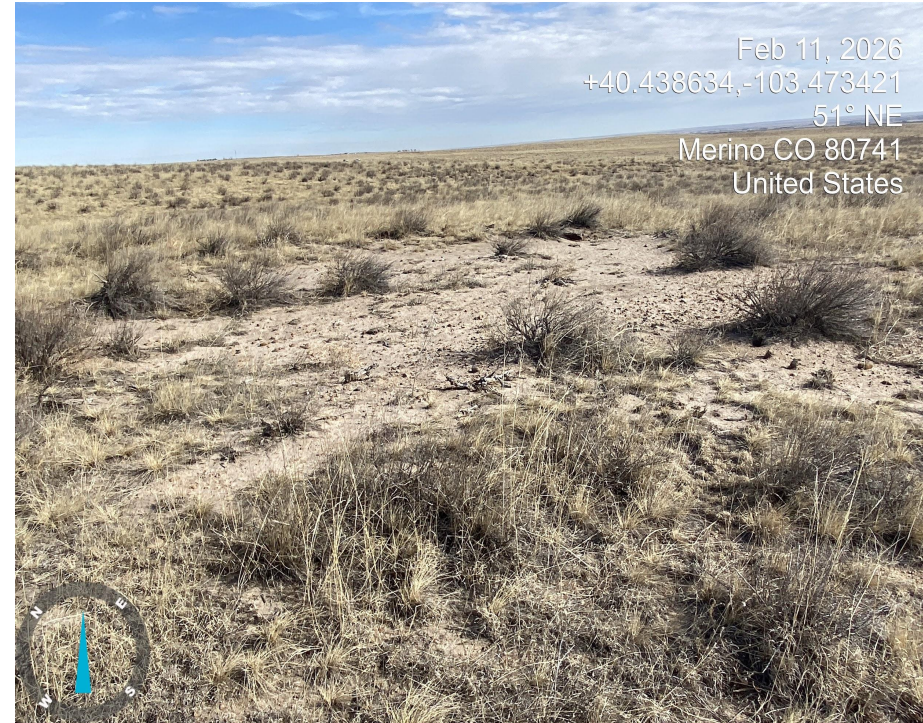
**Photo 6.** Photo of the hill to the west of the location. See comment under photo 5.

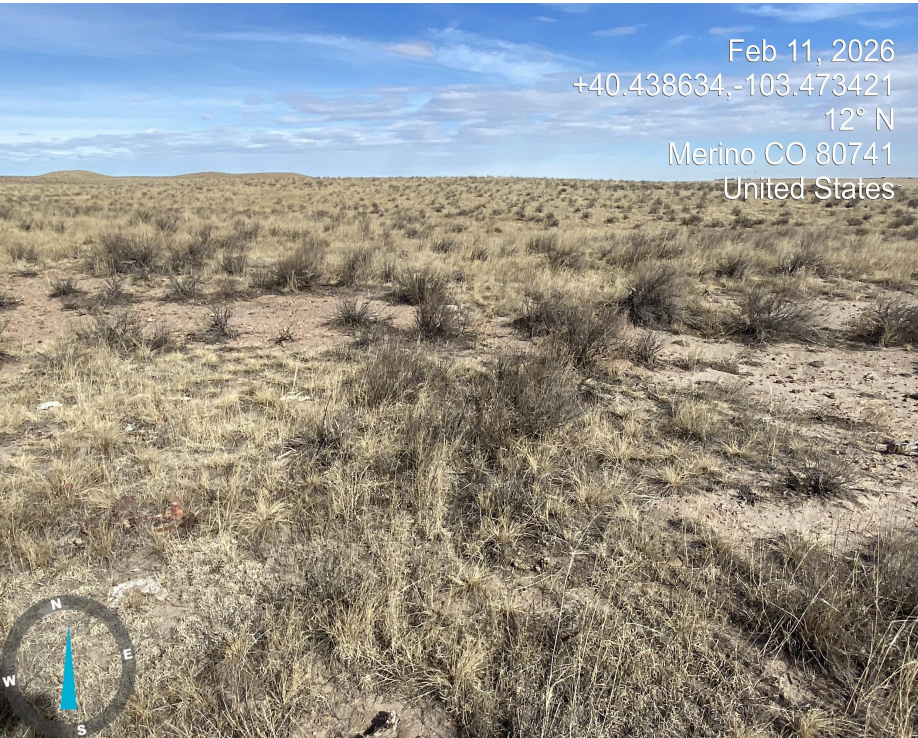
**Photo 7.** Photo taken from west of location. See comment in photo 5.

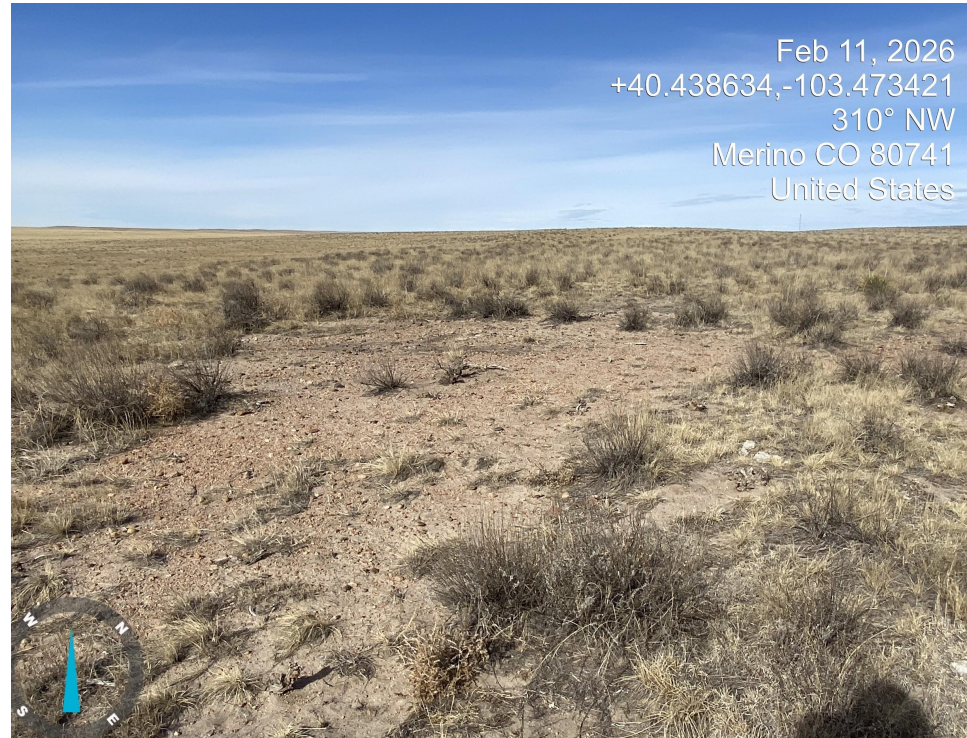
**Photo 8.** Photo taken from hill top west of location. See comment under photo 5.

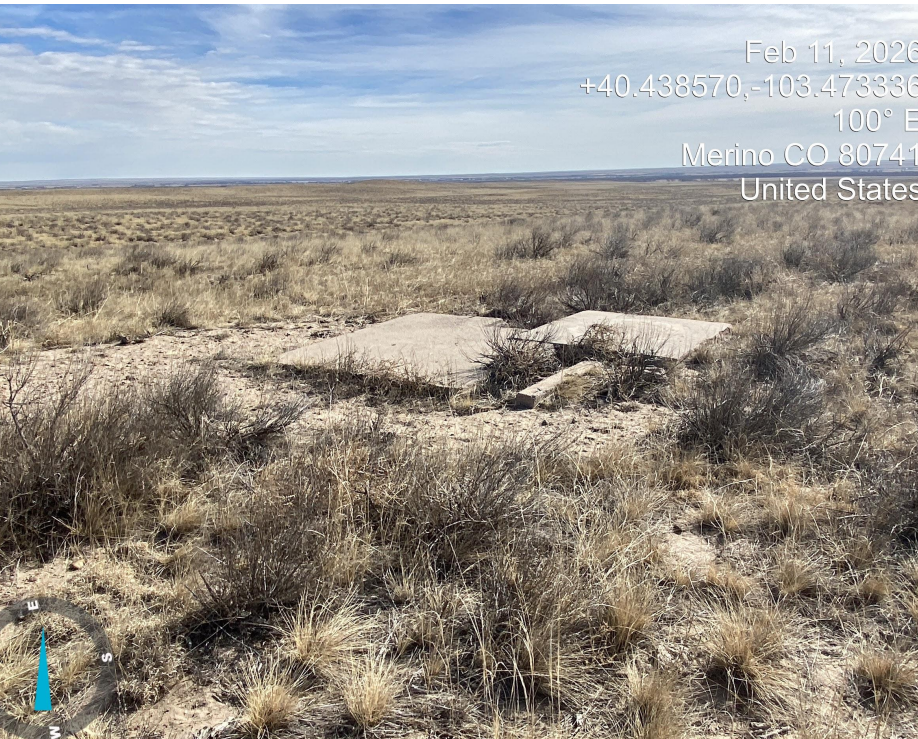
**Photo 9.** Photo taken from west of the location on the hilltop. The cement pad from that well is still present and needs to be removed. Bare areas present around the pad need to be vegetated with desirable native grass and shrub species.

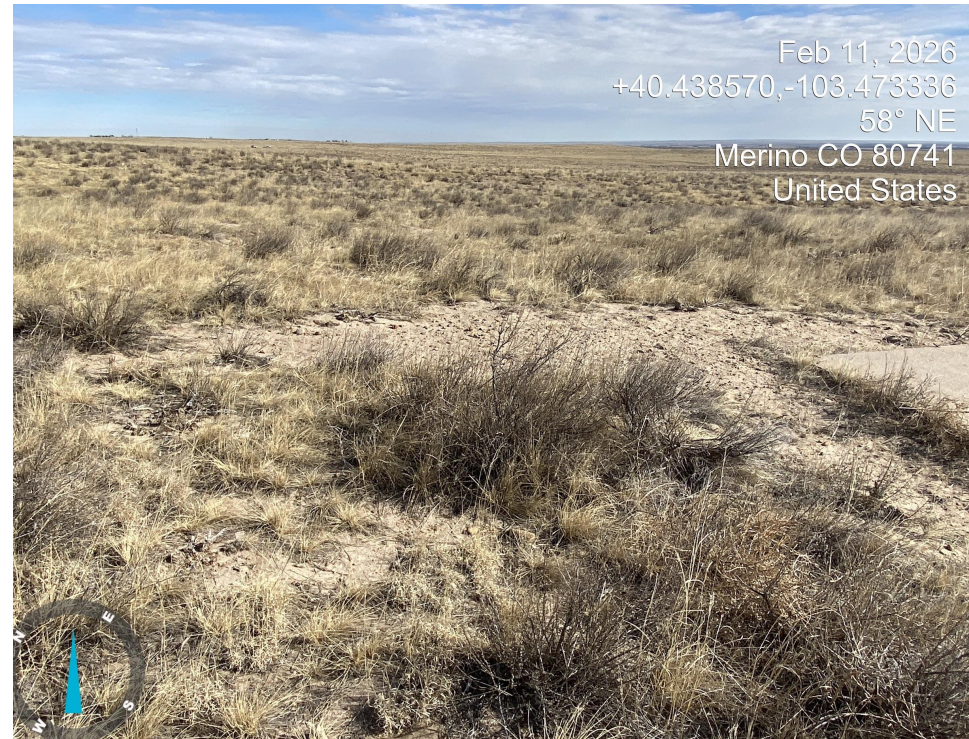
**Photo 10.** Photo taken from the hilltop west of the well. See comment under photo 9.
