# QB ENERGY OPERATING LLC BENTLEY-67S95W 11SWSE Facility # 324168

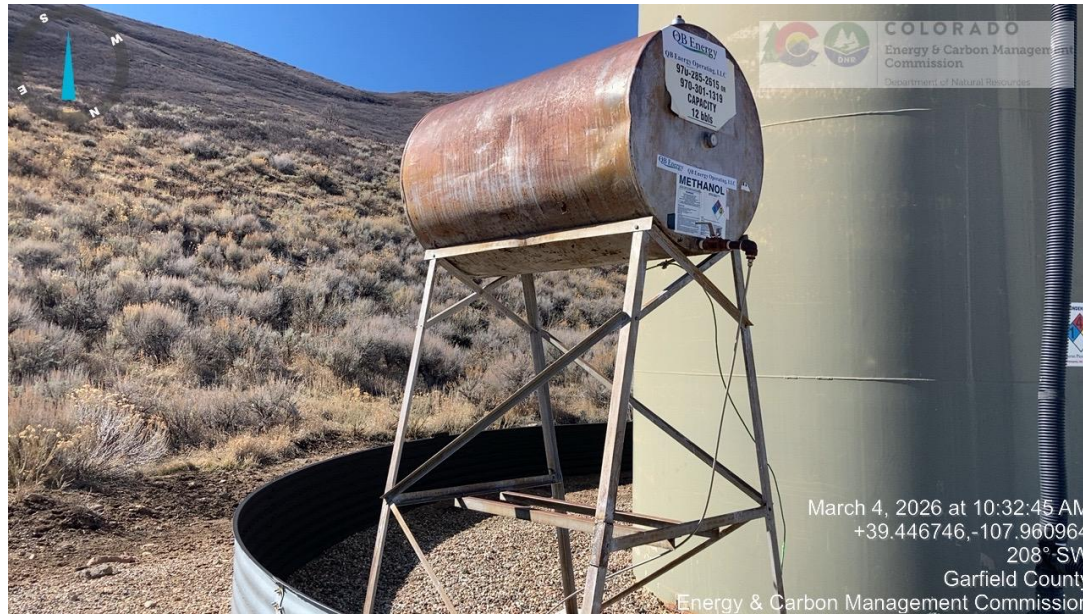
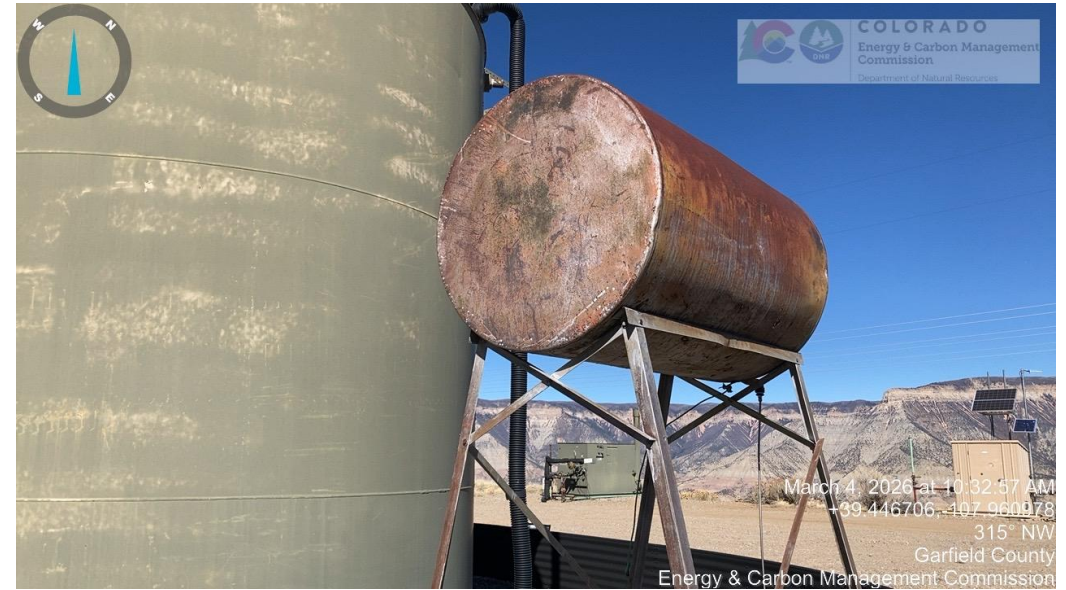
**500 gallon methanol tank paint is fading and showing signs of rust.**

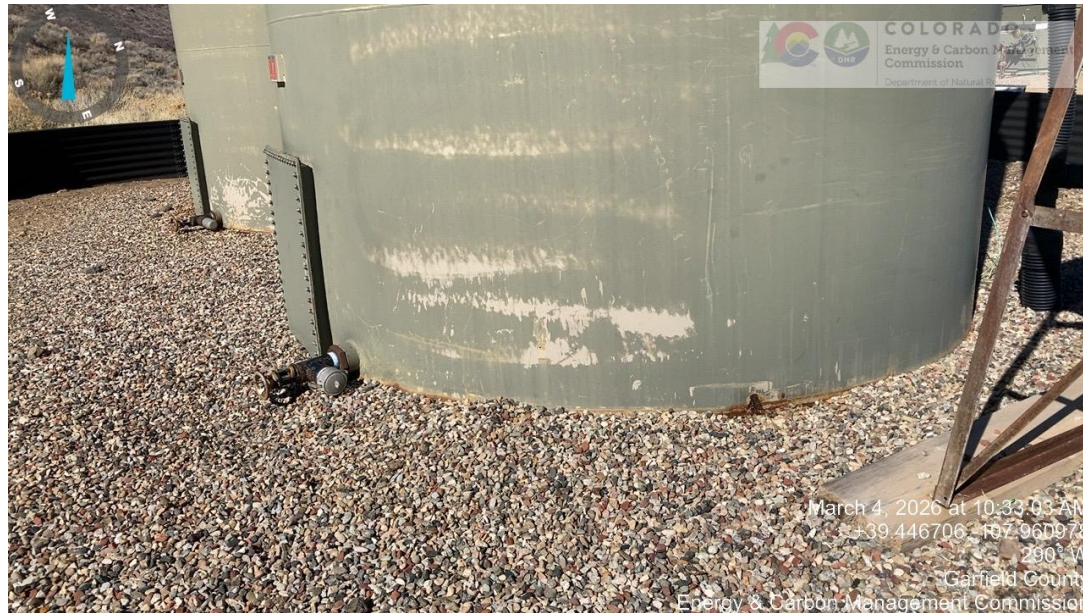
**East tank has seep occuring near the bottom of tank.**

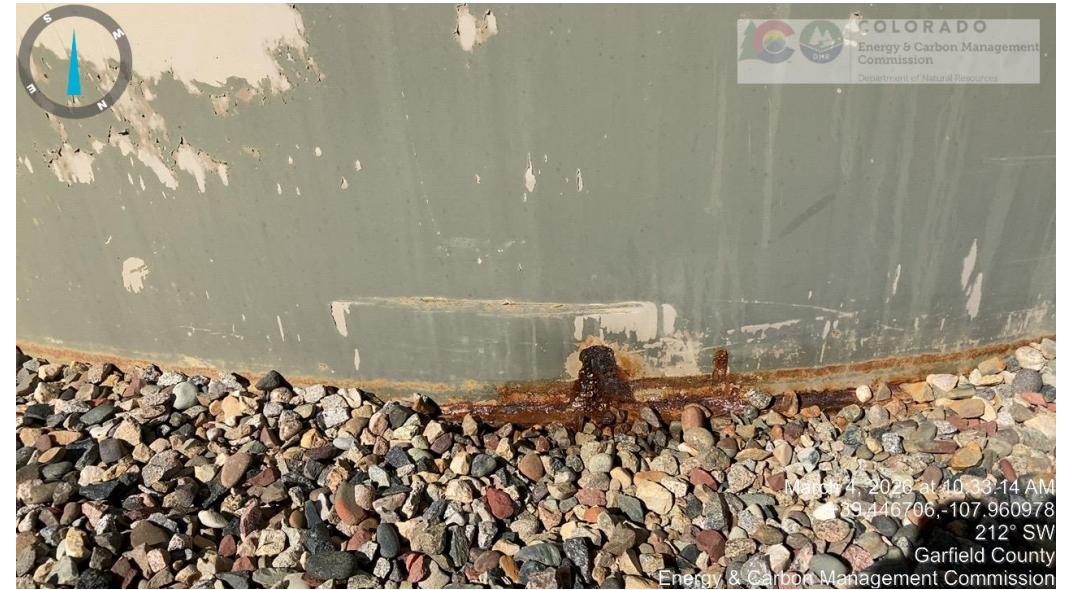
**East tank has seep occuring near the bottom of tank.**

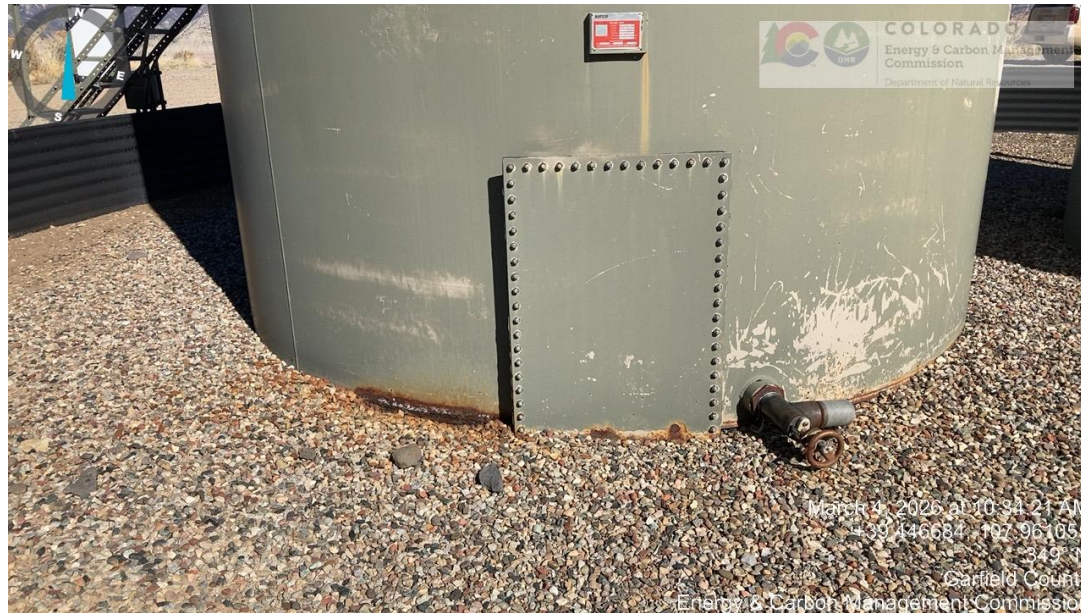
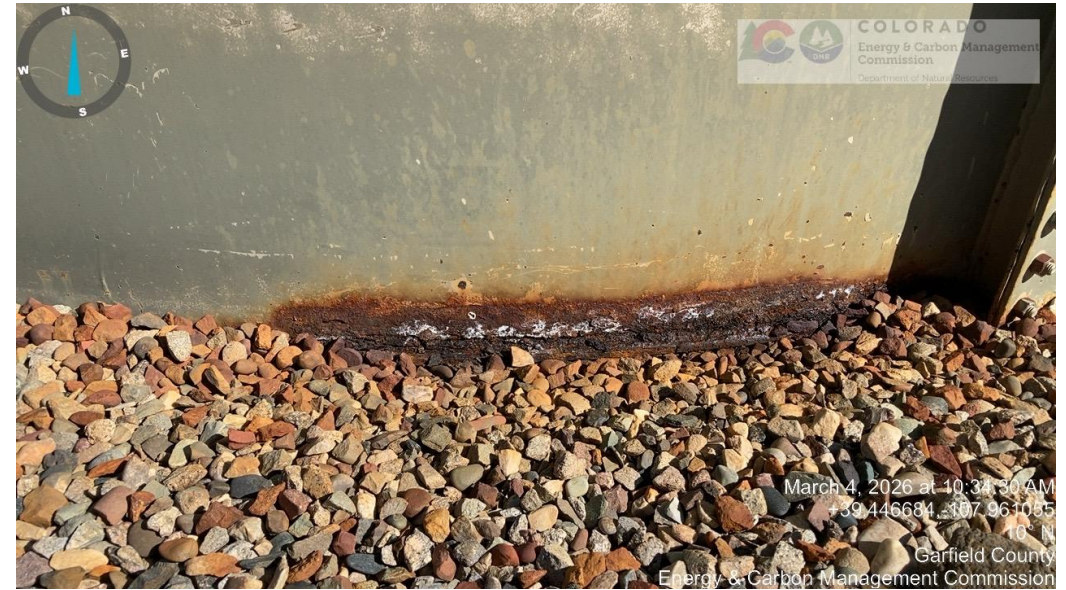
**West tank is rusted out neat the bottom of tank. West tank is shut in and is empty.**

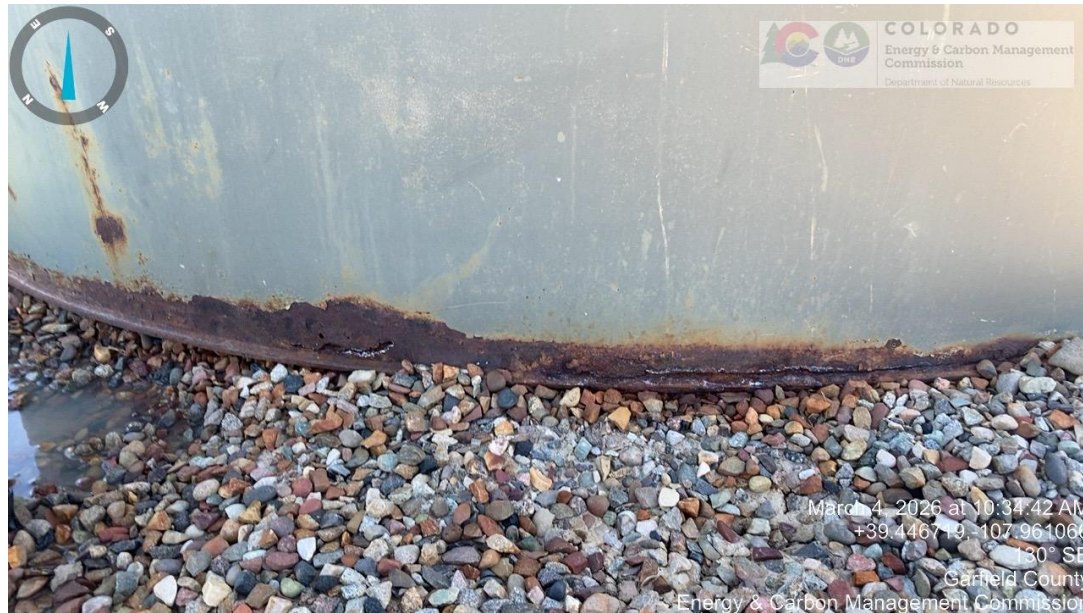
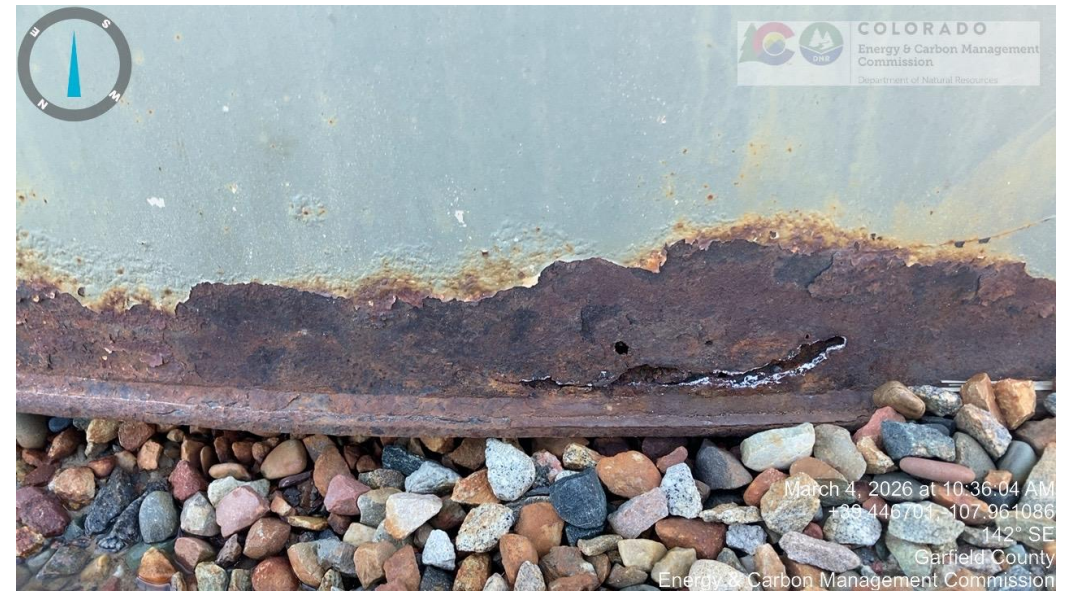
**West tank is rusted out neat the bottom of tank. West tank is shut in and is empty.**
