Inspection/Audit Photos

Location Name: QB ENERGY OPERATING LLC CHEVRON-66S96W 4SWSW (PARACHUTE CREEK 8)

Location #: 335766

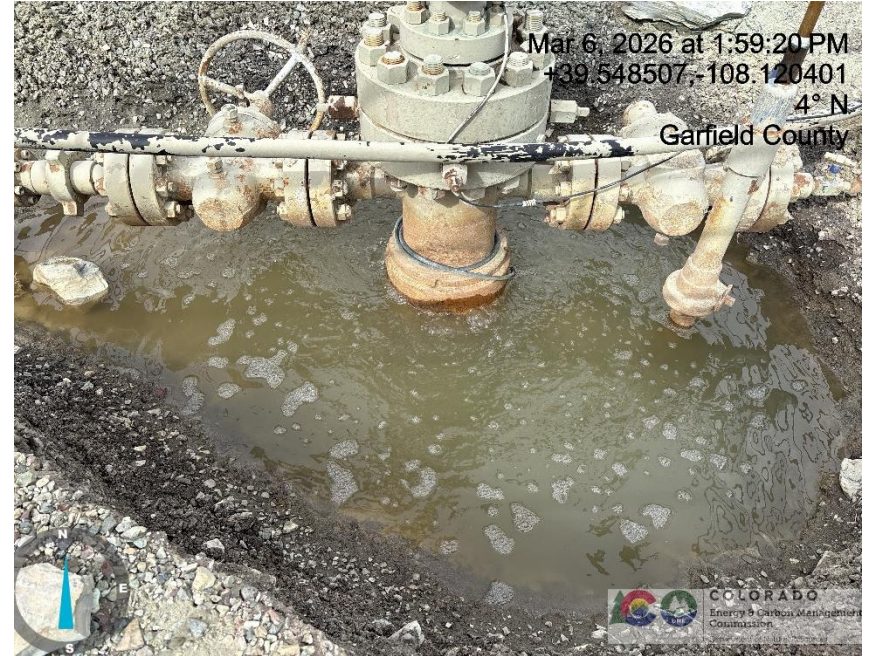
Photo # 7275 Leak/bubbling around CHEVRON 44-5D wellhead

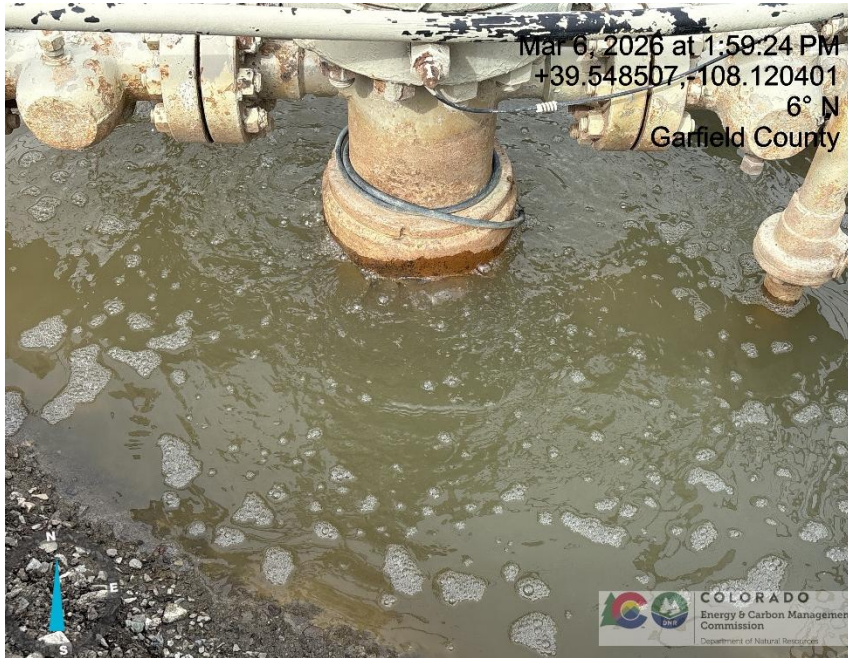
Photo # 7276 Leak/bubbling around CHEVRON 44-5D wellhead

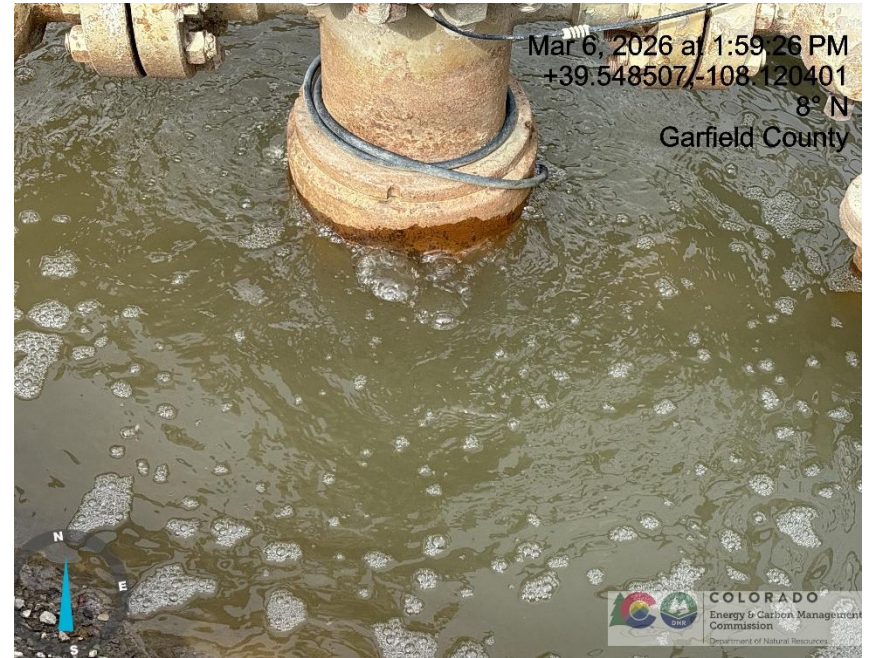
Photo # 7277 Leak/bubbling around CHEVRON 44-5D wellhead

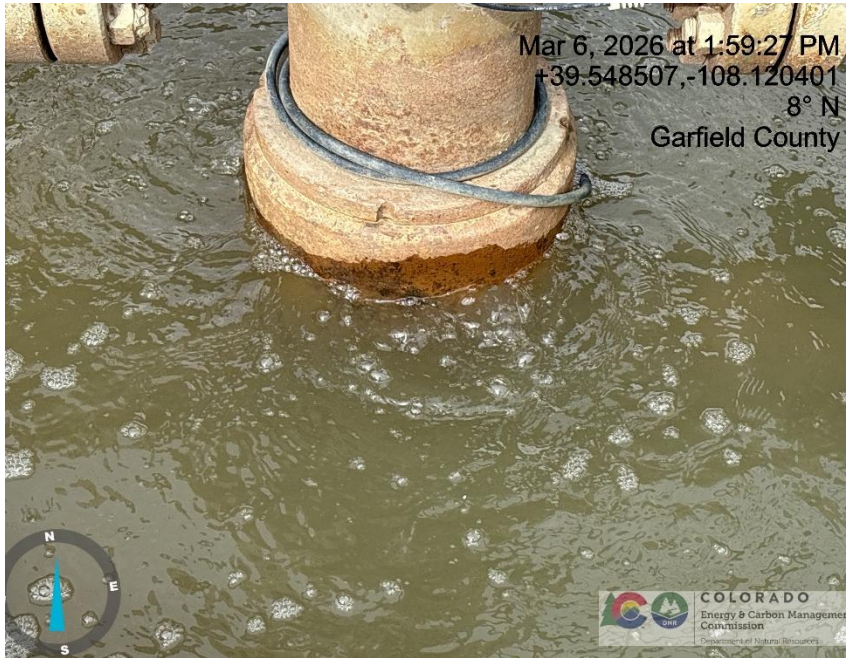
Photo # 7278 Leak/bubbling around CHEVRON 44-5D wellhead

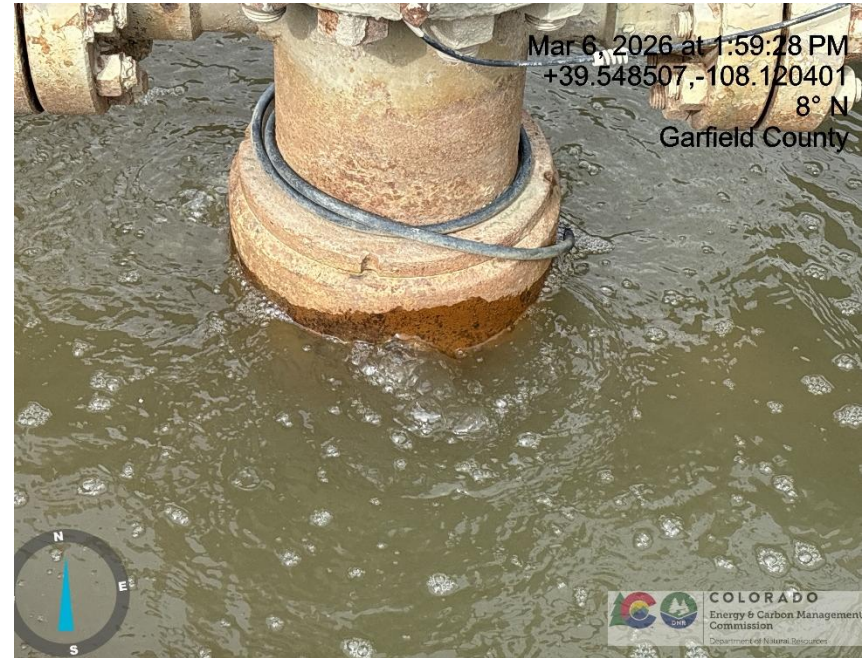
Photo # 7279 Leak/bubbling around CHEVRON 44-5D wellhead

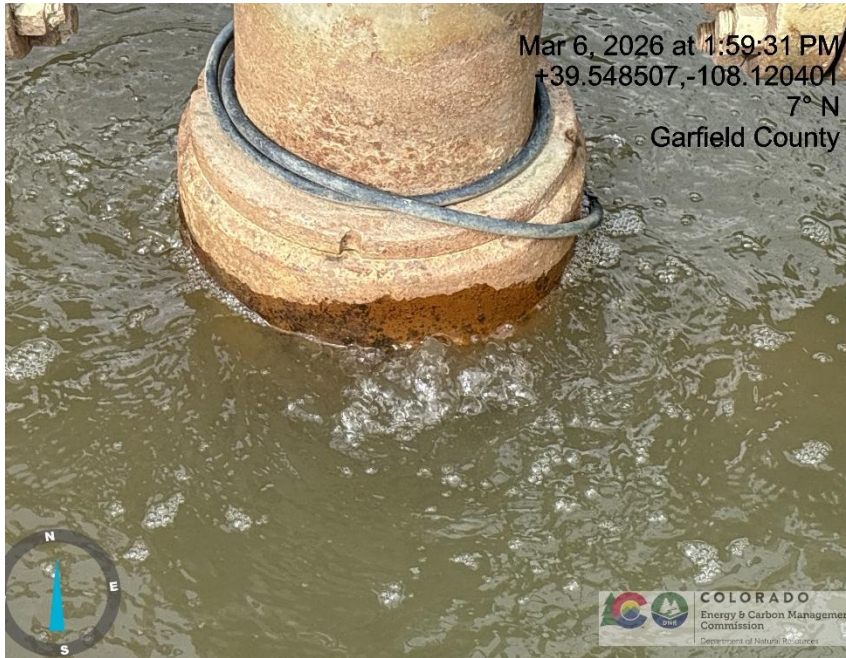
Photo # 7280 Leak/bubbling around CHEVRON 44-5D wellhead

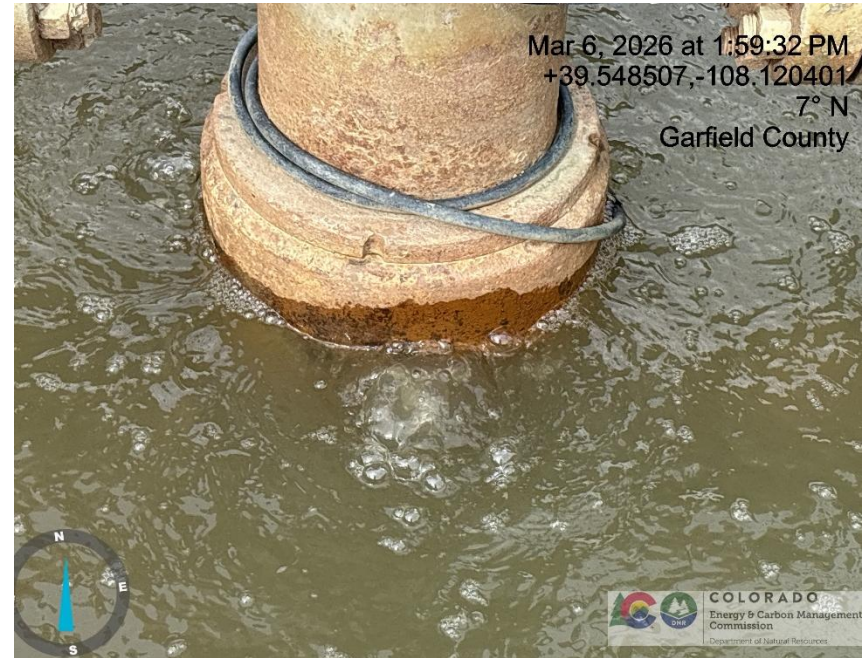
Photo # 7281 Leak/bubbling around CHEVRON 44-5D wellhead

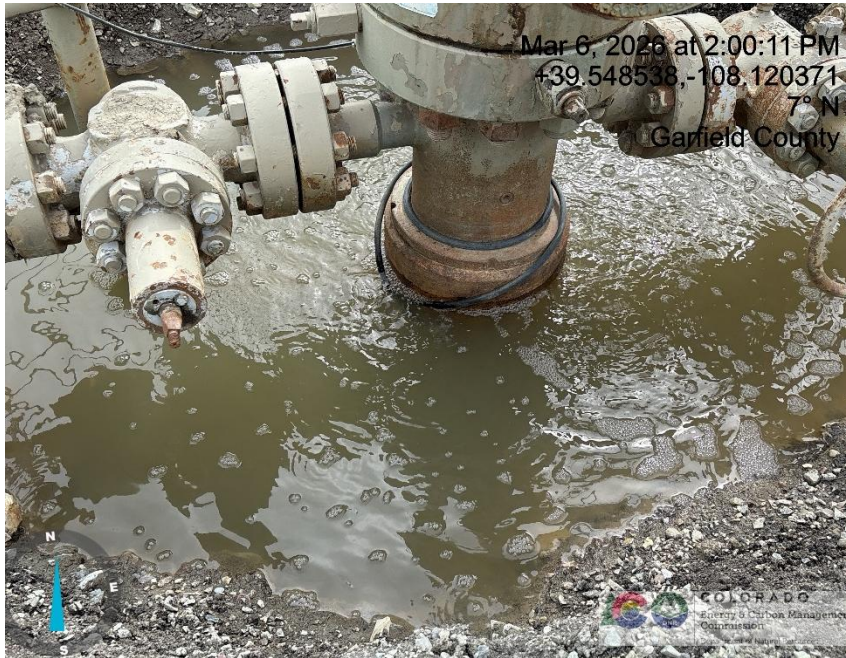
Photo # 7282 Leak/bubbling around CHEVRON 44-5D wellhead

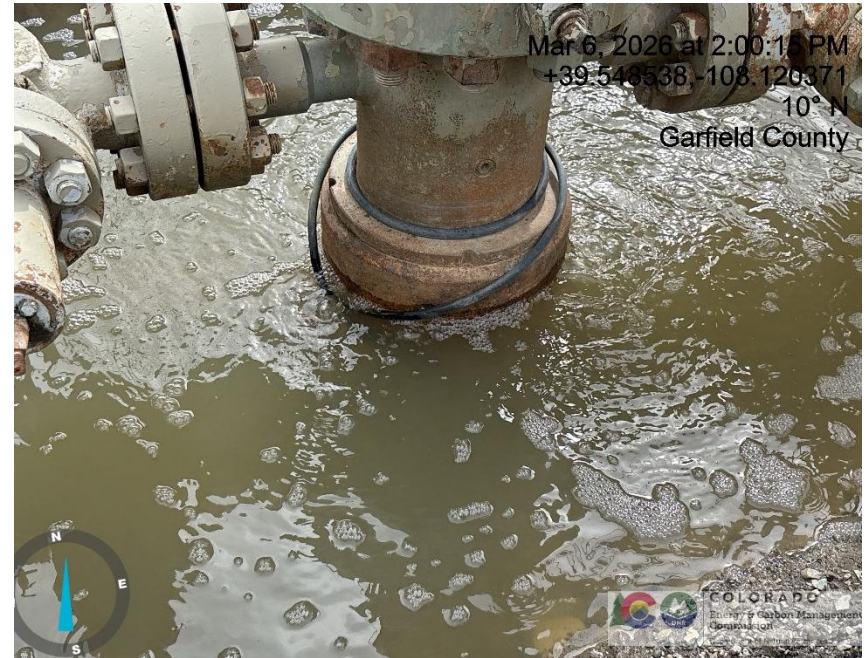
Photo # 7283 Leak/bubbling around CHEVRON 44-5D wellhead

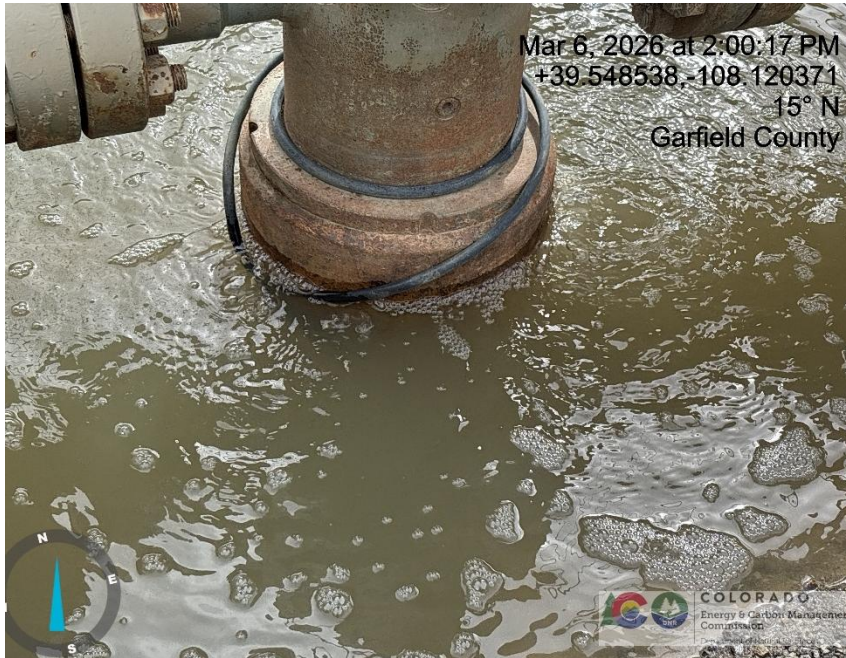
Photo # 7284 Leak/bubbling around CHEVRON 44-5D wellhead

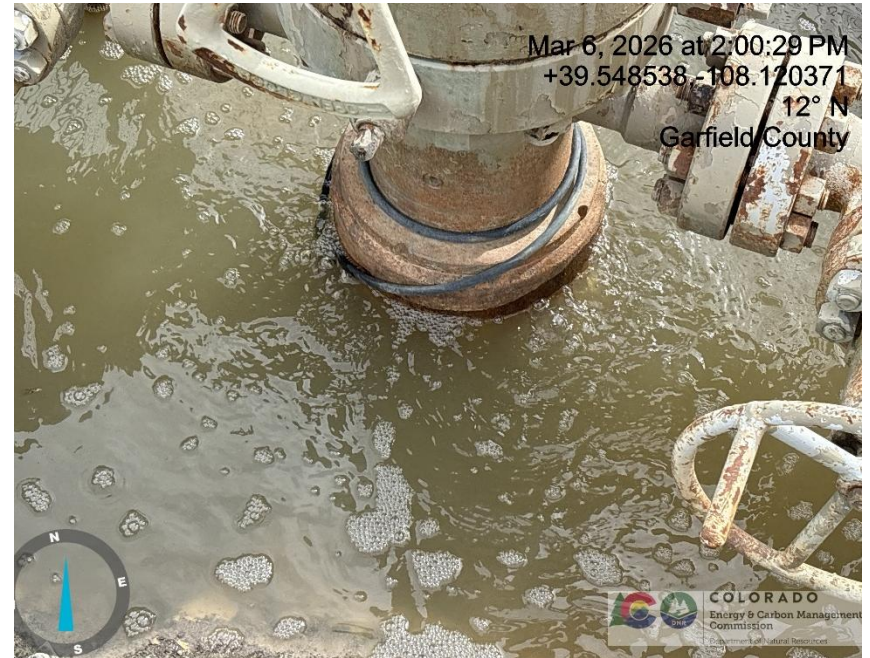
Photo # 7285 Leak/bubbling around CHEVRON 44-5D wellhead

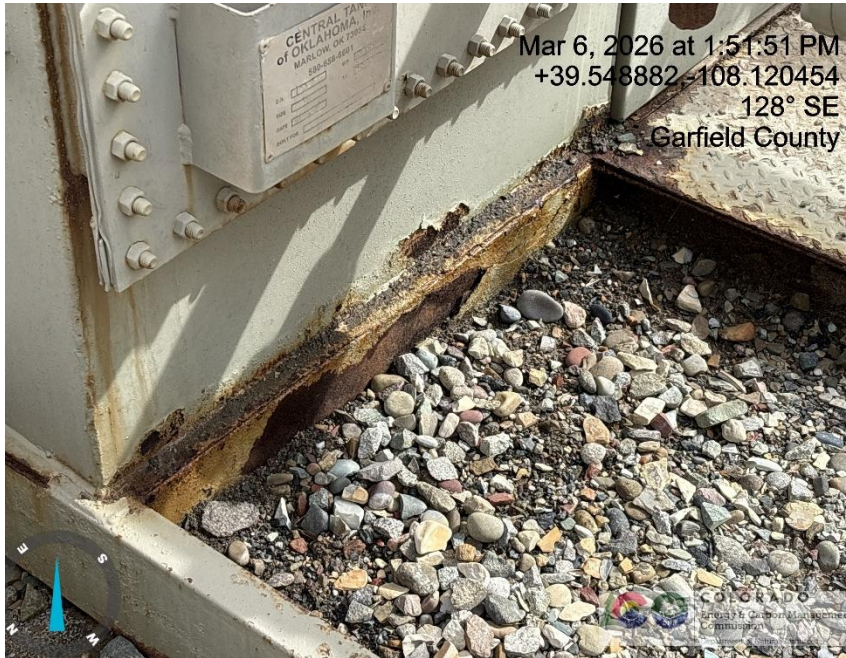
Photo # 7286 External corrosion visible on separator & staining near separator

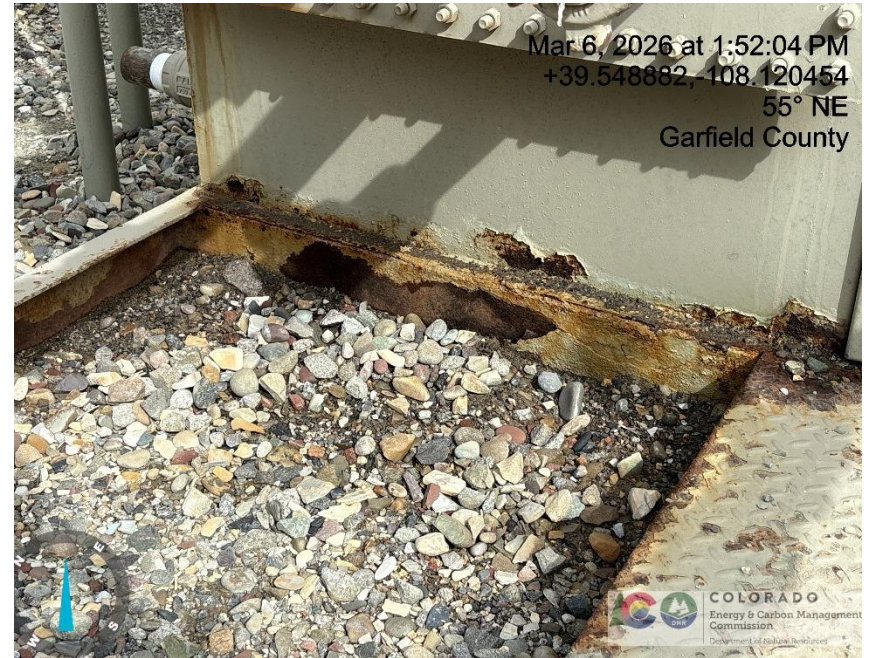
Photo # 7287 External corrosion visible on separator & staining near separator

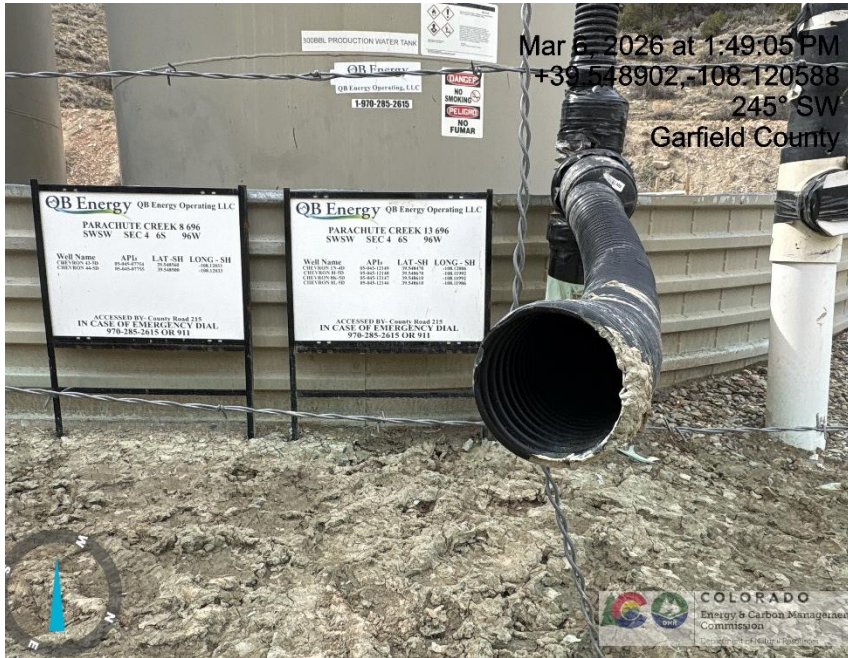
Photo # 7288 Flowline heating insulation open ended
/wildlife hazard/available for entry by wildlife
