Spill ID 493326

**ECMC  
Environmental  
Field Inspection**

Facility S4WB Sales  
© 03-Mar-26 09:17:08  
ECMC Environmental Inspection

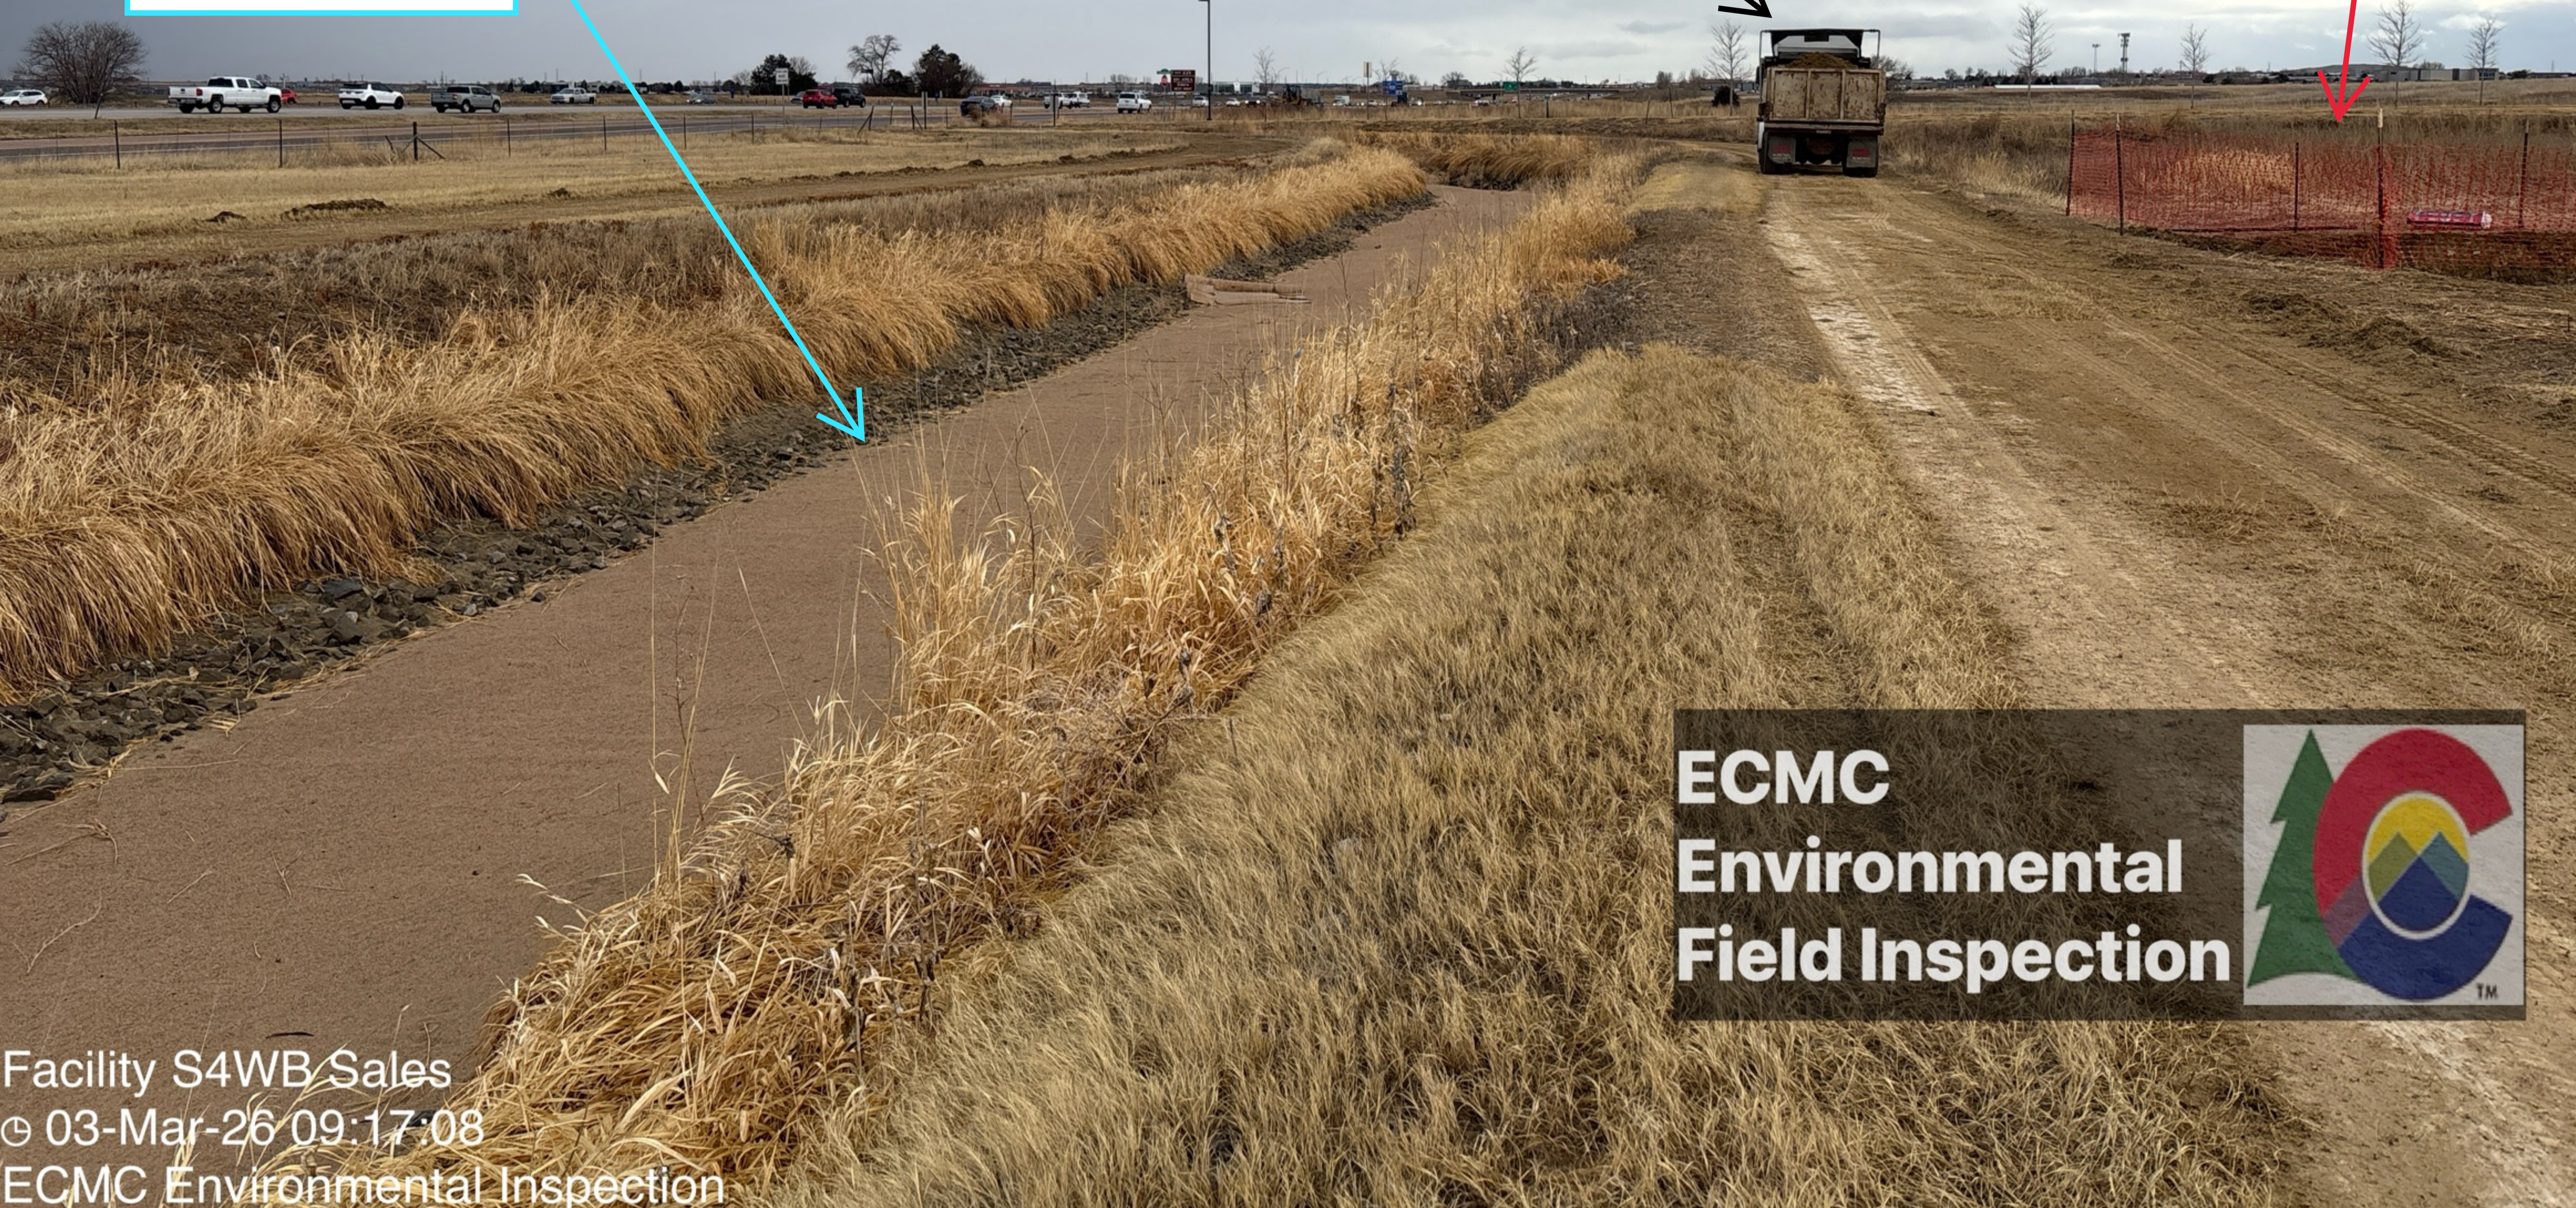
Operator owned  
truck with soil

Sullivan Ditch and  
Riverine Wetlands

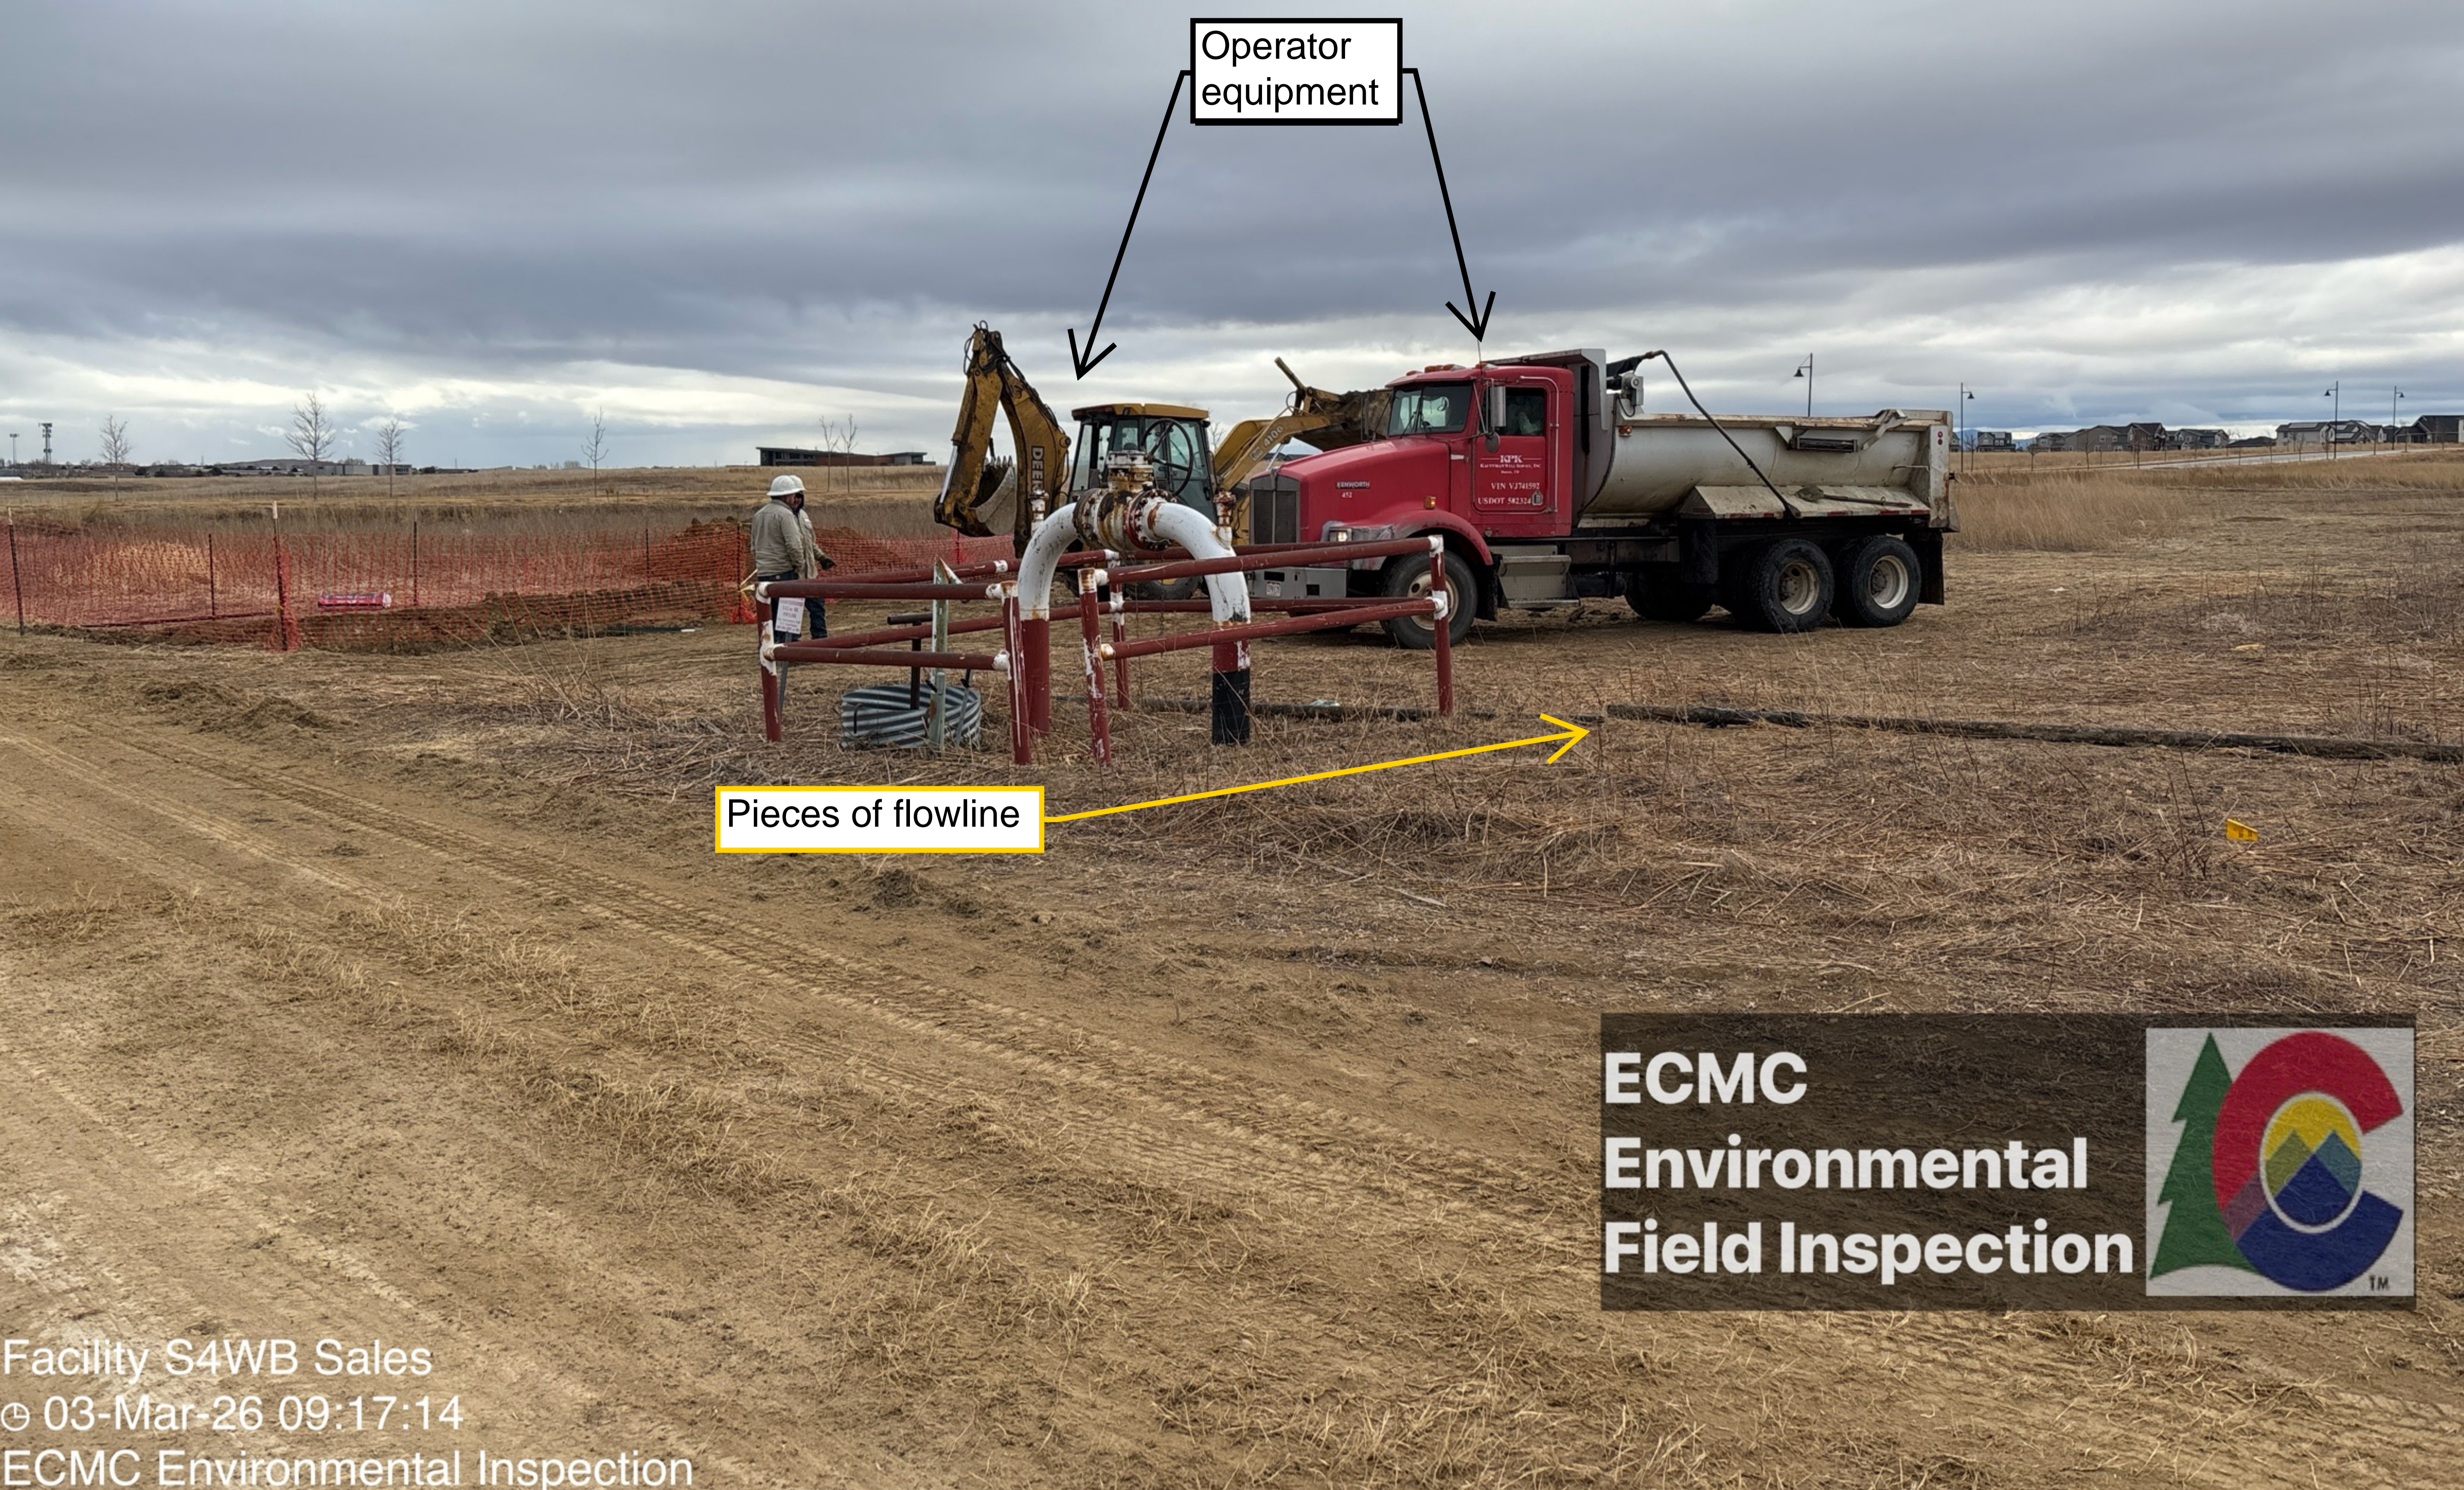
Operator  
equipment

Pieces of flowline

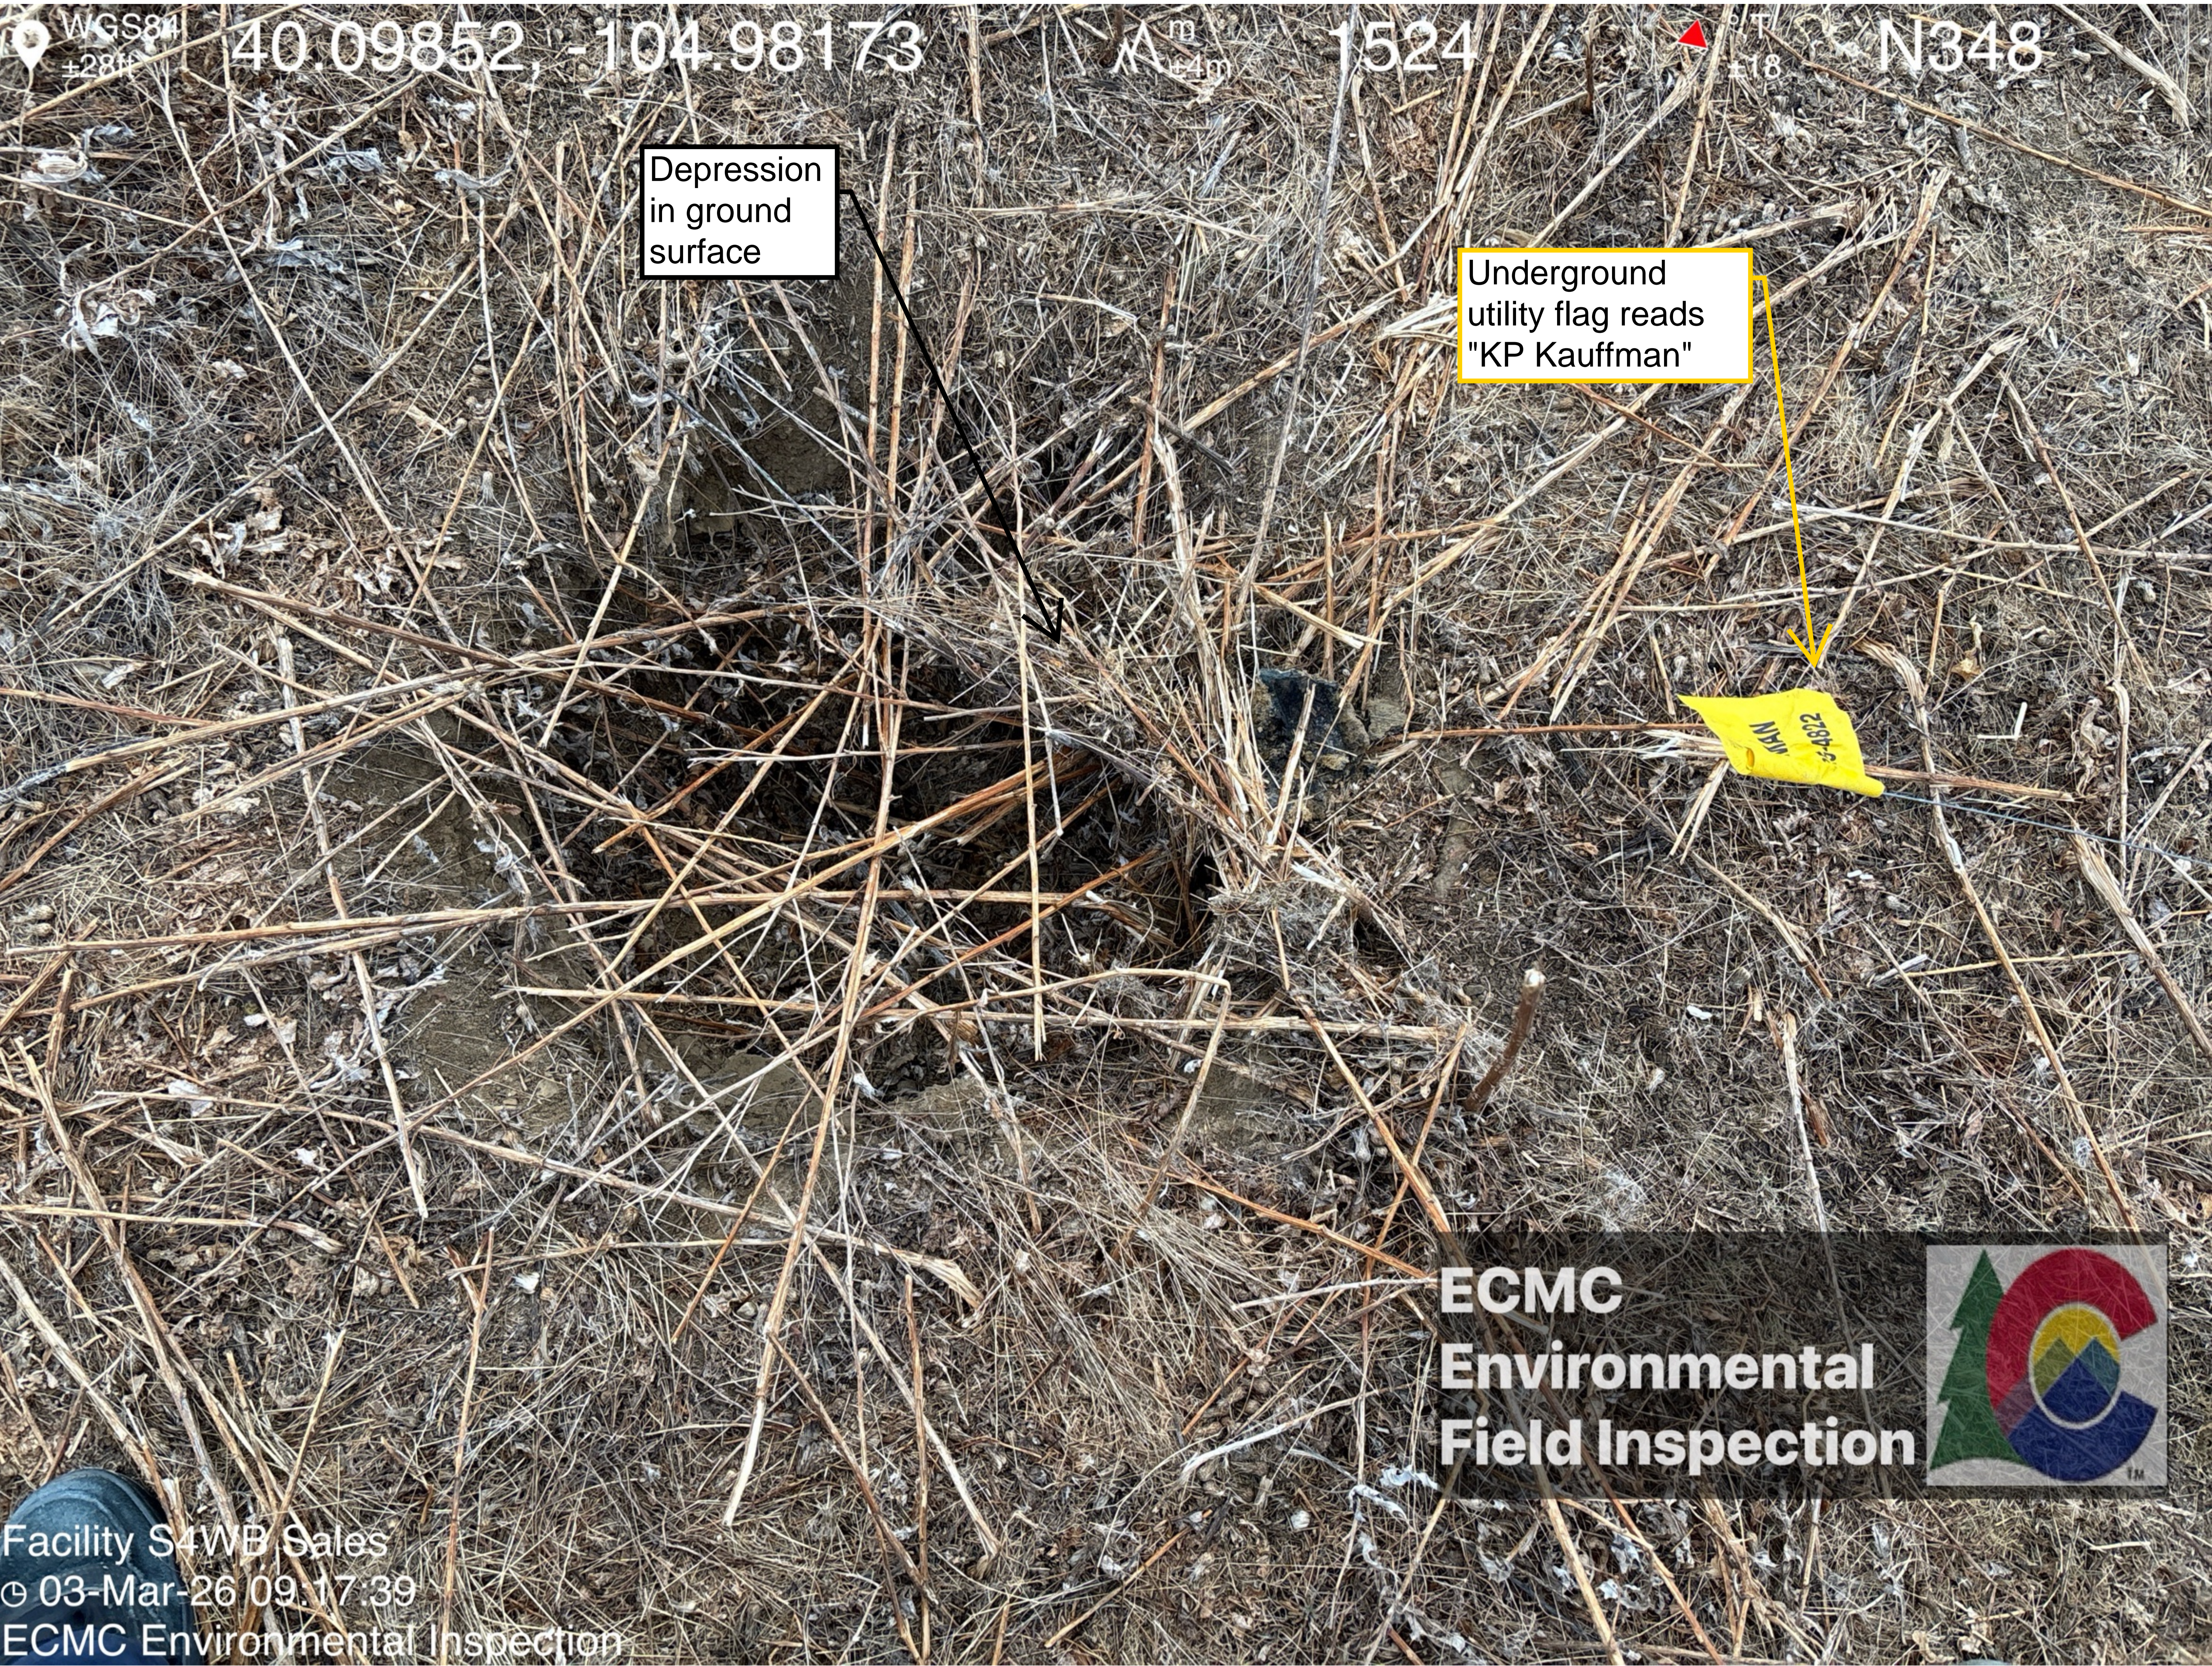
Depression  
in ground  
surface

Underground  
utility flag reads  
"KP Kauffman"

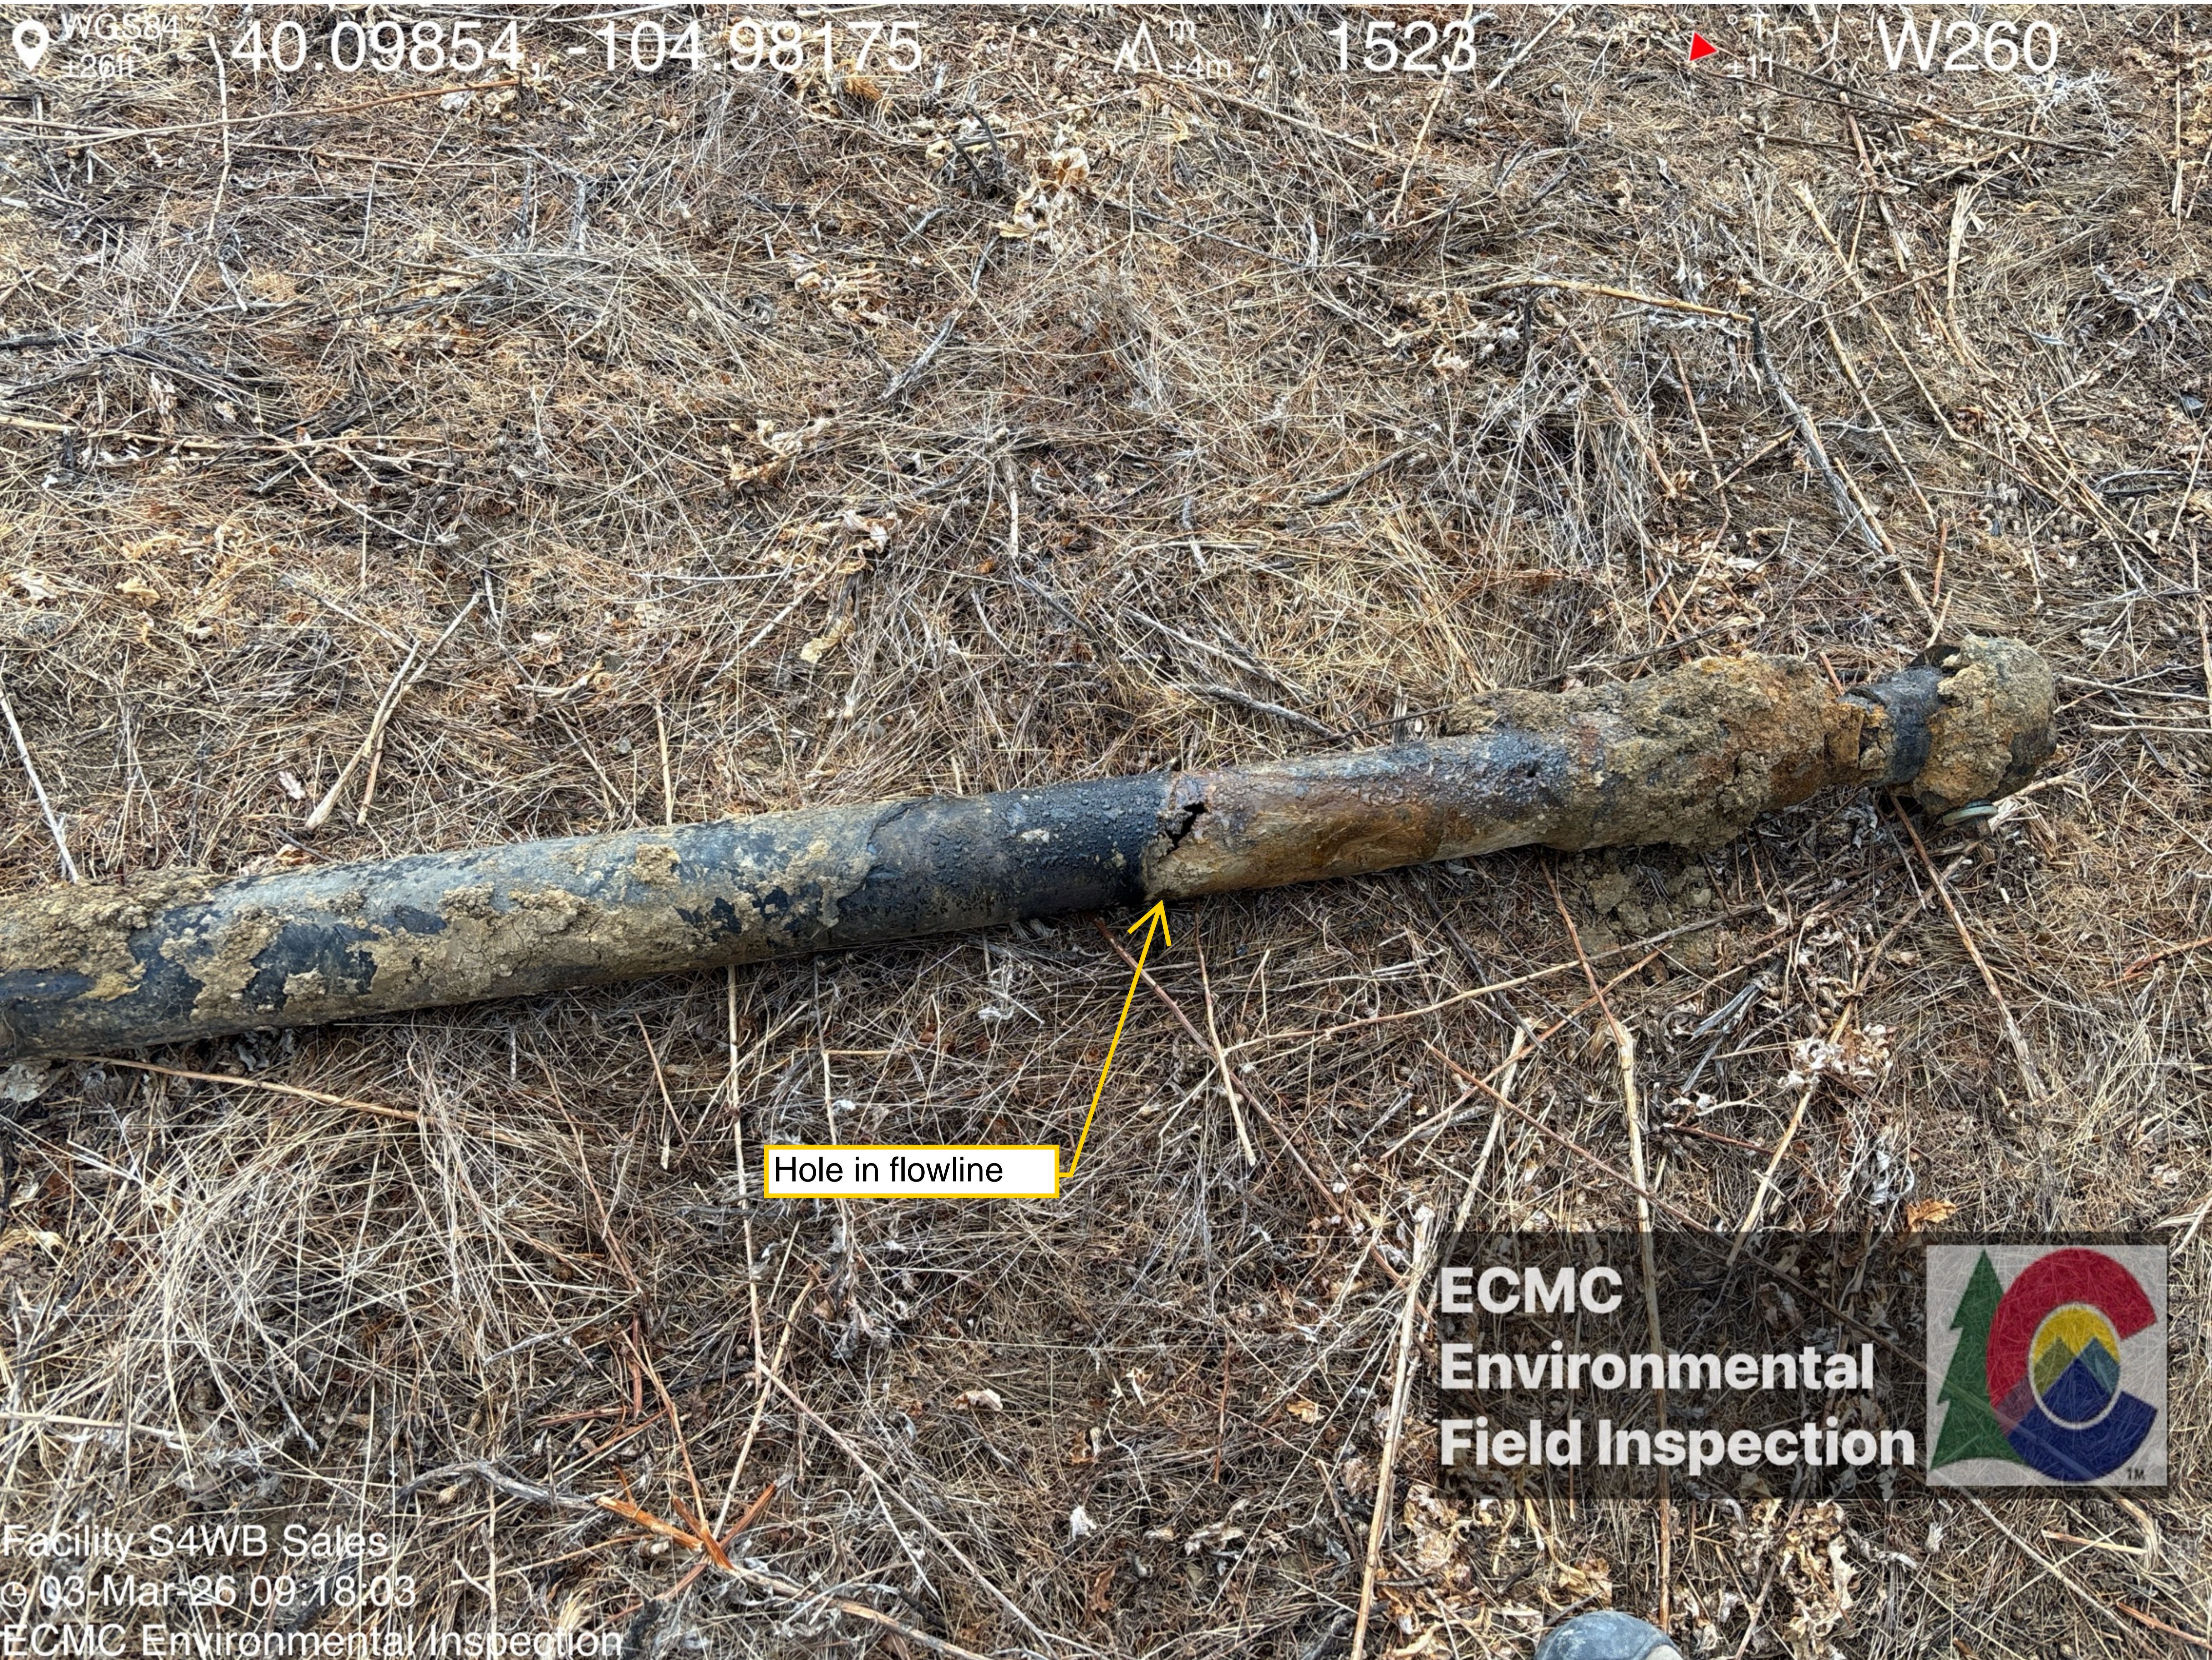
Hole in flowline

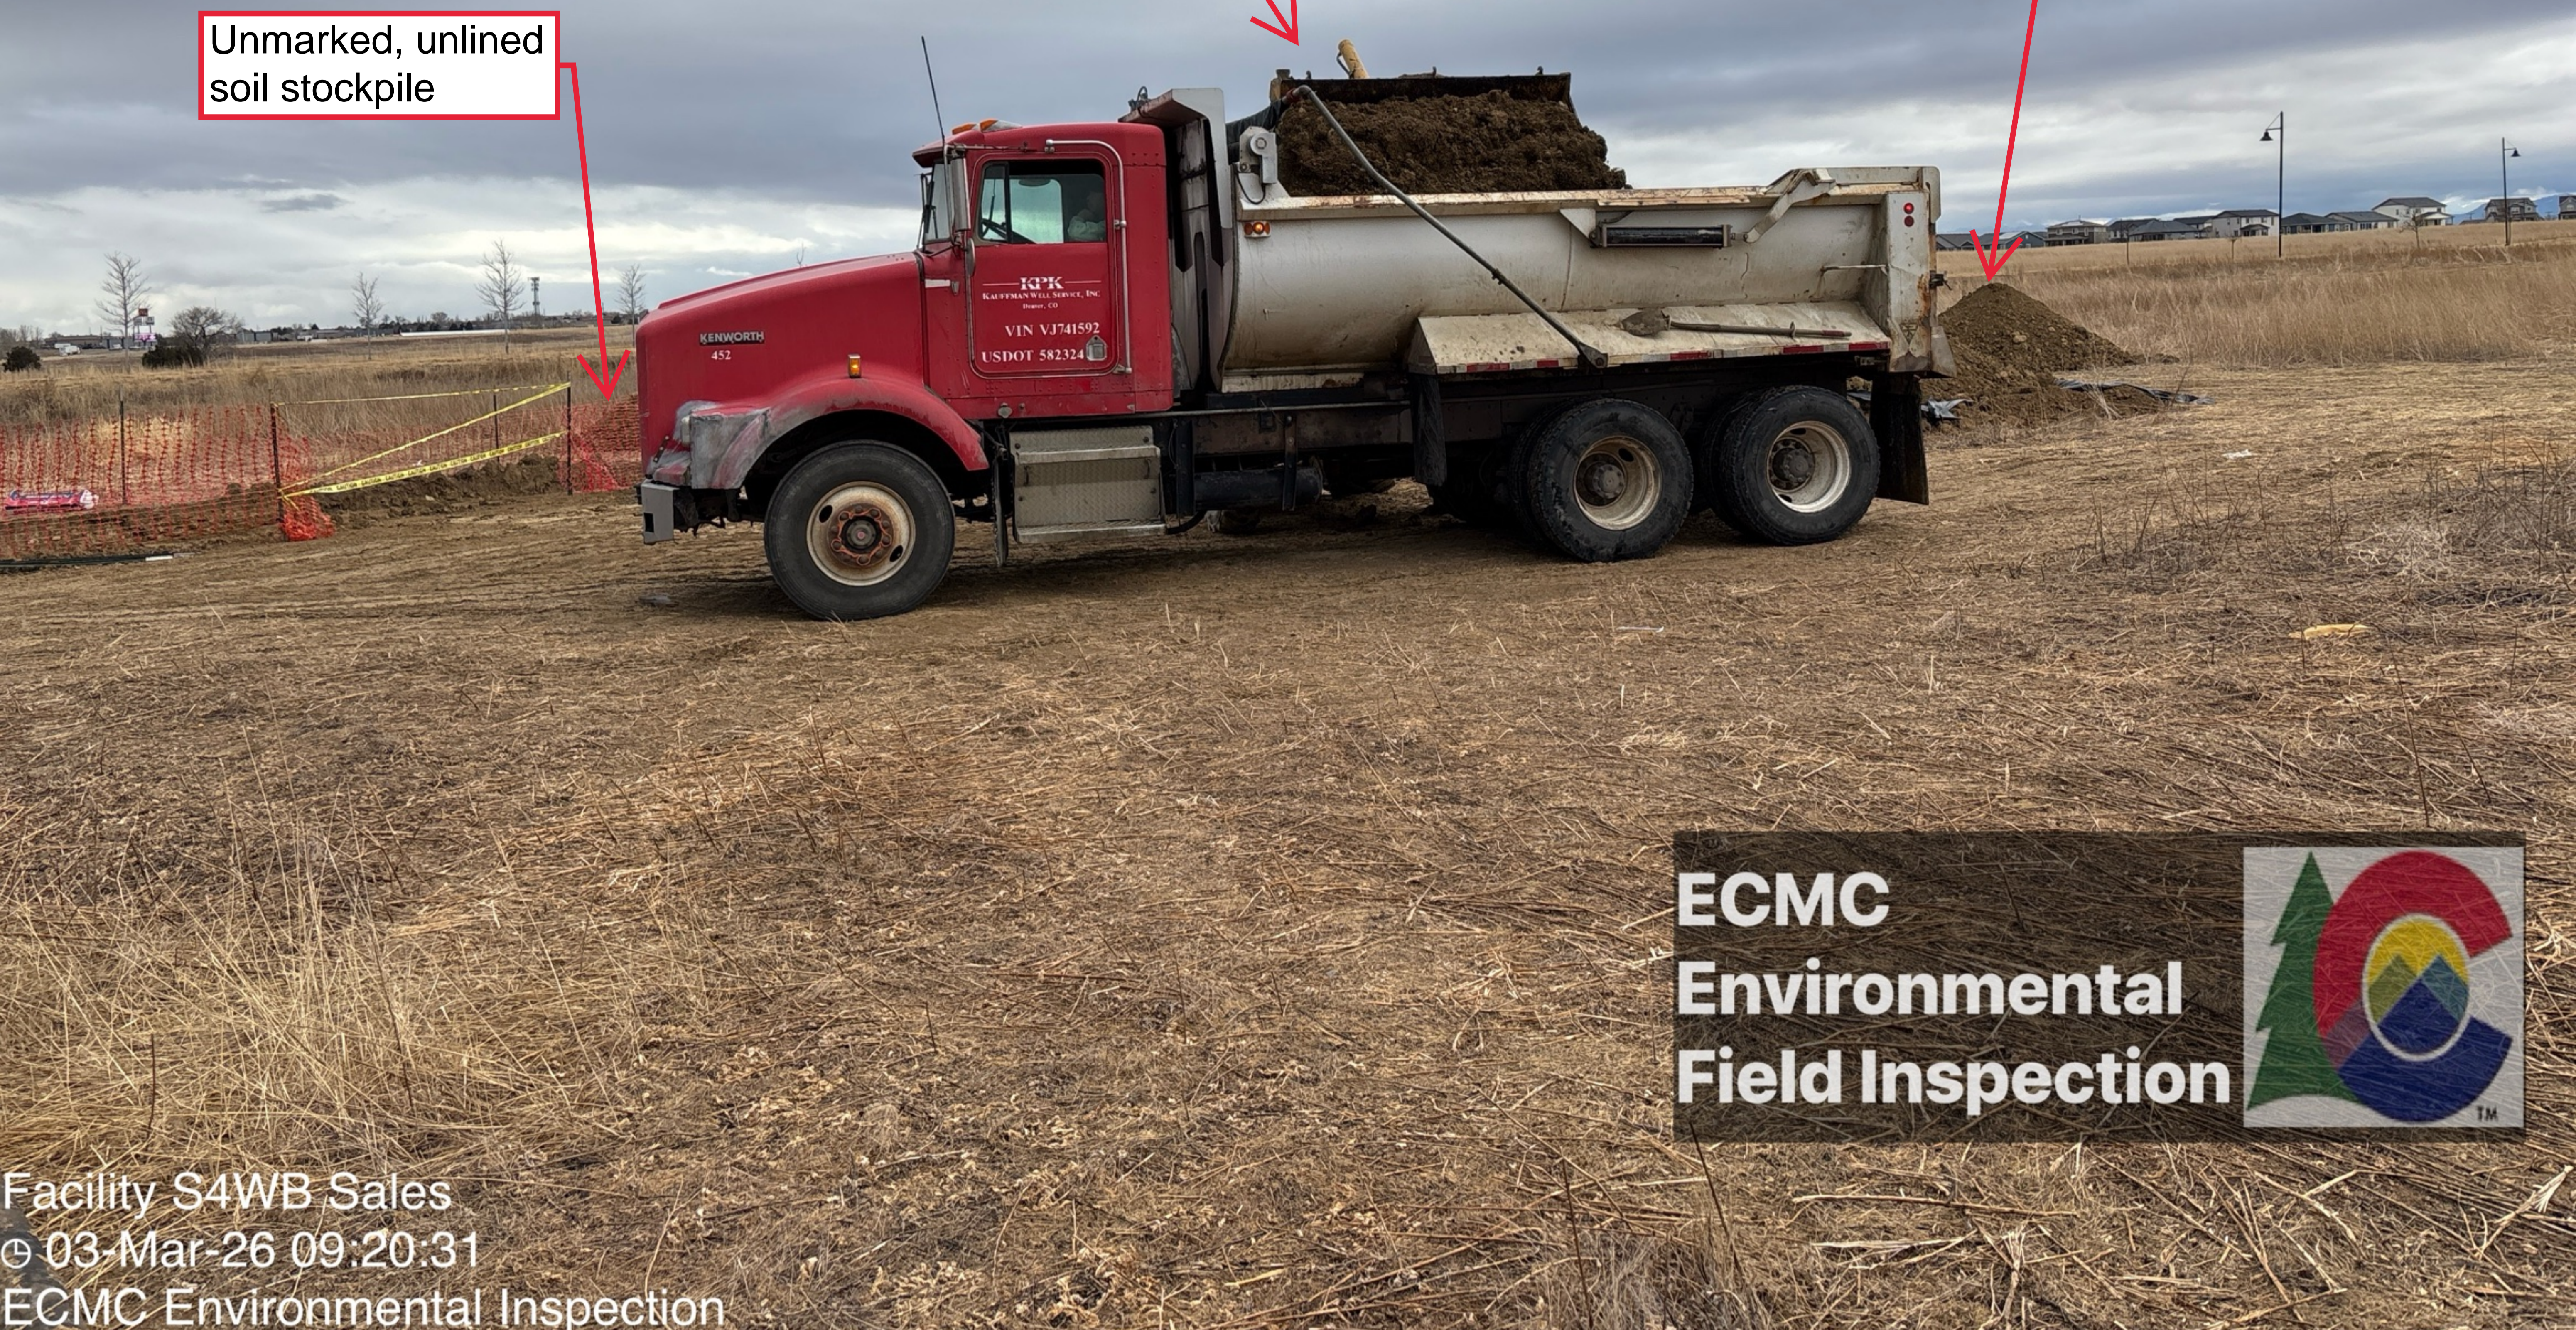
Backhoe loading  
soil into truck

Unmarked, unlined  
soil stockpile

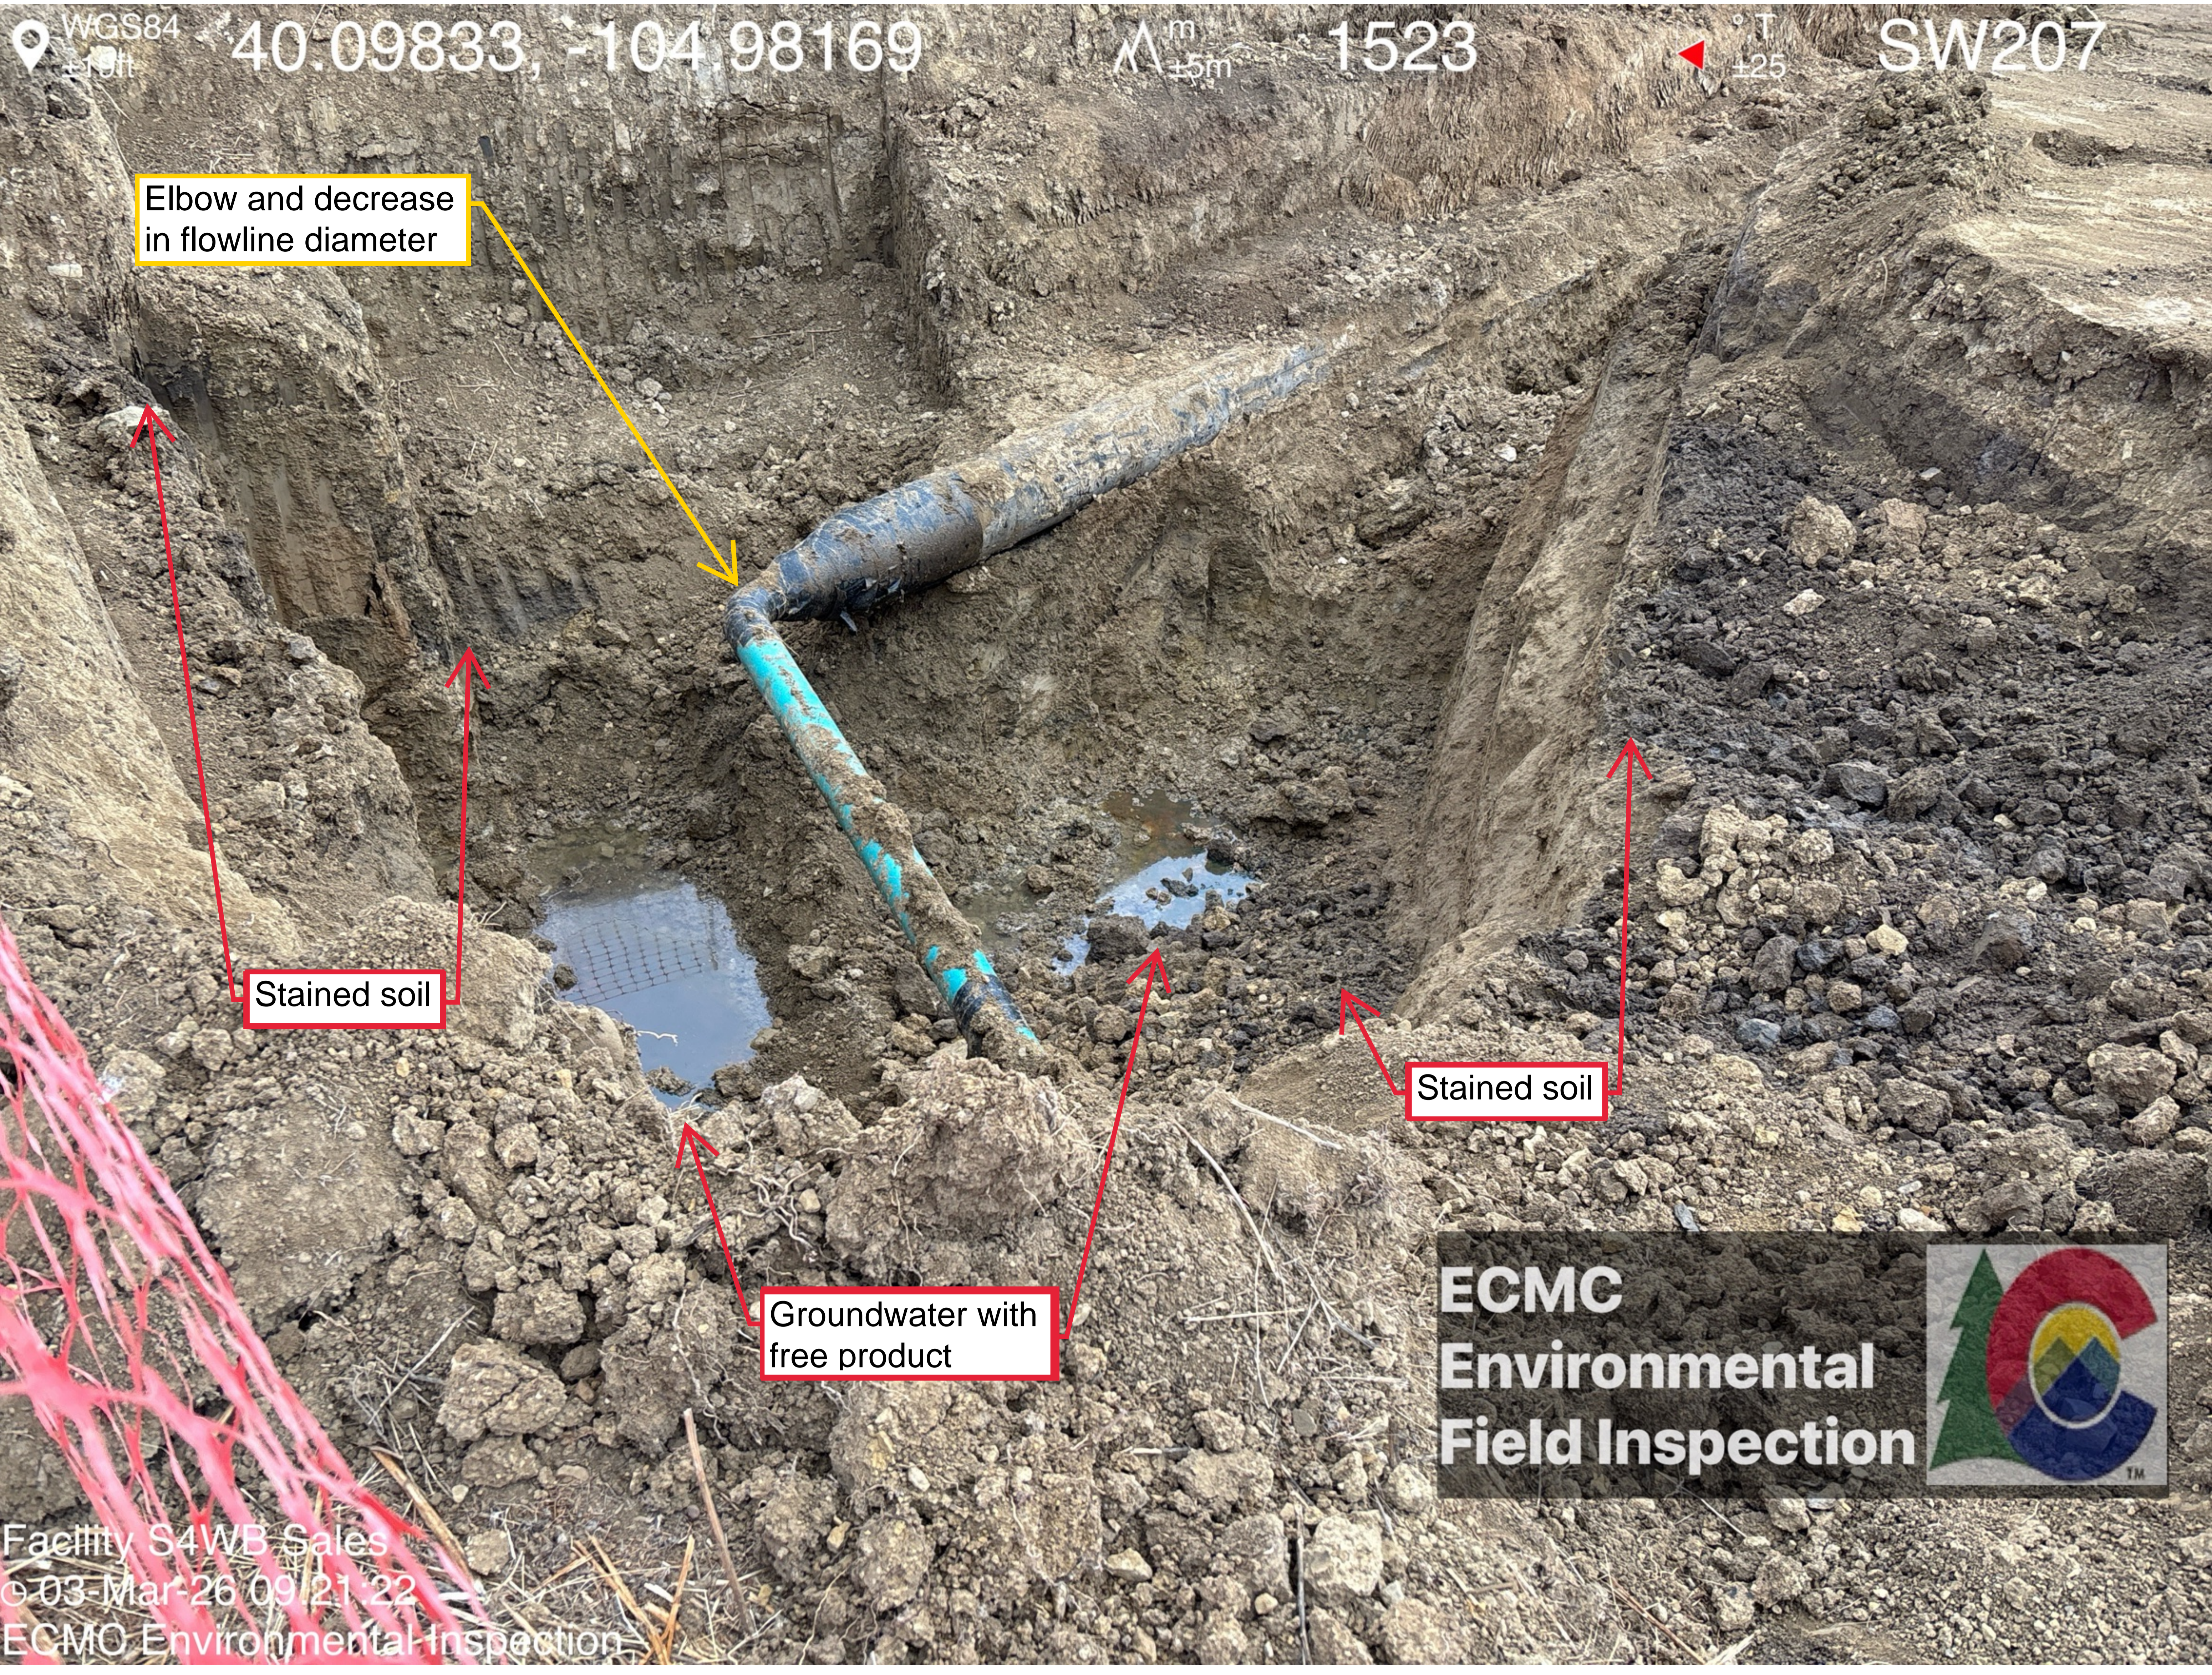
Elbow and decrease  
in flowline diameter

Stained soil

Groundwater with  
free product
