Spill ID 493326

**ECMC  
Environmental  
Field Inspection**

Facility S4WB Sales  
© 03-Mar-26 09:17:08  
ECMC Environmental Inspection

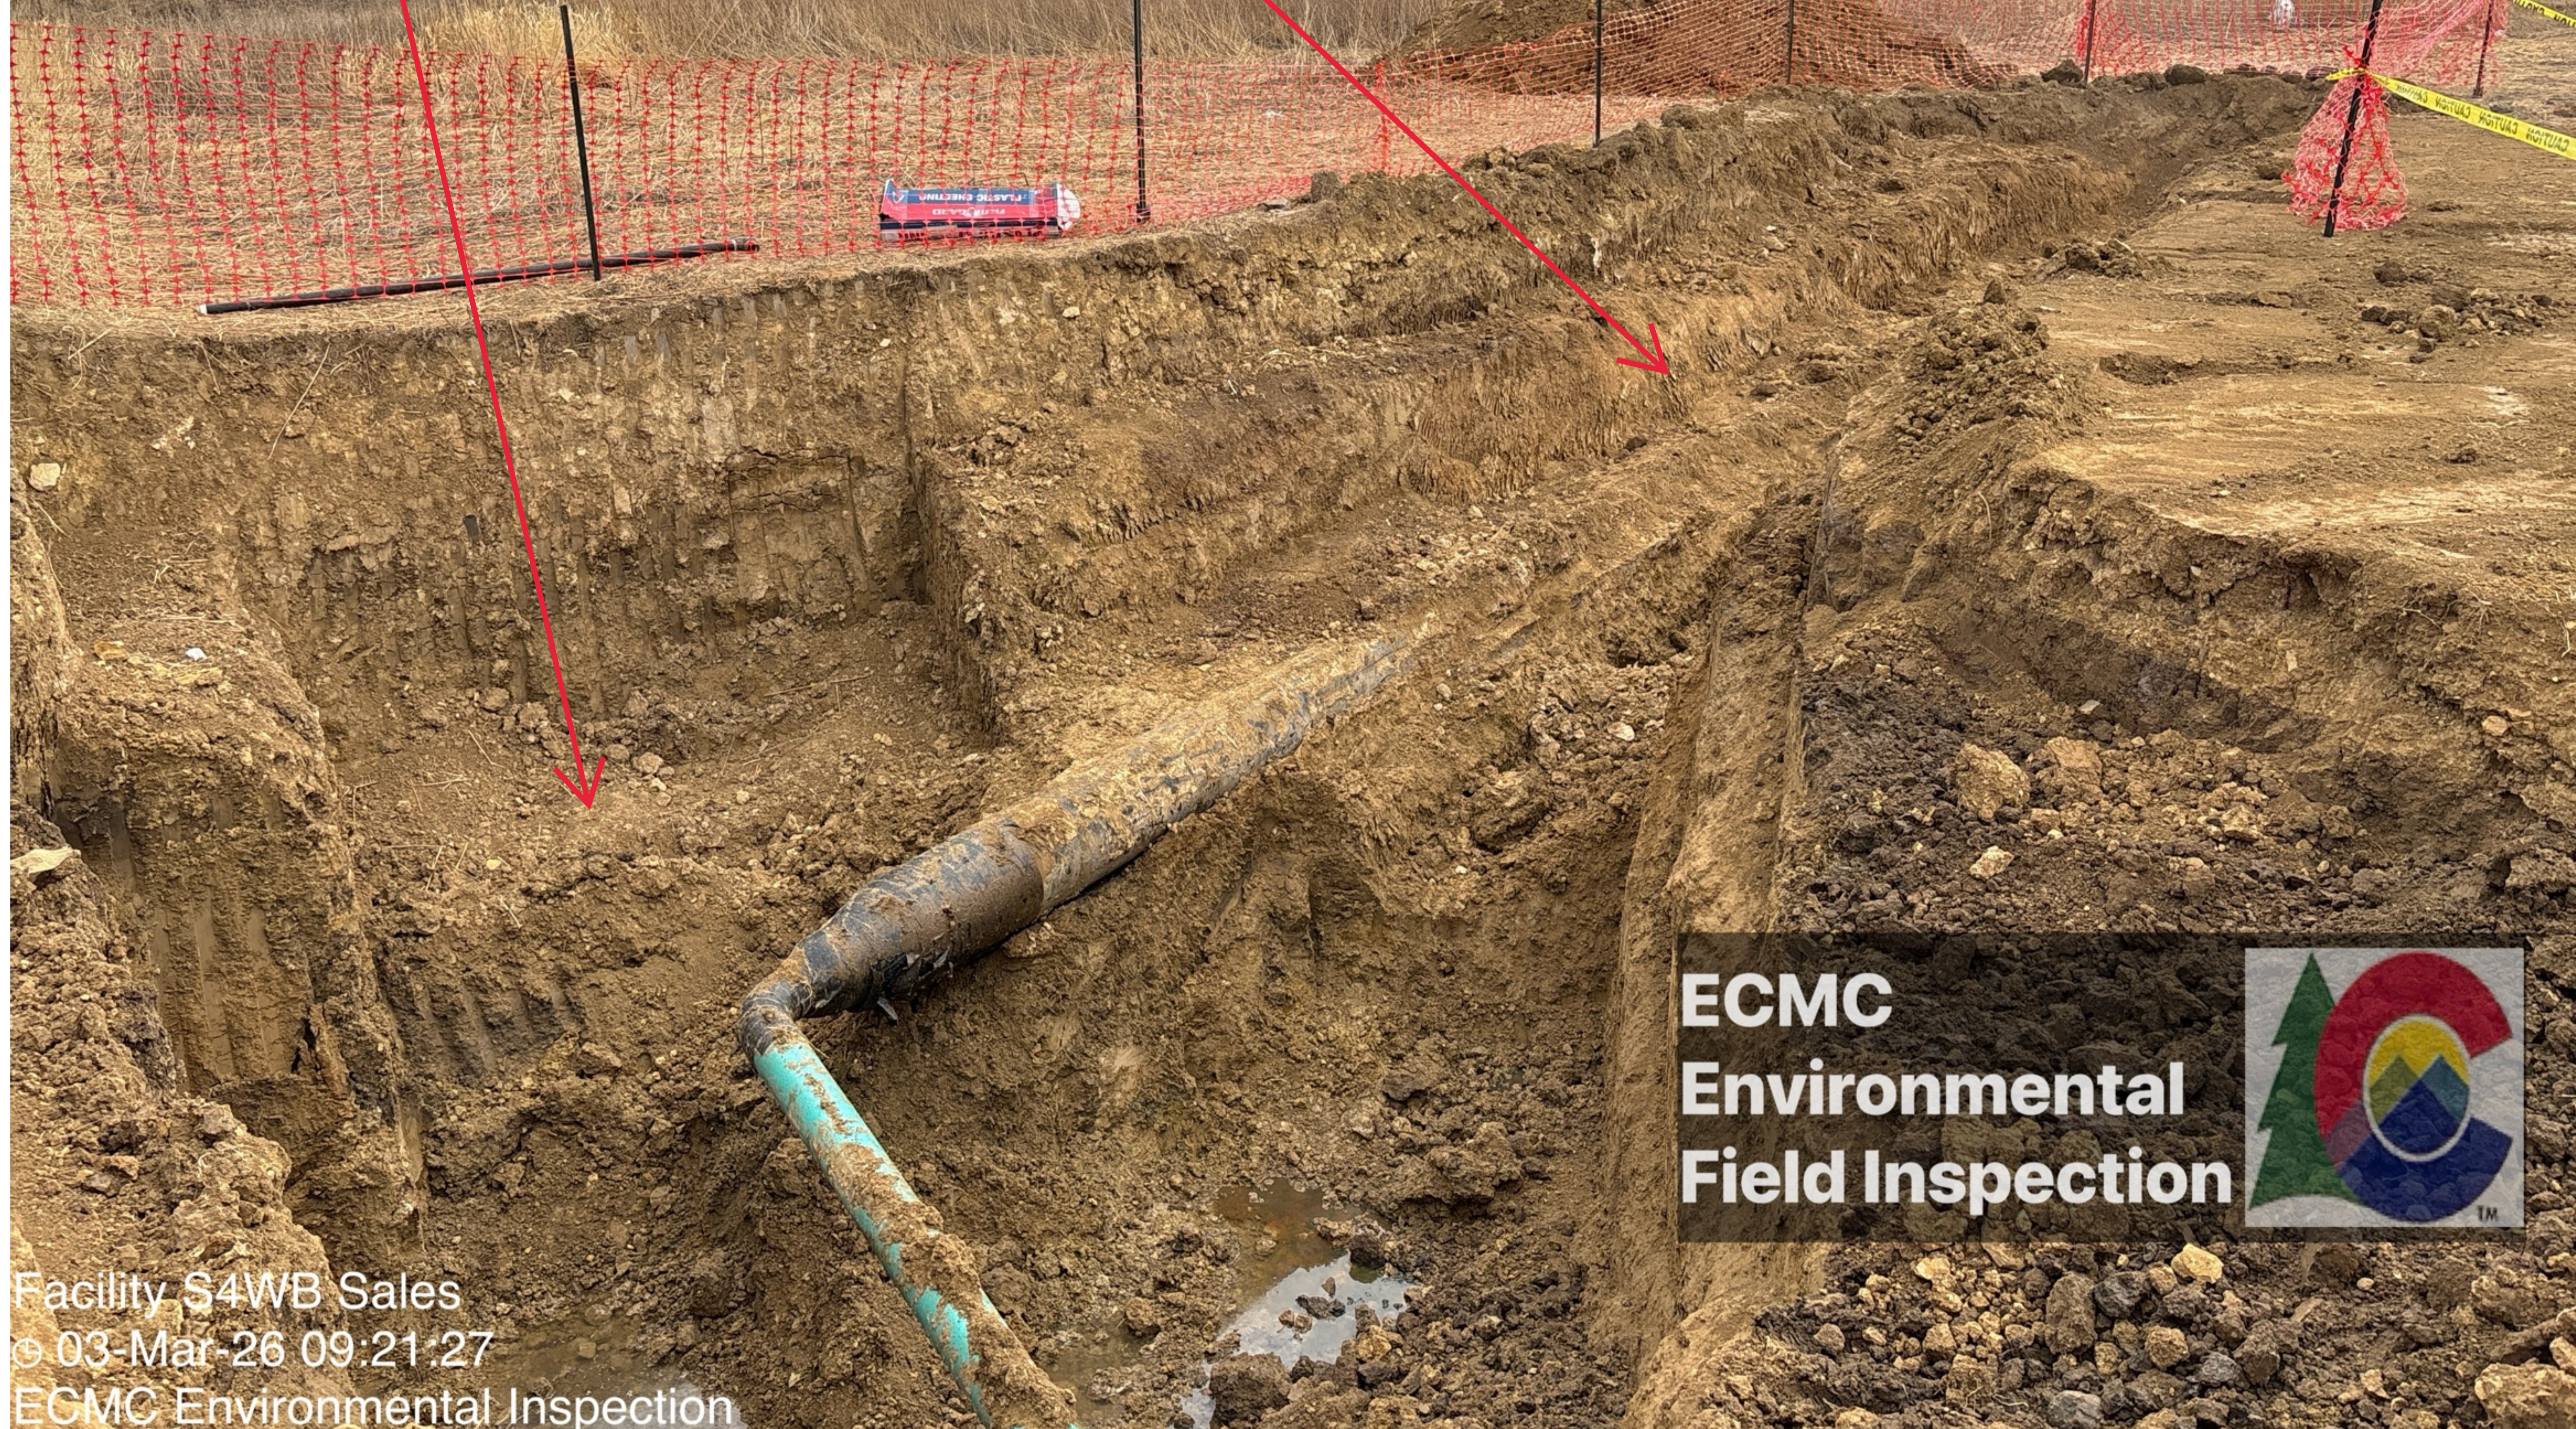
Unmarked, unlined  
soil stockpile

Excavation along  
flowline path

Point of spill  
discovery

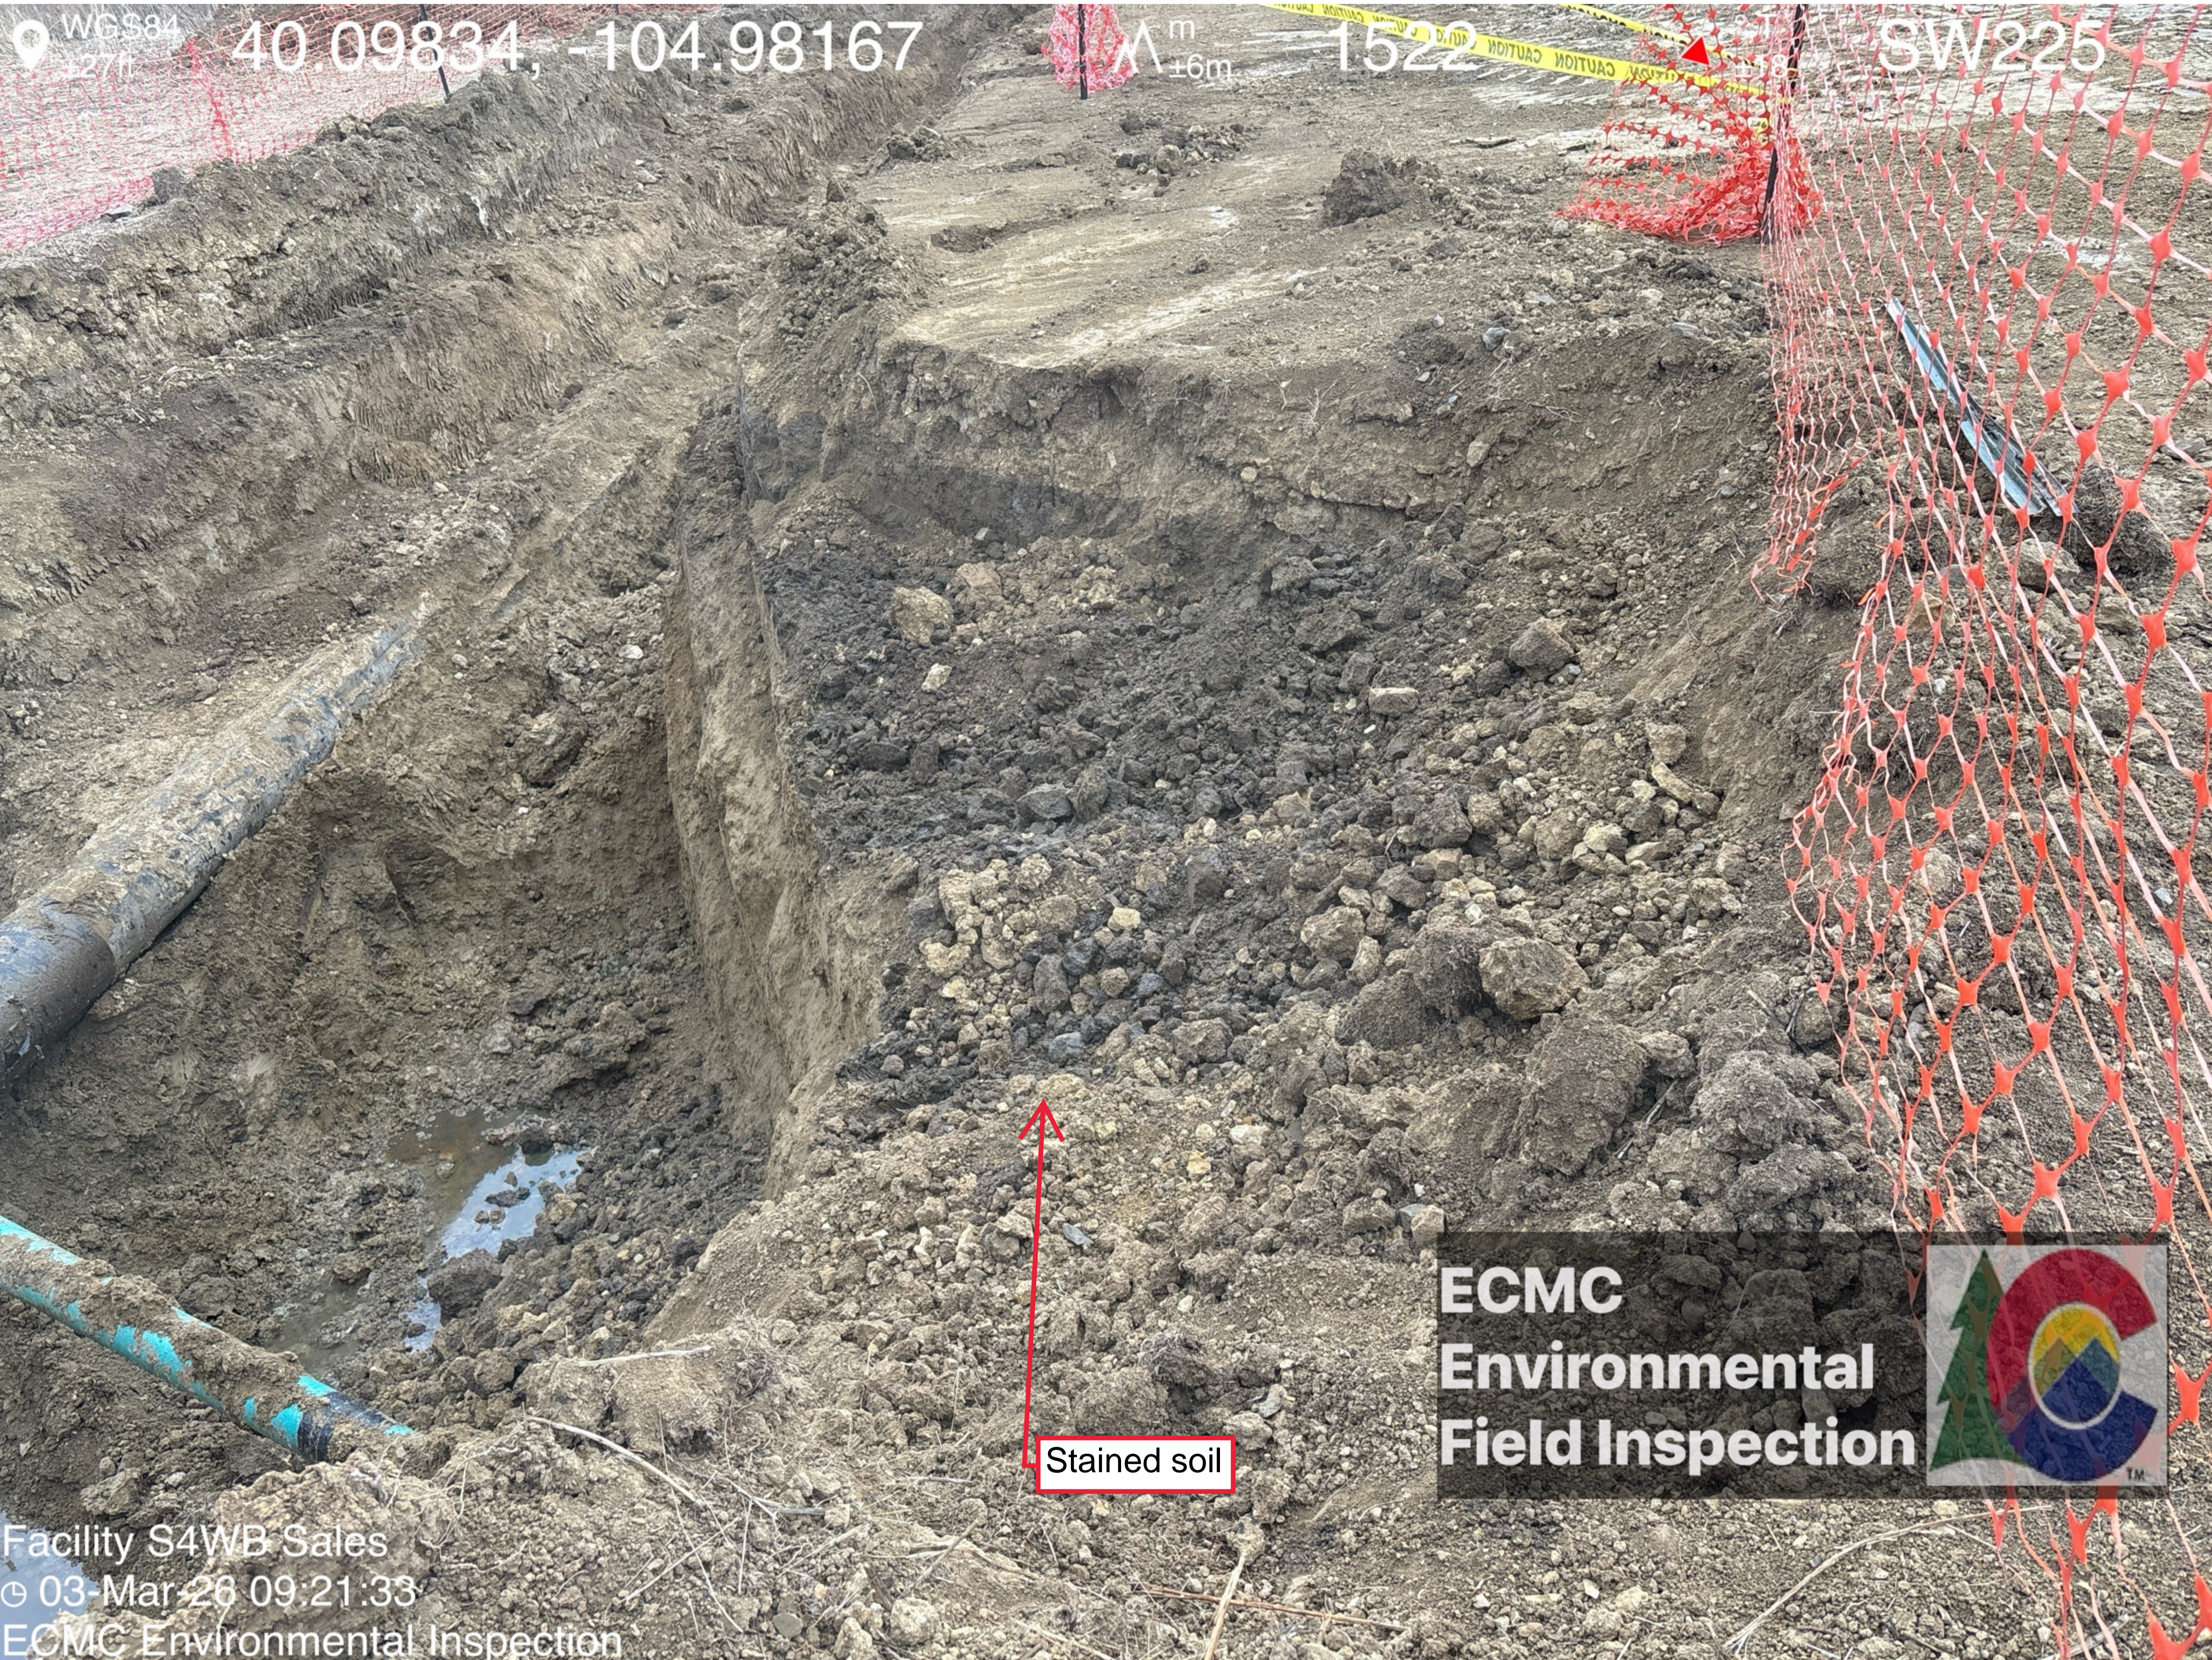
Stained soil

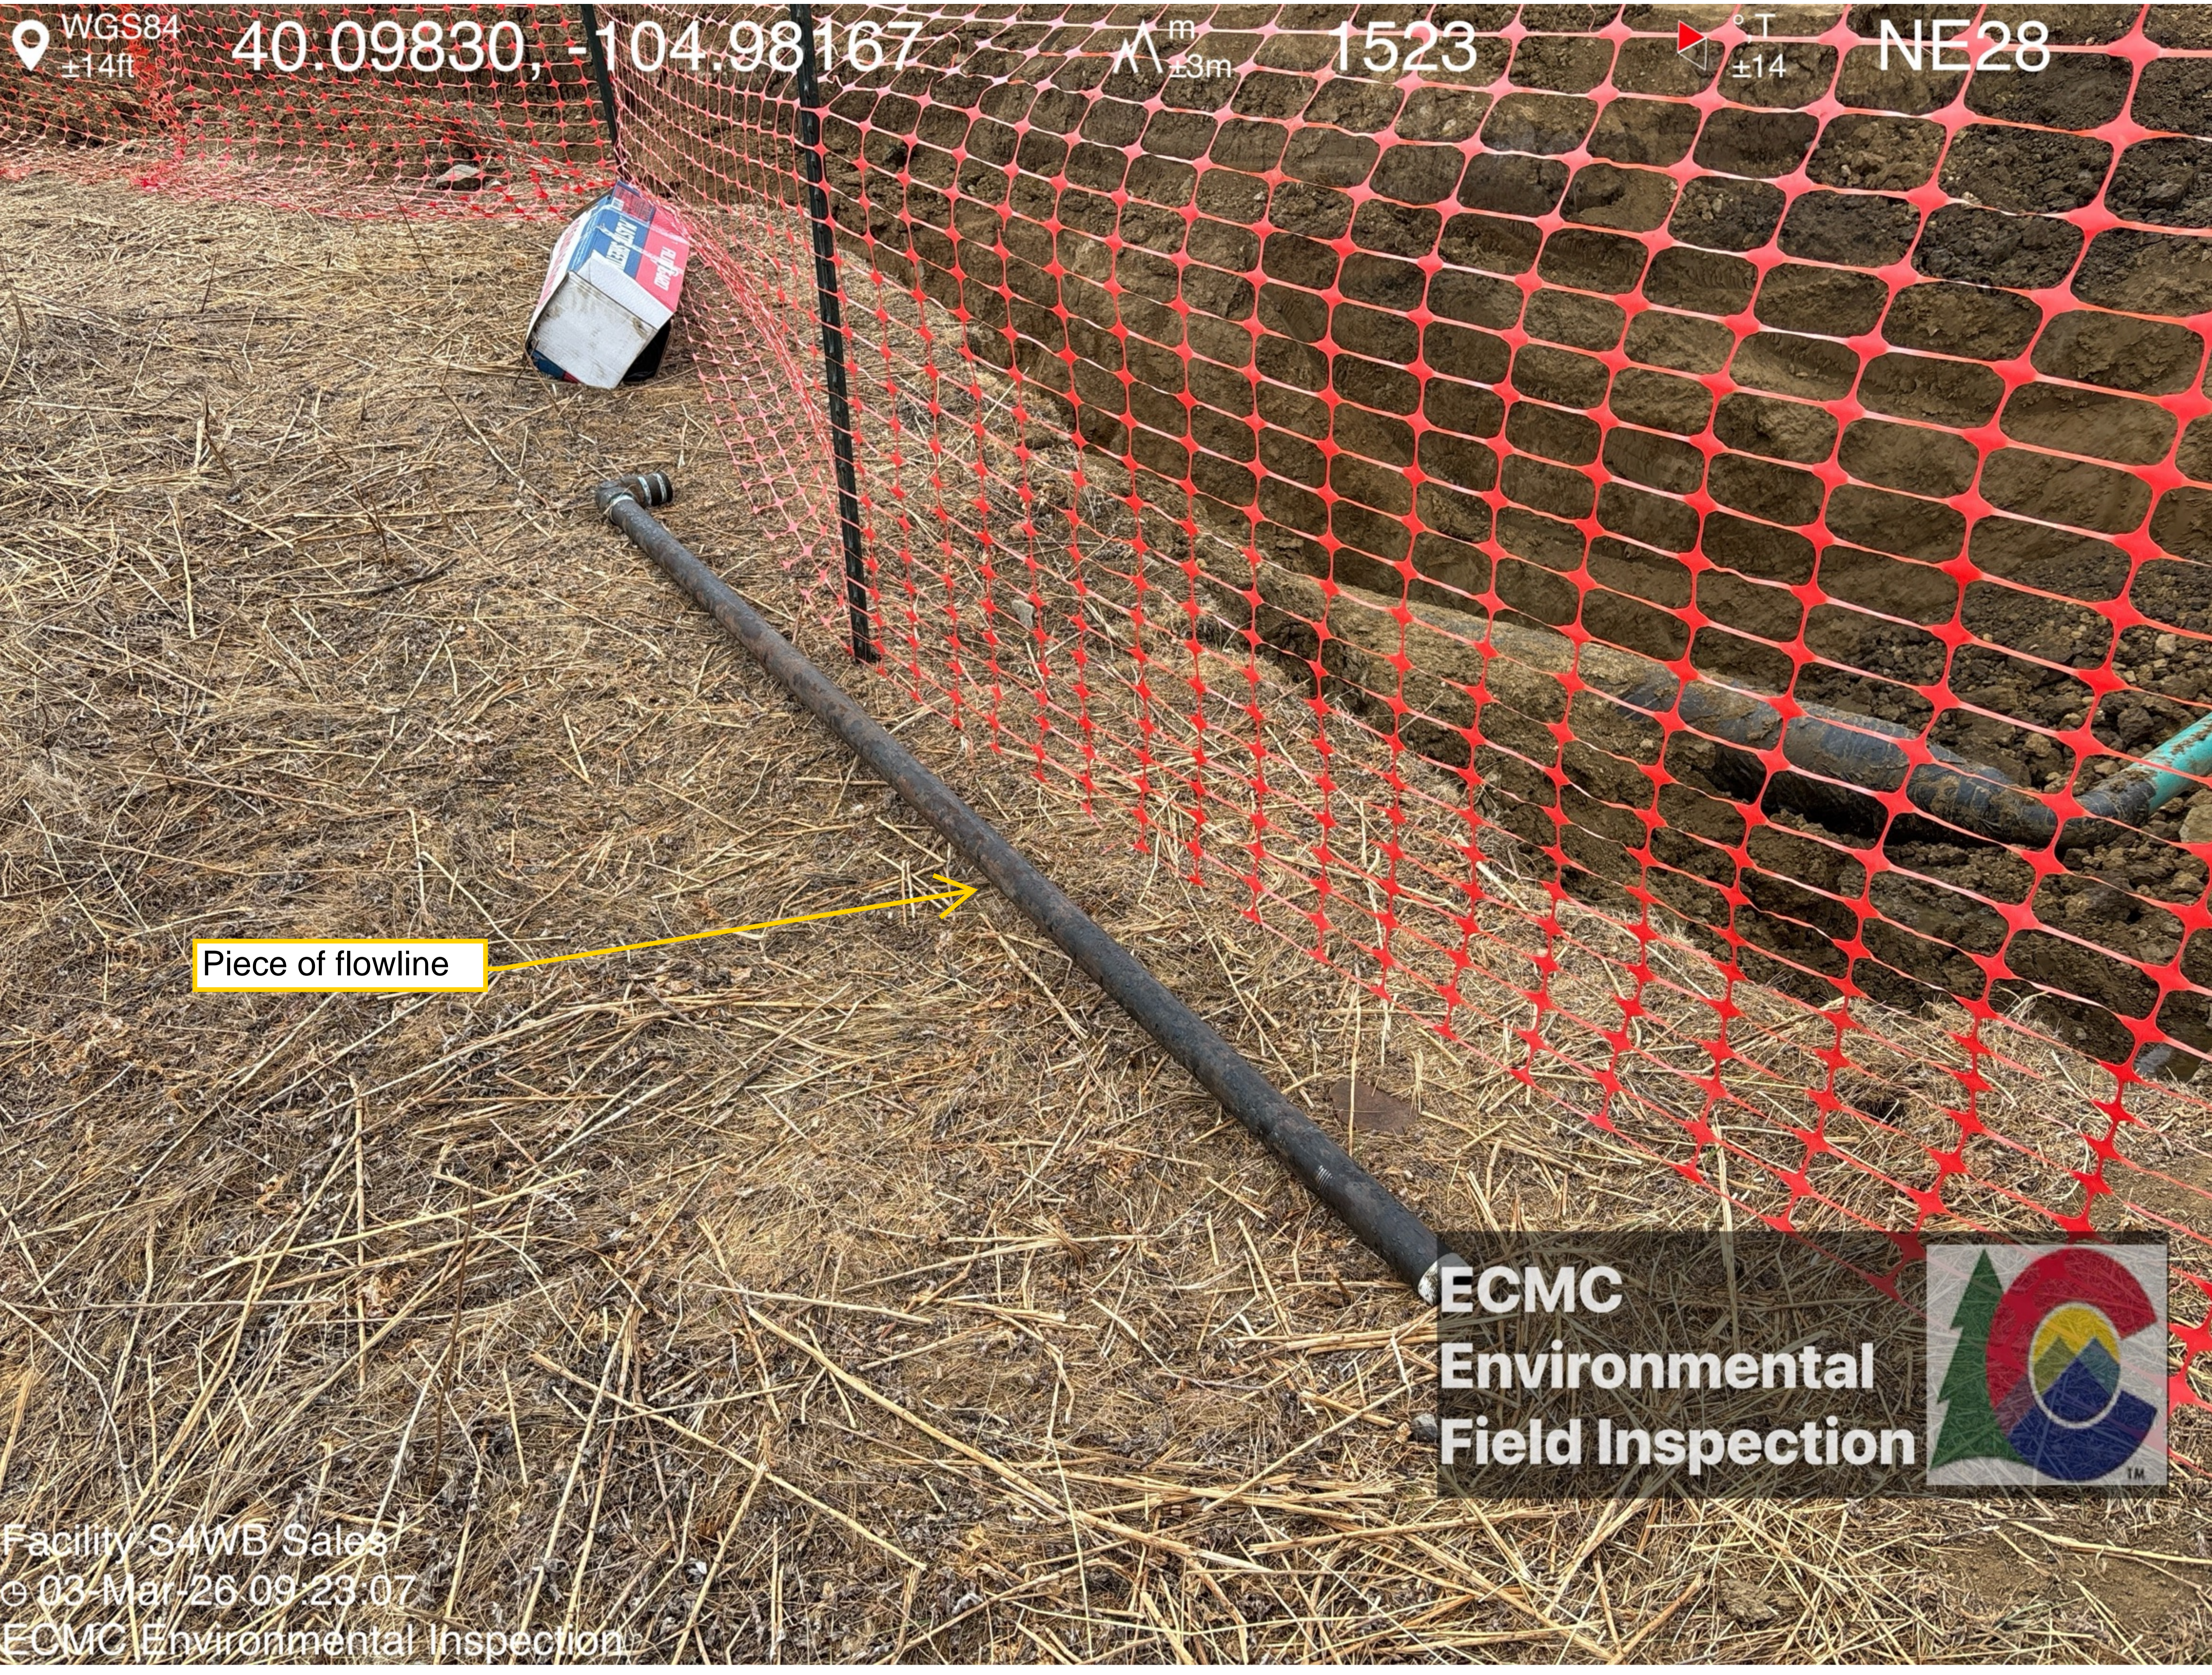
Piece of flowline

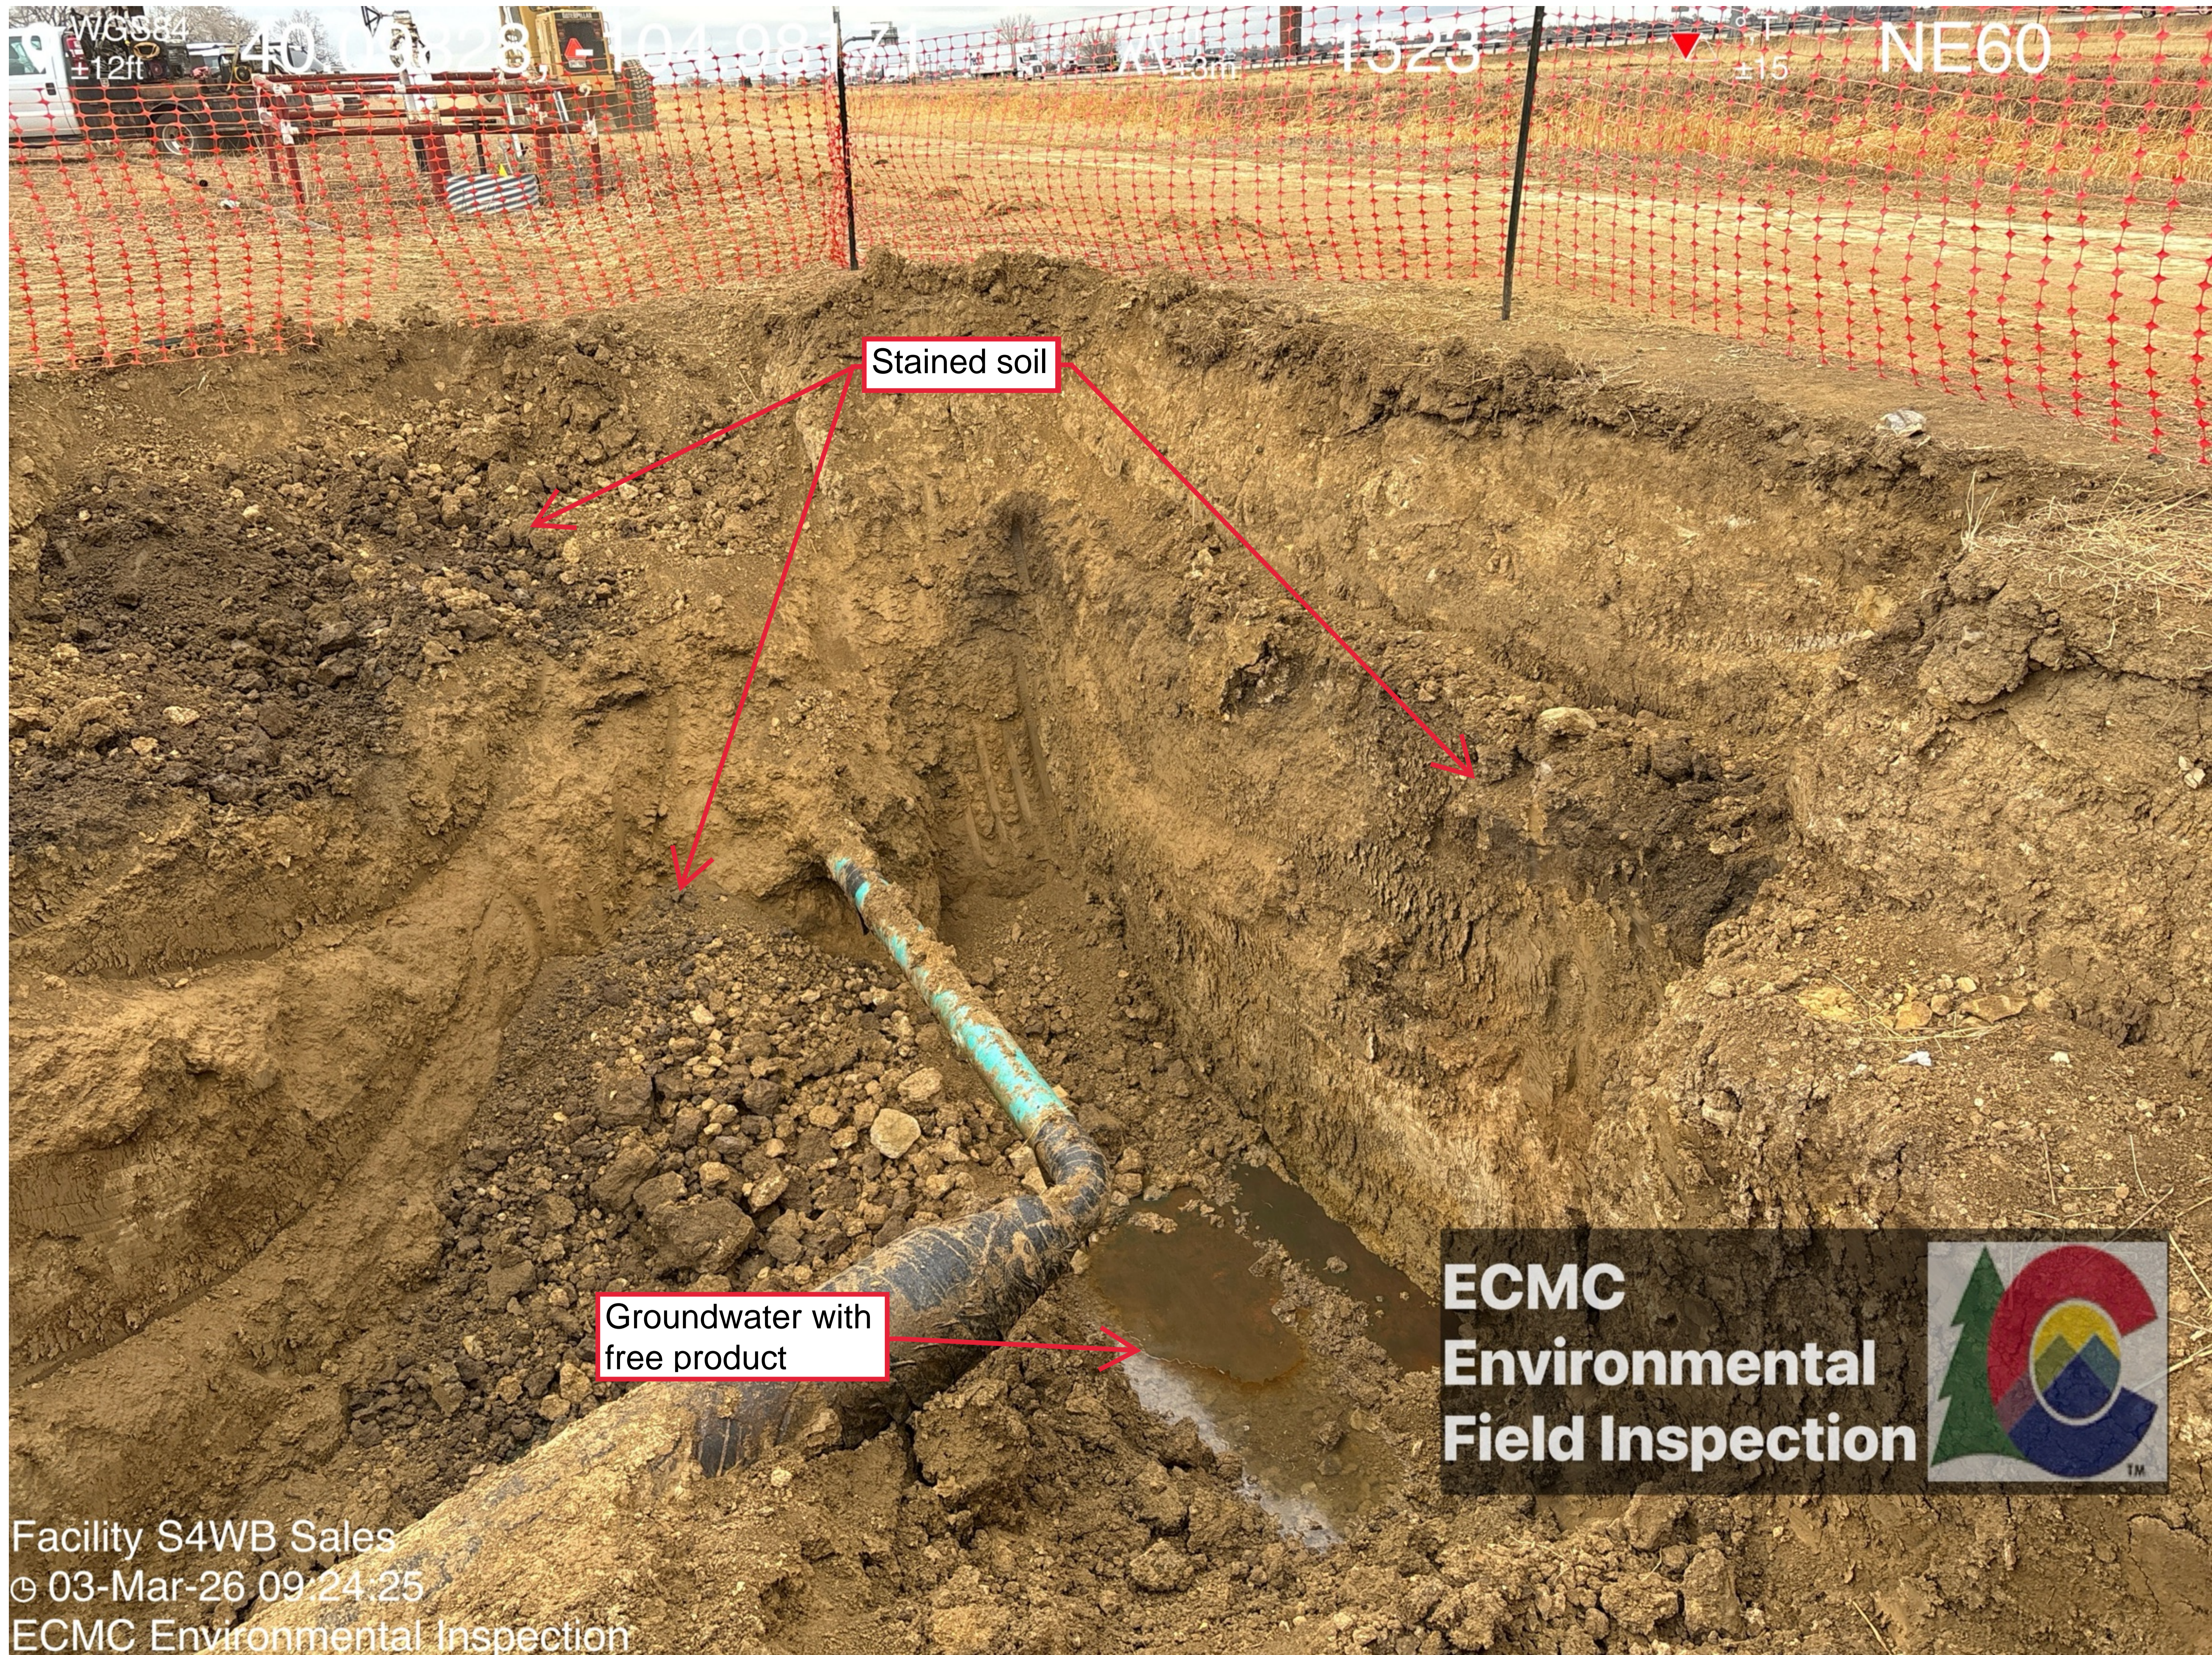
Unmarked, unlined soil stockpiles

Unmarked soil stockpile with liner

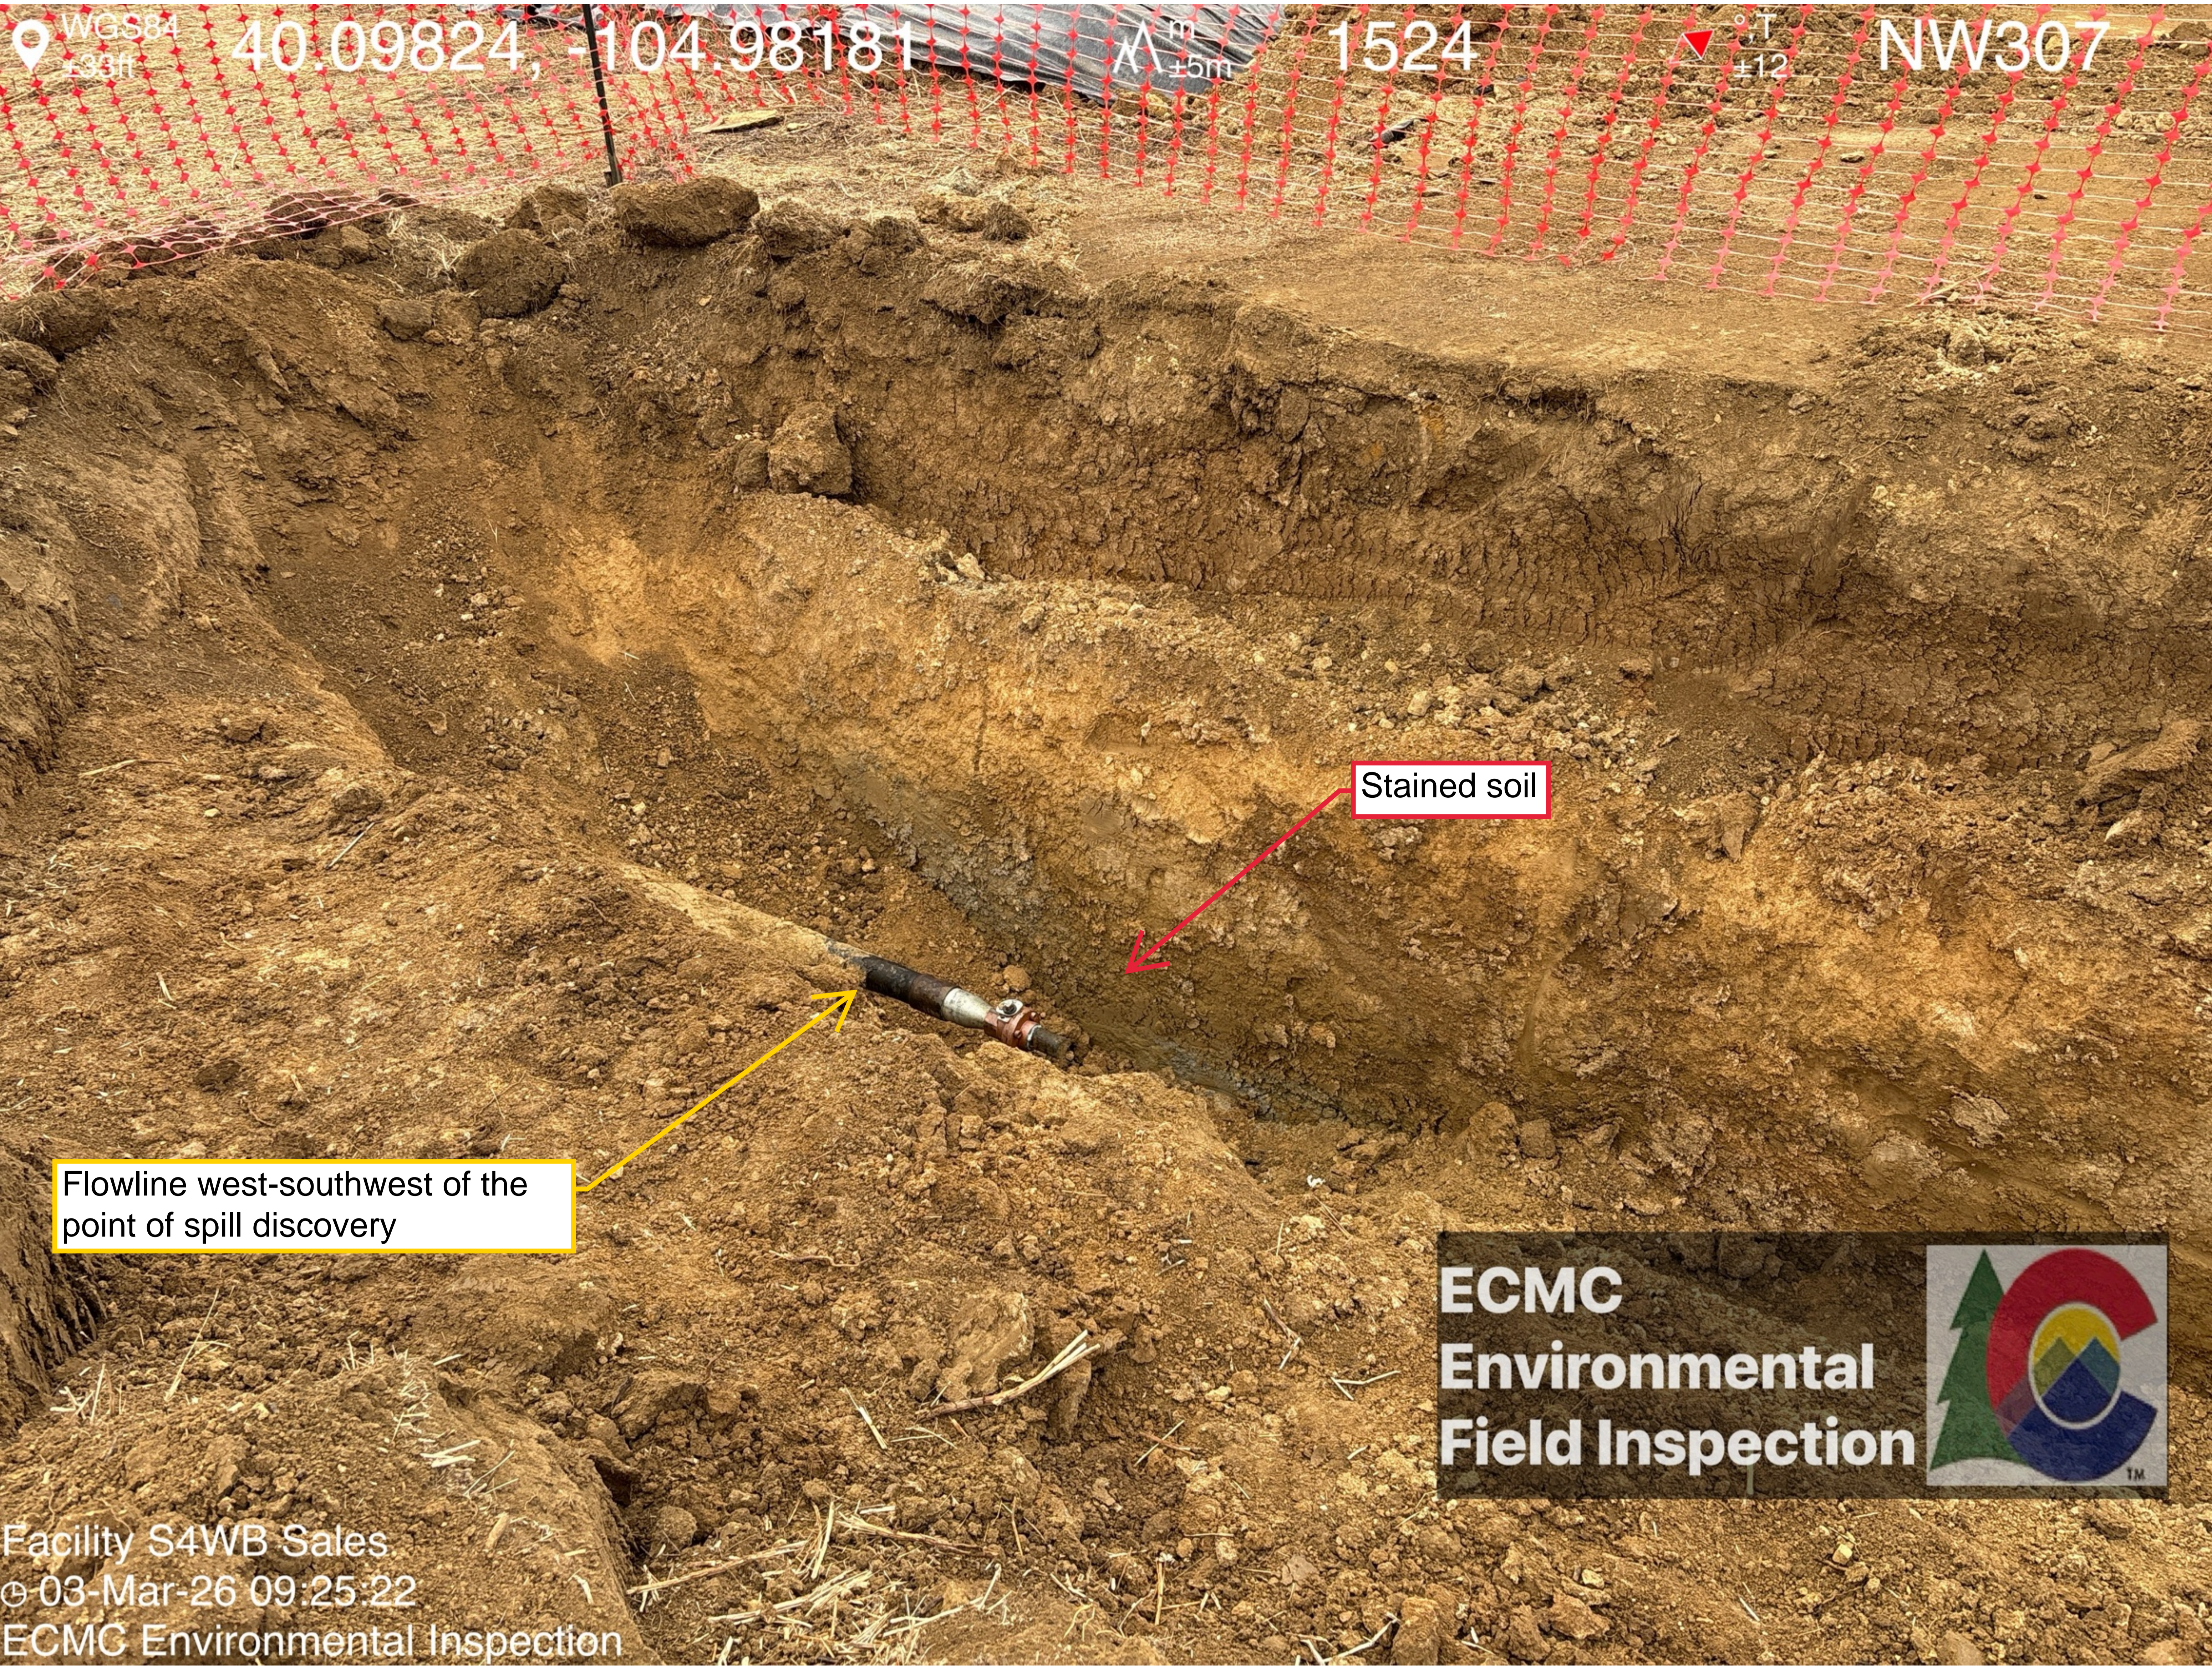
Stained soil

Groundwater with free product

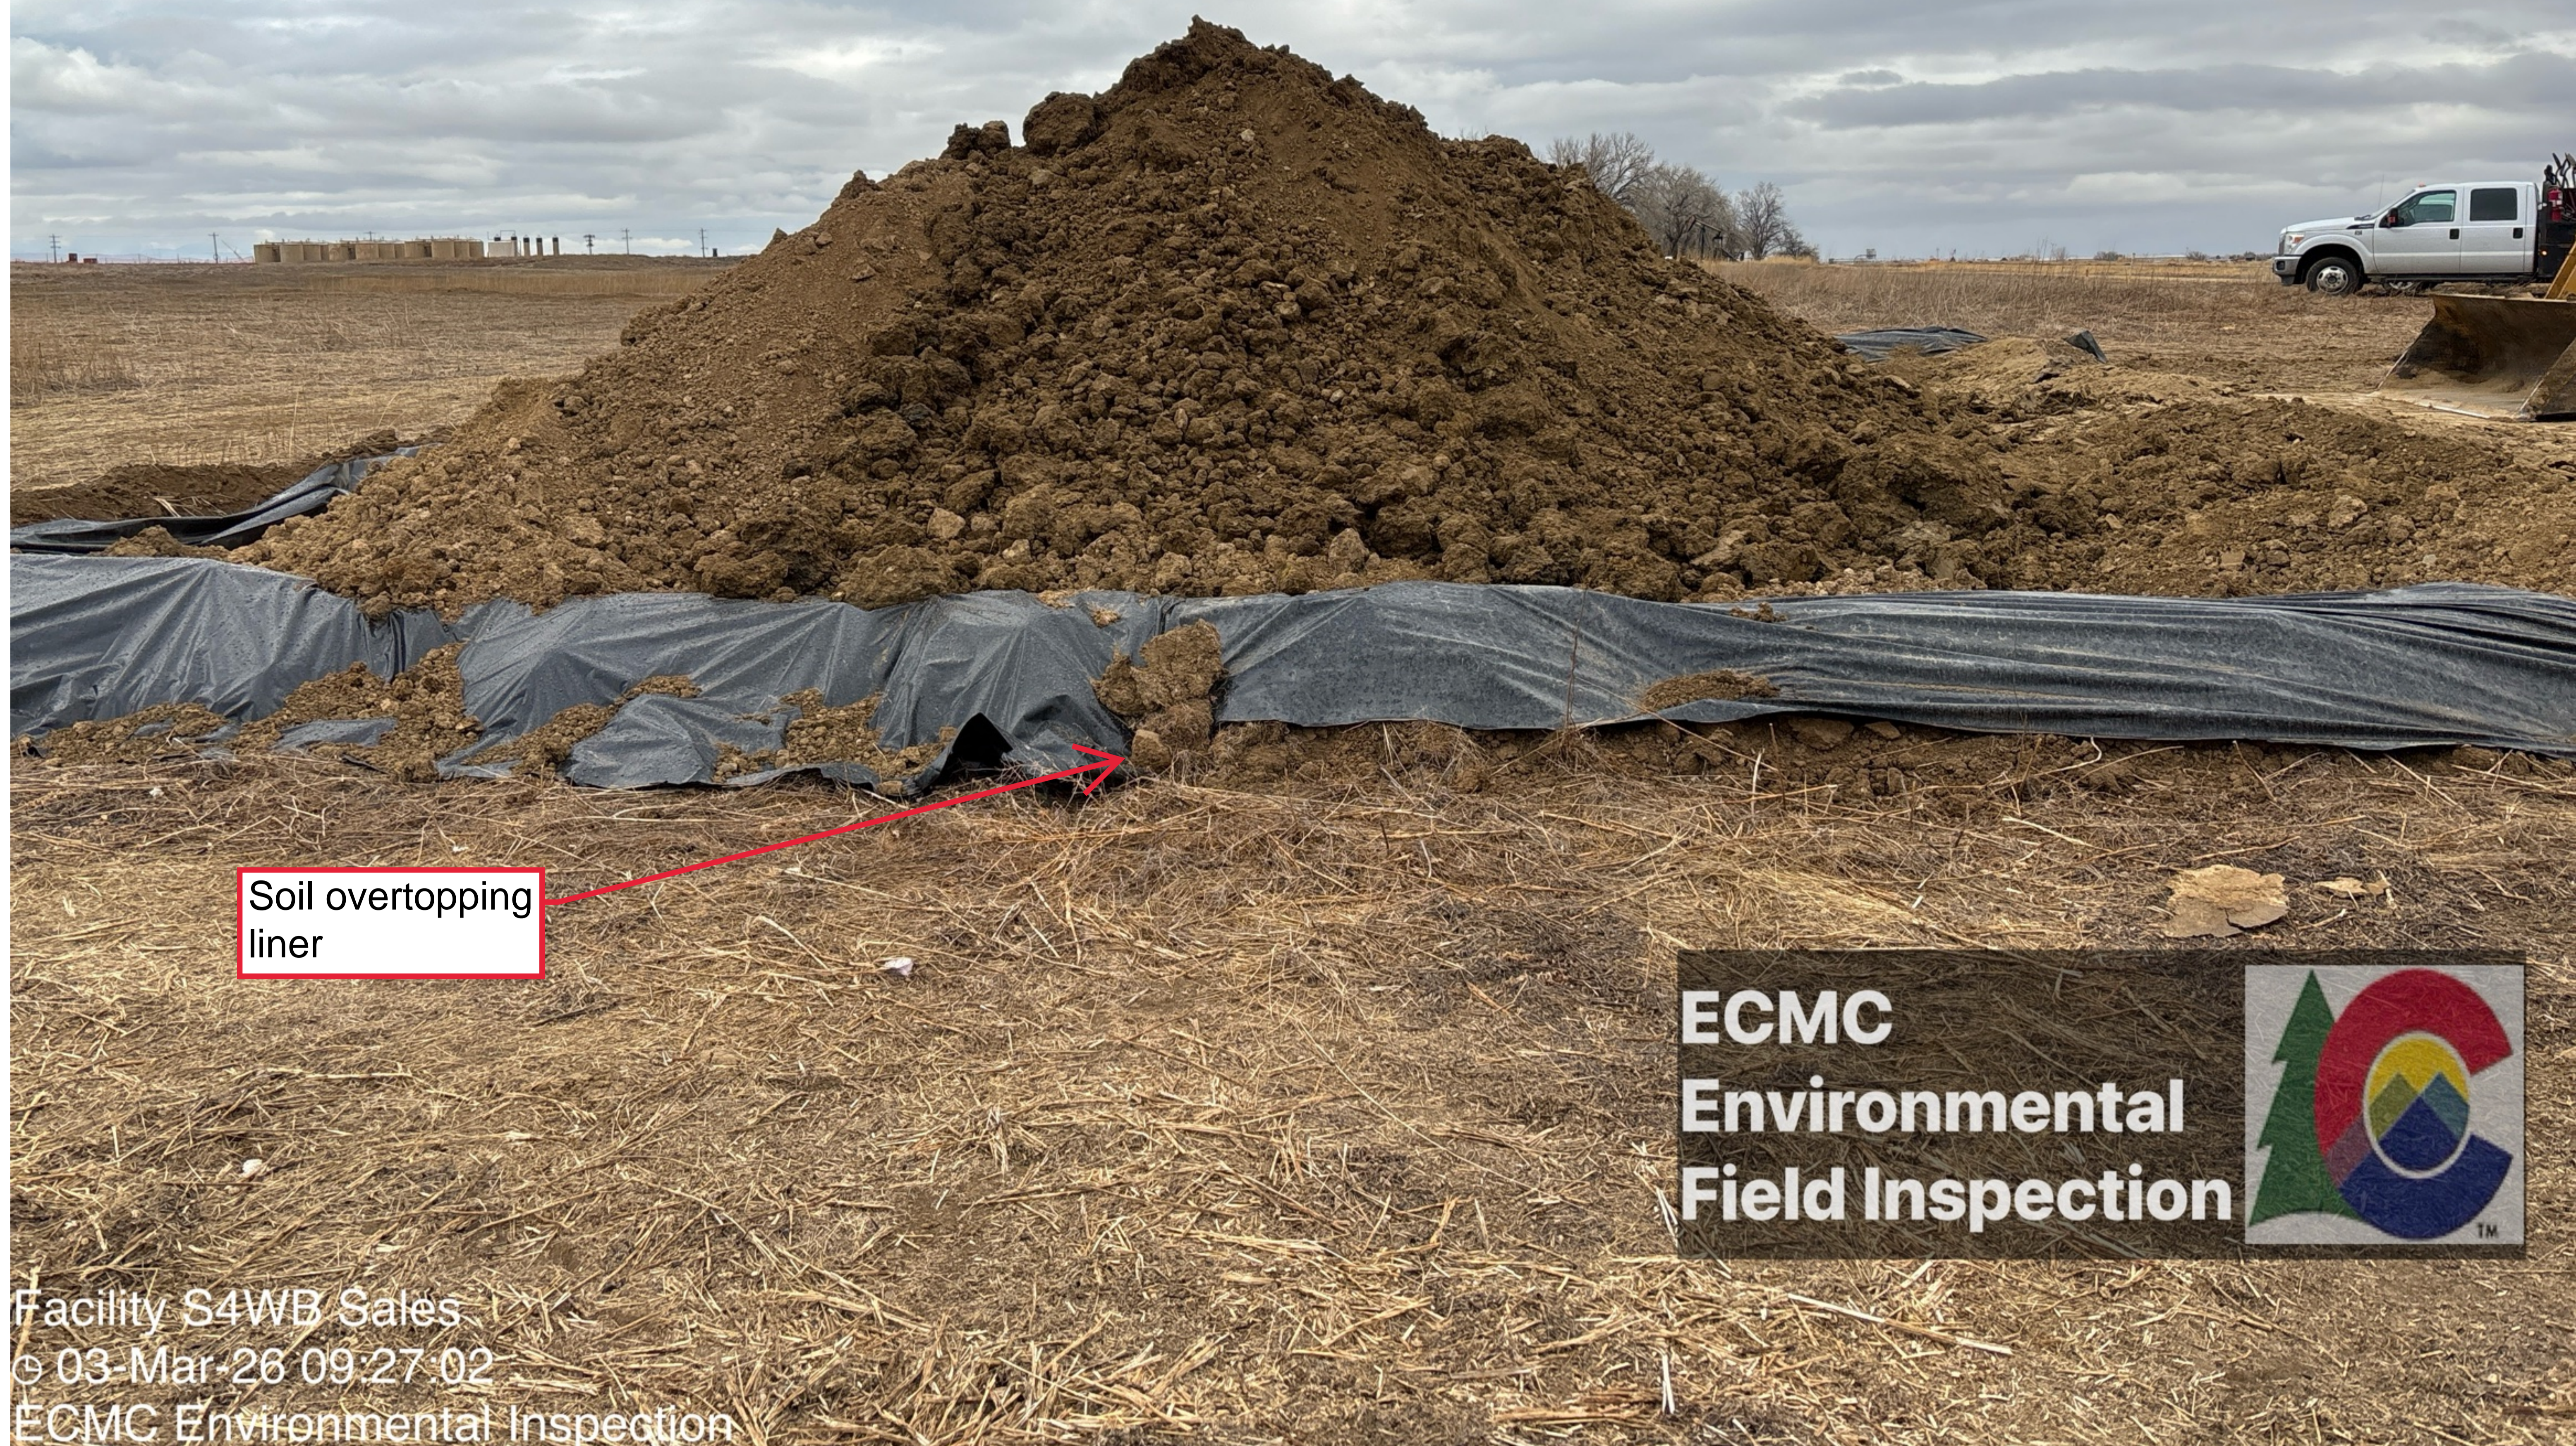
Stained soil

Flowline west-southwest of the  
point of spill discovery
