Inspection Photos

Location Name: TEP ROCKY MOUNTAIN LLC PUCKETT GM 41-29 Pad

Location ID: 335075

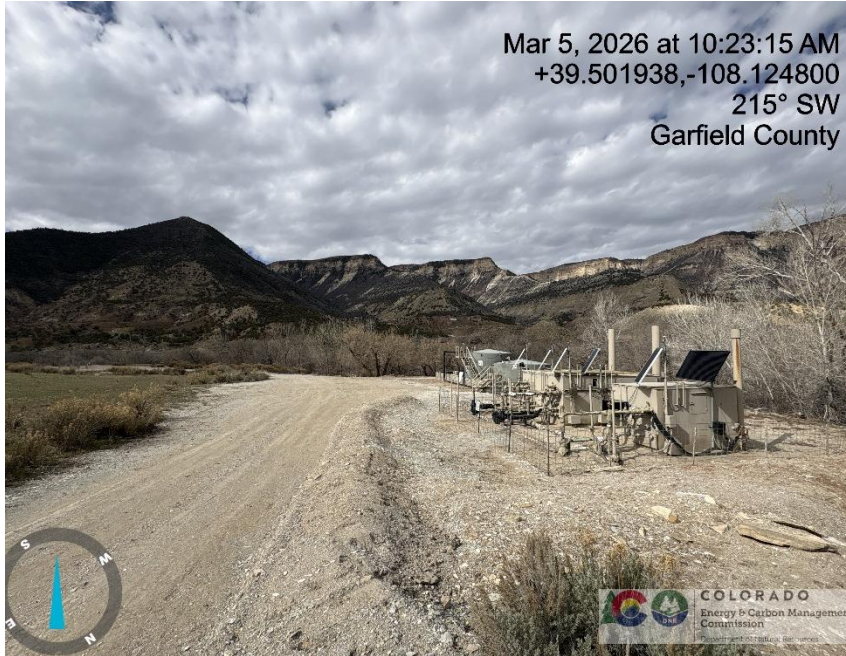
Photo # 5933 From entrance to location

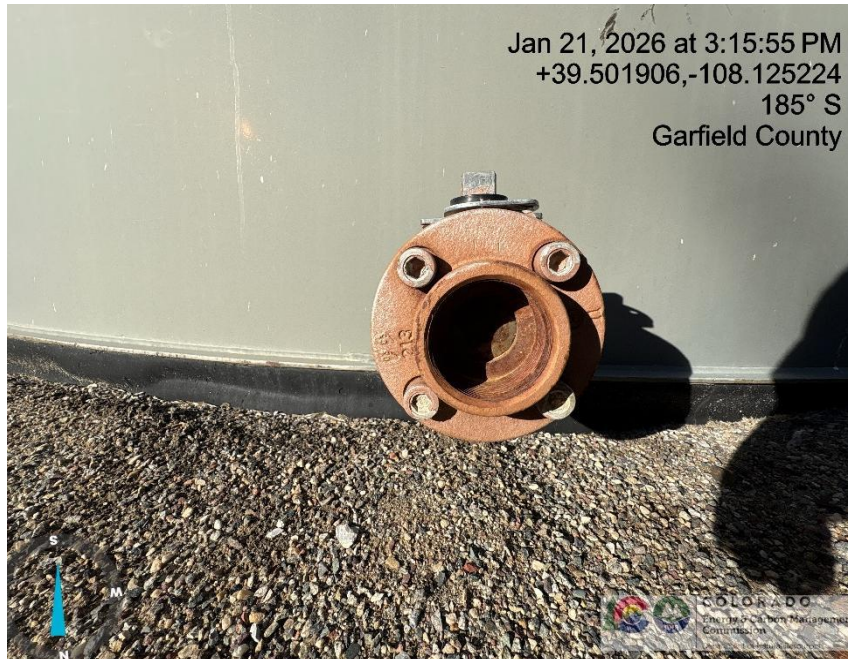
Photo # 3598 From inspection/audit 708908346 conducted on 01/21/2026 - Open ended load line

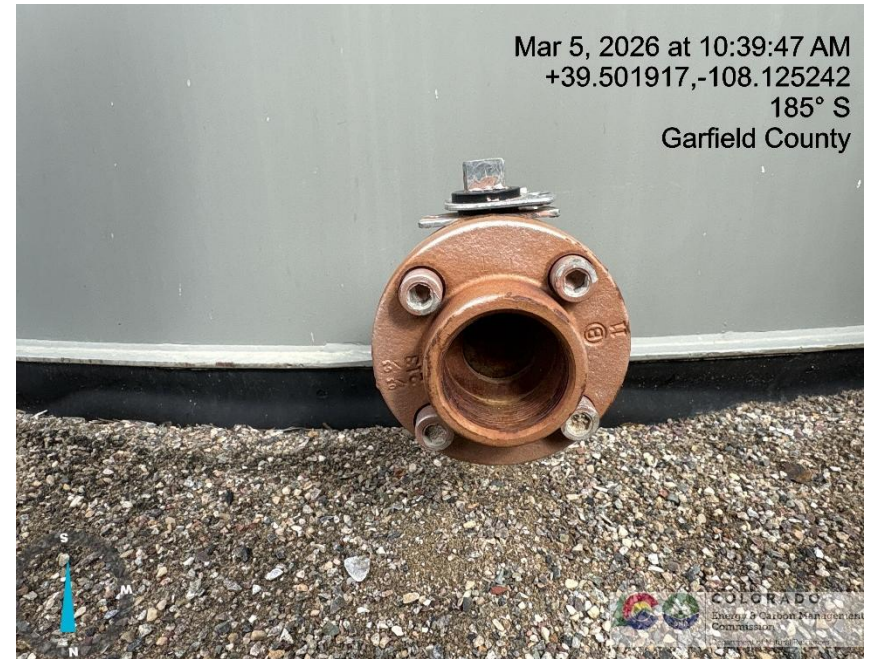
Photo # 5939 Open ended load line

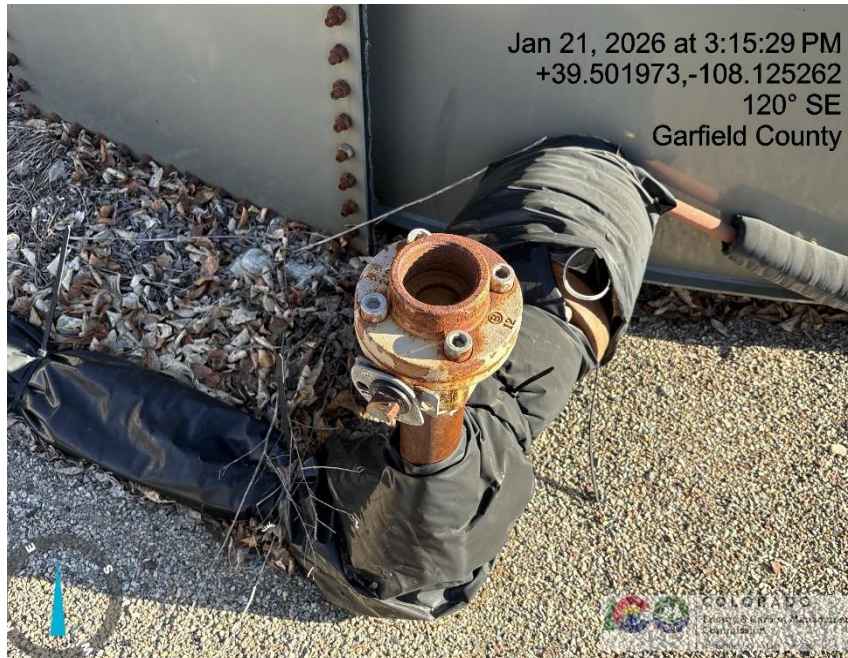
Photo # 3599 From inspection/audit 708908346 conducted on 01/21/2026 - Open ended load line

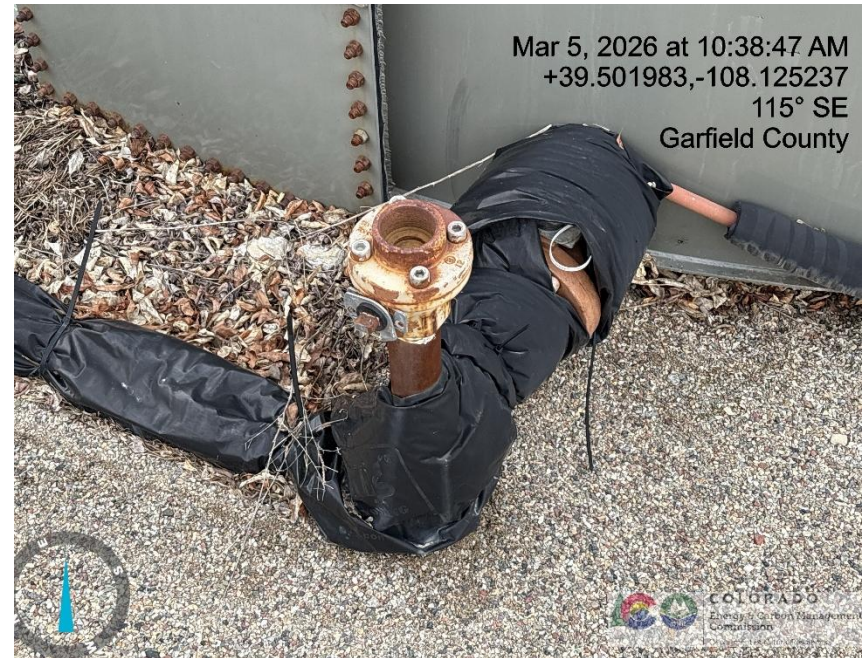
Photo # 5940 Open ended load line

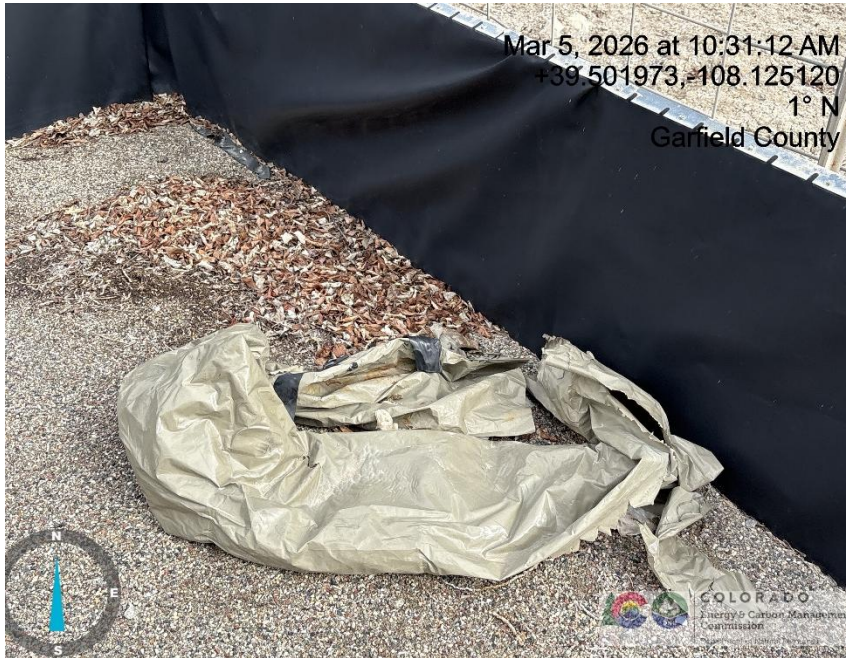
Photo # 5941 Debris

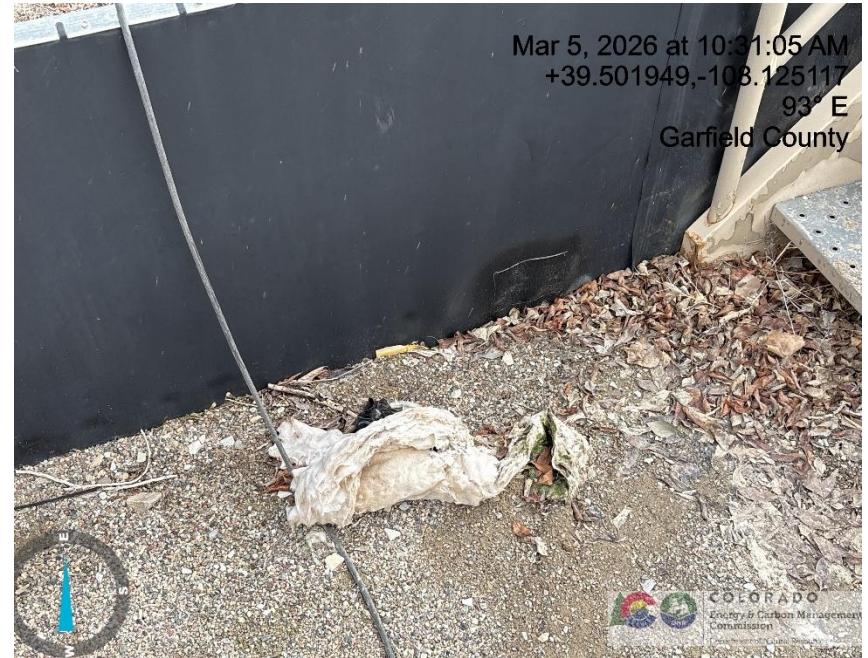
Photo # 5942 Debris
