# Inspection Photos

**Operator:** TEP Rocky Mountain LLC #96850

**Location ID:** 335044

**Inspection Doc:** 719200916

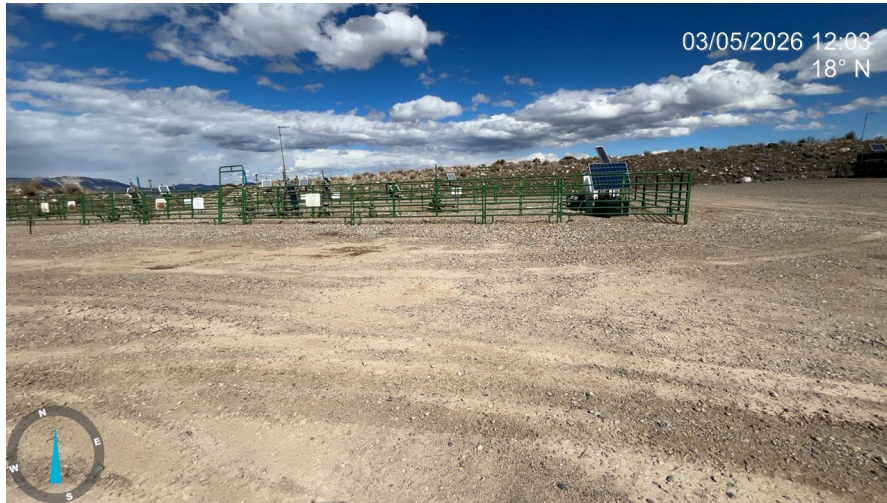
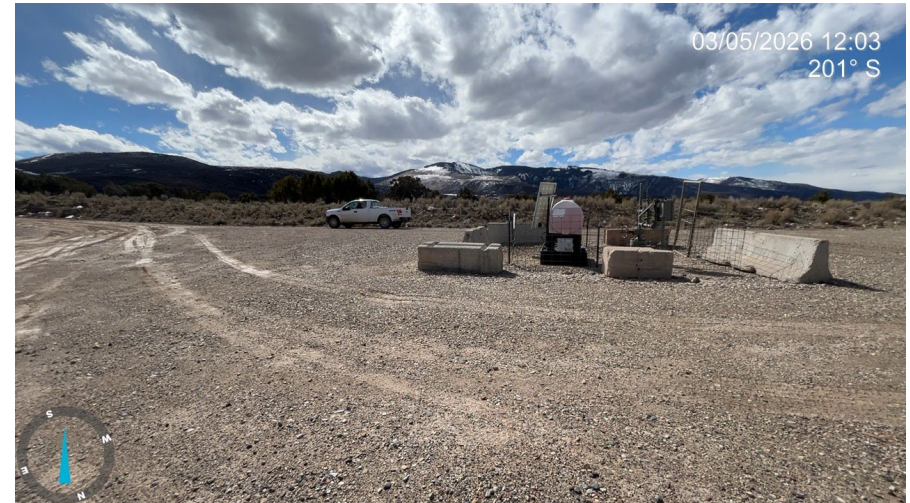
**Photo 1:** Photos showing an overview of the location looking north and south, respectively.

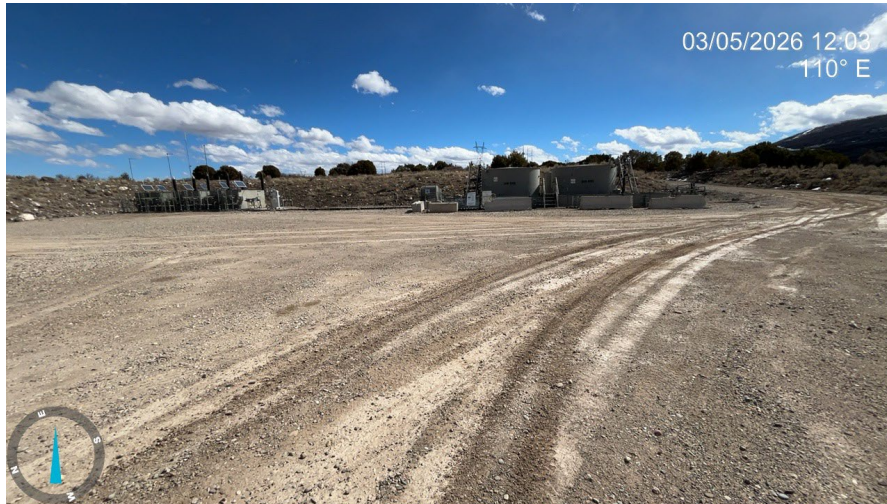
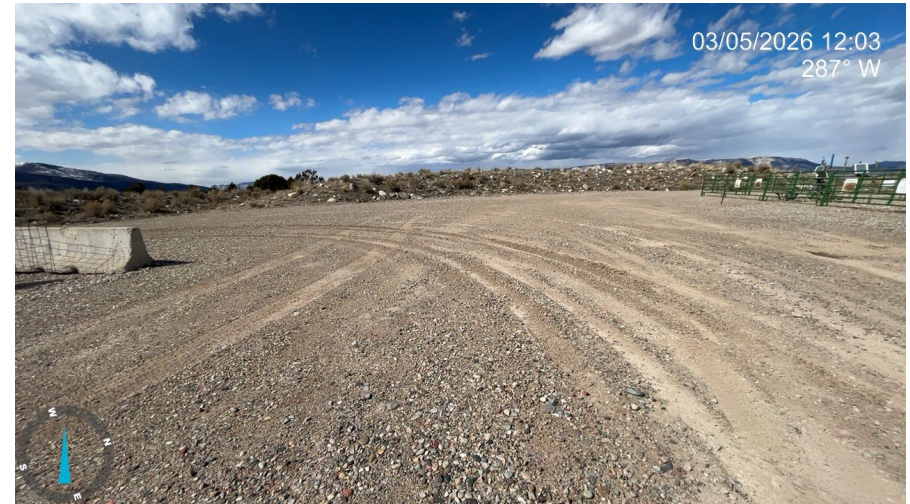
**Photo 2:** Photos showing an overview of the location looking east and west, respectively.

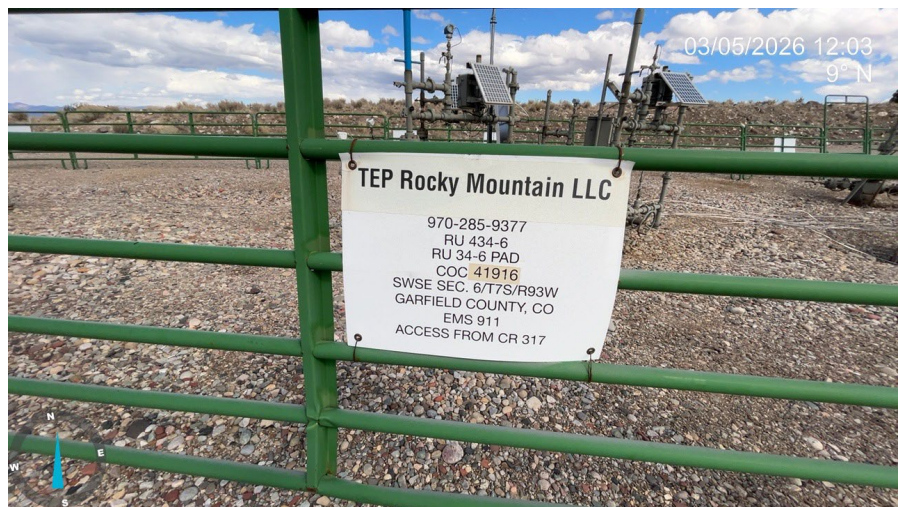
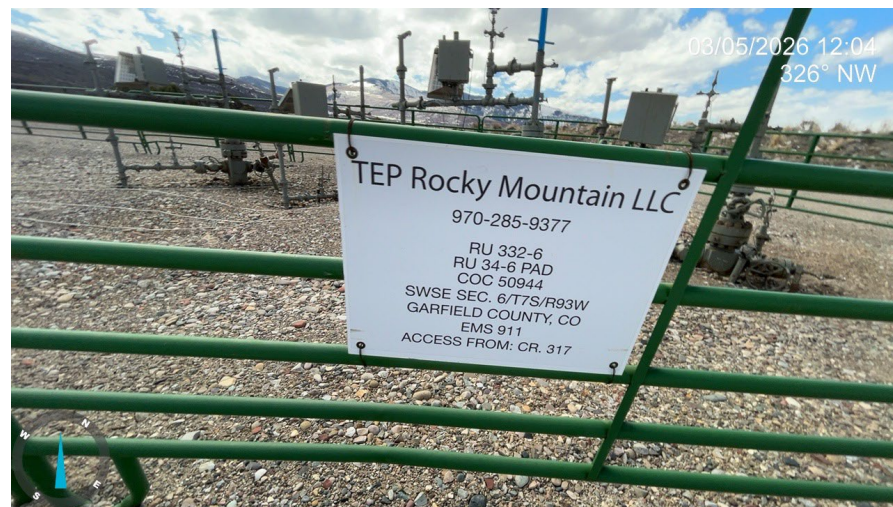
**Photo 3:** Photos showing an example of newer wellhead signs with missing API numbers; comply with Rule 605.d.

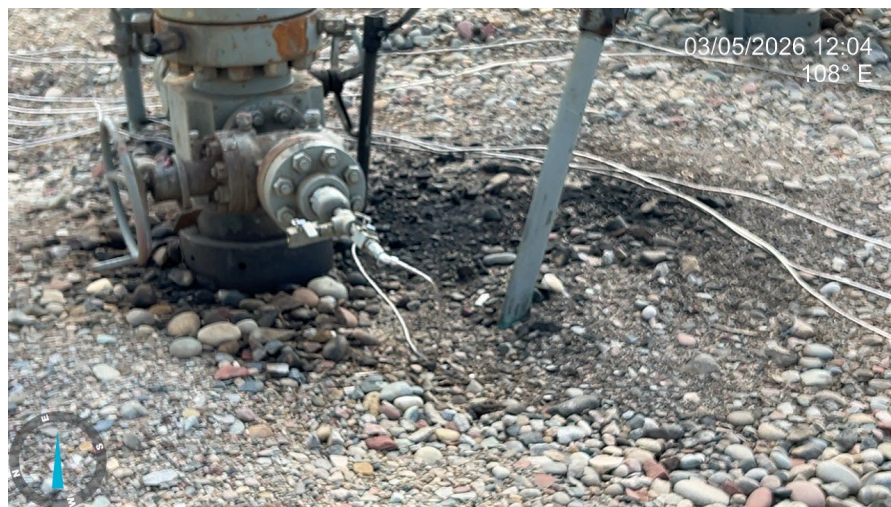
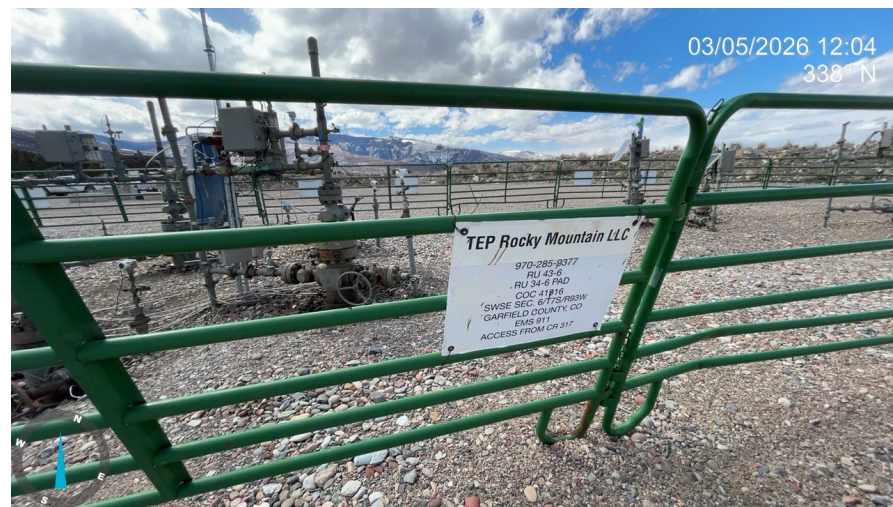
**Photo 4:** Photos showing stained soils around wellhead RU 43-6; clean up/removal of stained soils pursuant to Rule 912.a. is required. Wellhead sign is missing API number.

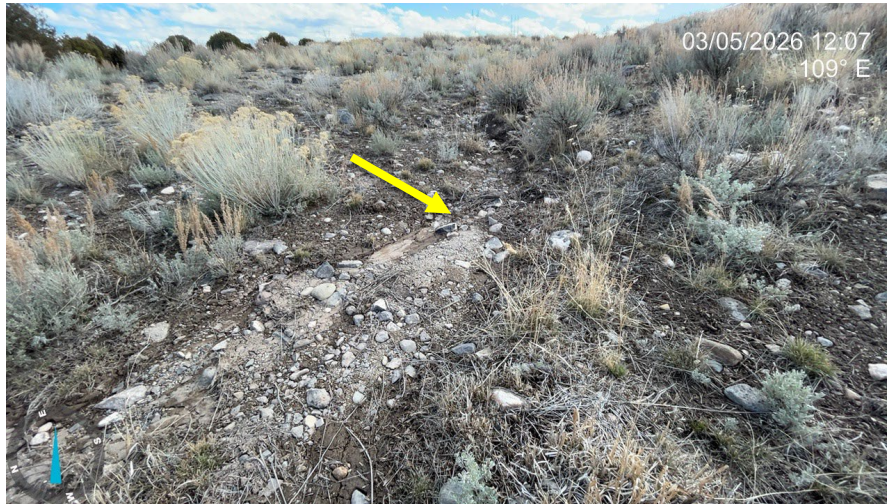
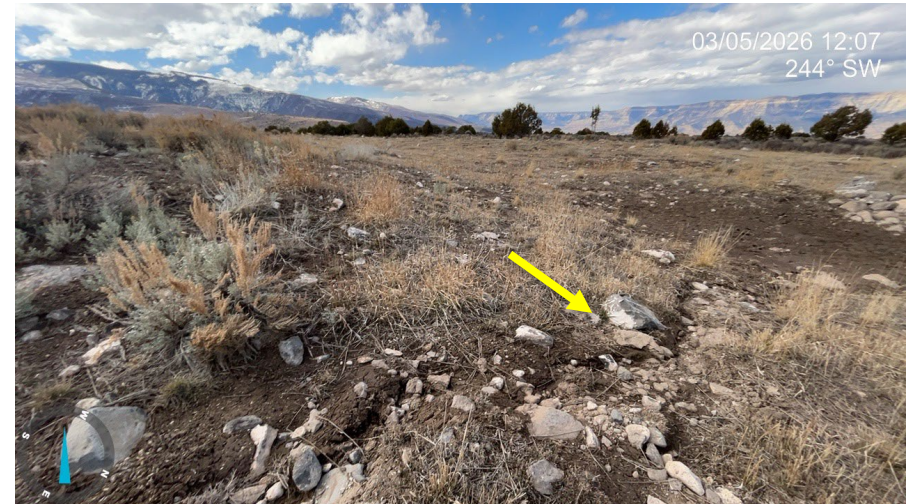
**Photo 5:** Photos showing an example of erosion and rilling that is occurring on the northern corner of the location and discharging into the interim area; stormwater BMP's appear to be missing or insufficient. Maintenance is required; comply with Rule 1002.f.

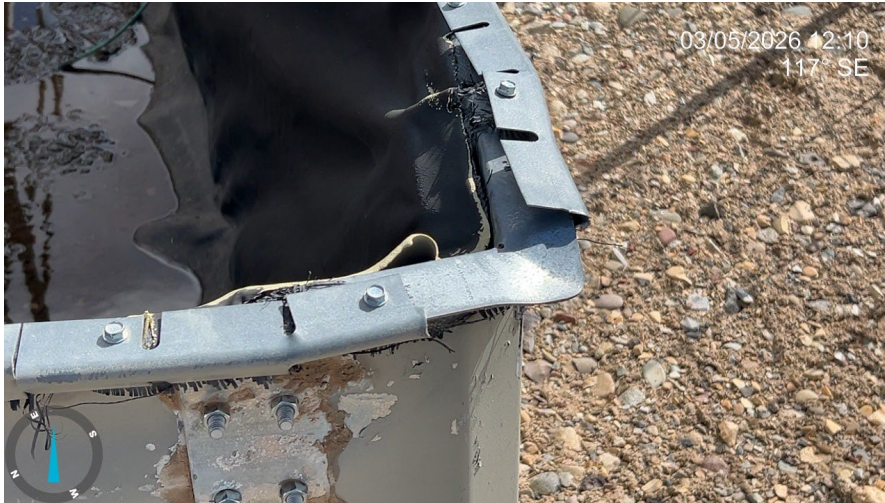
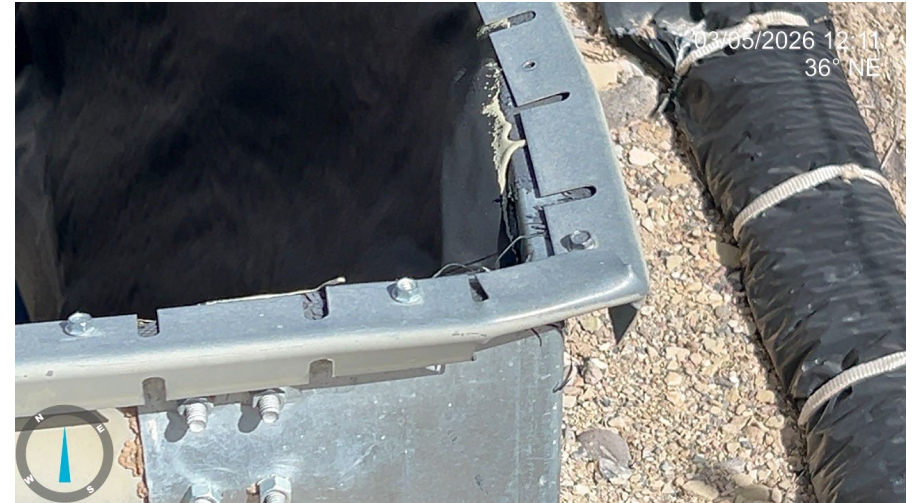
**Photo 6:** Photos showing examples of rips/tears in the corners of the secondary containment's black geotextile liner. Comply with Rule 603.o.

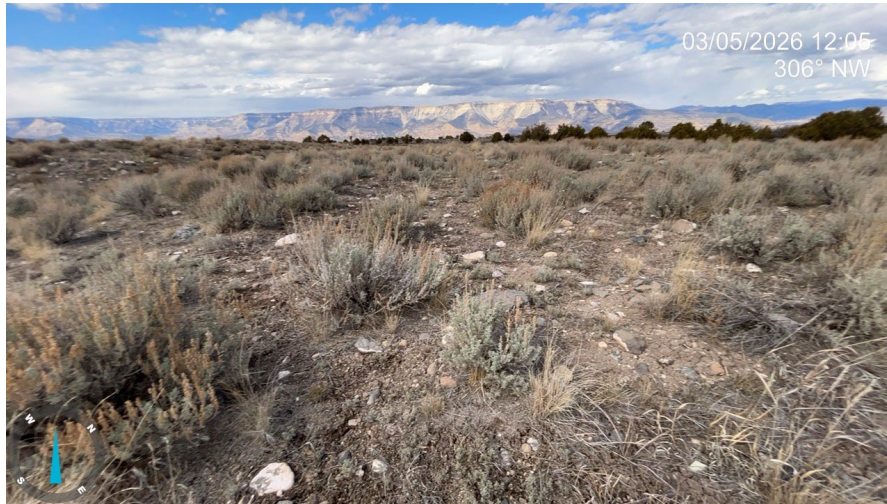
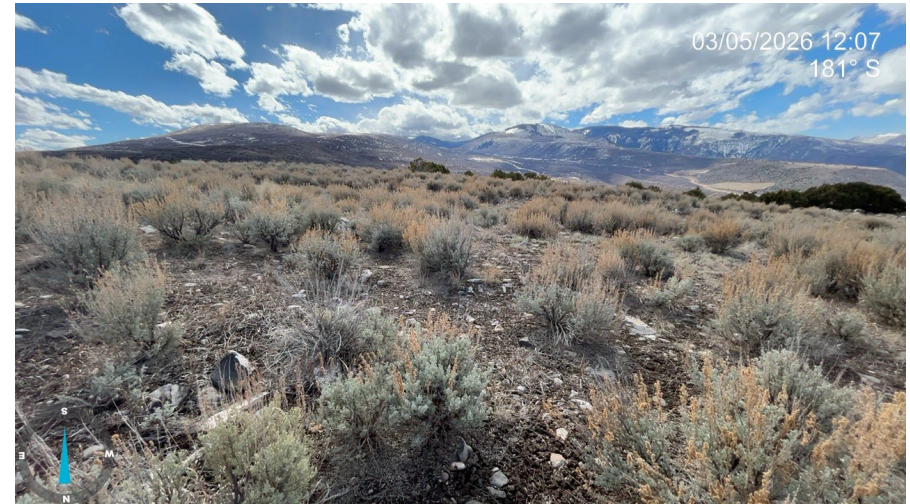
**Photo 7:** Photos showing an overview of the northwestern and southern interim areas; interim areas are well established with big sagebrush. Interim areas appear to be progressing towards 1003 reclamation requirements.
