**ECMC Inspection Photos - KP Kauffman**  
**Location: Facility S4WB Sales Line**  
**Date 03/09/2026**

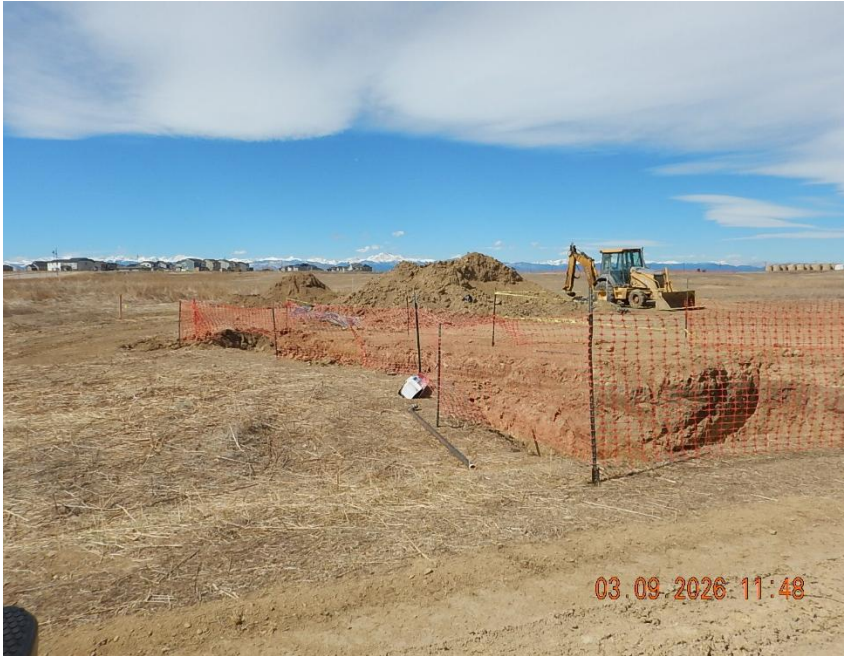
**View looking west of fenced excavation at KPK Facility S4BW spill/ release. Spill Id # 493326 @ 40.098305, -104.981653**

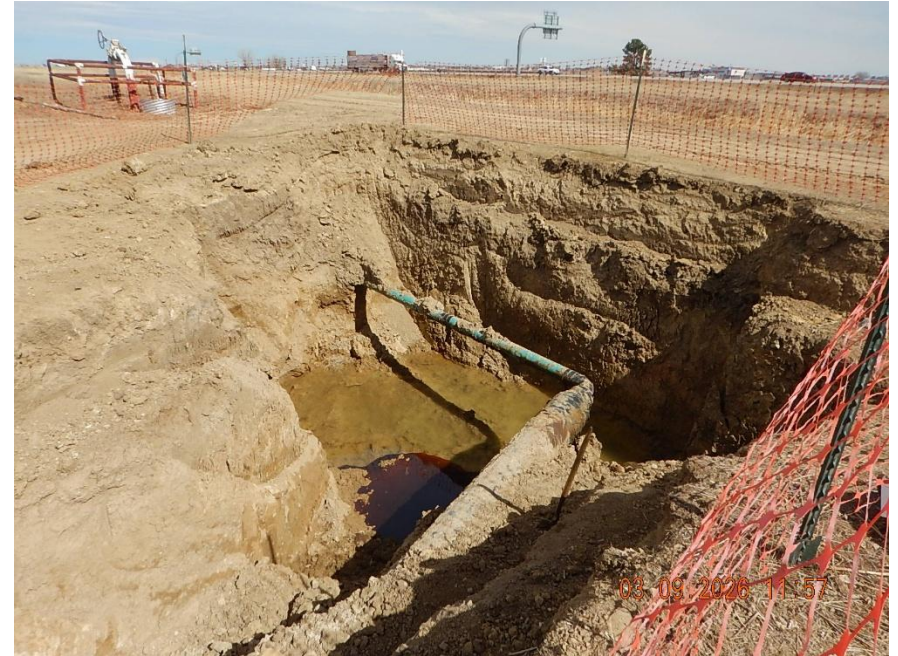
**View into excavation of large off location flowline measuring approximately 20" in diameter transitioning down to 6" diameter flowline via welded pipe reducer. This flowline is not the reported source of the release. Free oil product is seen floating on the surface of ground water in excavation.**

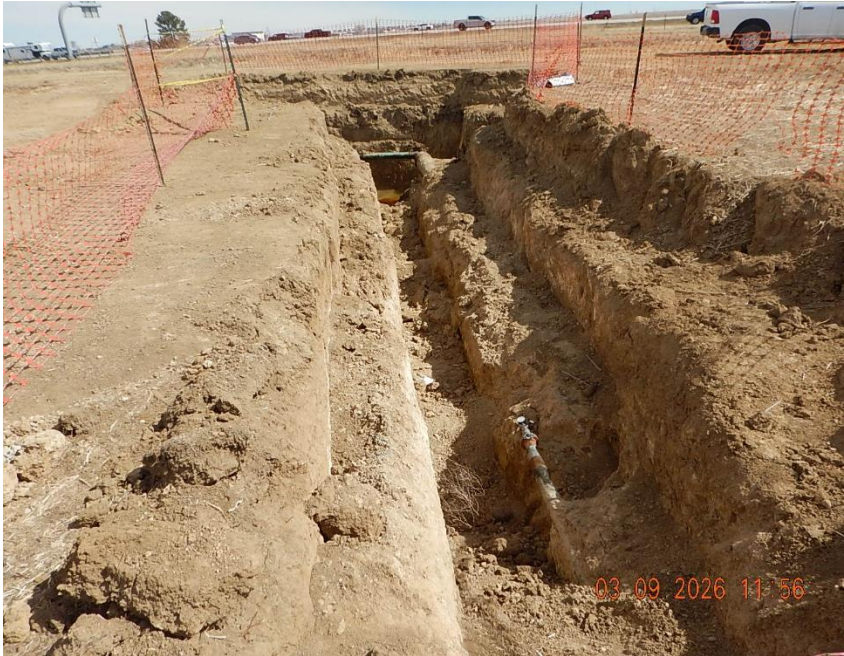
**(1) 3" carbon steel flowline exposed in excavation is the reported source of the spill/ fluid release. This line is a pressurized dead leg (no downstream connection). Approximately 60' of corroded pipe has been cut out and removed. View looking east.**

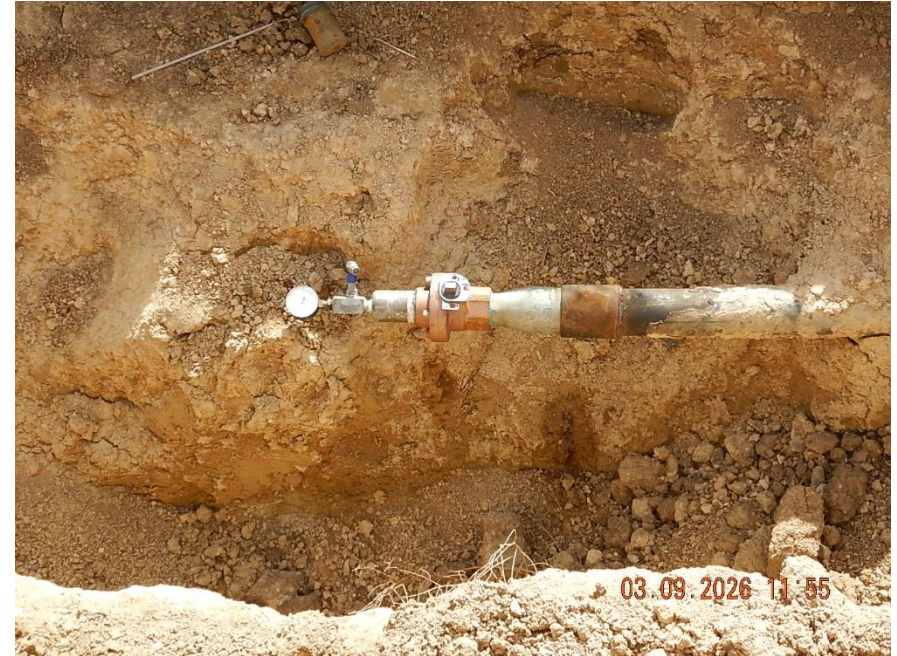
**Closer view of the cut end of the 3" CS flowline dead leg; the cut end has been bull plug/ valved. The pressure gauge shows a reading of 23 psi.**

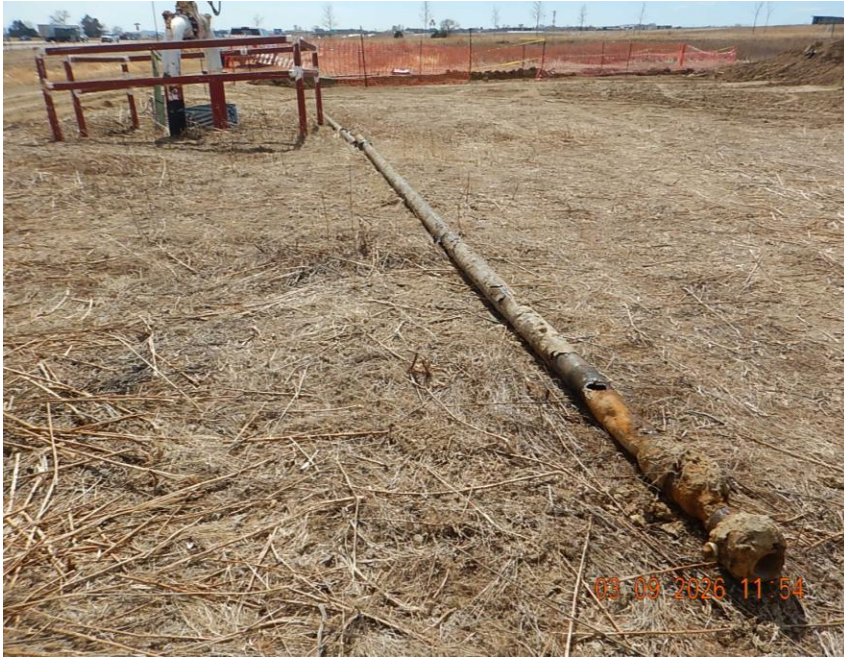
**Approximately 60' of the corroded 3" carbon steel pipe has been cut out and removed from excavation. A corrosion hole near the valved end can be seen and is the point source of reported spill/ release.**

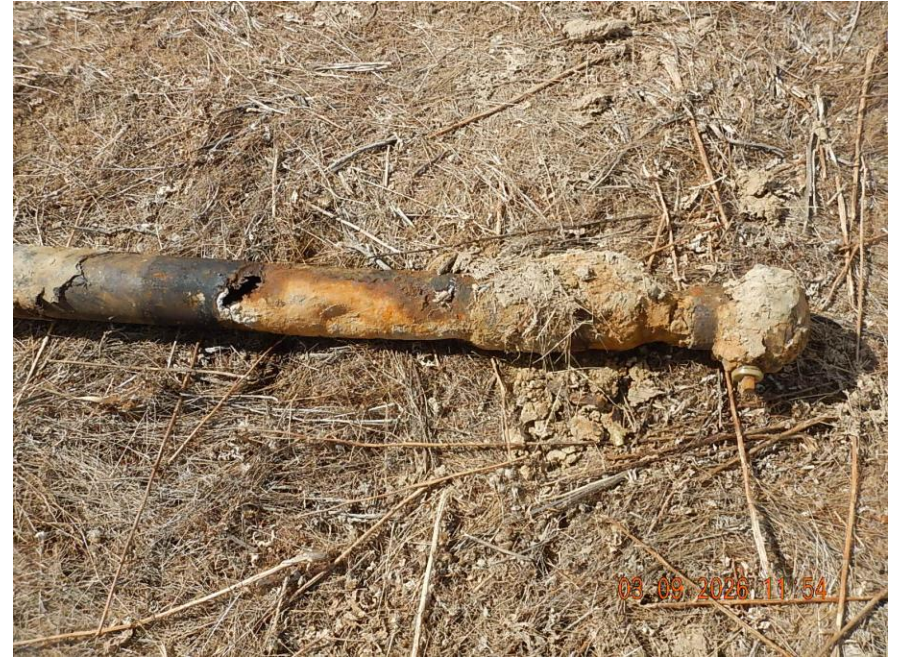
**Closer view of the flowline failure/ hole near the valved end of the 3" pipe. As reported, external corrosion appears to be the root cause of failure leading to the spill.**
