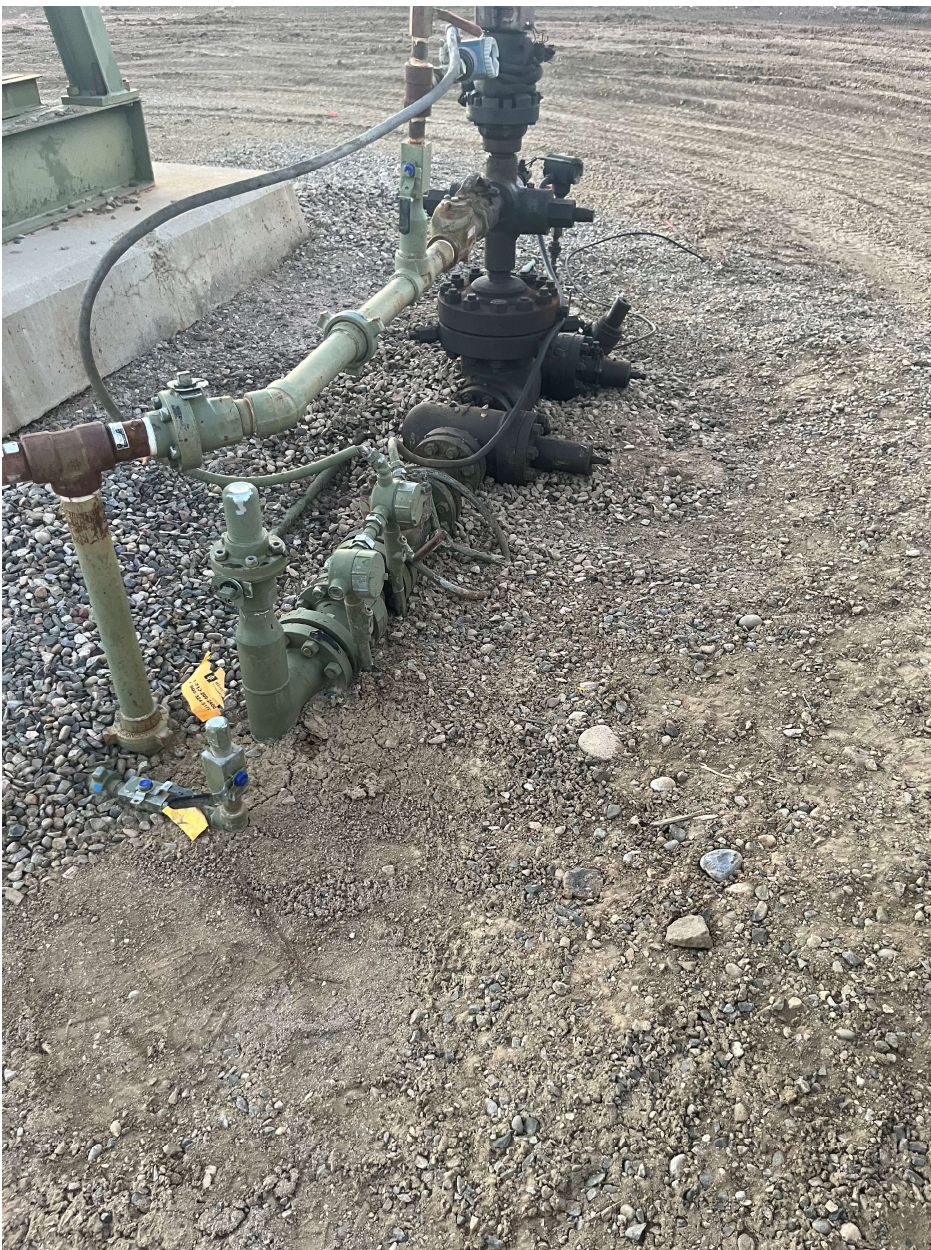
**Comment:** Stained soil beneath wellhead. Photo 2.

**Corrective Action:** Remove stained soil to comply with 1002.f.(2).D **Date:** 03/11/2026

Stained soil has been cleaned up.

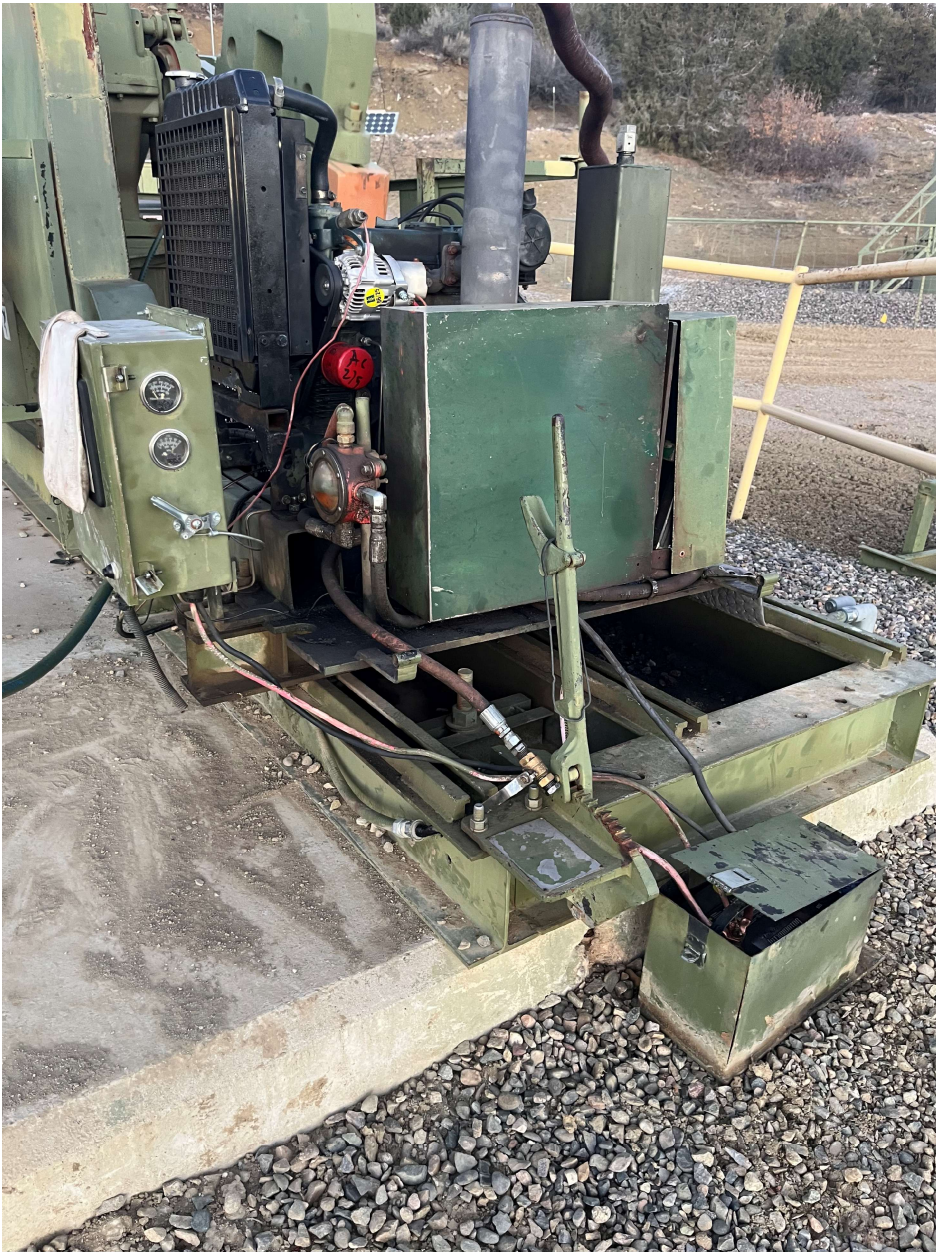
**Comment:** Gas. Broken electrical conduit with exposed frayed wires. Photo 6.

**Corrective Action:** Install or repair wires to comply with 608.d. **Date:** 03/11/2026

Wiring has been repaired and oily jug has been removed.
