Construction Reclamation and Stormwater Inspection

March 9, 2026

Location Name: Washington/Pad

Inspection Document #: 718601466

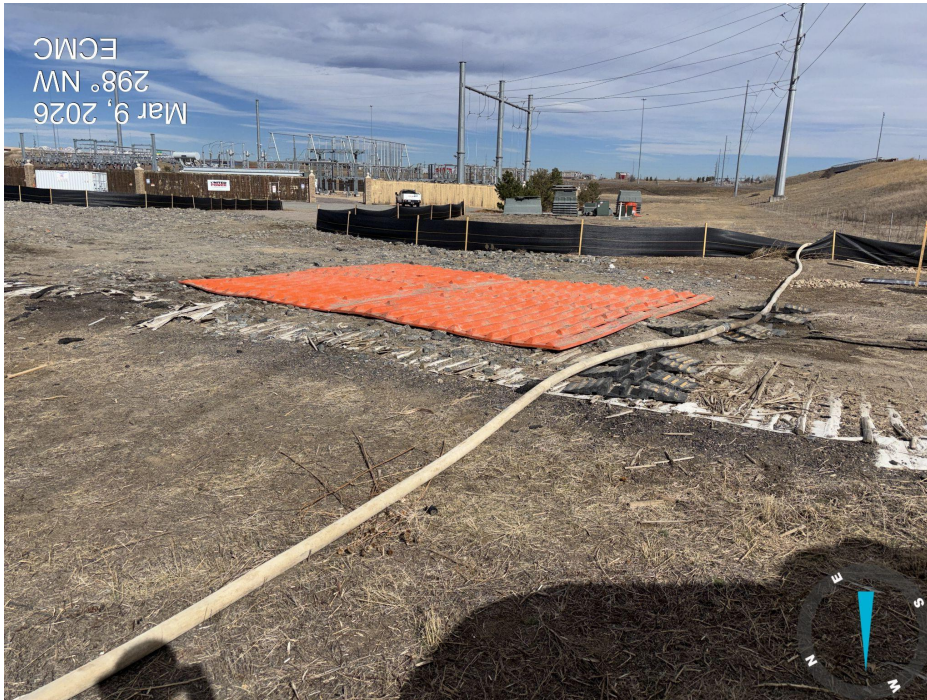
Photo 1. Trackpads are installed on top of existing electric substation BMPs. A water hose for nearby construction is present and unprotected.

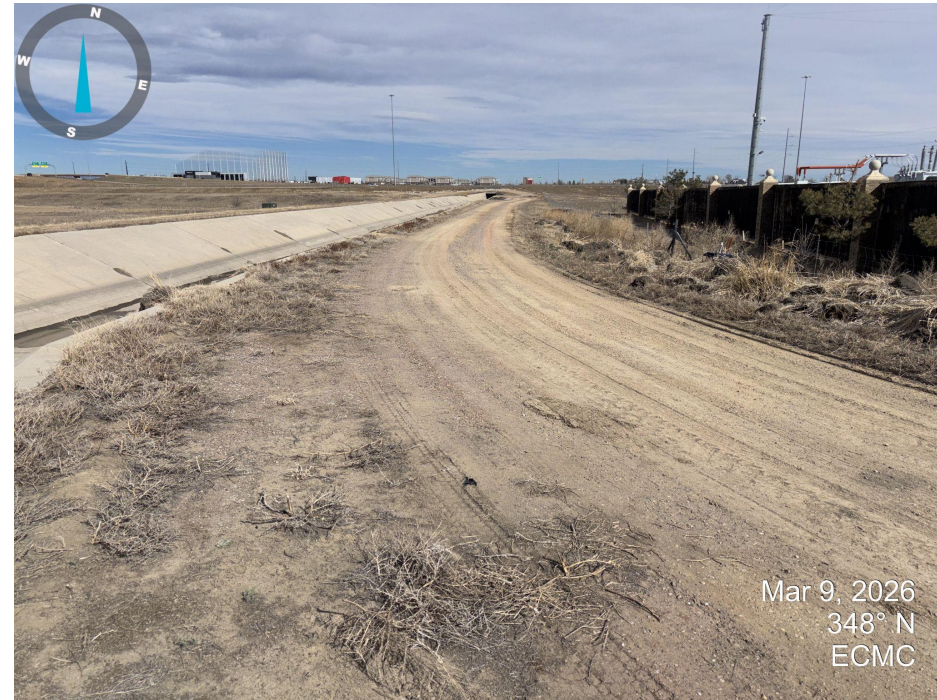
Photo 2. Vehicles are accessing the location via an existing road to the north of the location. The road travels along the active irrigation ditch and crosses near the highway. See photo 17.

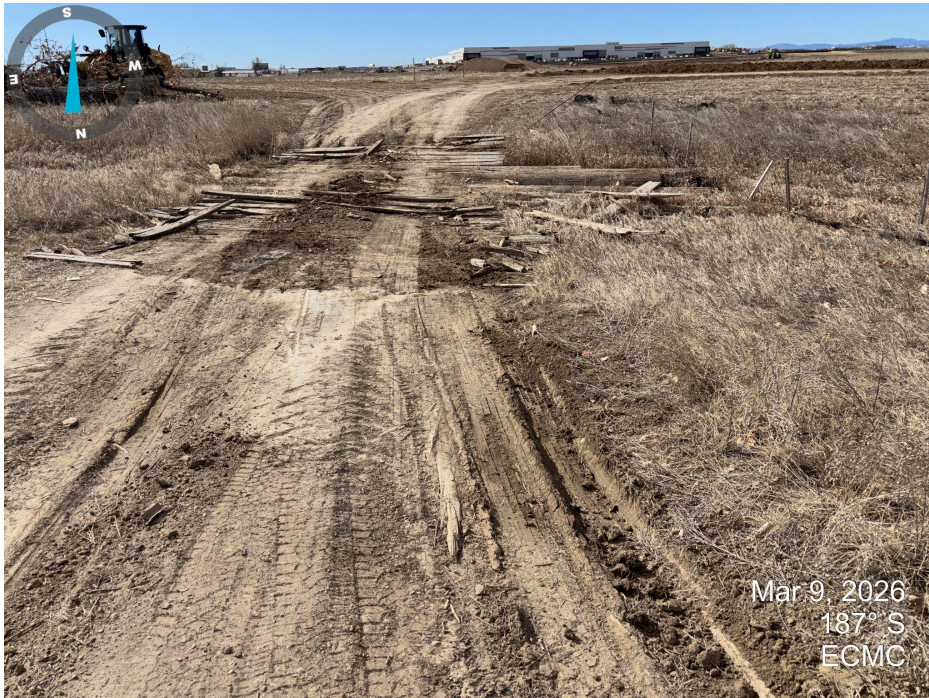
Photo 3. The currently utilized access road crosses an unused ditch section. The crossing is constructed of telephone poles and boards. The crossing is in poor condition.

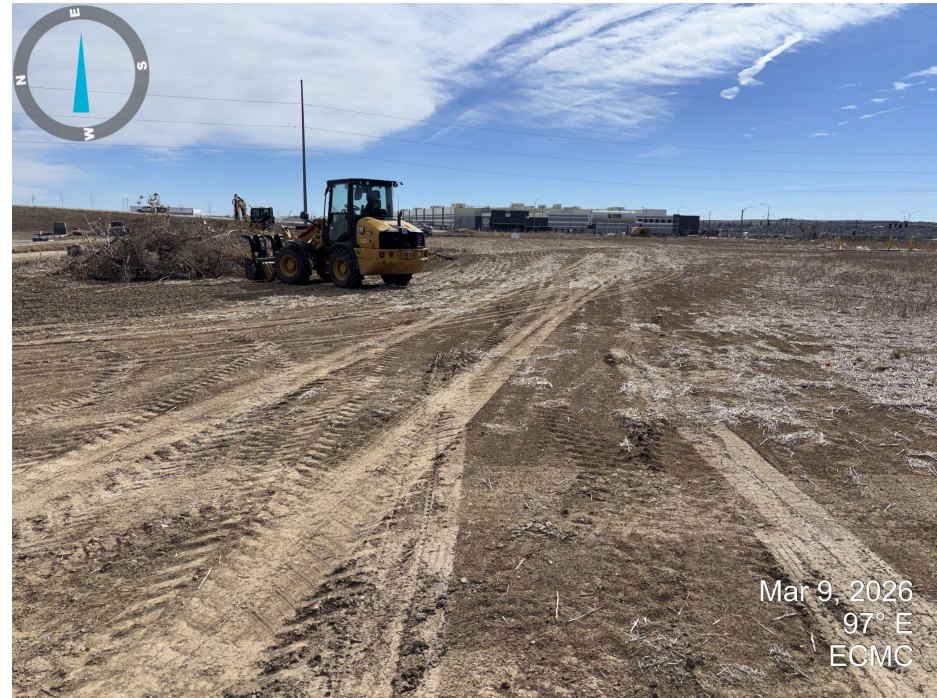
Photo 4. Looking east towards the entrance and proposed bridge area. Crews were clearing trees at the time of inspection. It did not appear that construction on the bridge had begun at the time of inspection.

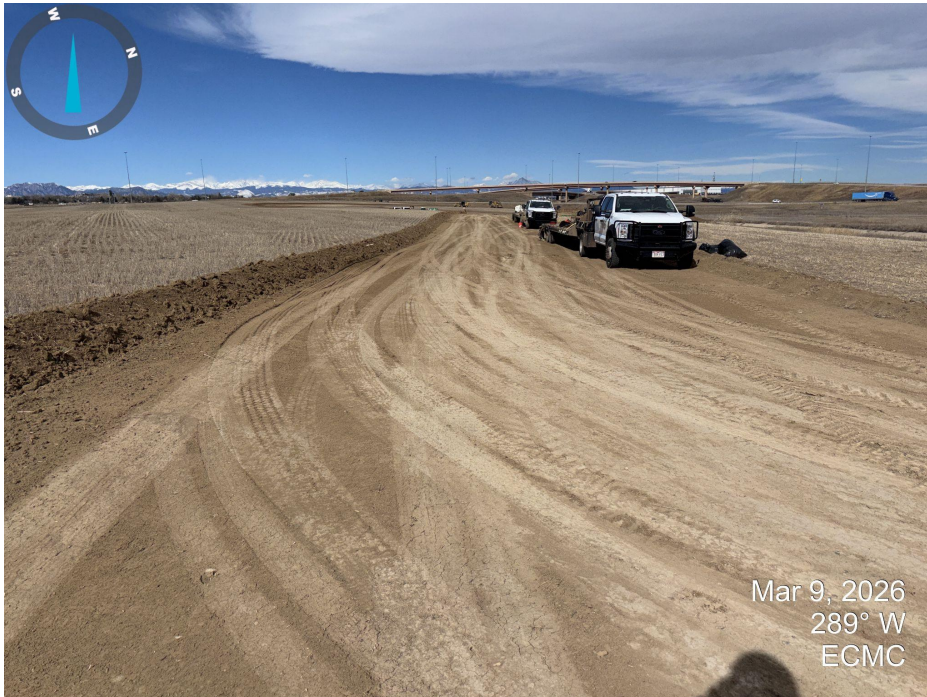
Photo 5. Looking west down the access road towards the well location. It appears that topsoil was salvaged from the access road.

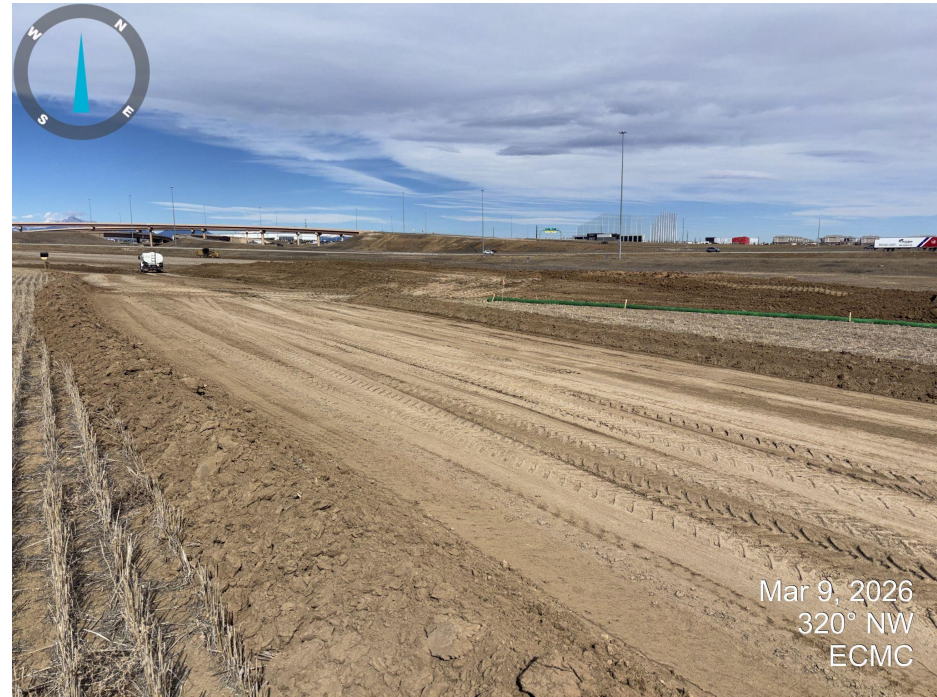
Photo 6. Looking northwest across the location. Topsoil was being salvaged at the time of inspection.

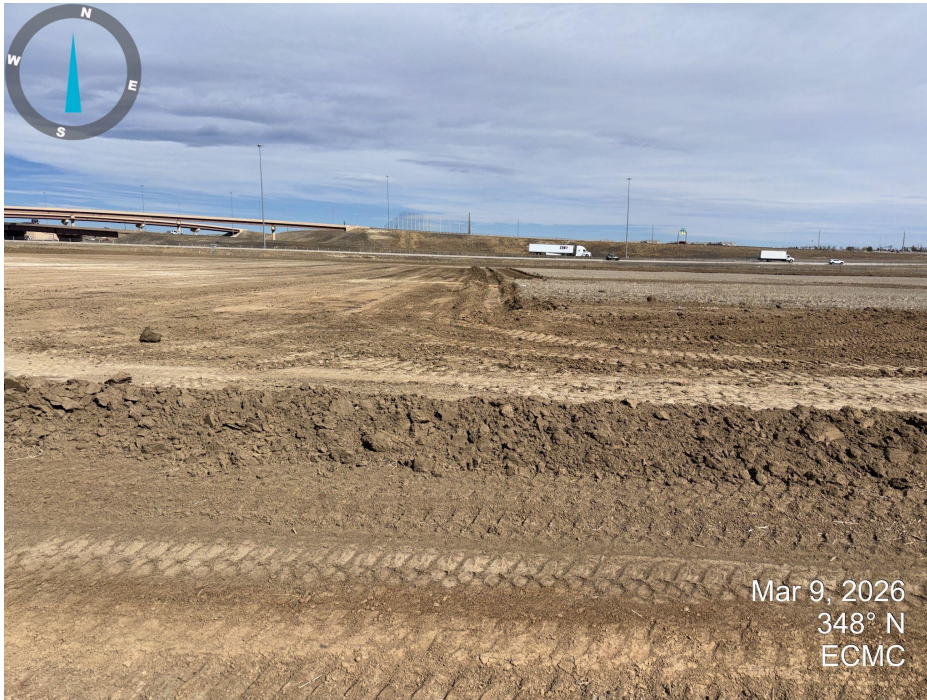
Photo 7. photo taken from the south side of the location looking north across the location. Topsoil was being salvaged at the time of inspection.

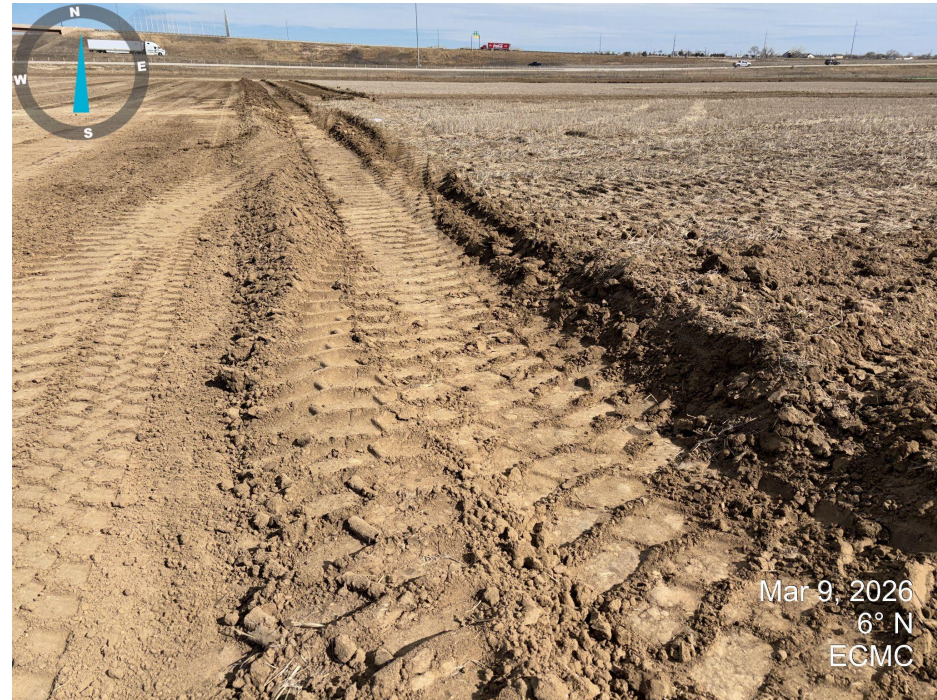
Photo 8. It appears that approximately 10 inches of topsoil was salvaged in this area.

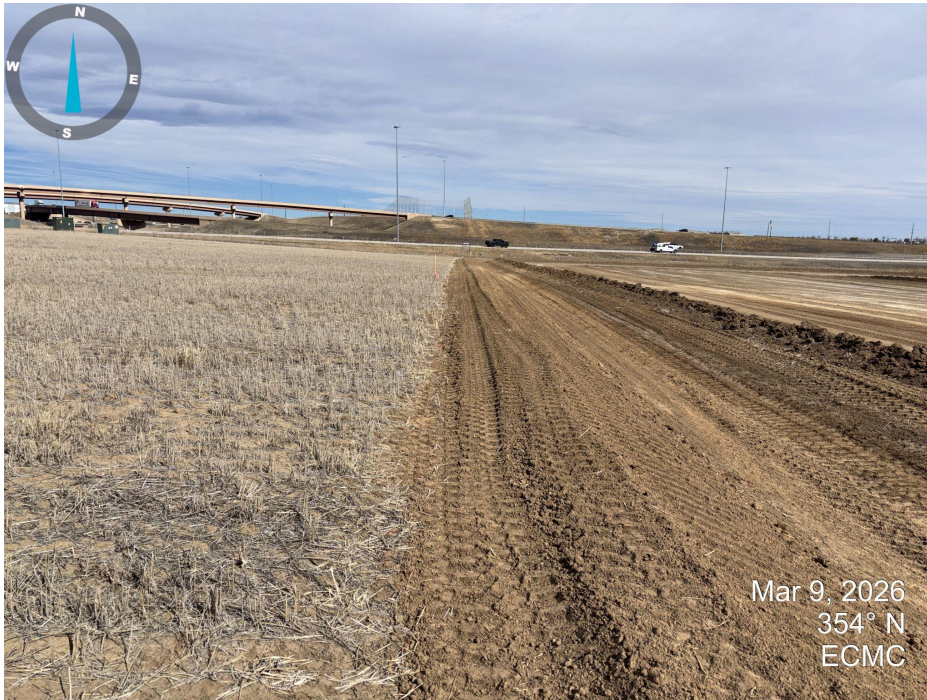
Photo 9. Looking north down the west side of the location. A ditch and berm is present on this side of the location.

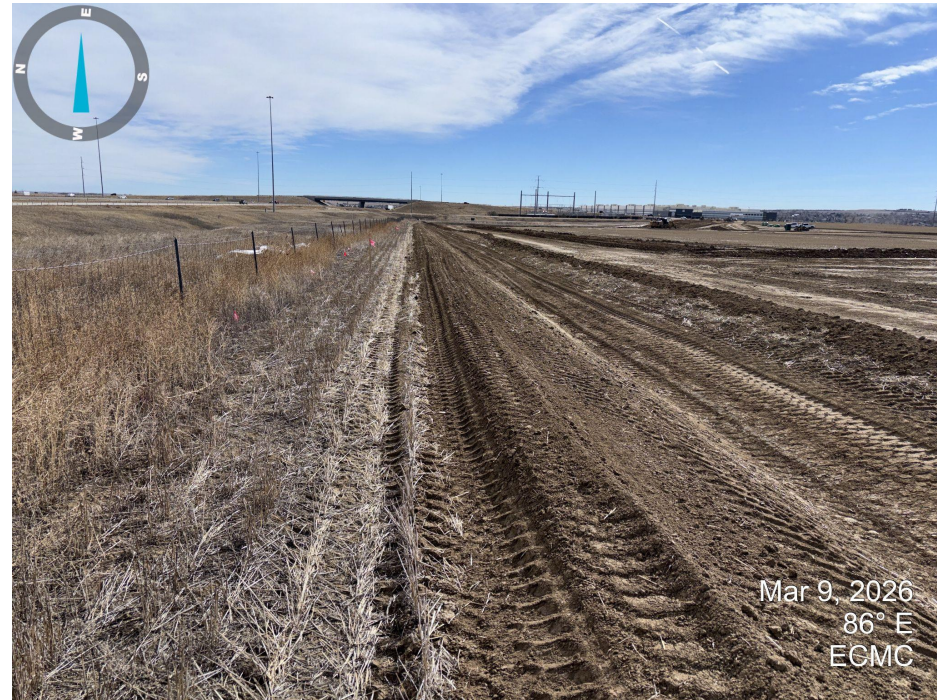
Photo 10. Looking east down the north side of the location. A ditch and berm is present on a portion of this side of the location. Th ditch and berm transitions to filtrex waddles near the east side.

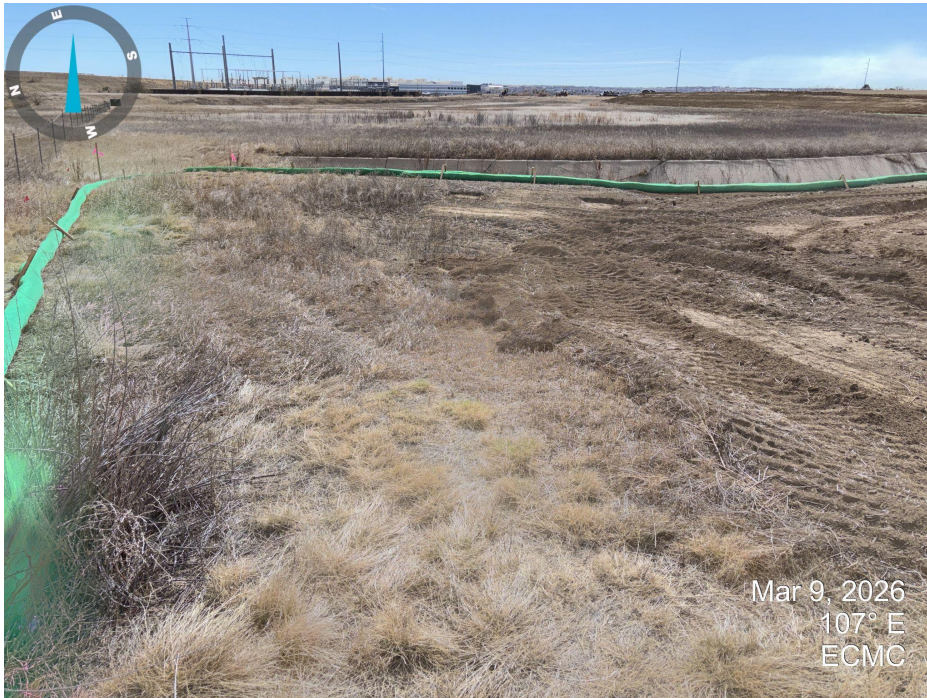
Photo 11. Picture taken at the northeast corner of the location. This area has a filtex waddle installed around it. No additional BMPs were constructed at the time of inspection. It appears this is the low/water accumulation area for most of the pad.

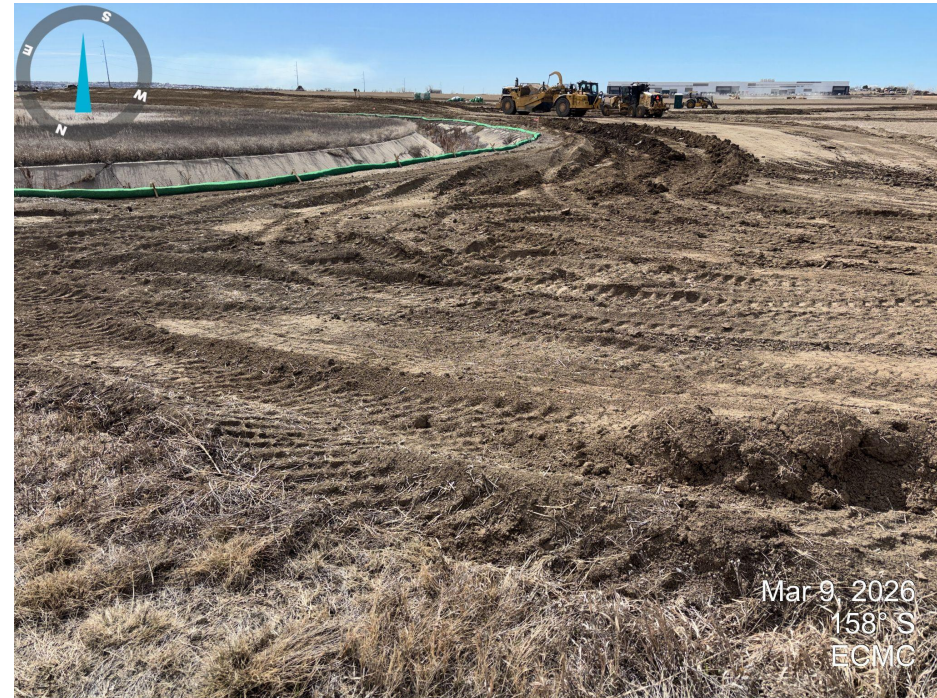
Photo 12. Looking south across the same northeast corner.

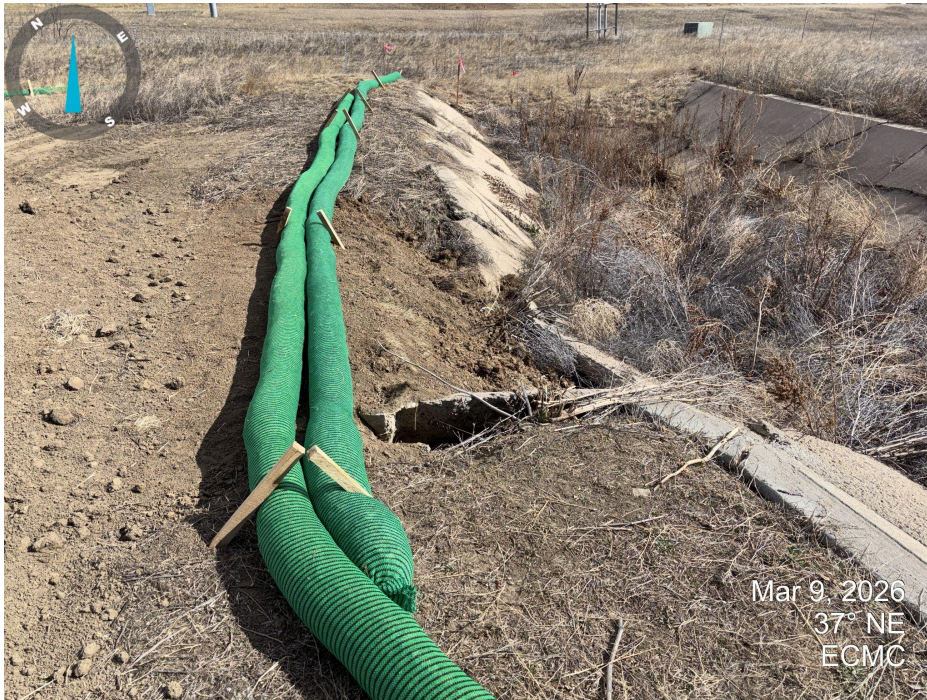
Photo 13. Photo taken at the northeast corner looking north. Filtrex waddles are installed at the edge of the unused portion of the canal. The height difference and low spots along the canal are shown in this photos.

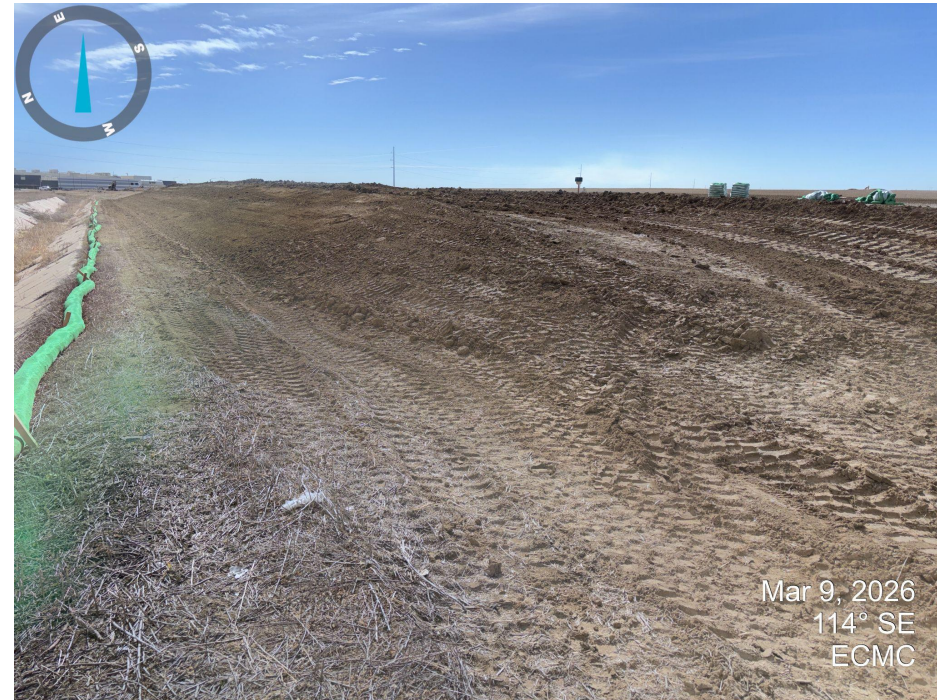
Photo 14. A topsoil stockpile was being constructed at the time of inspection. The only stormwater bmp around the topsoil stockpile is filtrex waddle on the canal side.

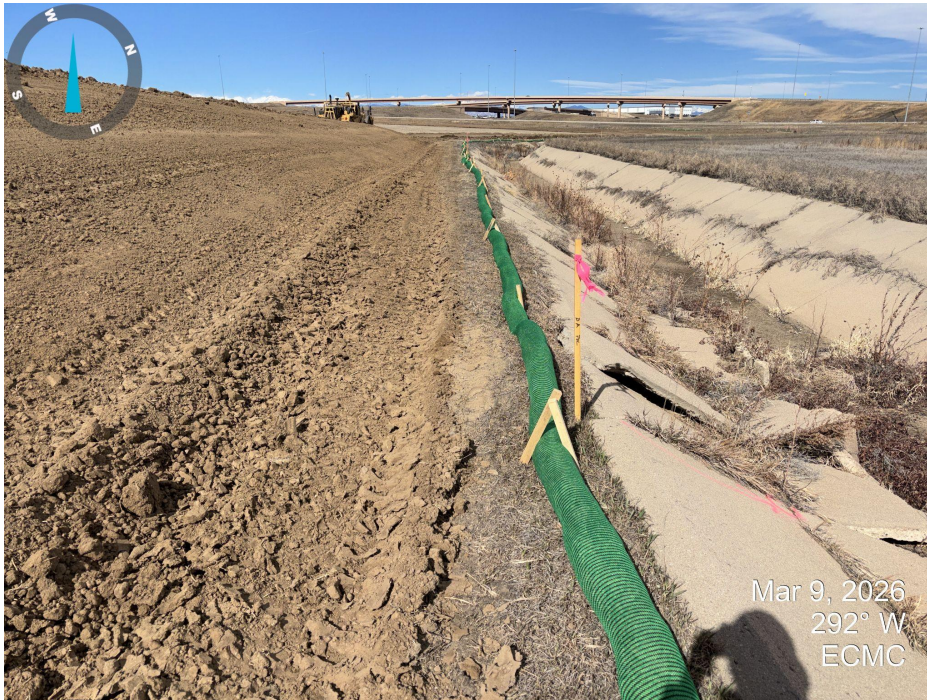
Photo 15. Looking west down the topsoil stockpile. Filtrex wattle is laid over low spots that will allow water and sediment build up/ overflow.

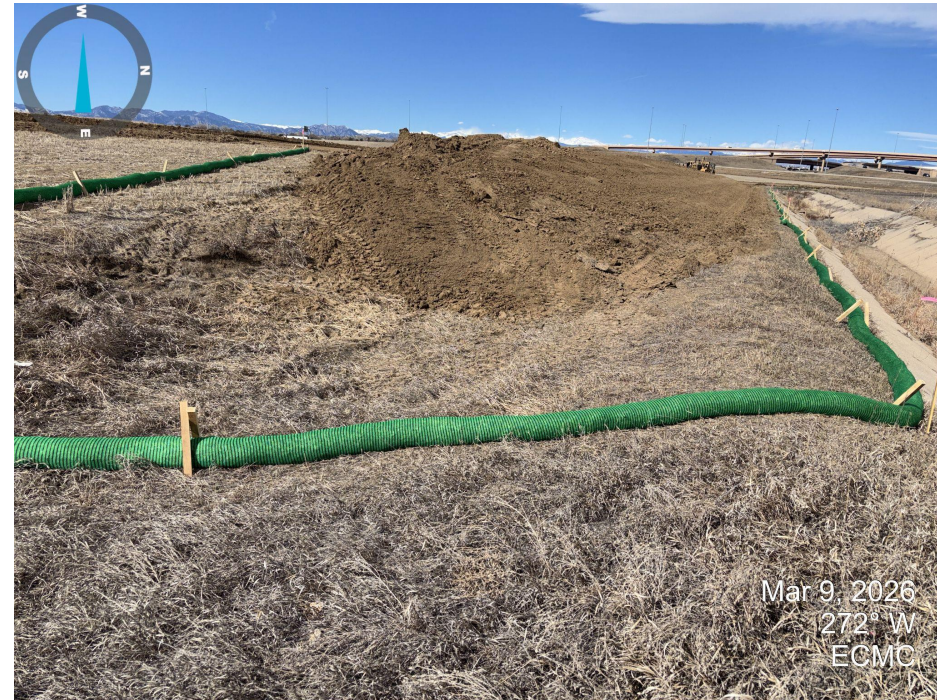
Photo 16. Picture looking west at the east side of the topsoil stockpile. Slope heads northeast .

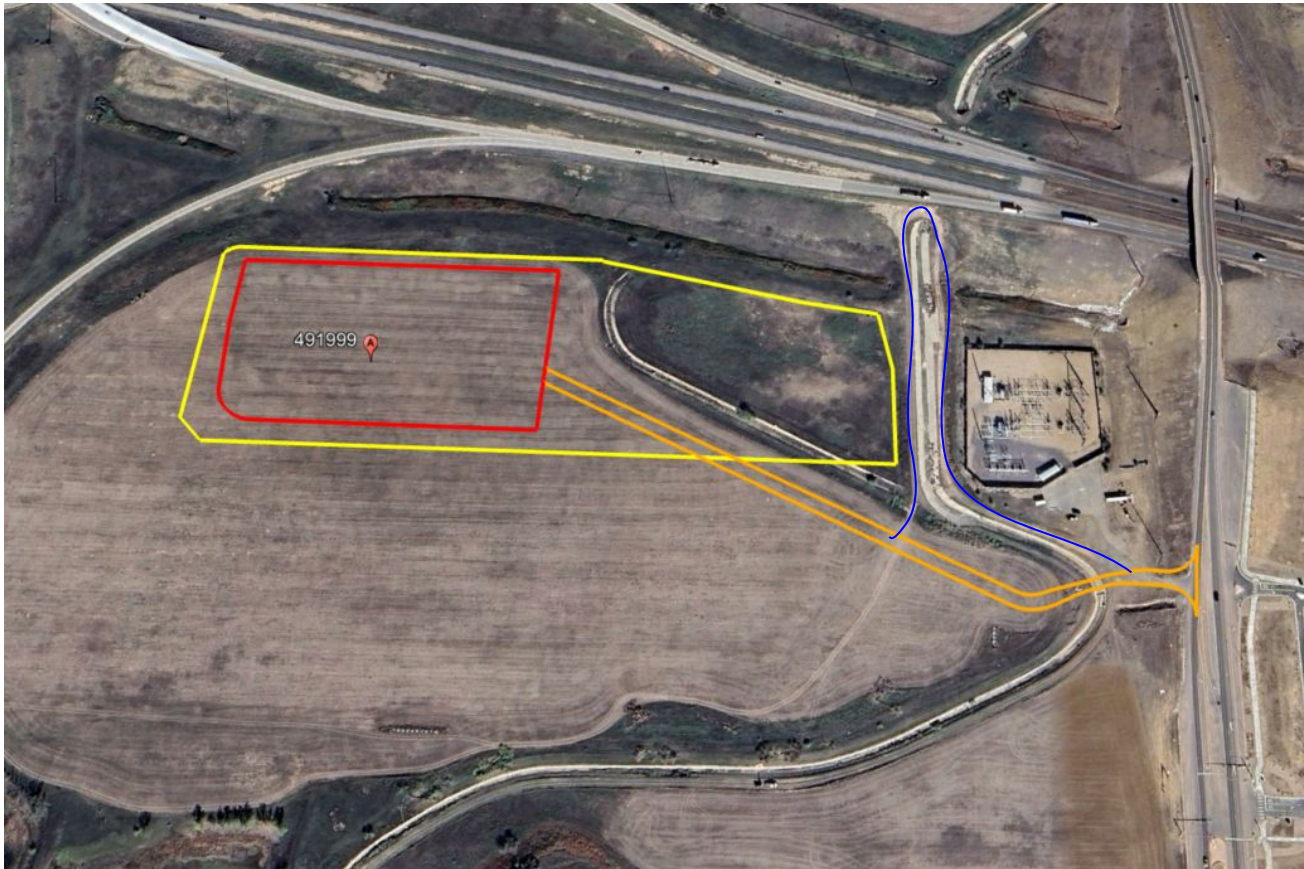
Photo 17. Google earth aerial imagery taken 10/2025 with the proposed location and approved access road (orange outline). The approximate path of the unauthorized access road usage is drawn in blue.
