Final Reclamation and Stormwater Inspection

Location ID: 317279

Well Name: PACHNER #1-30

Inspection Document #: 718601408

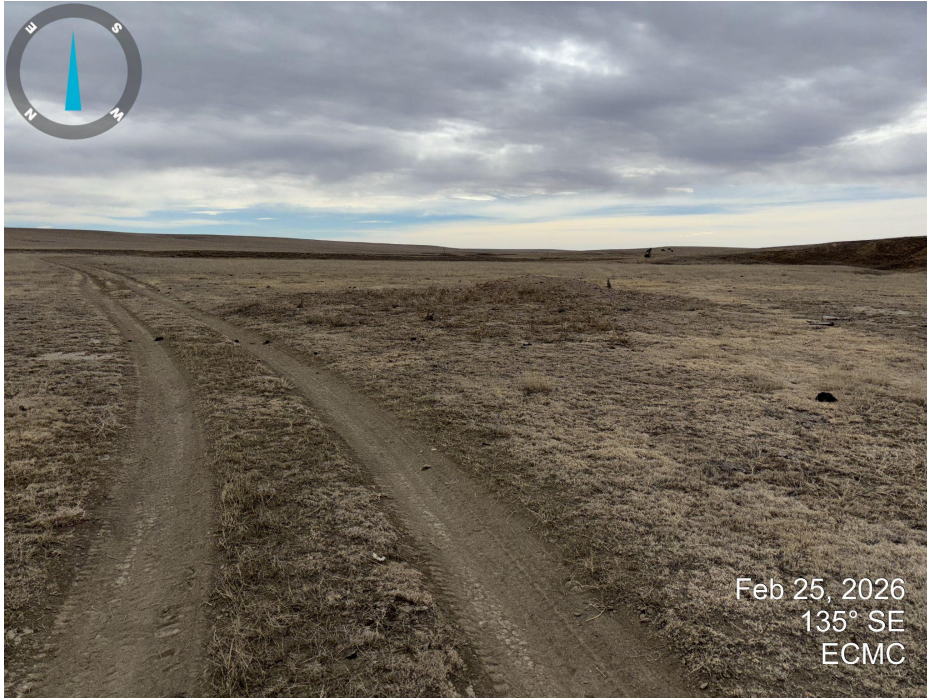
Photo 1. Looking southeast across the well location. An approximately 3ft pile of gravel/soil is present over the wellbore. No oil and gas equipment is present on the surface.

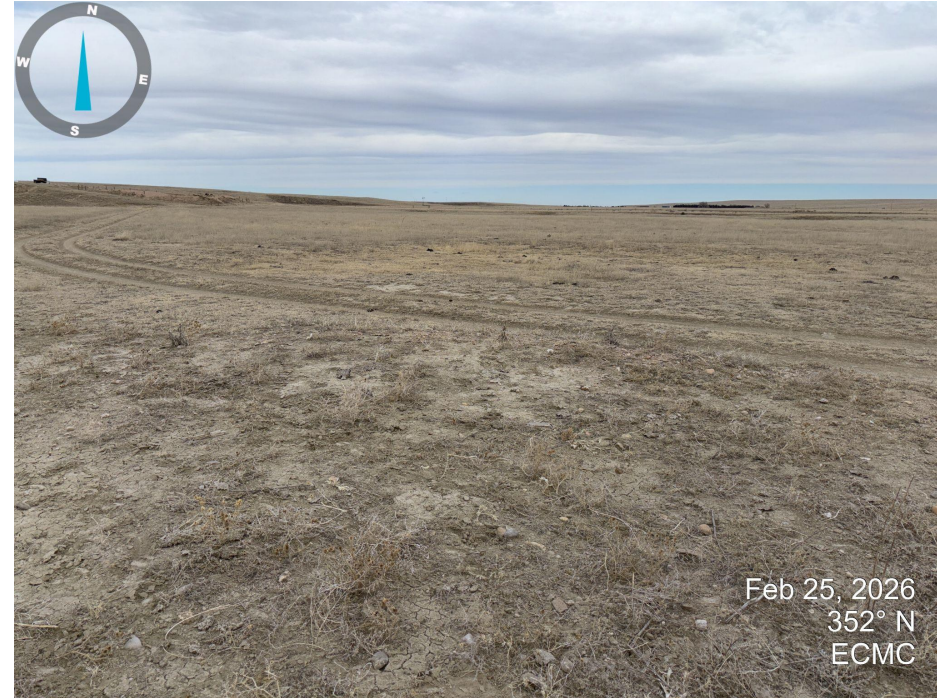
Photo 2. Looking north from the wellbore area. The area around the wellbore including the gravel pile is primarily bare soil or undesirable weedy species such as kochia. List B noxious weed bull thistle was also observed on location.

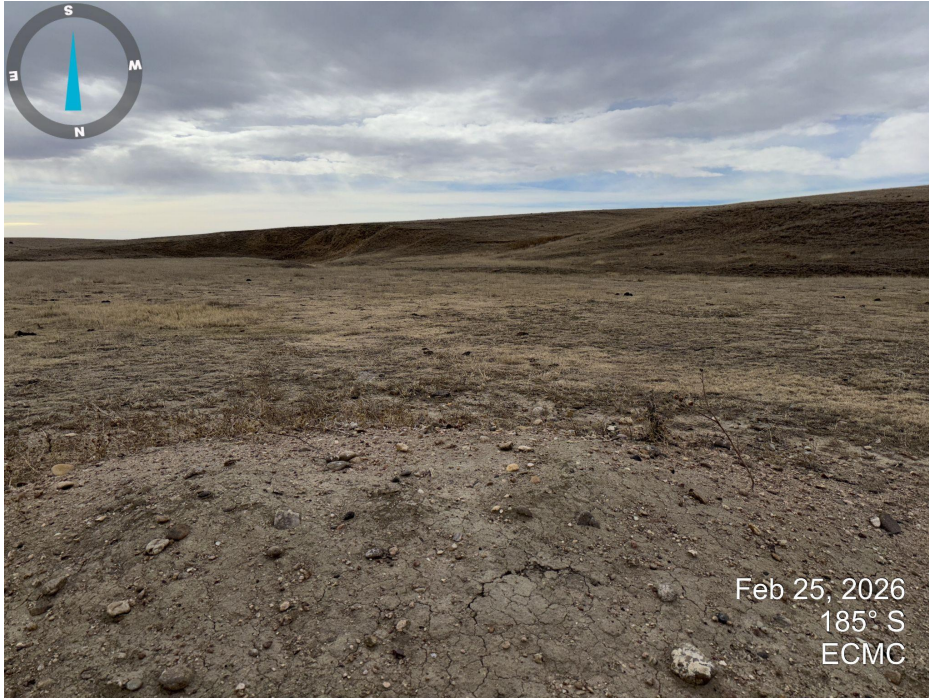
Photo 3. Looking south from the wellbore. See photo 2 comments.

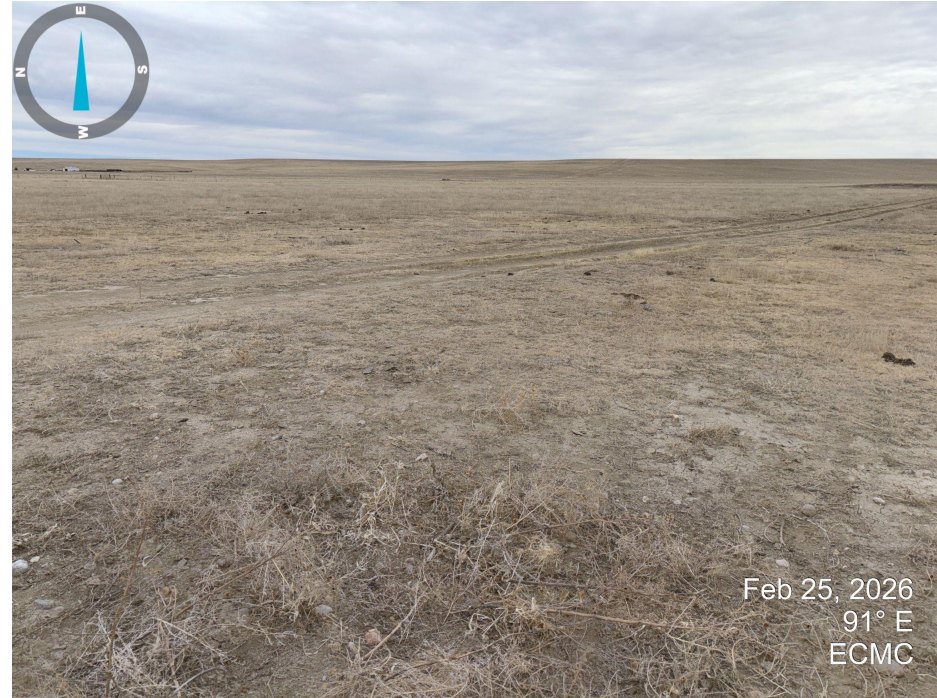
Photo 4. Looking east from the wellbore. See photo 2 comments.

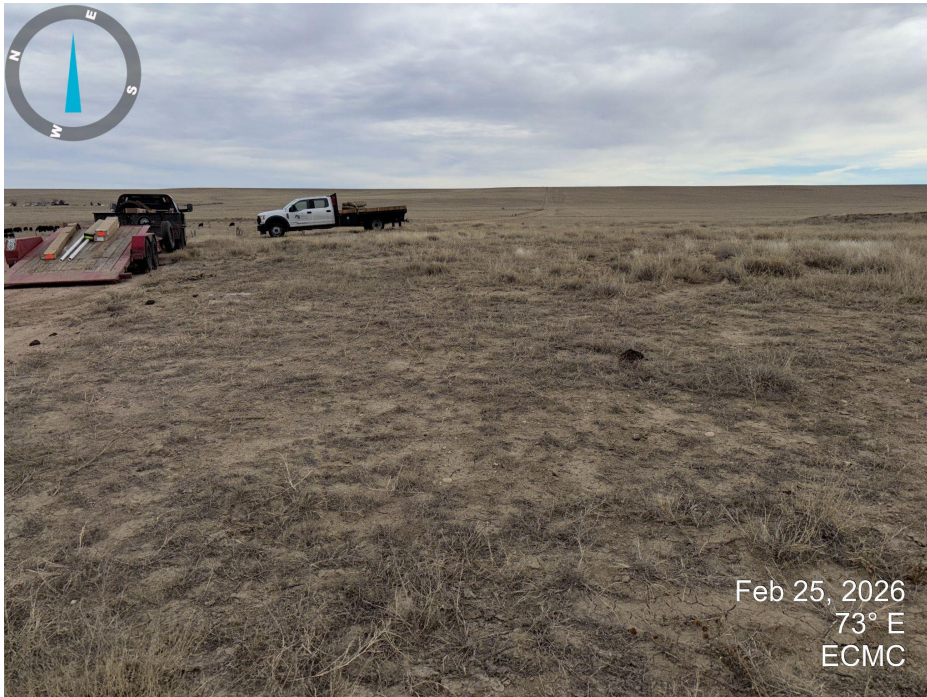
Photo 5. Looking east across the tank battery location. At the time of inspection contracts were conducting environmental sampling on location. Vegetation on the tank battery is not uniform and areas of bare soil and undesirable weedy species are present.

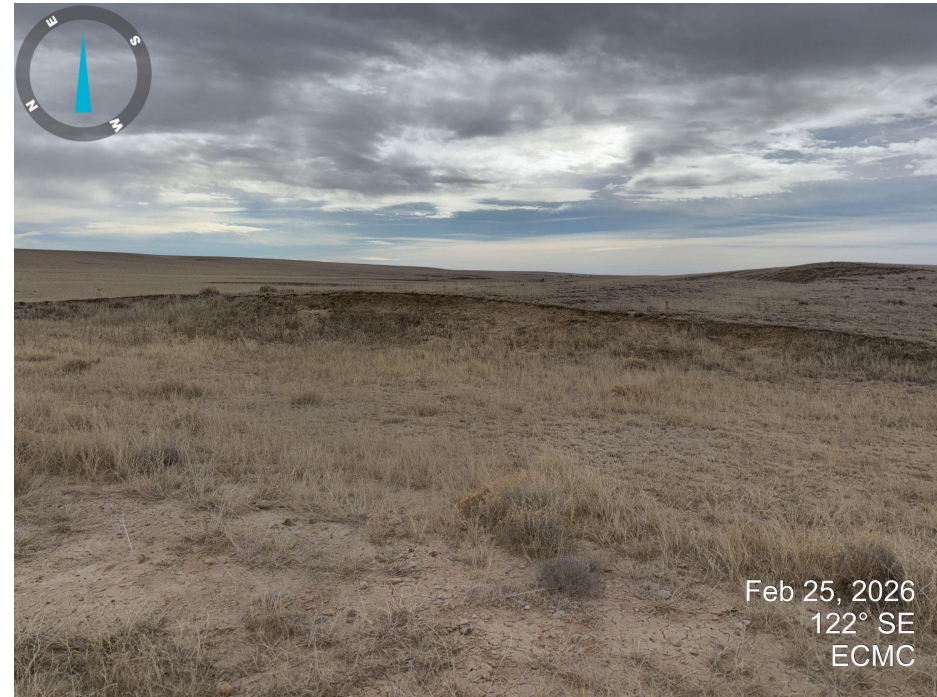
Photo 6. Looking east across the tank battery location. The tank battery has not been recountured to match the surround terrain. The east cut slope does not appear to be stabilized and does not have vegetation establishment that is reflective of the surrounding area.

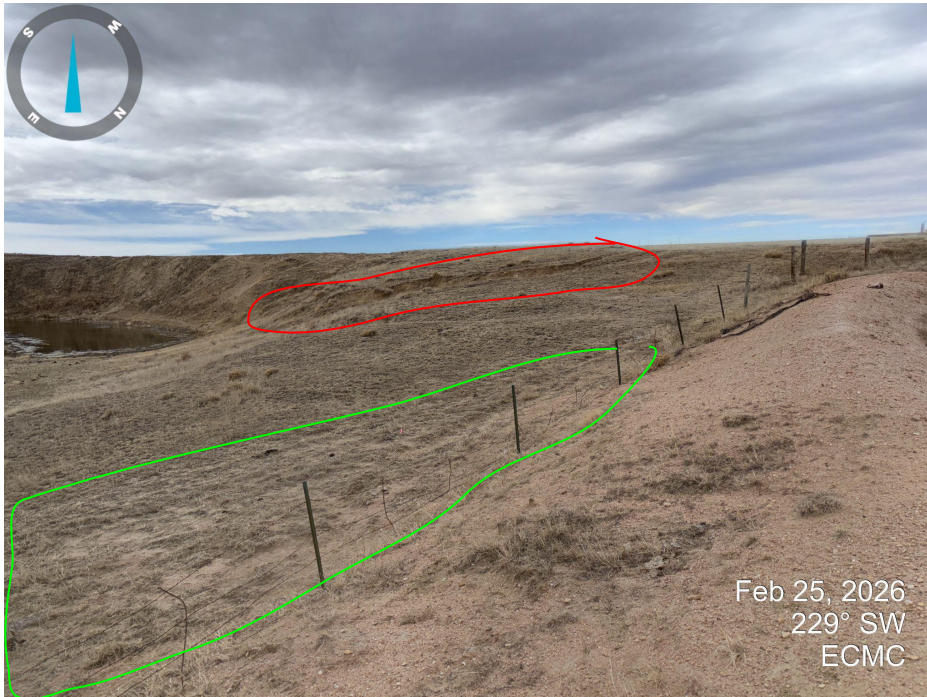
Photo 7. Photo taken from the southeast corner of the southern pit looking towards the tank battery area. A stormwater erosion channel travels off the tank battery pad down towards the pond (red circle). Downgradient of the pit, vegetation appears to have less coverage than surrounding areas (green circle). This area does appear to be stabilized by perennial vegetation at the time of inspection.

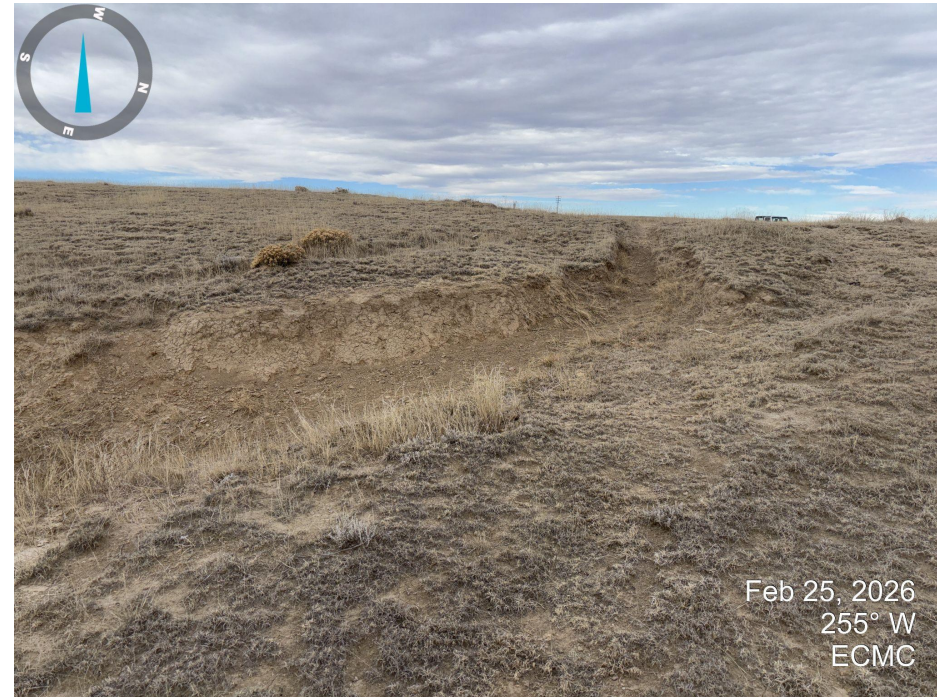
Photo 8. Closeup photo of erosion channel from the tank battery pad. Channel forms at the southeast corner of the tank battery pad and gully erosion is present. Livestock may be contributing to erosion.

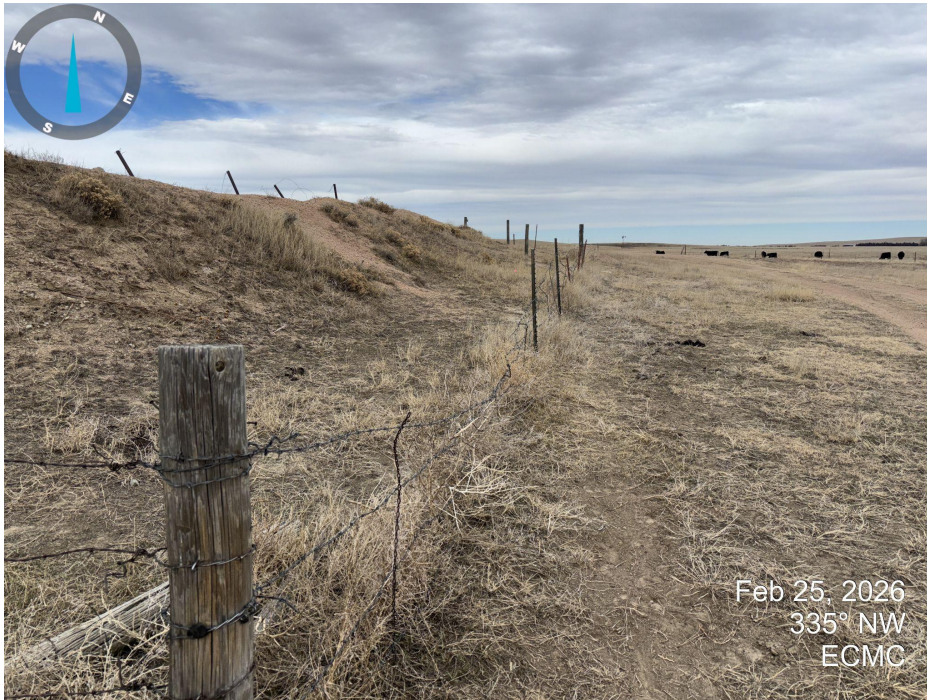
Photo 9. Looking north along the east side of the south pit. Desirable vegetation is present in this area. Fence is loose and down around both pits. Debris including netting and metal scrap is present around the pits.

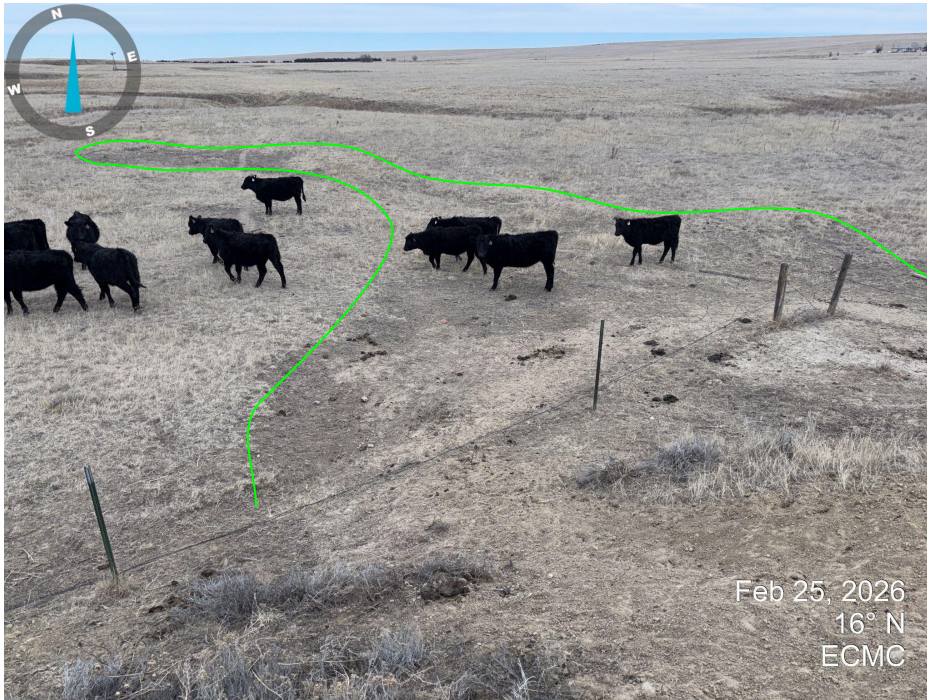
Photo 11. photo taken at the northeast corner of the northern pit. A saltkill area was observed downgradient of the pit (green circle). The saltkill area has limited desirable vegetation establishment compared to the surrounding reference area.

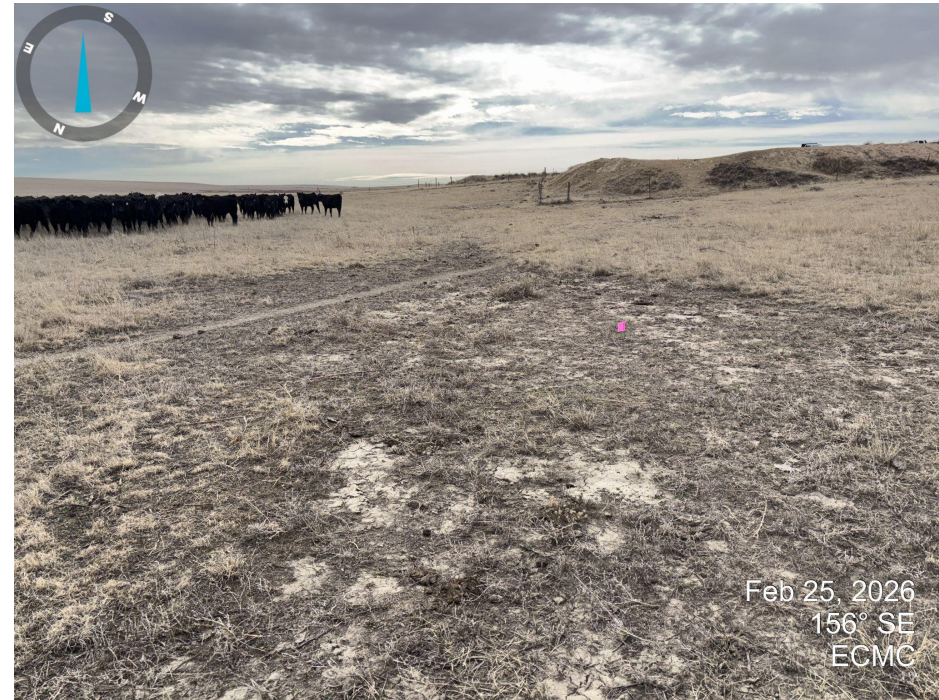
Photo 12. Photo taken north of the north pit looking south across the saltkill area. This area is primarily bare soil or undesirable weedy vegetation.

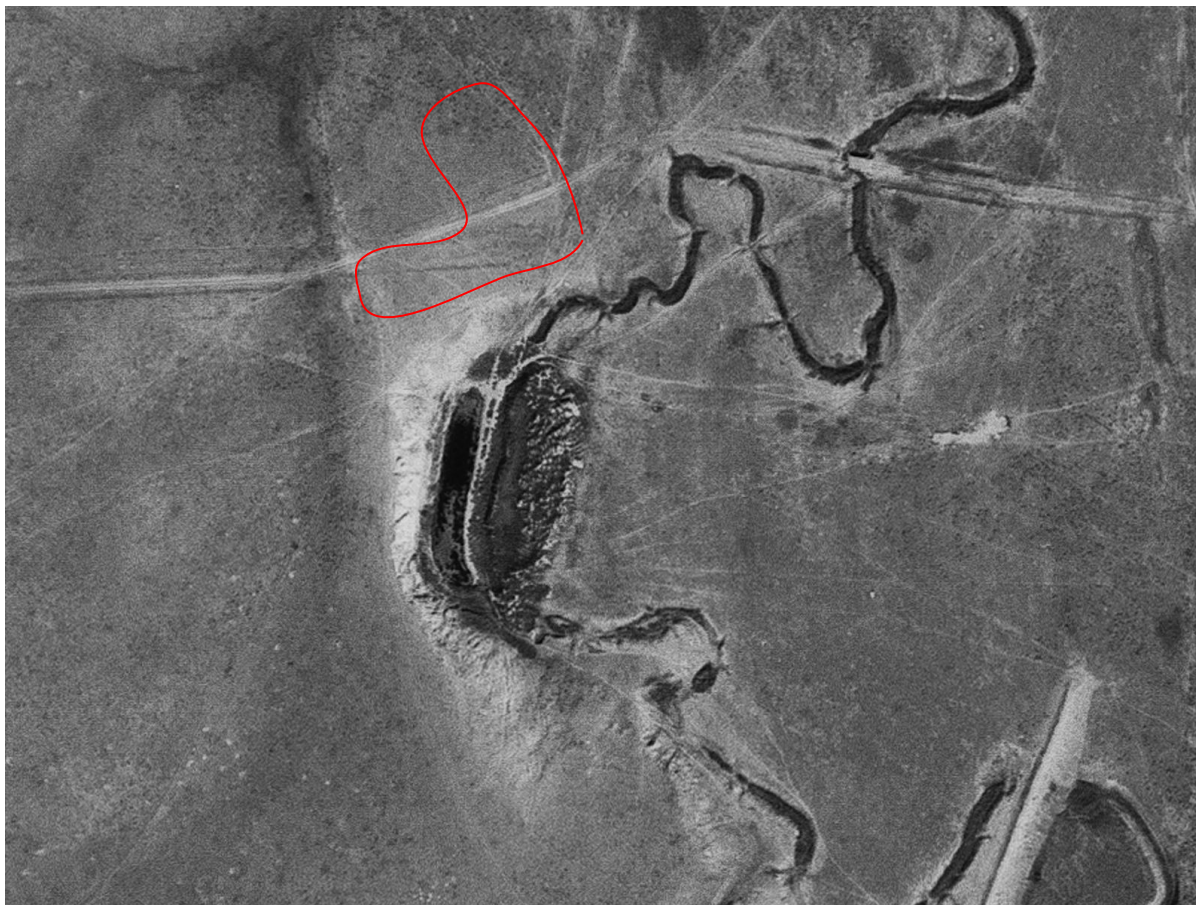
Photo 14. Historic aerial imagery taken 01/1972. It appears the pond was excavated before oil and gas development. Approximate tank battery and pit location (red circle)
