Inspection Photos

Location Name: Dillard USX/AB29-02

Location #: 420817

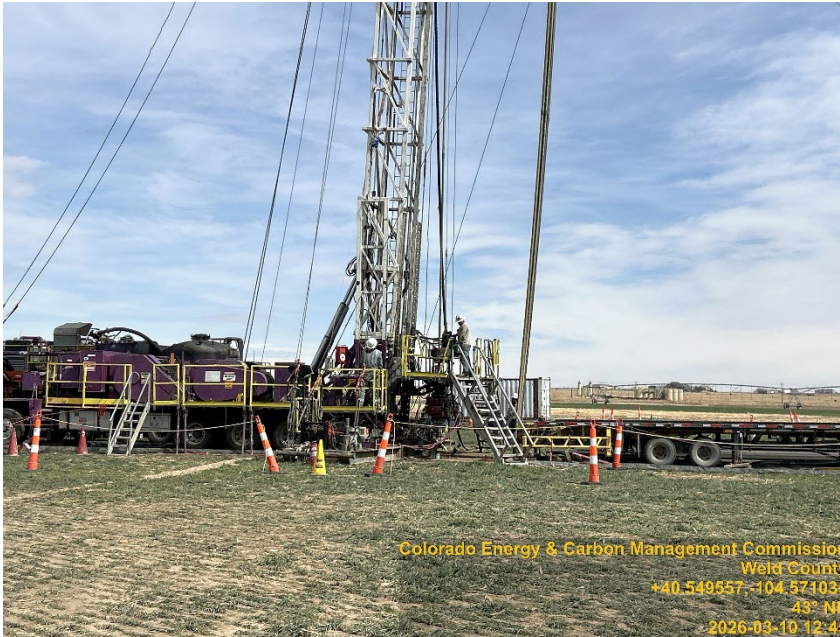
Photo #1

Dillard USX AB29-02 (123-32720) Wellsite
Plugged & Abandoned | PA
Plugging Ops; Cementing: Cement-surface

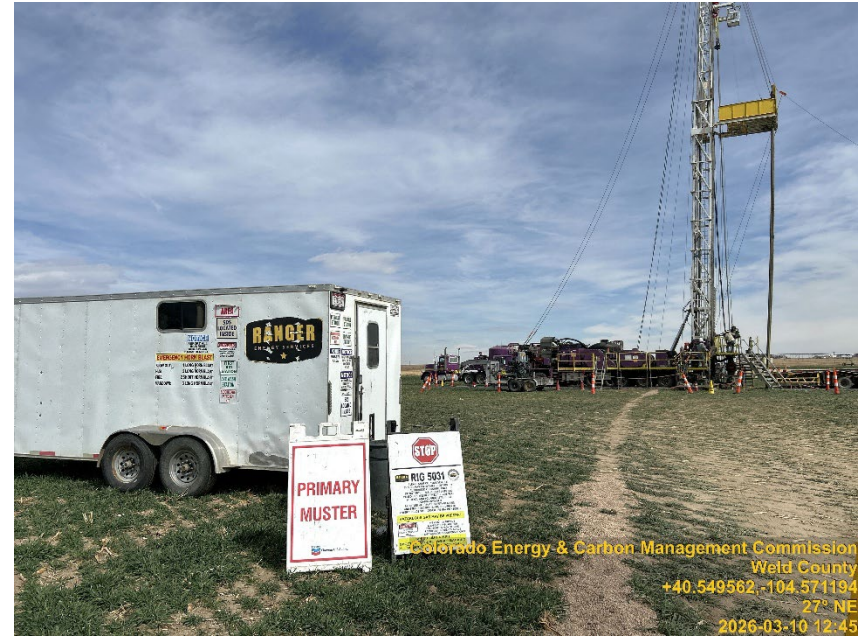
Photo #2

Dillard USX AB29-02 Wellsite
Plugged & Abandoned | PA
Plugging Ops; Cementing: Cement-surface
Site safety signage

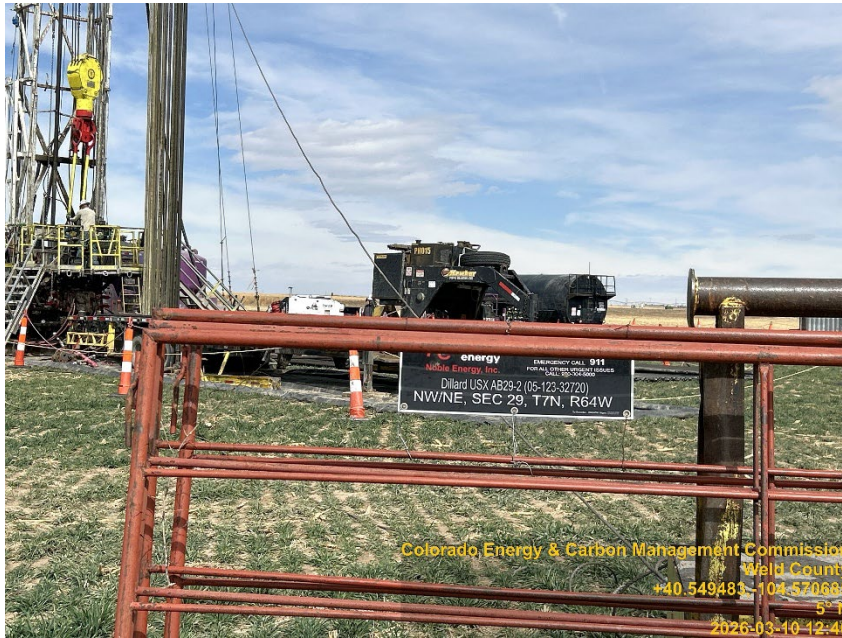
Photo #3

Dillard USX AB29-02 Wellsite

Plugged & Abandoned | PA

Plugging Ops; Cementing: Cement-surface

wellsite signage

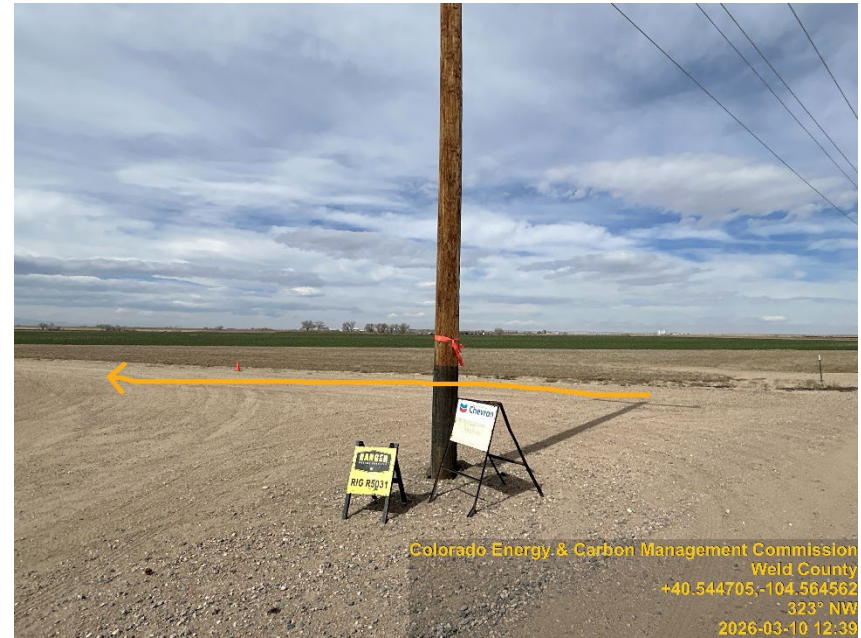
Photo #4

Dillard USX AB29-02 Wellsite

Plugged & Abandoned | PA

Plugging Ops; Cementing: Cement-surface

Wellsite entrance

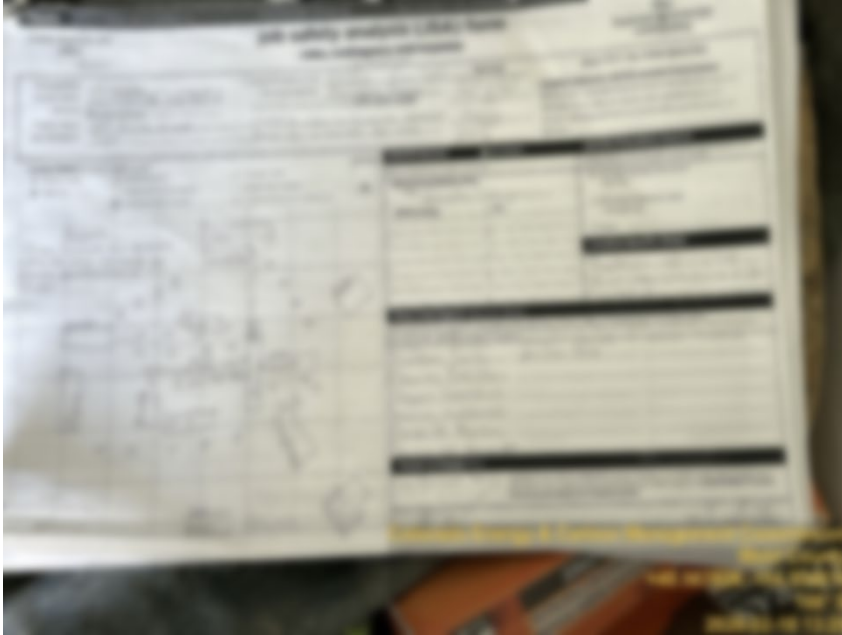
Photo #5

Dillard USX AB29-02 Wellsite

Plugged & Abandoned | PA

Plugging Ops; Cementing: Cement-surface

JSA; 2026-03-10;

Digital on file

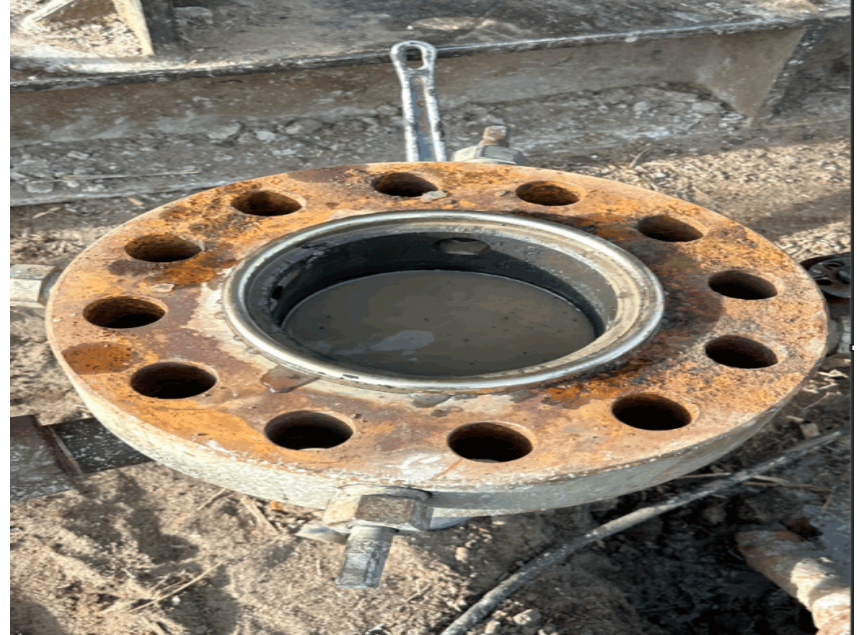
Photo #6

Dillard USX AB29-02 Wellsite

Plugged & Abandoned | PA

Plugging Ops; Cementing: Cement-surface

Well; Operator photo
