# Inspection/Audit Photos

Location Name: QB ENERGY OPERATING LLC CHEVRON 41A-8D (PARACHUTE CREEK 7 696)

Location #: 335811

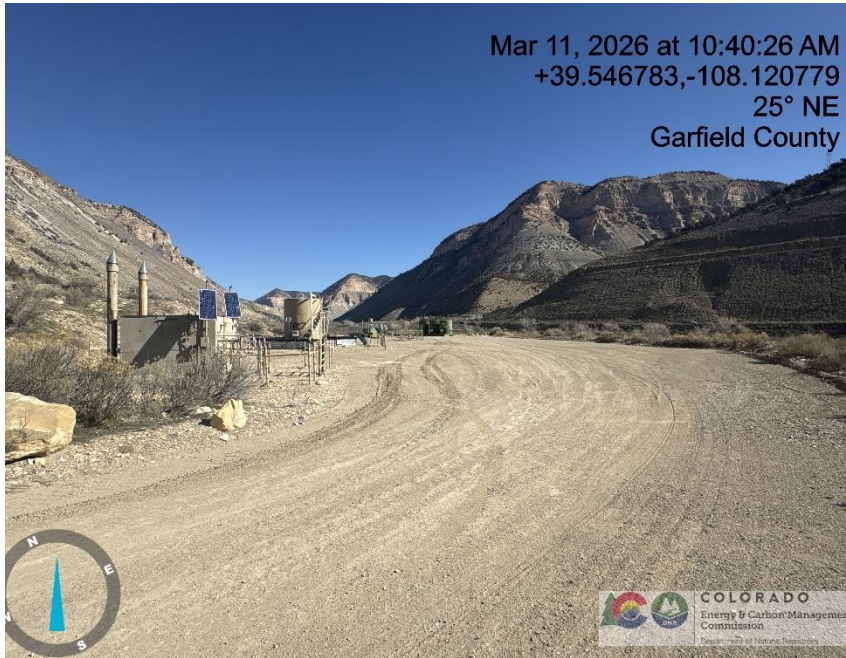
Photo # 8372 From entrance to location

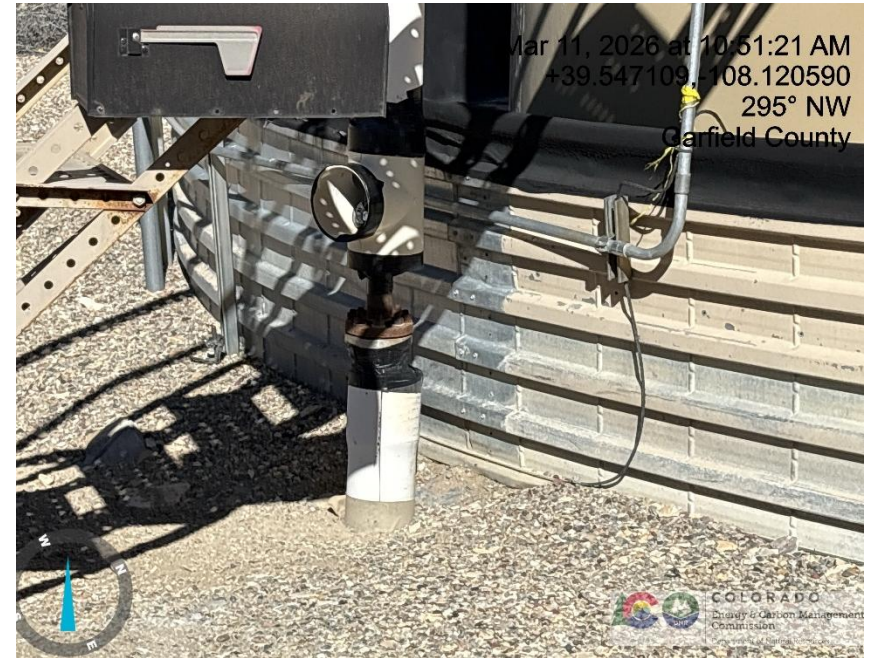
Photo # 8377 Flowline heating insulation open ended  
/wildlife hazard/available for entry by wildlife

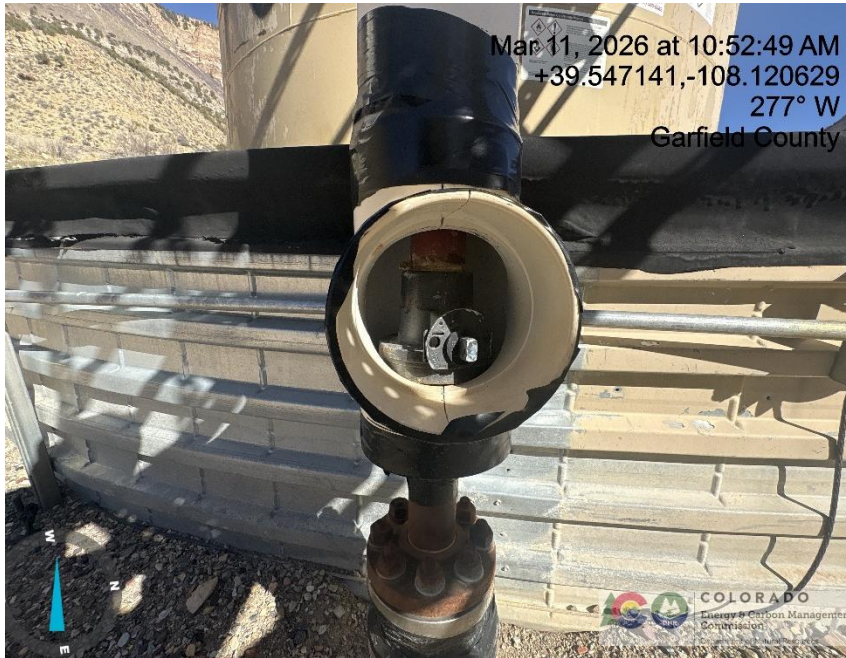
**Photo # 8378 Flowline heating insulation open ended  
/wildlife hazard/available for entry by wildlife**
