Inspection Photos
Location Name: Jones 32-18
API: 05-125-11698

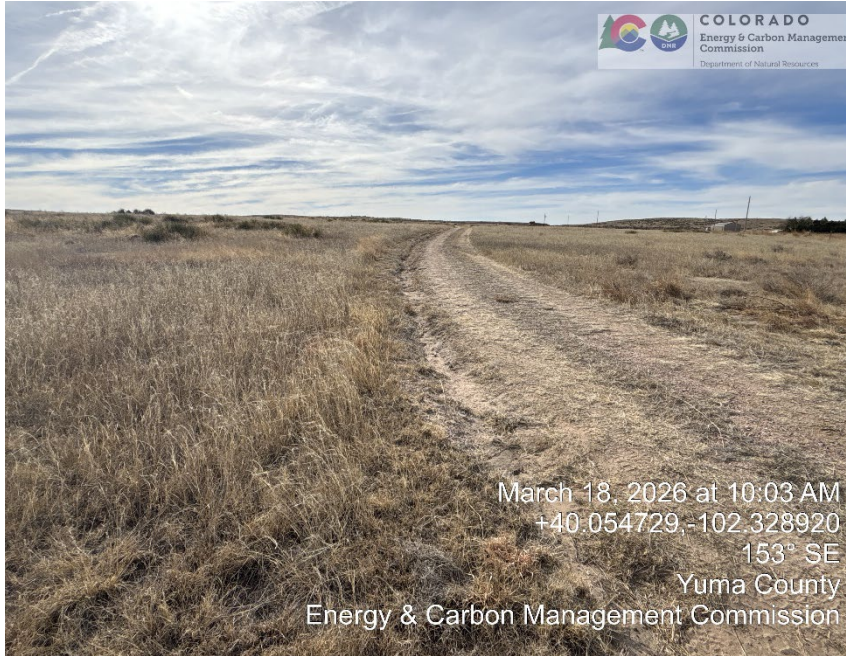
2 track erosion
