Inspection/Audit Photos

Location: TEP ROCKY MOUNTAIN LLC FEDERAL RG #31-20-298 PAD

Location ID: 316473

Date: 03/17/2026

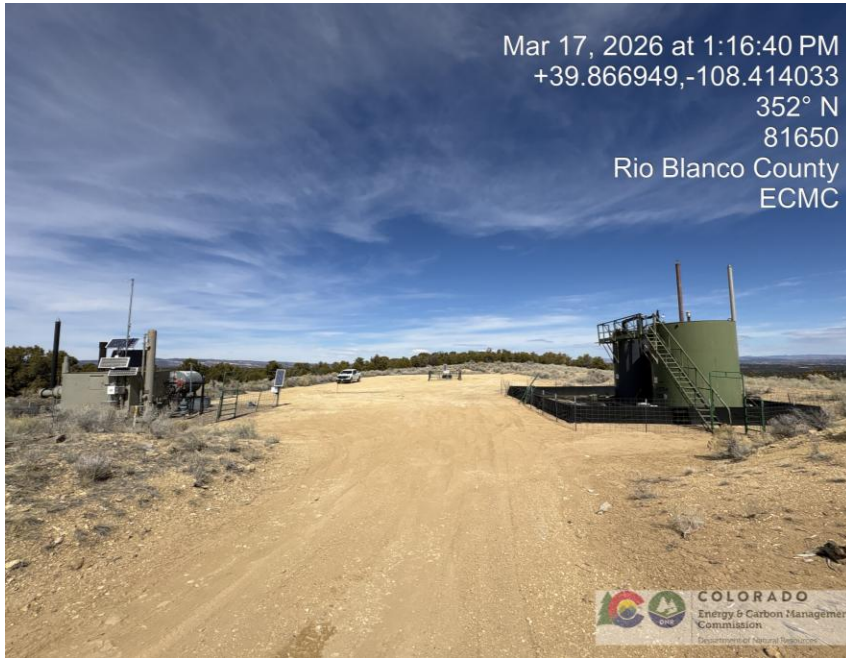
Photo # 3223 Entrance to location

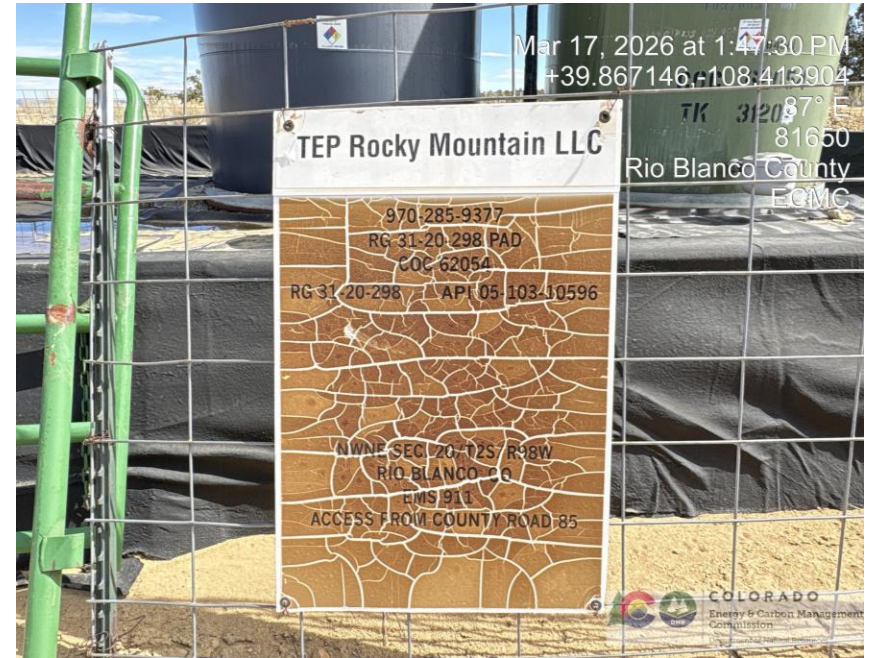
Photo # 3252 Battery sign is weathered & cracking/starting to become illegible

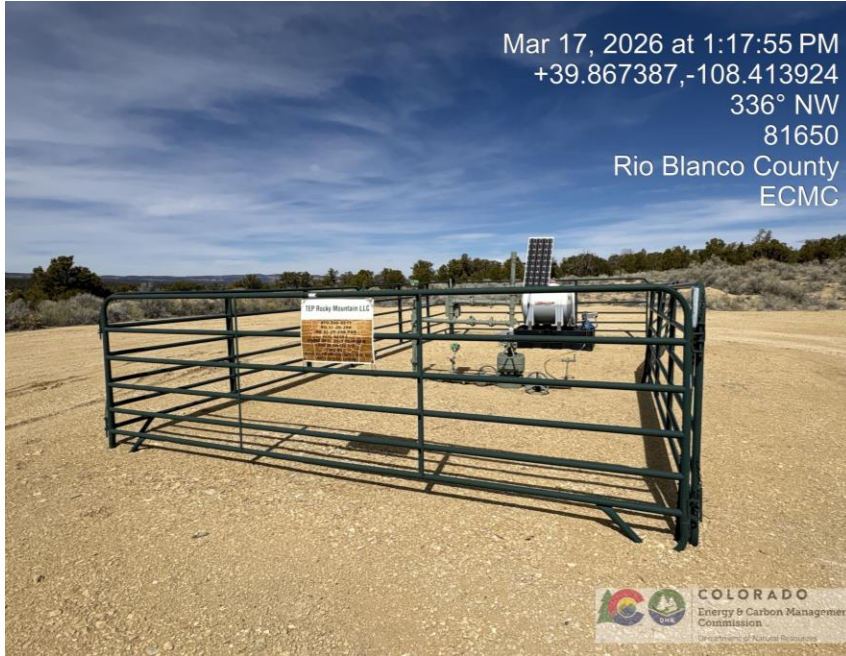
Photo # 3224 Location

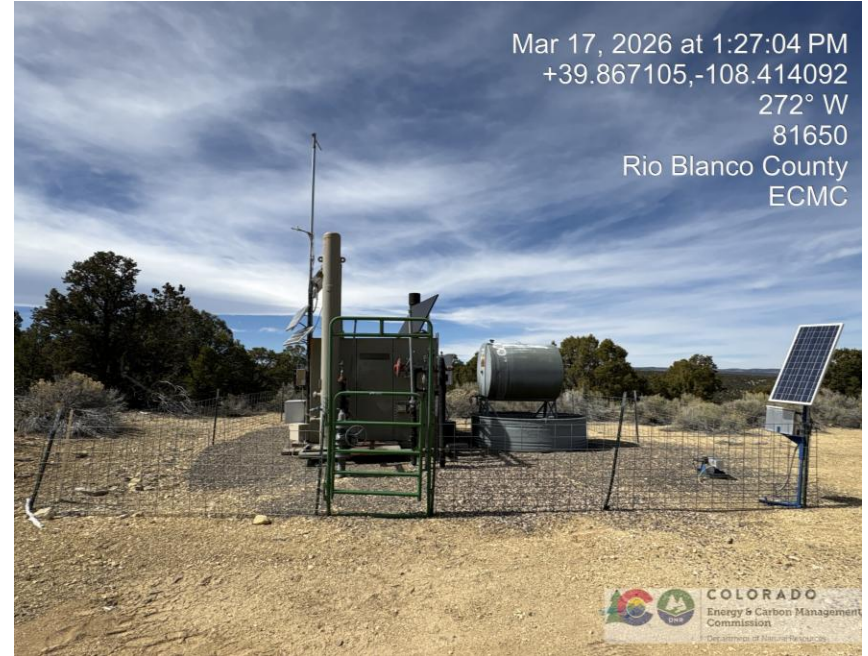
Photo # 3232 Location

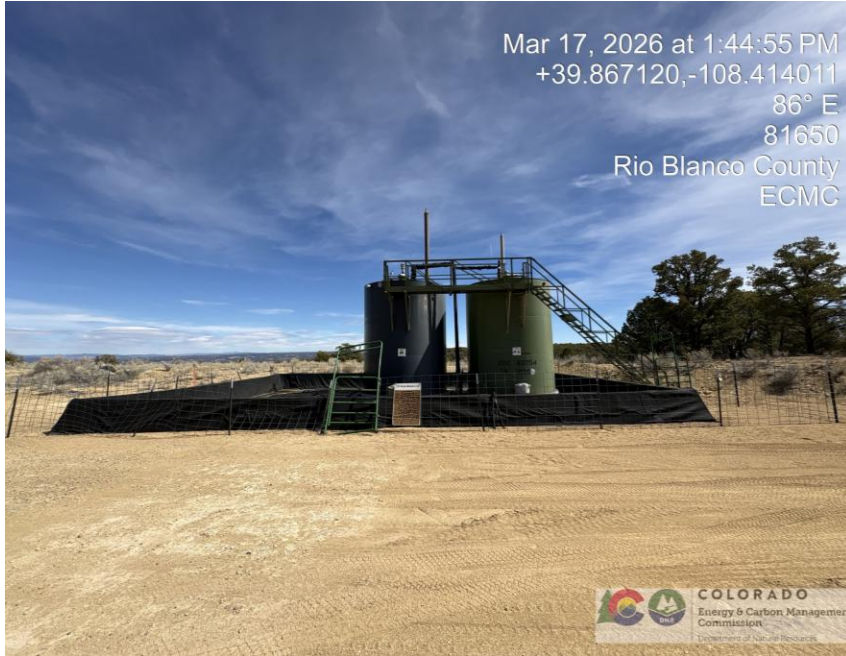
Photo # 3249 Location

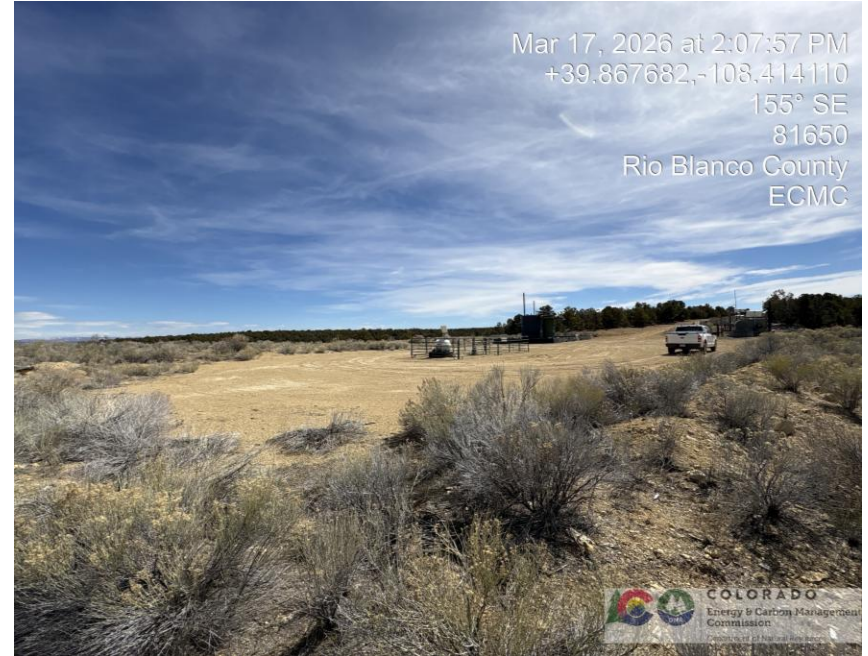
Photo # 3265 NW corner of location

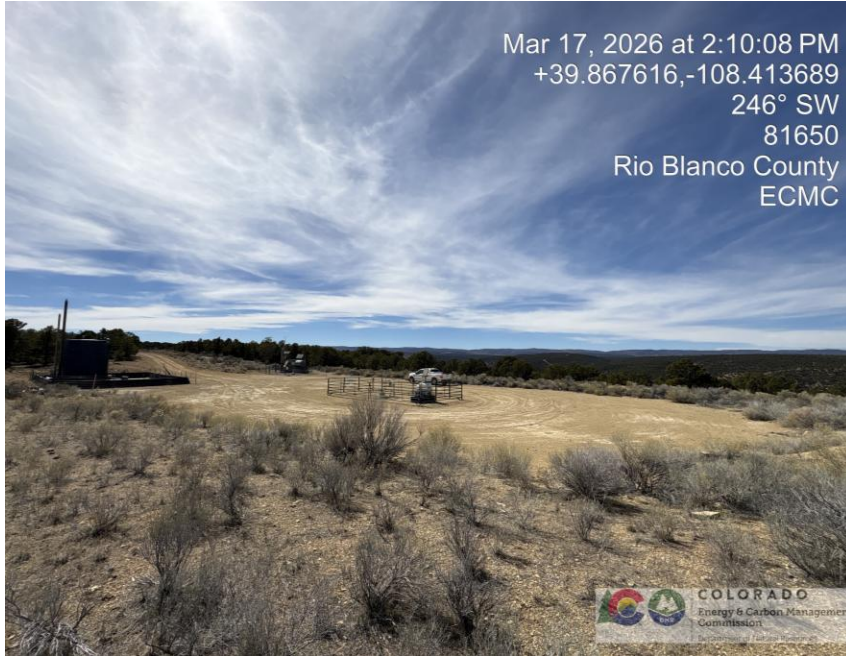
Photo # 3266 NE corner of location

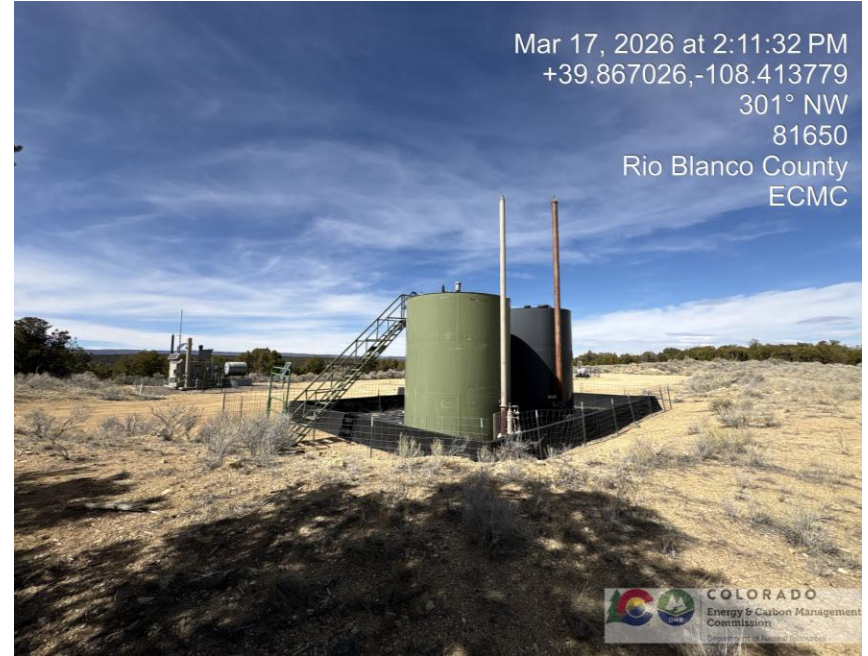
Photo # 3267 SE corner of location

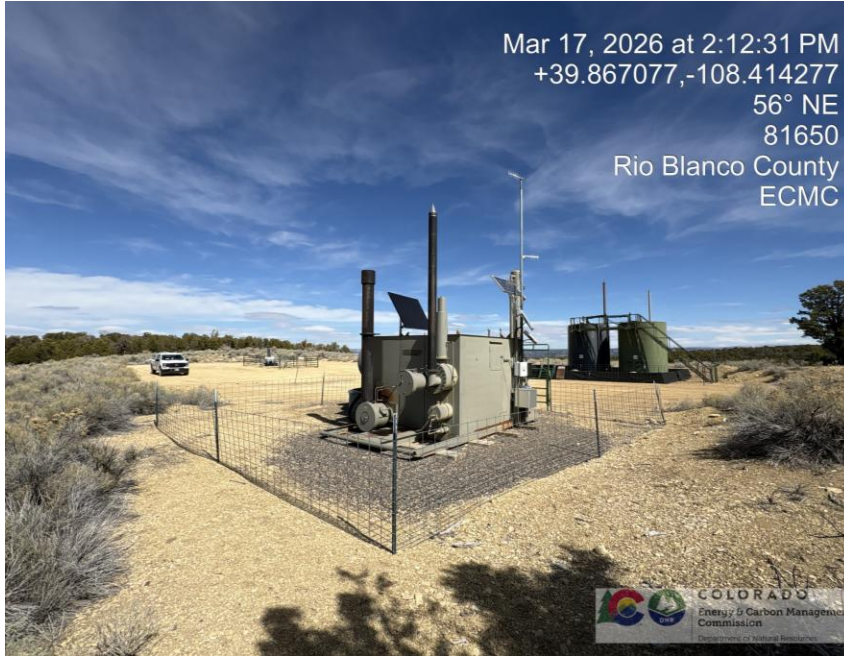
Photo # 3268 SW corner of location

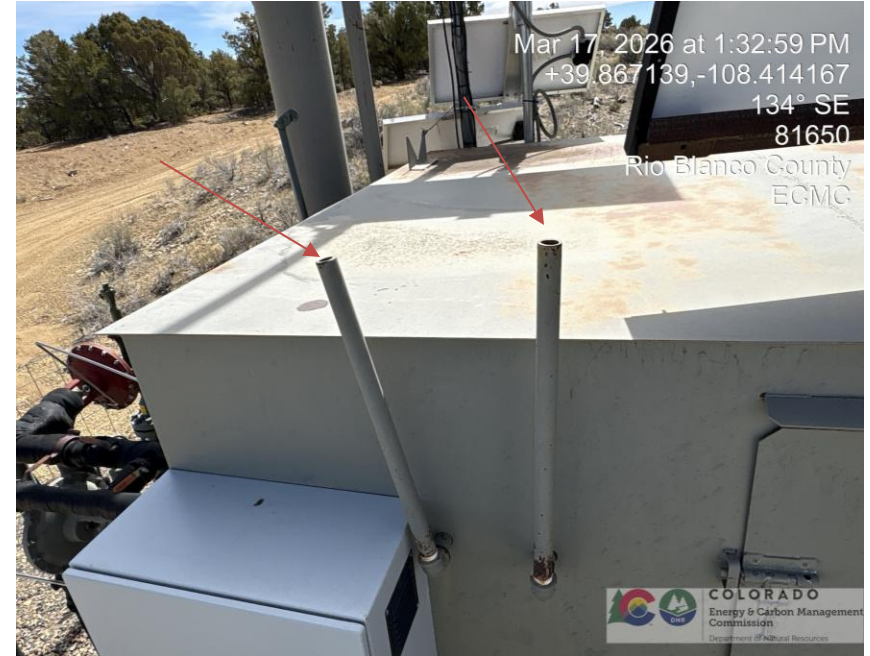
Photo # 3240 PRV vent line & Rupture disc vent line does not comply with CECMC pressure safety device rules

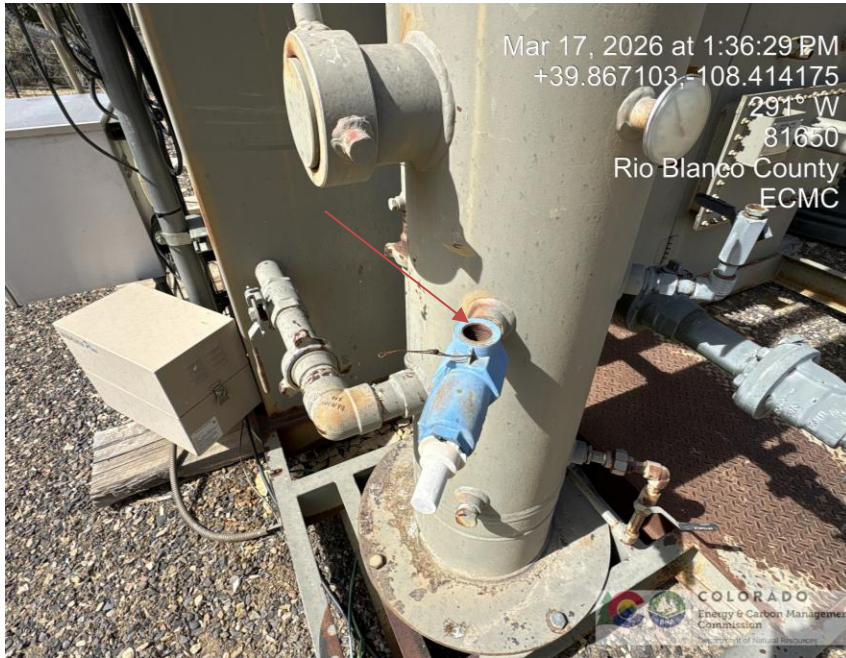
Photo # 3242 PRV vent line does not comply with CECMC pressure safety device rules

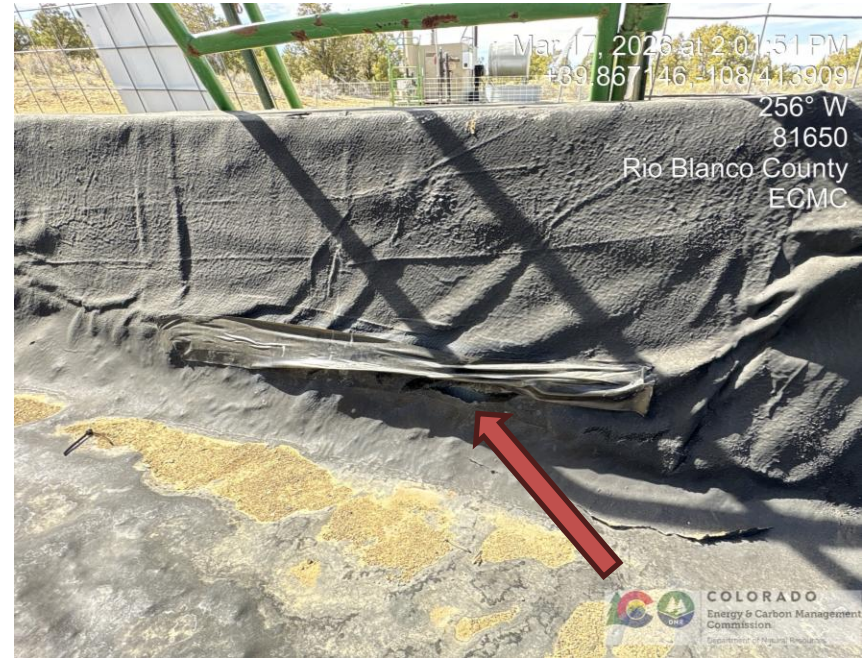
Photo # 3261 Hole in secondary containment liner/liner needs maintenance

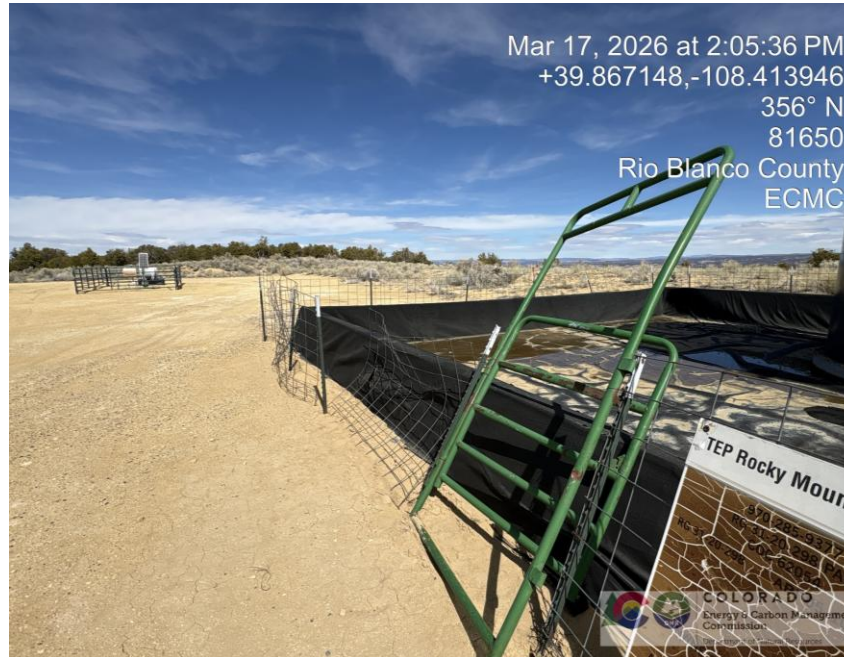
Photo # 3264 Tank battery fencing is in disrepair
