Inspection/Audit Photos

Location: SCOUT ENERGY MANAGEMENT LLC F V LARSON "B" #27X PAD

Location ID: 315966

Date: 03/16/2026

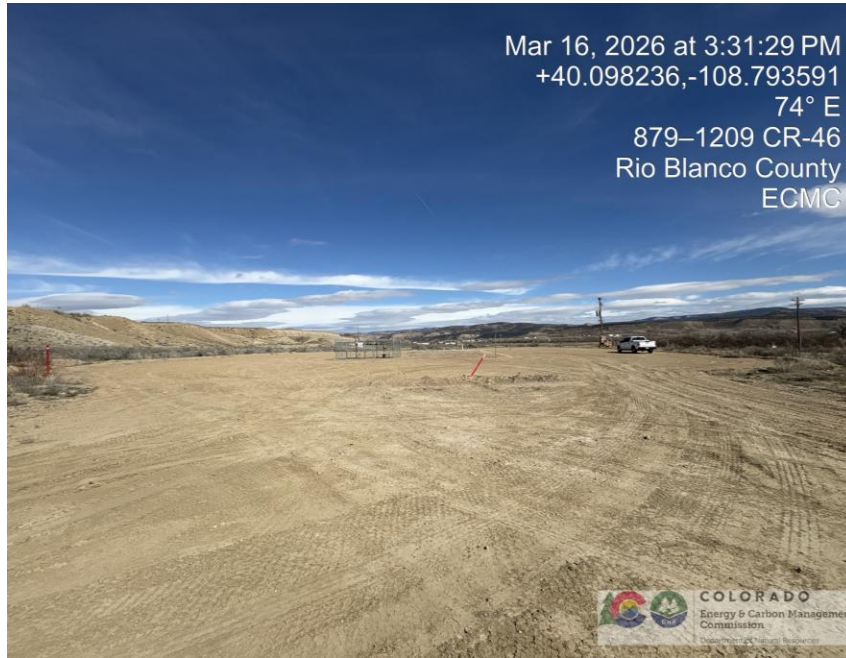
Photo # 3168 Entrance to location

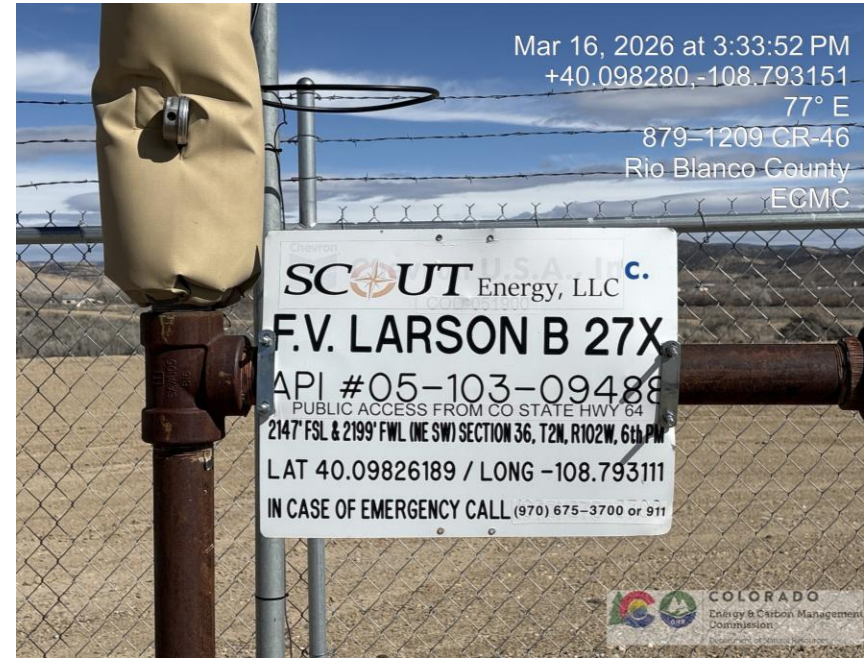
Photo # 3170 Location

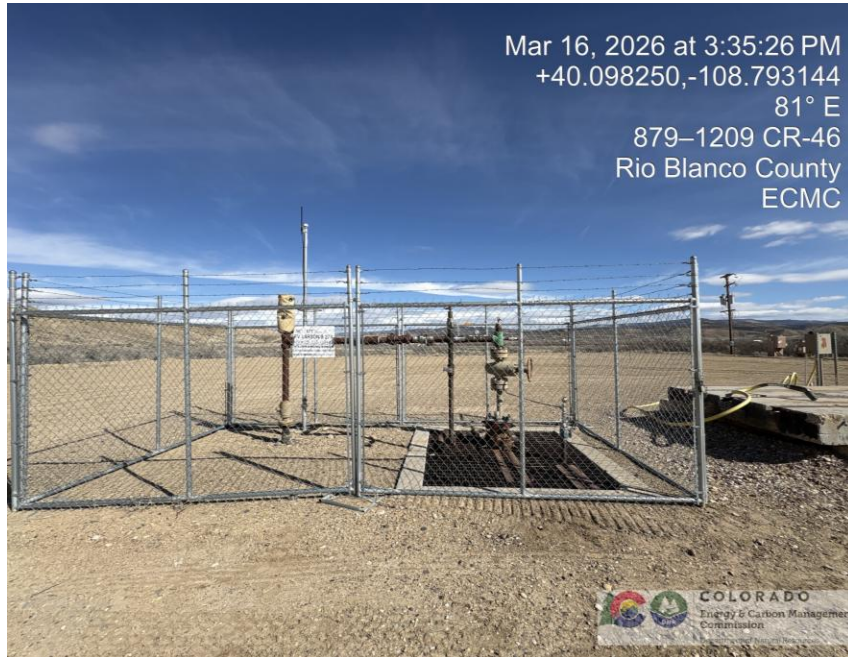
Photo # 3171 Location

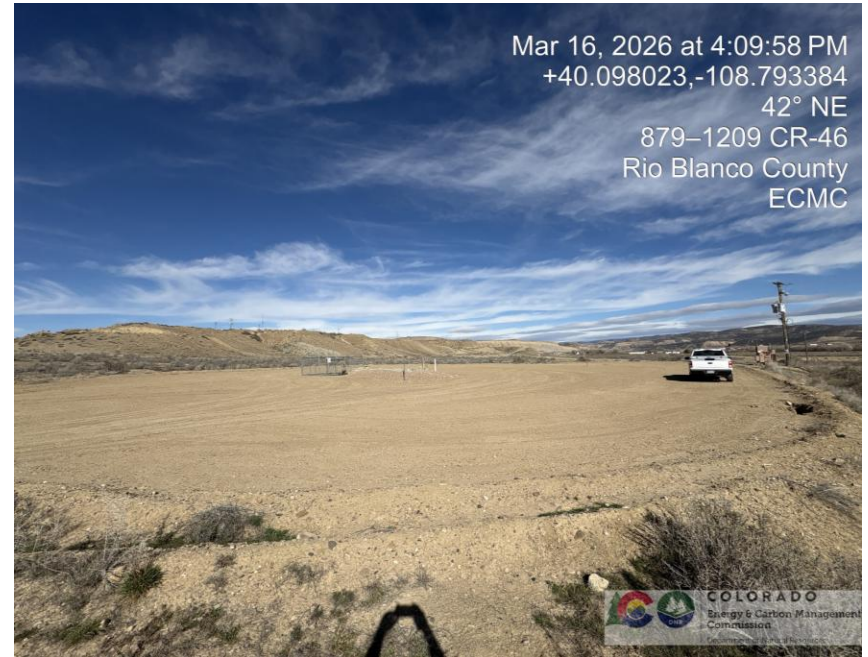
Photo # 3201 SW corner of location

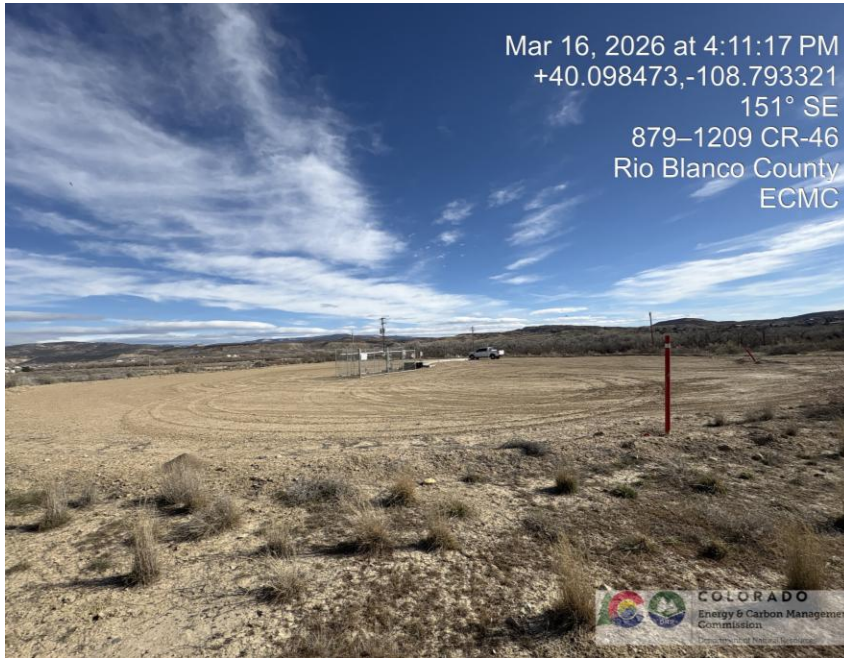
Photo # 3202 NW corner of location

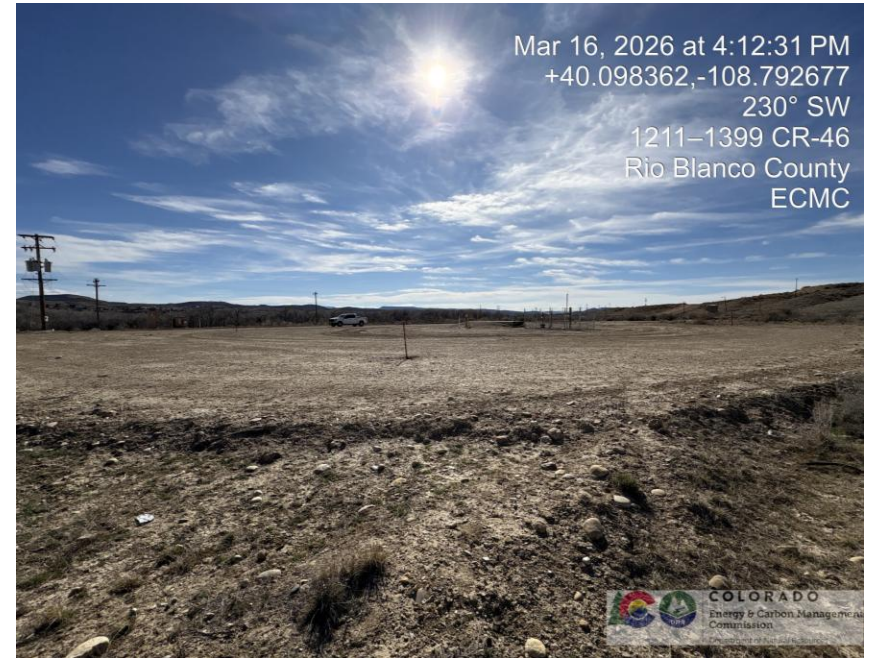
Photo # 3203 NE corner of location

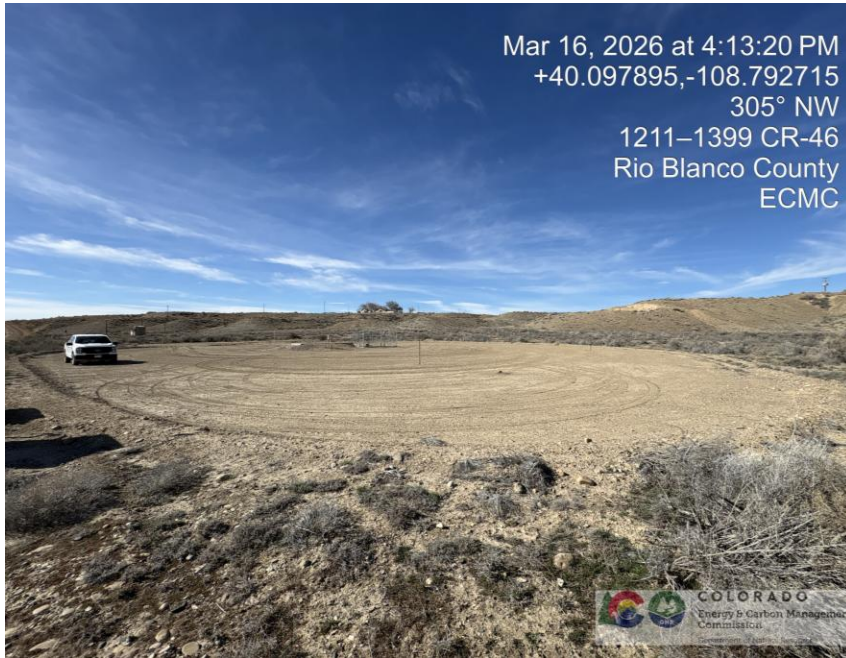
Photo # 3204 SE corner of location

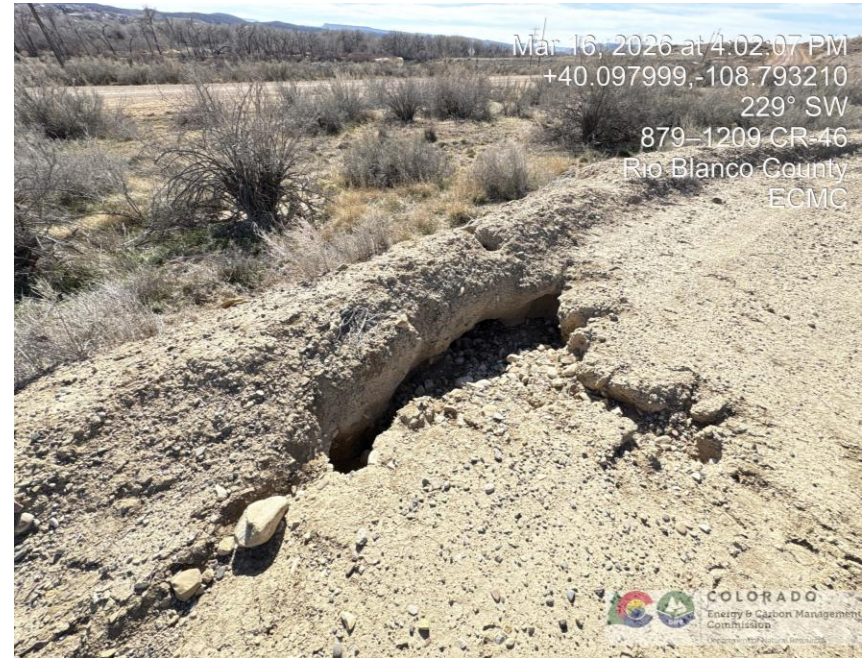
Photo # 3189 Failure to minimize erosion & transport of sediment on SW corner of location/berm needs maintenance

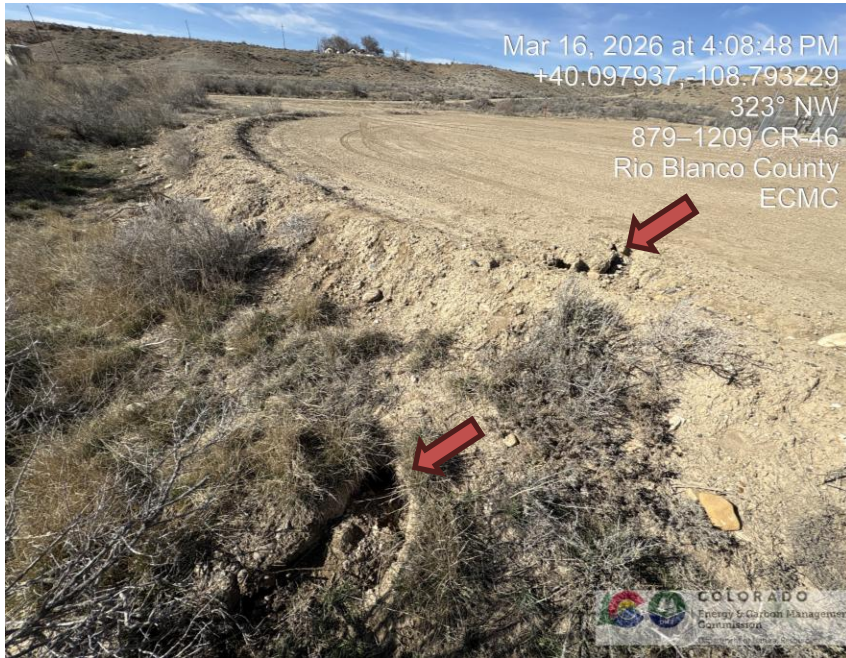
Photo # 3199 Failure to minimize erosion & transport of sediment on SW corner of location/berm needs maintenance

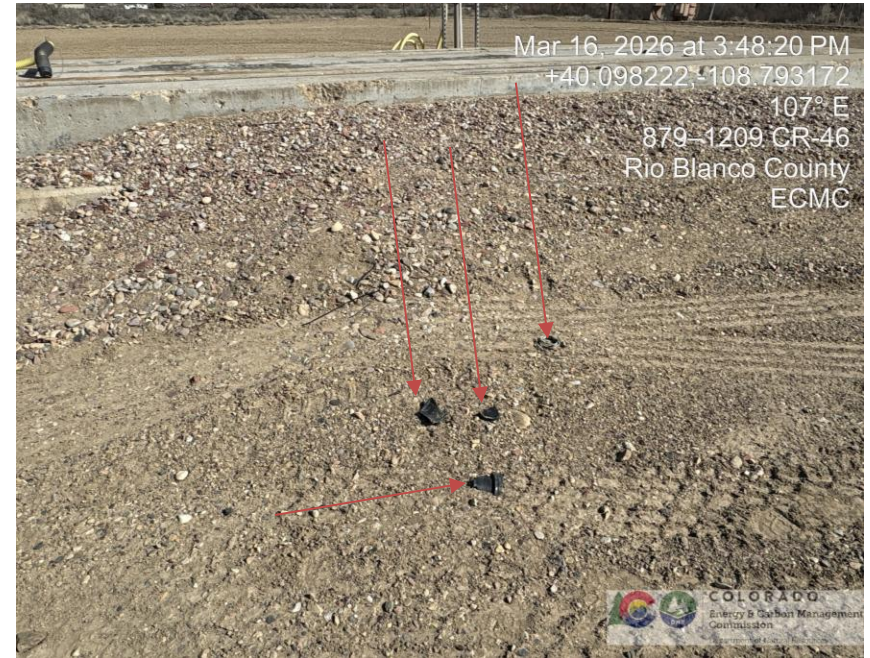
Photo # 3182 Debris

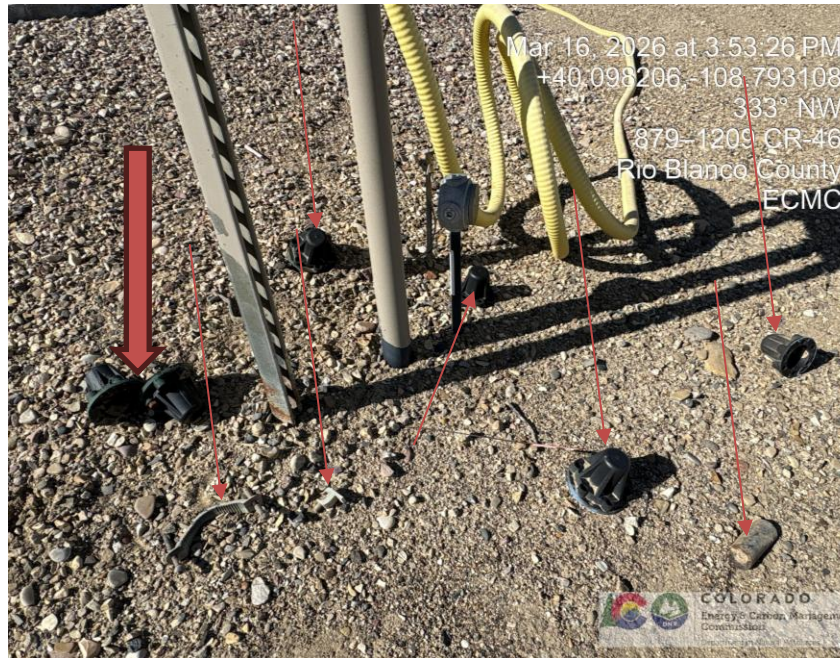
Photo # 3184 Debris
