QB ENERGY OPERATING LLC Federal 20-11 (PN20) Facility # 334682

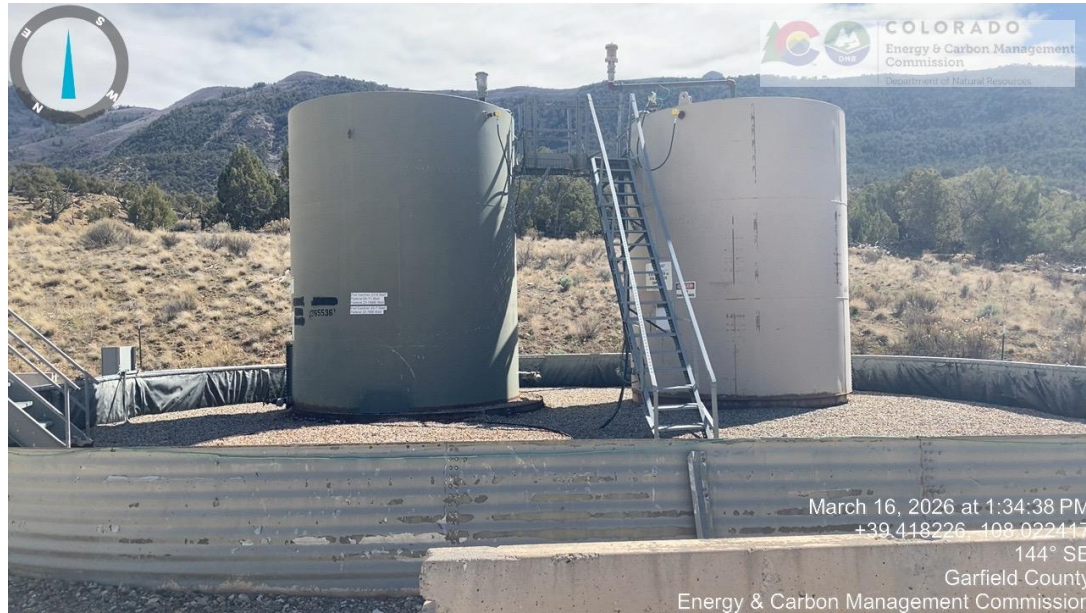
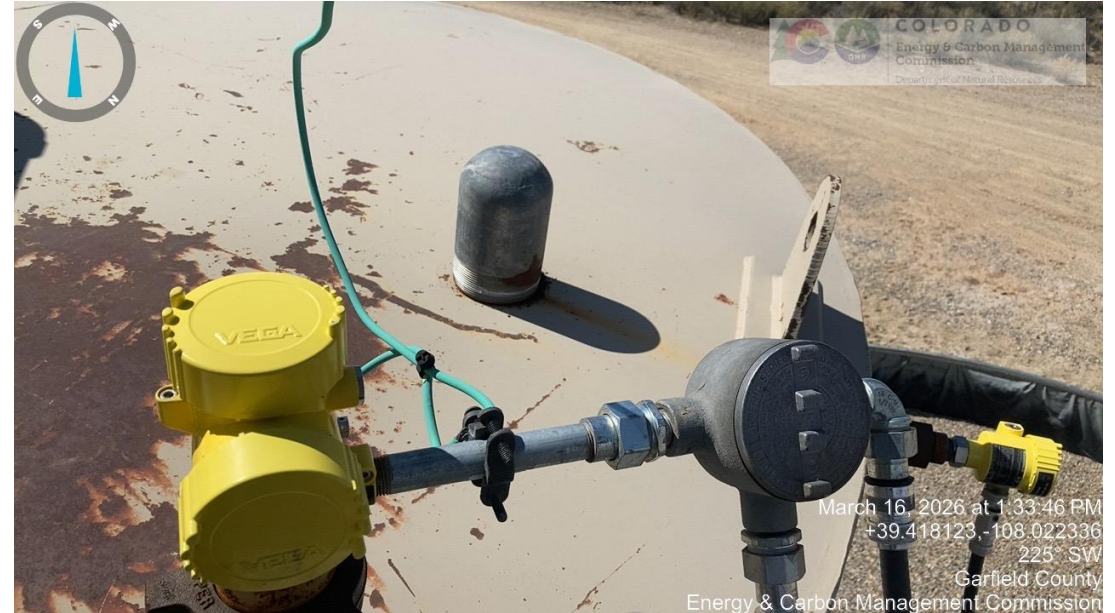
Unused plug on top of tank.

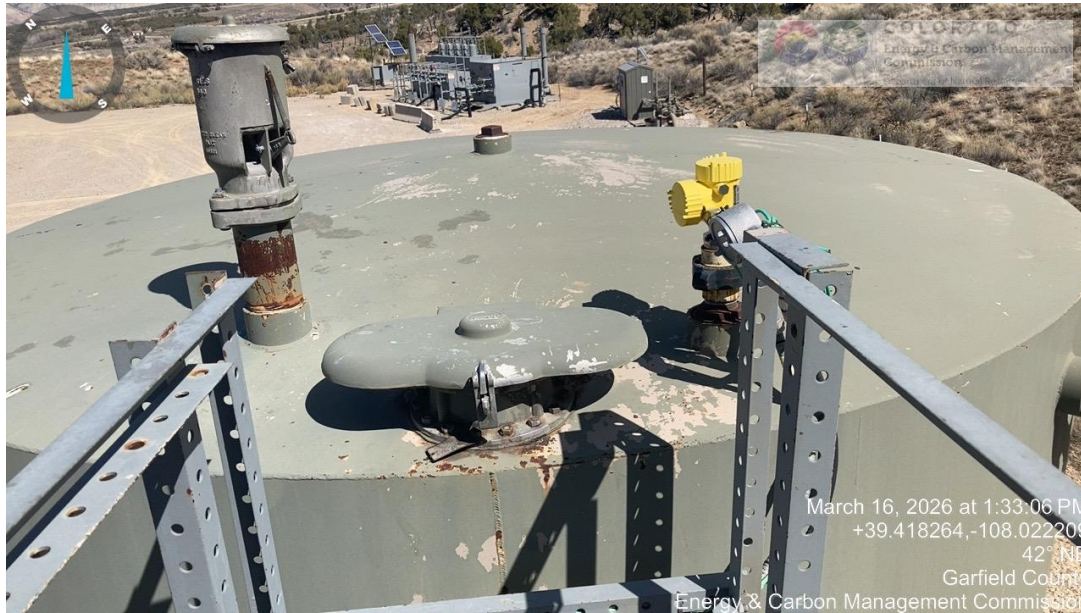
Paint deterioration and areas of rust.

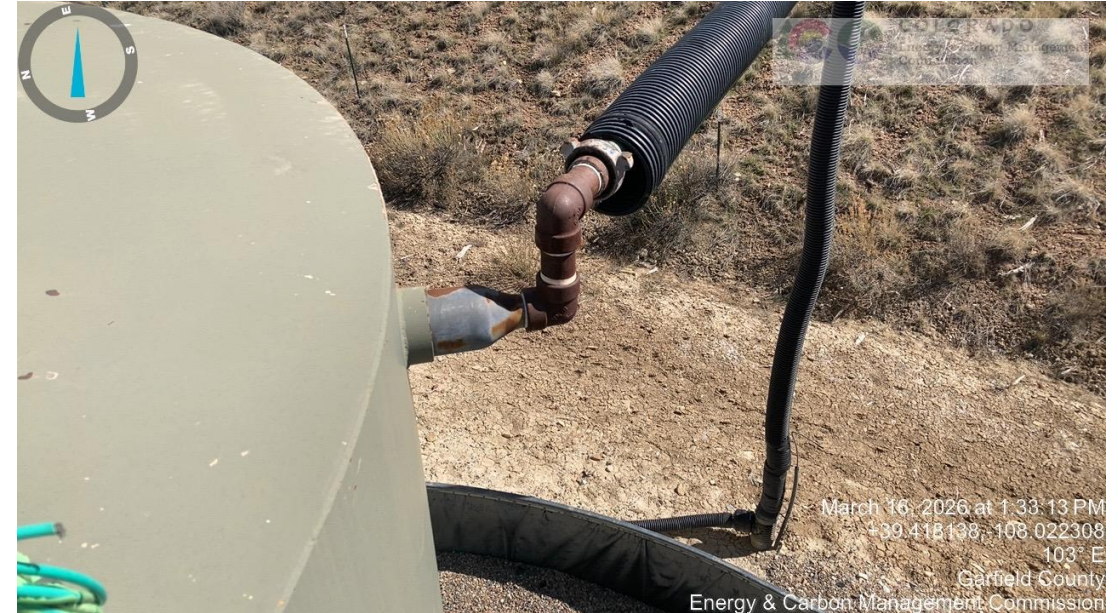
Rust on swedge and pipe fittings.

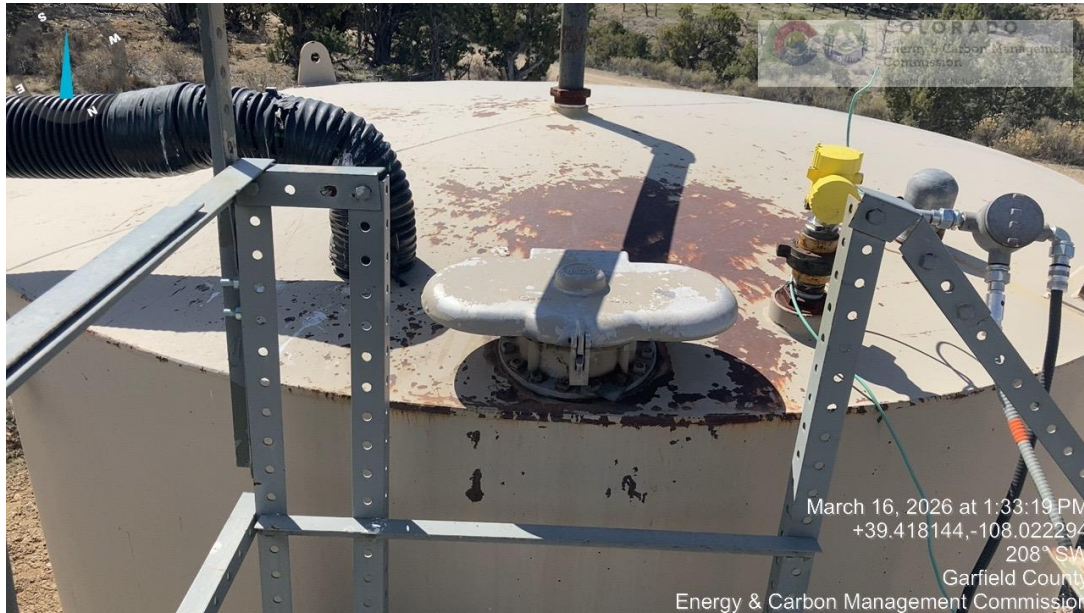
Paint deterioration and areas of rust.

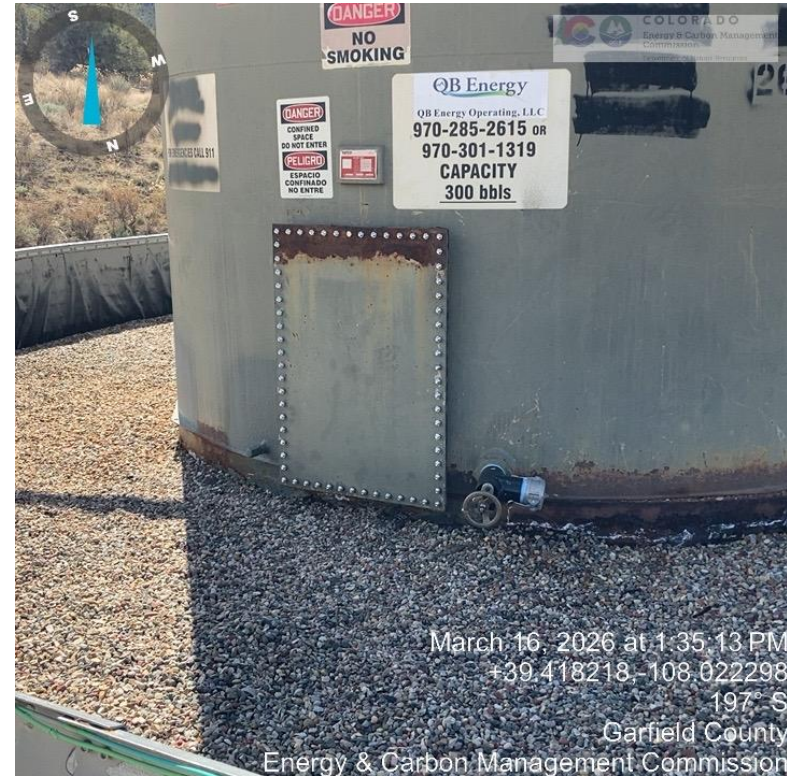
Paint deterioration and areas of rust.

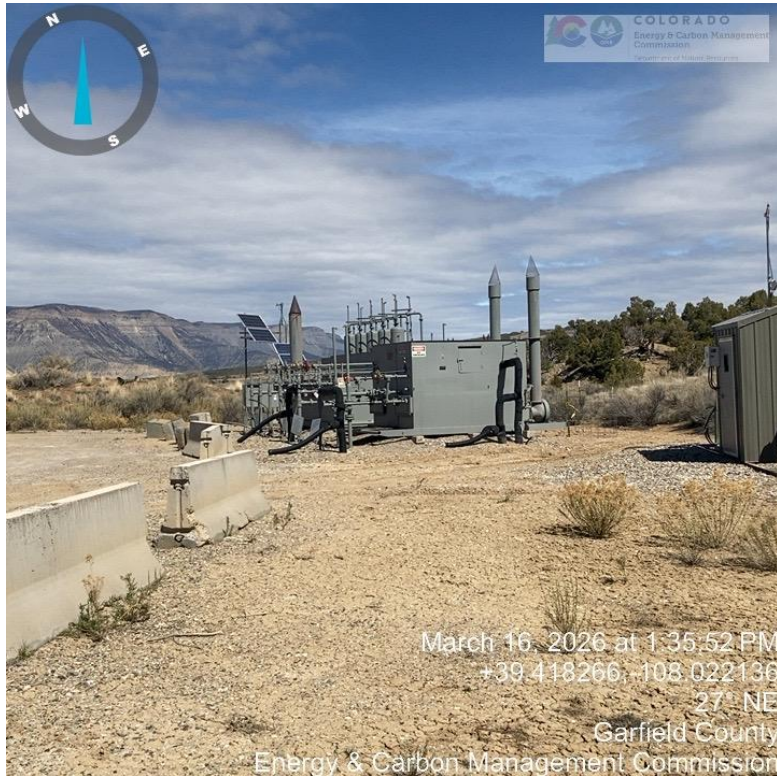
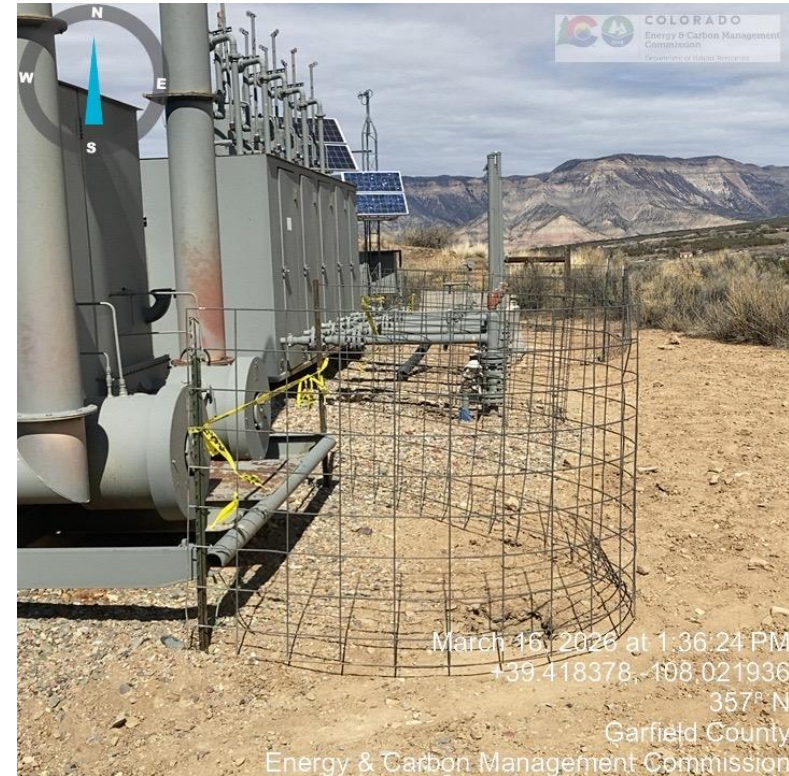
Dumpline excavated.

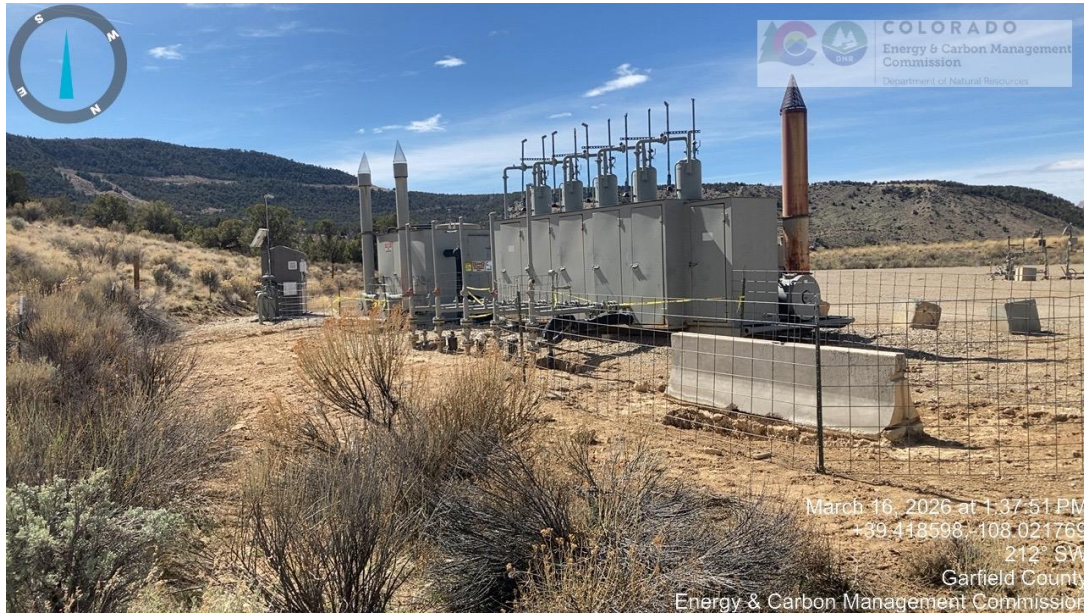
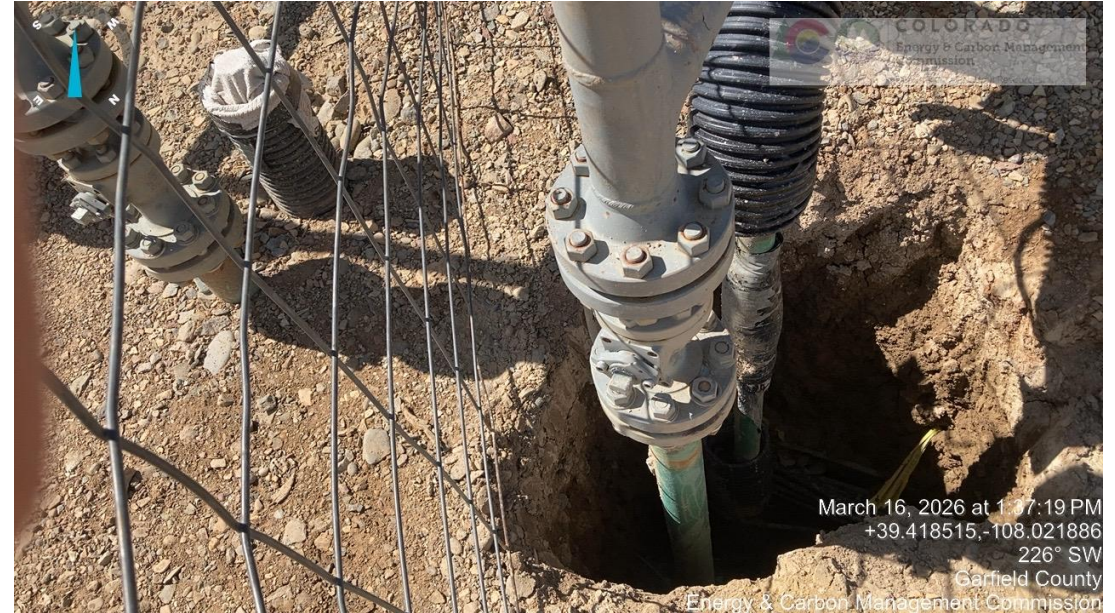
Dumpline excavated.

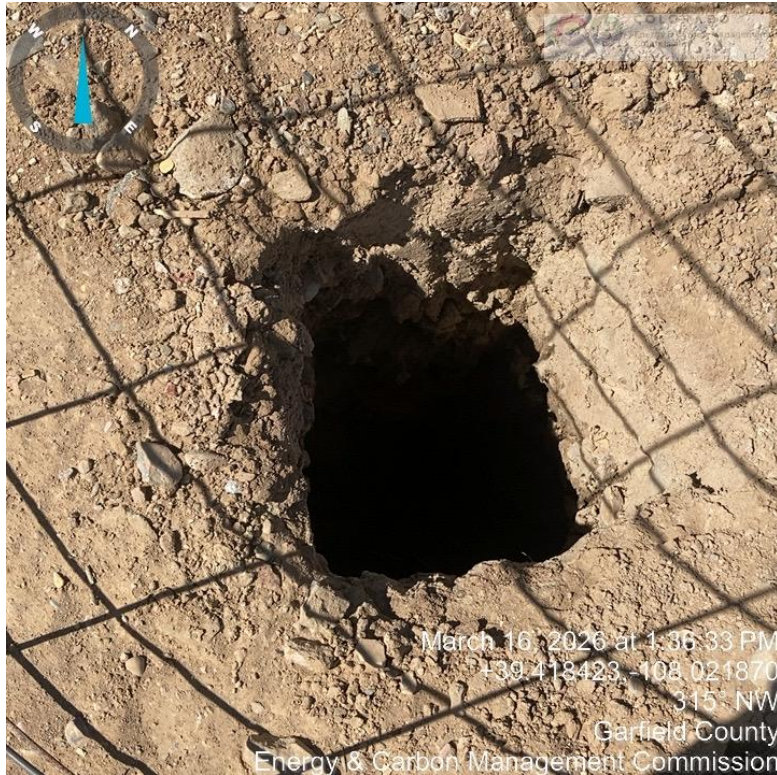
Dumpline excavated.

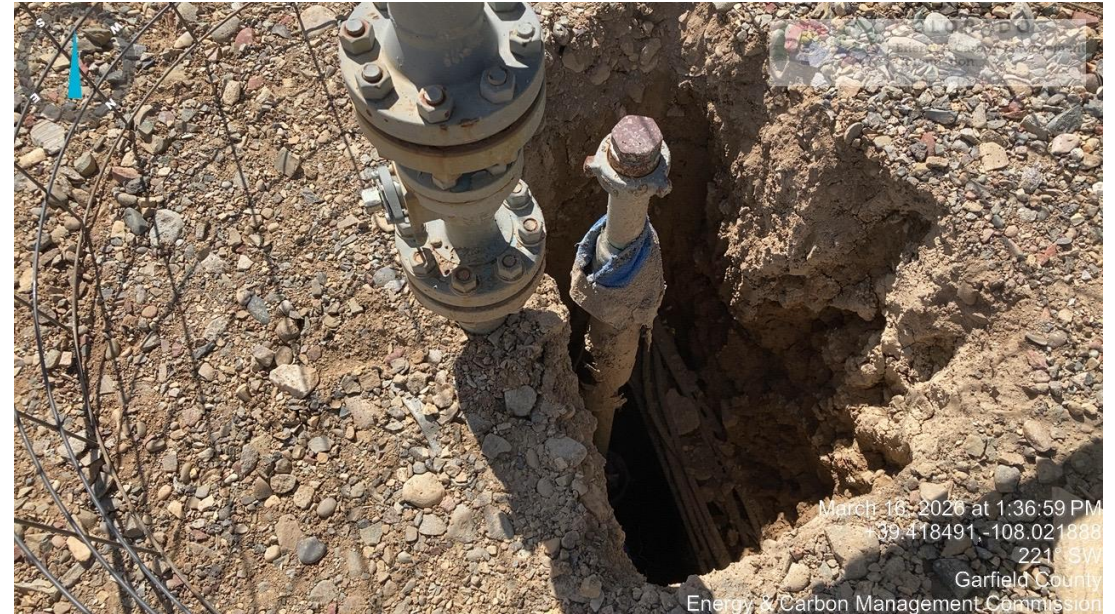
Dumpline excavated.

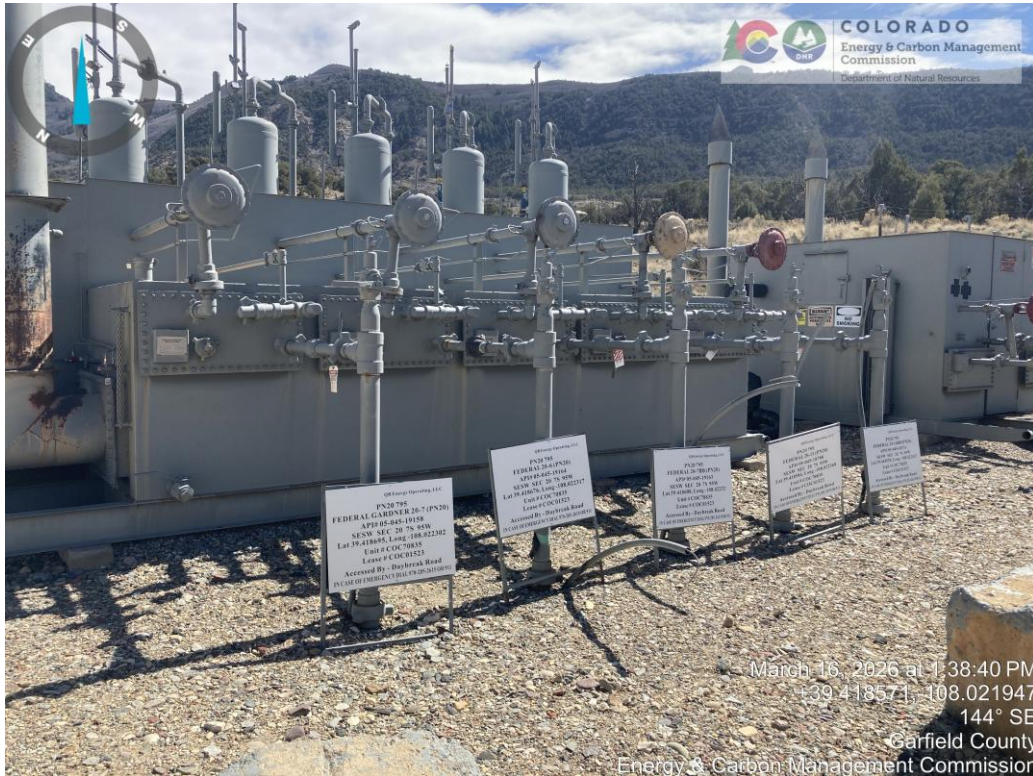
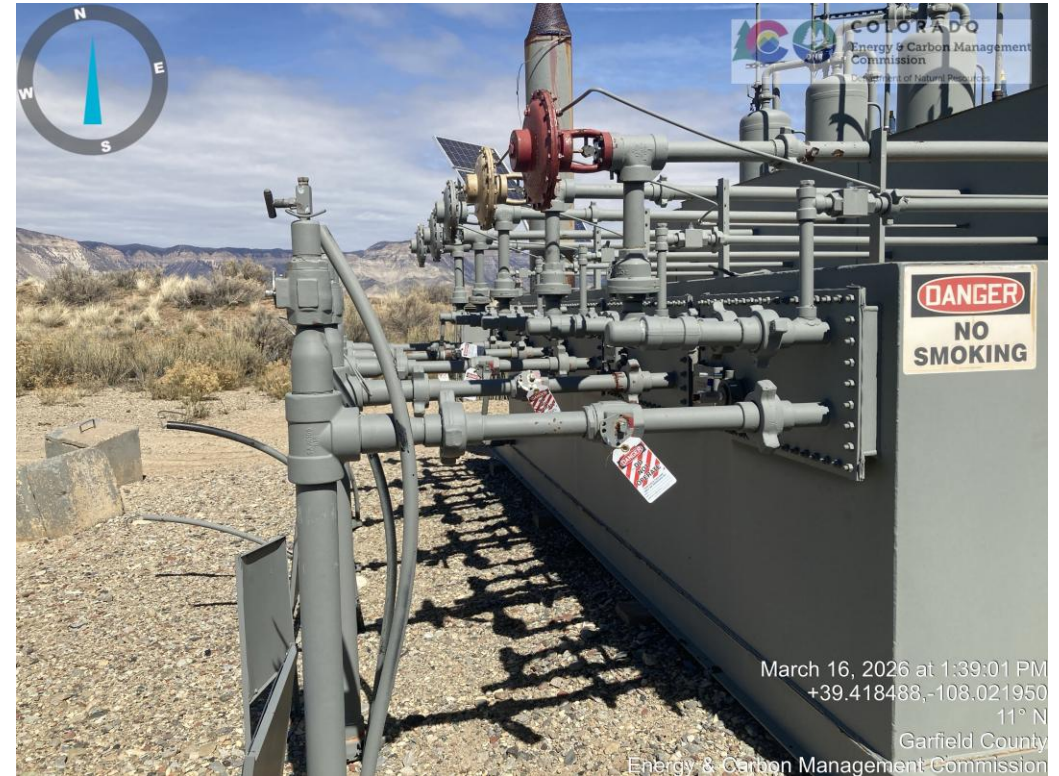
Separators shut in.

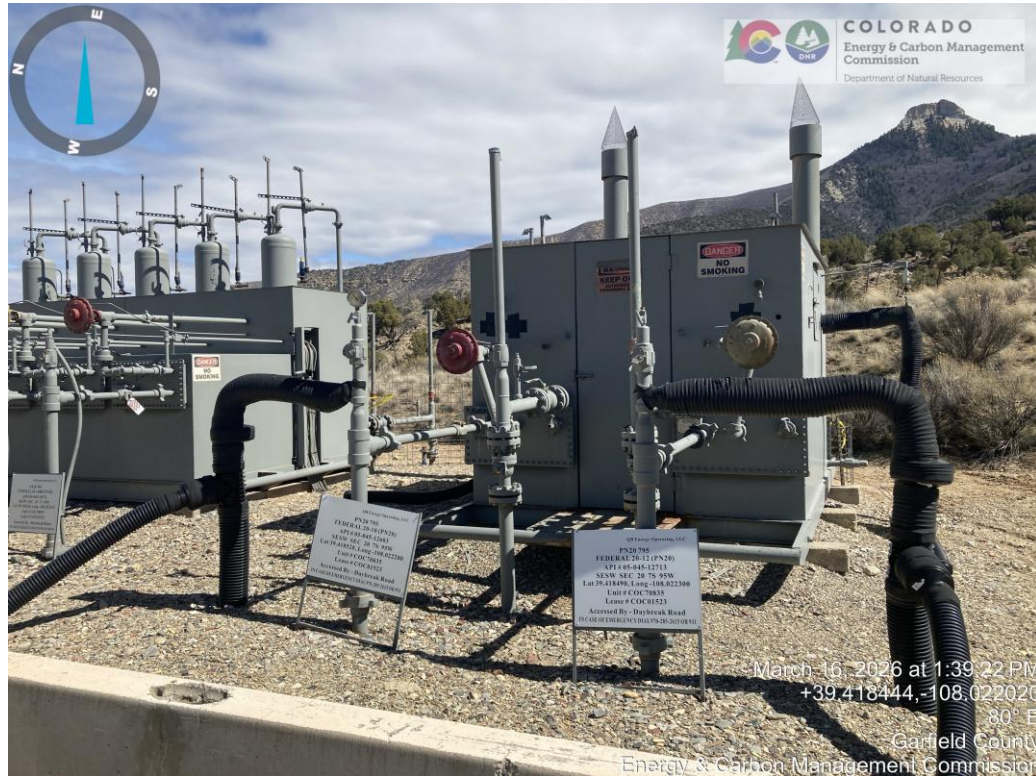
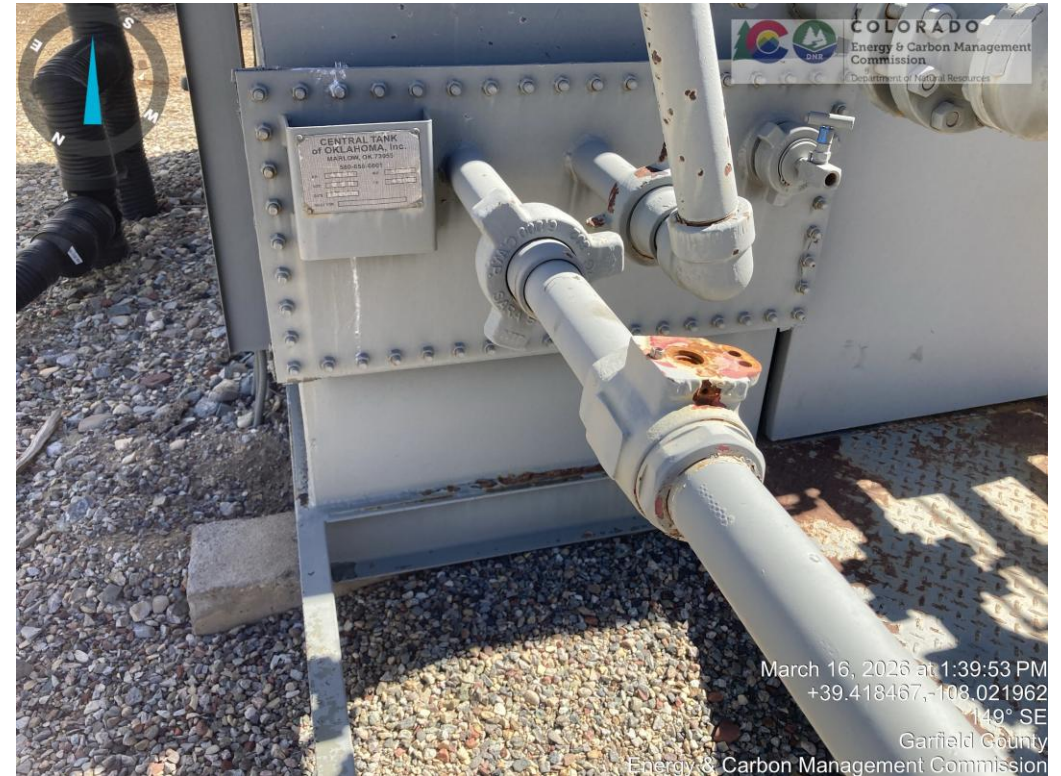
Stem broken off of valve.

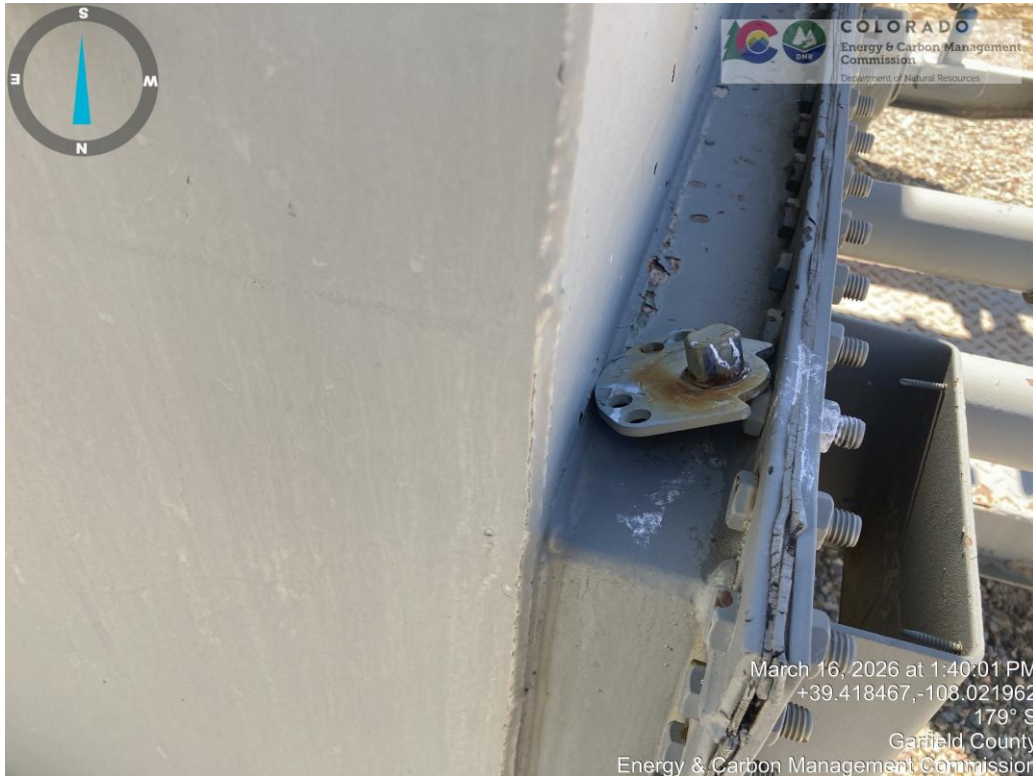
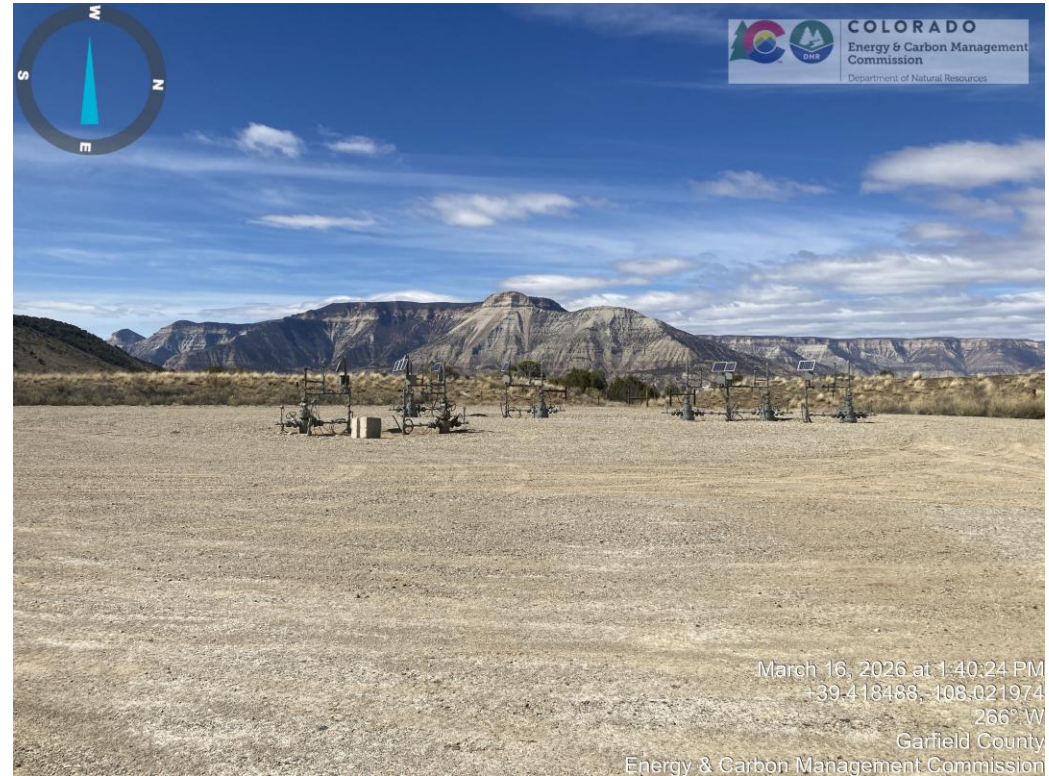
Stem broken off of valve.
