Inspection Photos

Loc: 324901

Operator: RAMPIKE RESOURCES LTD

Inspection Date: 3/23/2026

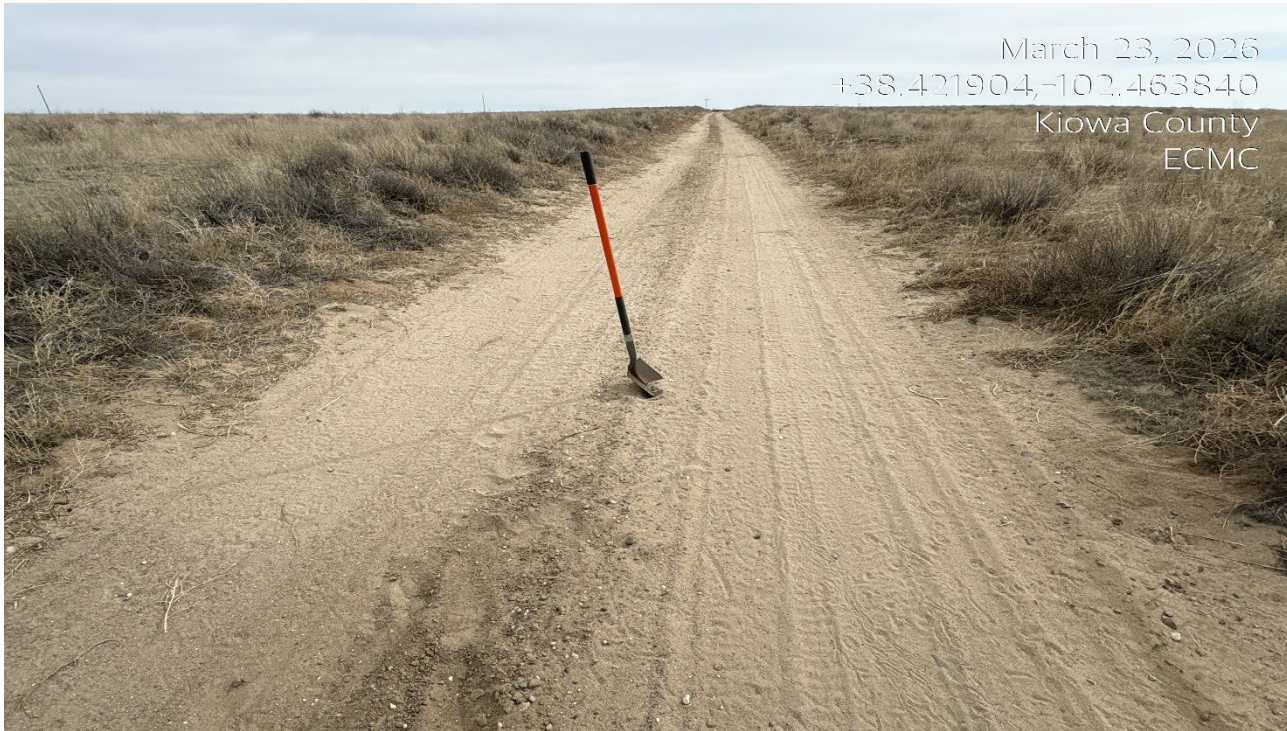
Photo 1. Facing east along the main road. The road is swaled and below the original grade of the terrain. There is concern for winter snow to blow onto the road impeding vehicle passage. This area of the road consists of sandy soil that needs to be stabilized with BMP's such as roadbase.

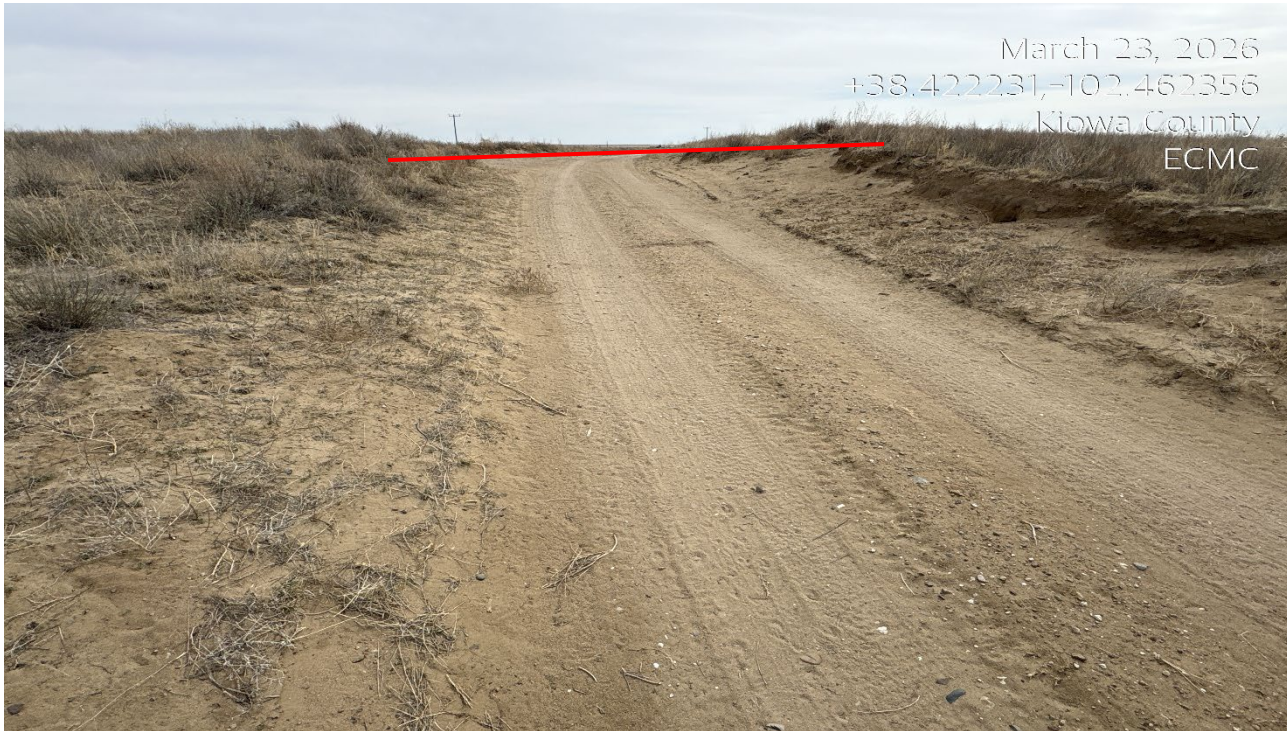
Photo 2. Facing east along the main access road. Red line is the approximate original grade and the shovel is 4.5 feet for scale. There is concern for winter snow to blow onto the road impeding vehicle passage.

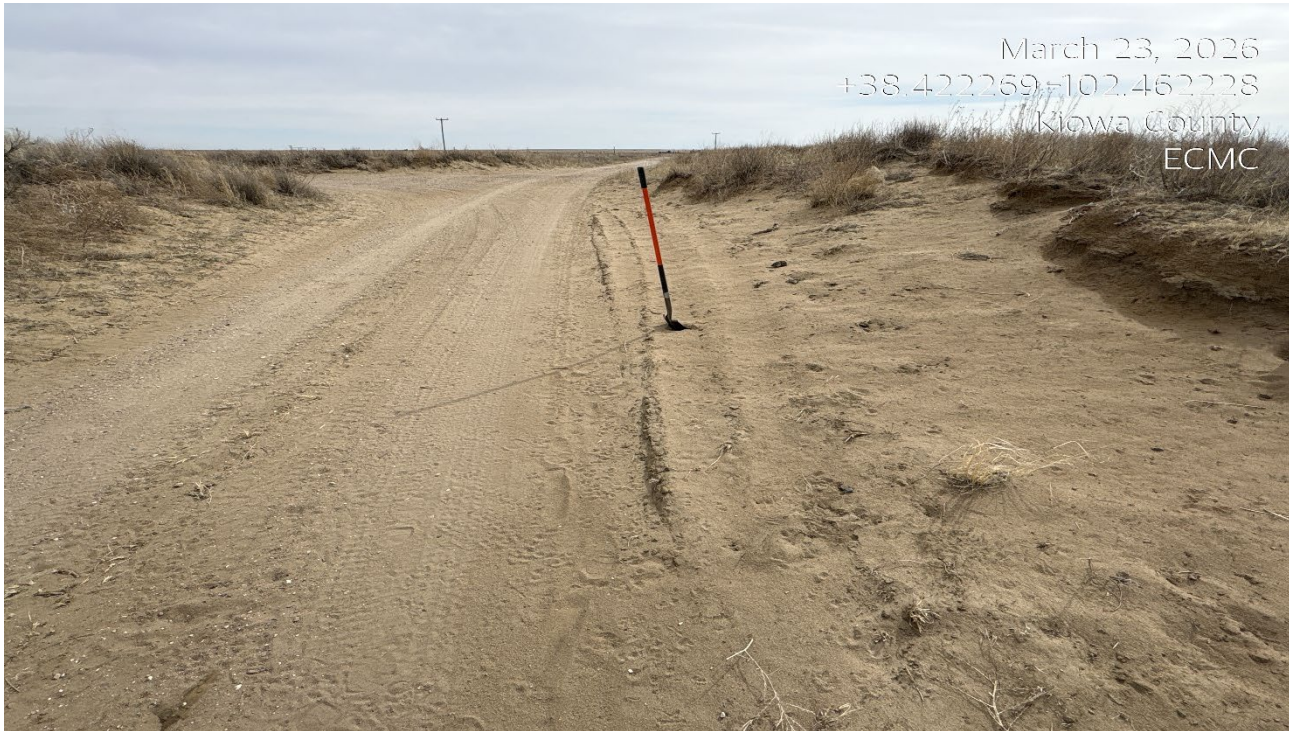
Photo 3. The roadside has eroded and is not stabilized with vegetation. The sandy soils are susceptible to further erosion. This area needs to be repaired and stabilized.

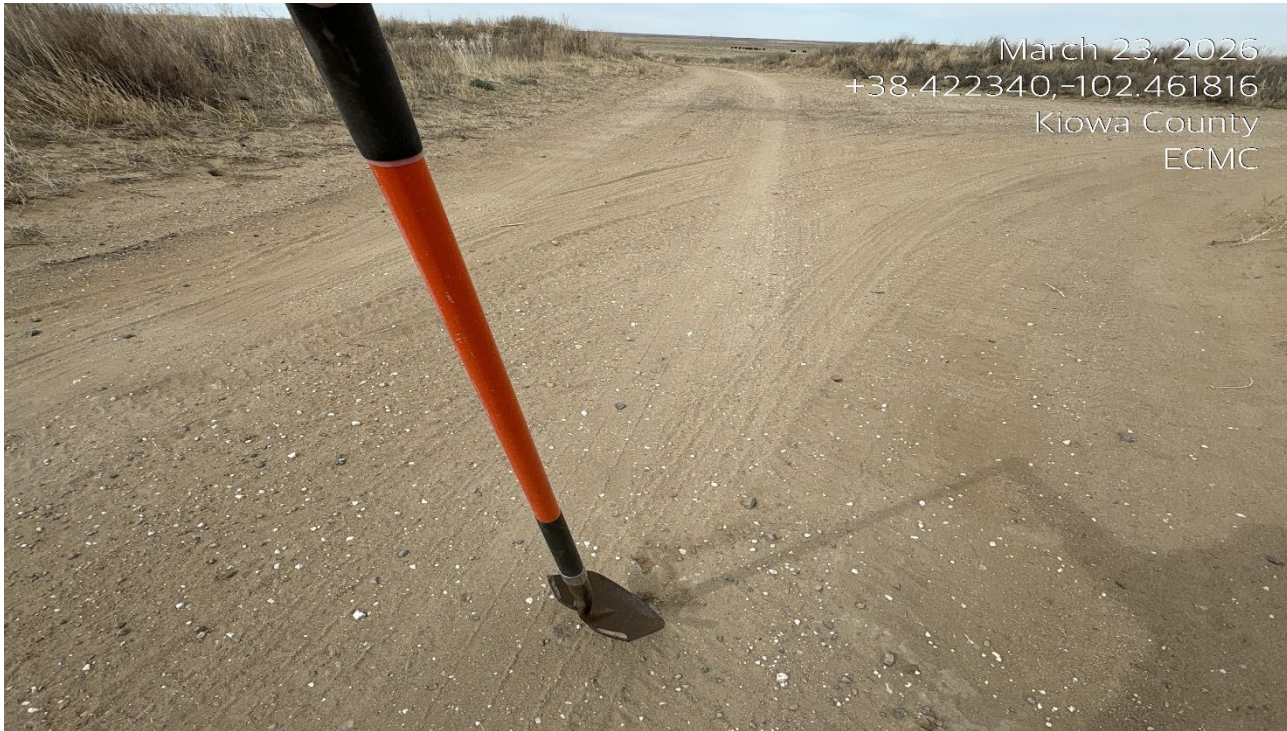
Photo 4. Facing back to the west. At this point the road is compacted and stabilized.

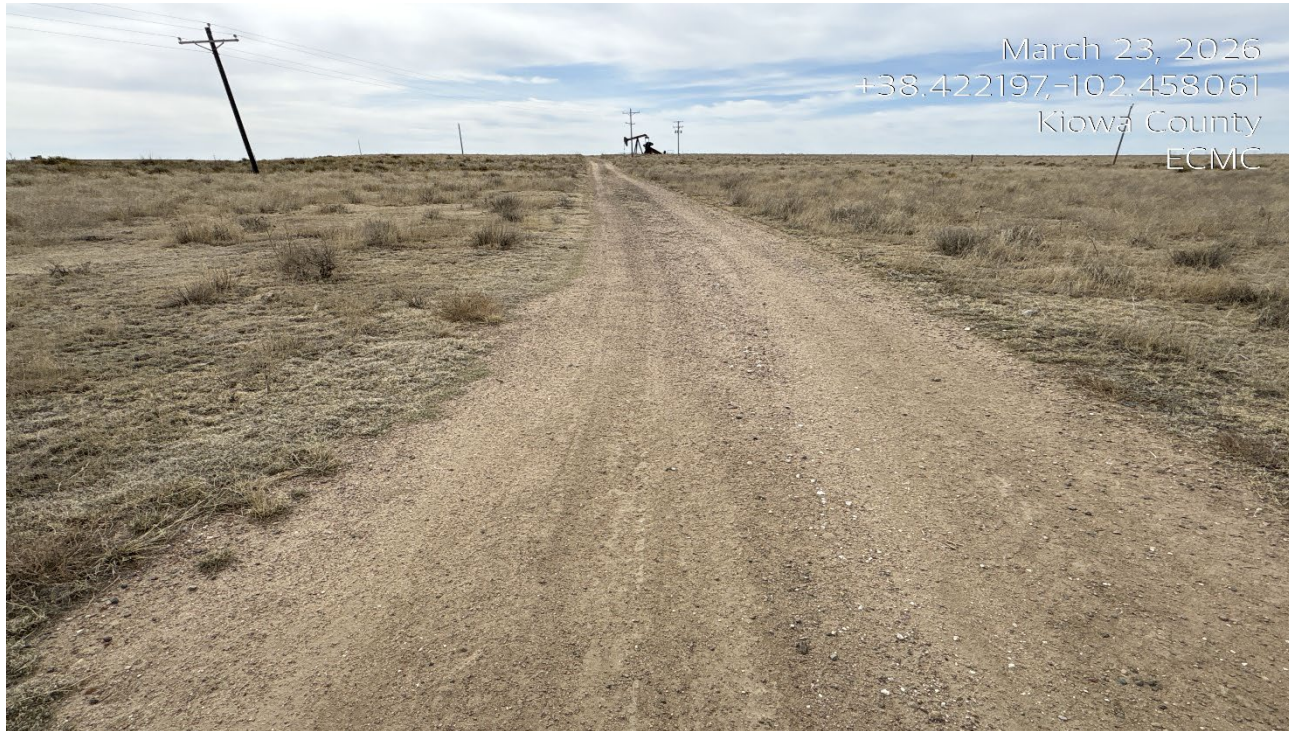
Photo 5. Facing south along the access road.

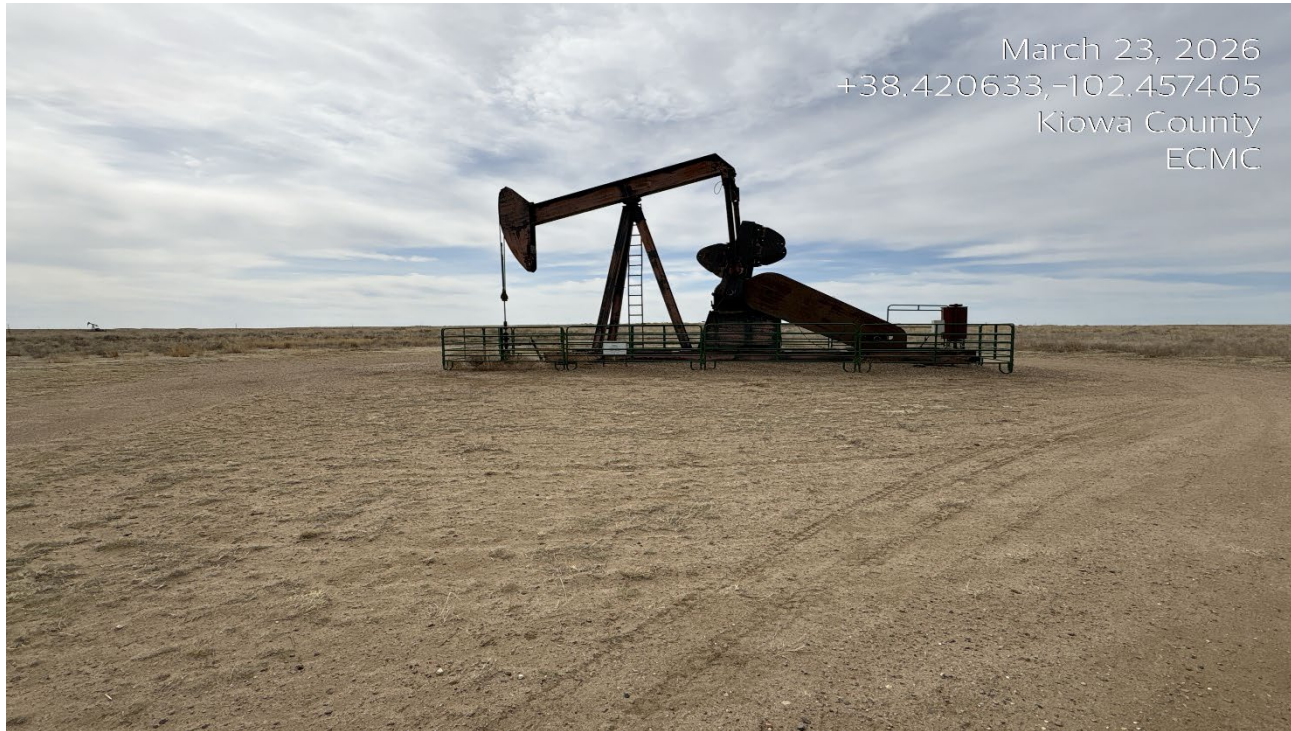
Photo 6. Facing south toward the wellsite.

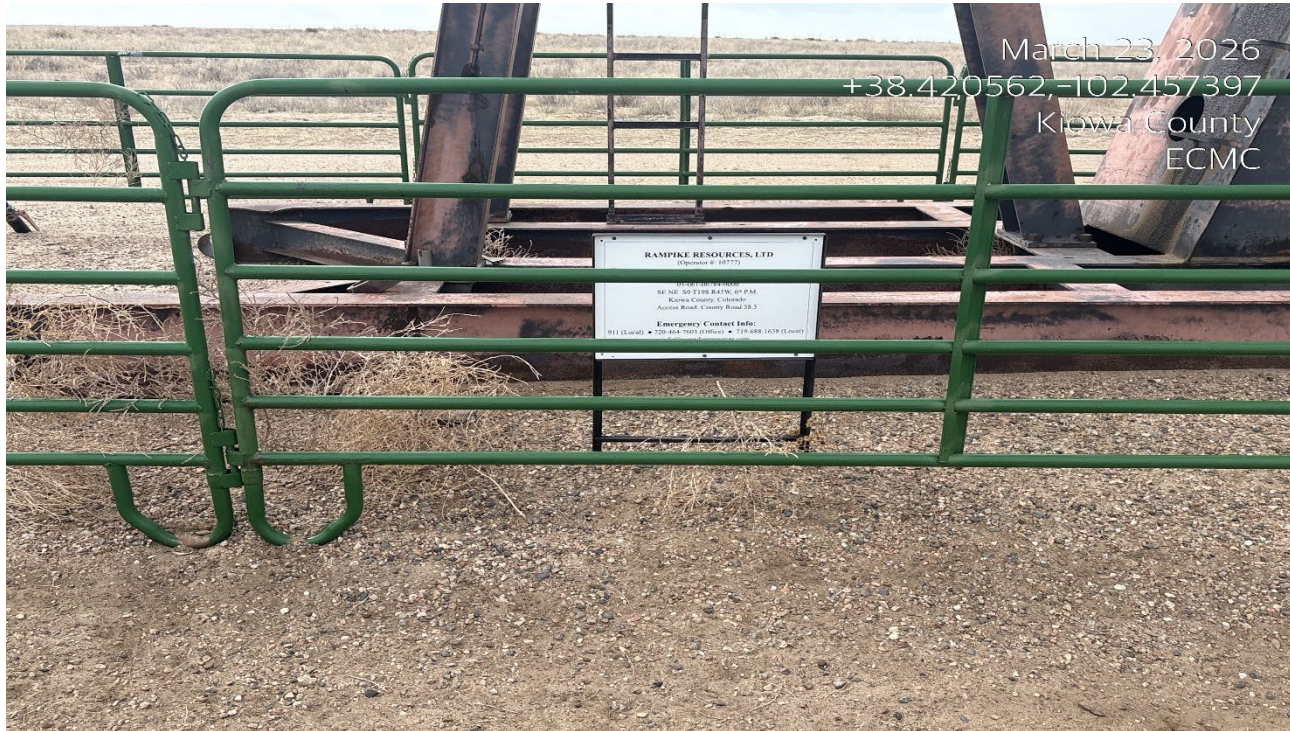
Photo 7. The operator sign has been updated.
