**Inspection Photos**  
**Location Name: Simcoe Larsen #01-12 1**  
**Location ID: API 05-067-06767**

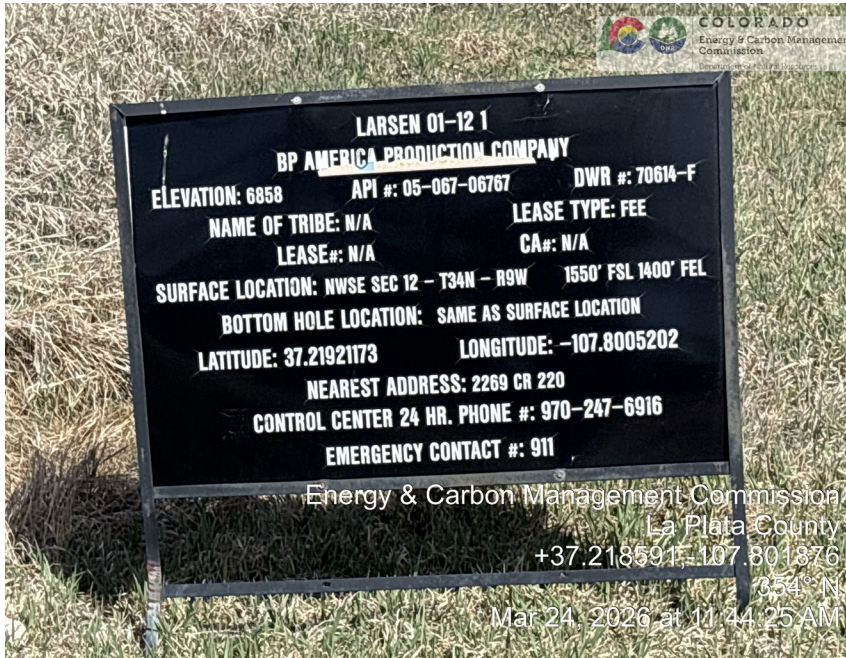
**1. Well Sign. Sign still indicates BP America as operator.**

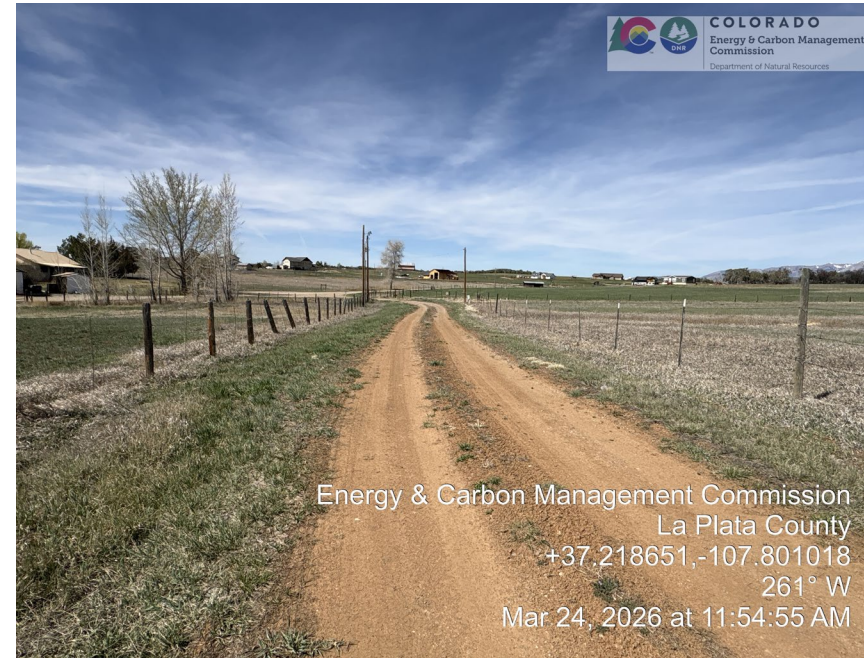
**2. Access road.**

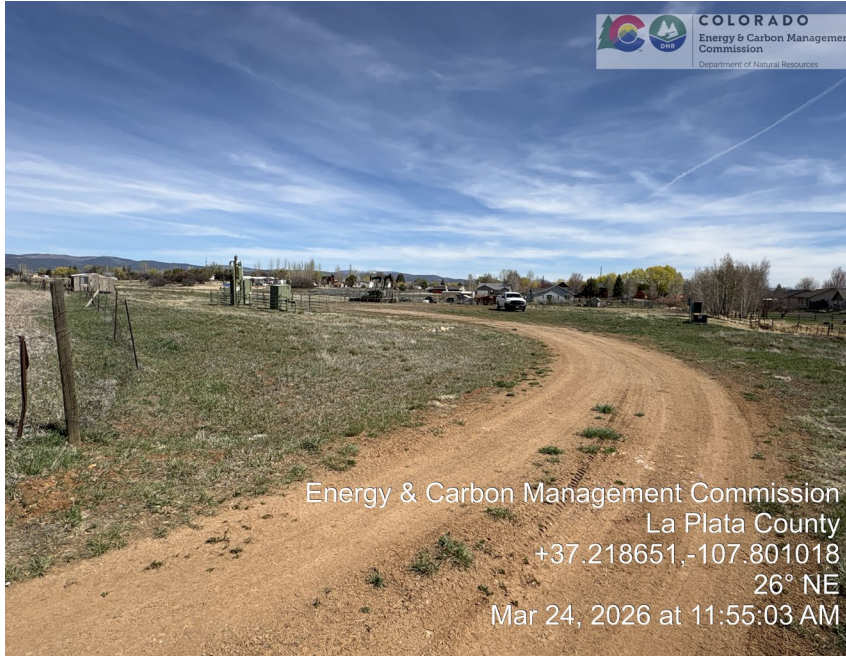
**3. Access road and well pad area with pump jack, separator, meter run, telemetry and electrical service. Location is a horse pasture in a suburban/semi rural neighborhood with several residences nearby.**

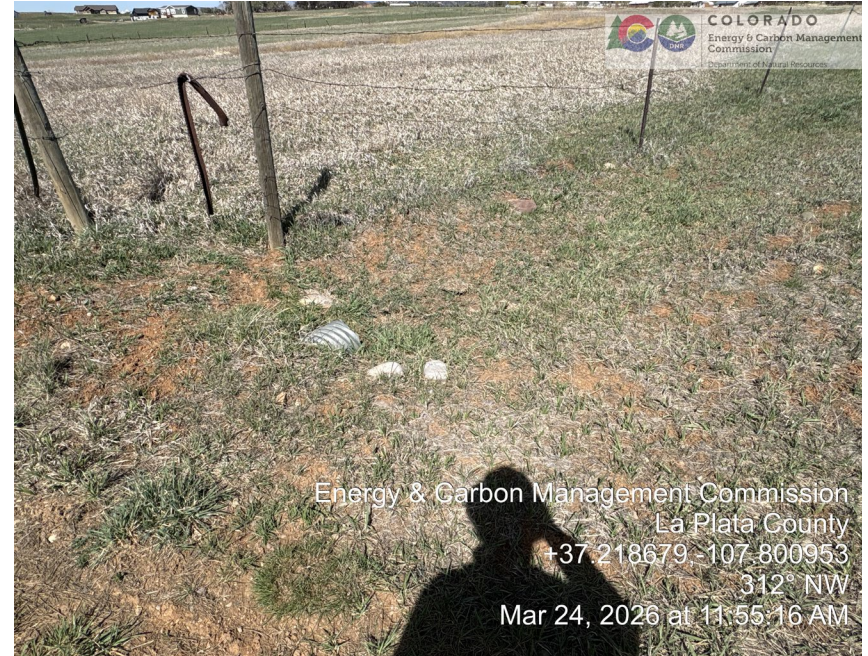
**3. Culvert beneath access road.**

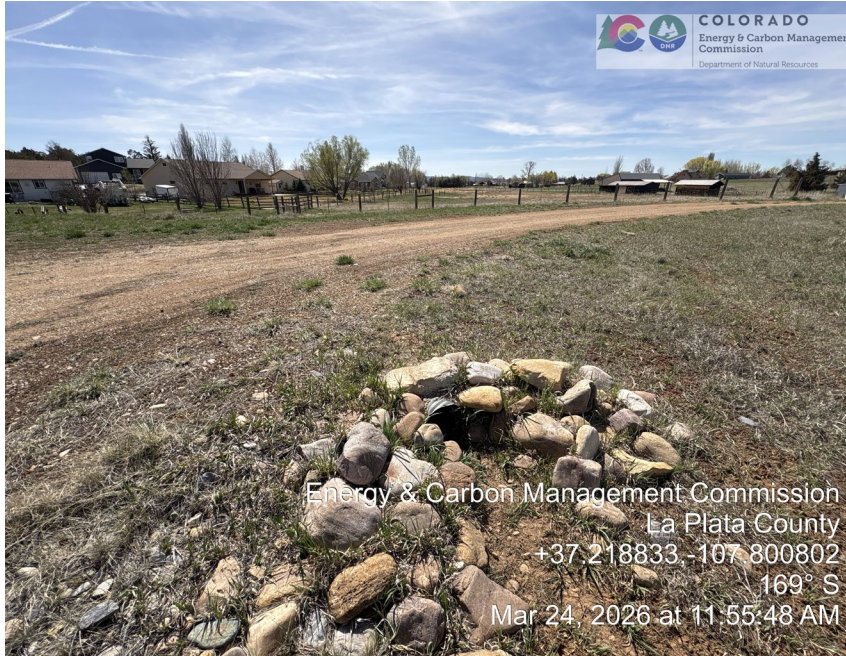
**5. Culvert near access road.**

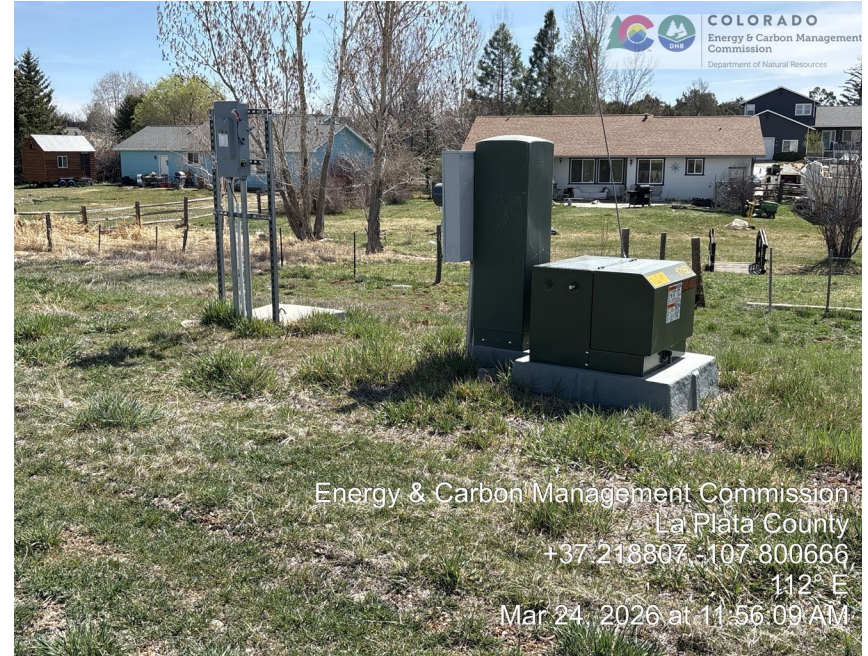
**6. Electrical service.**

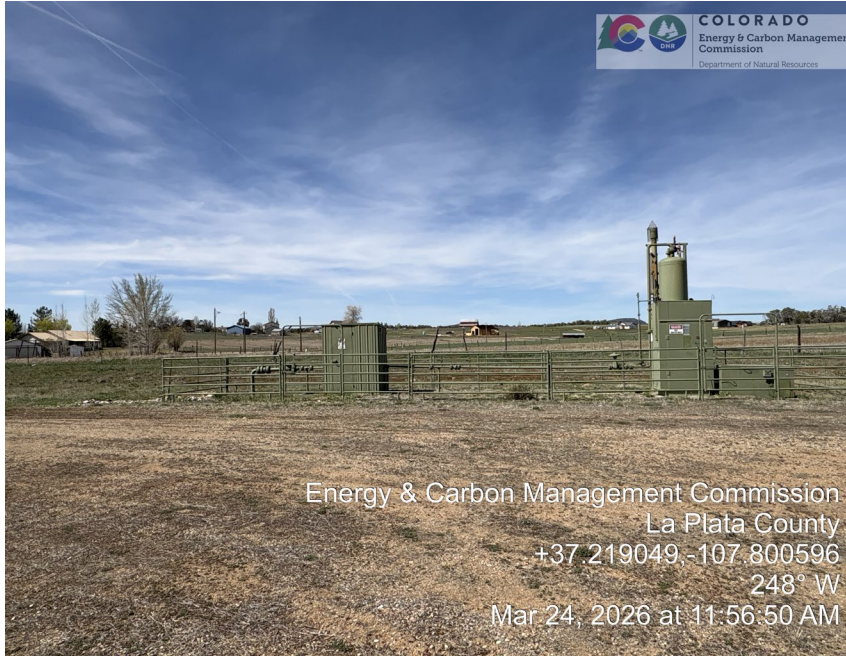
**7. Meter run and vertical heated separator.**

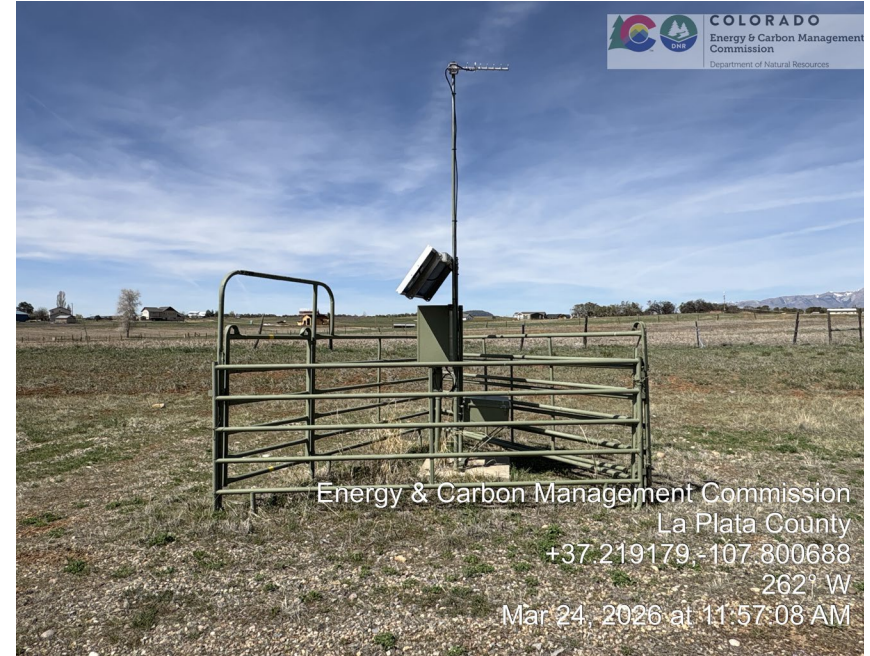
**8. Solar telemetry.**

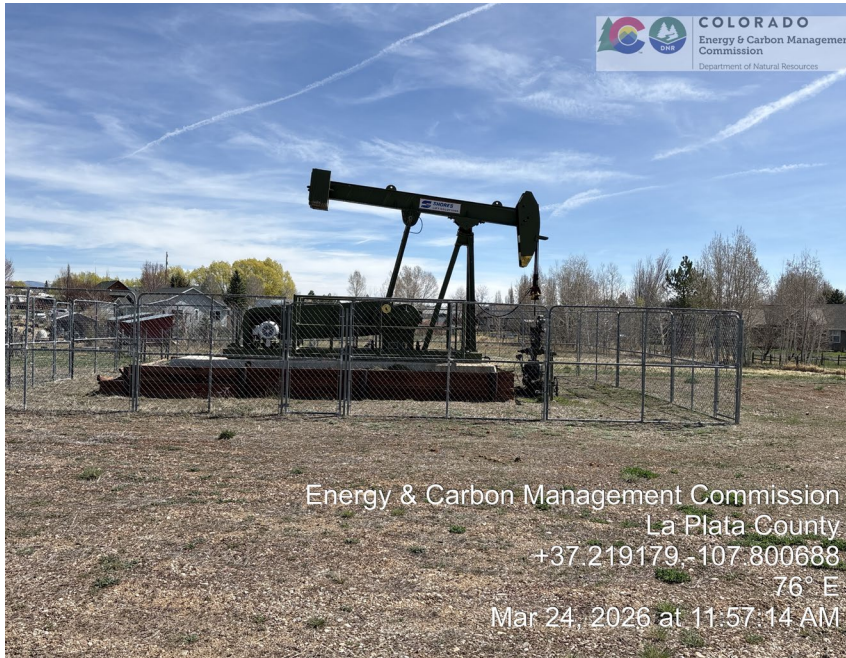
**9. Pump jack and wellhead. Electric motor prime mover.**

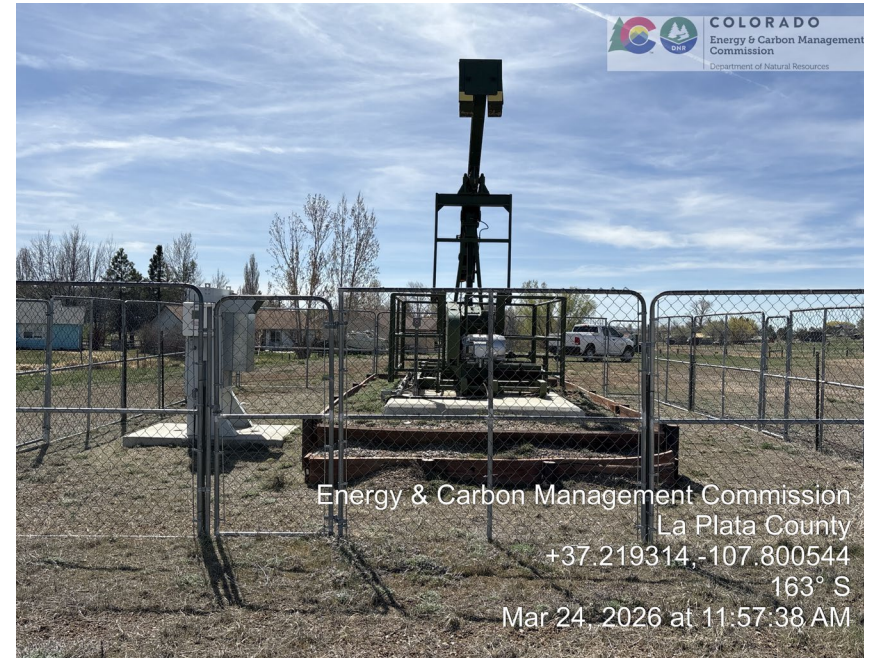
**10. Pump jack and motor. Electrical controls on left.**

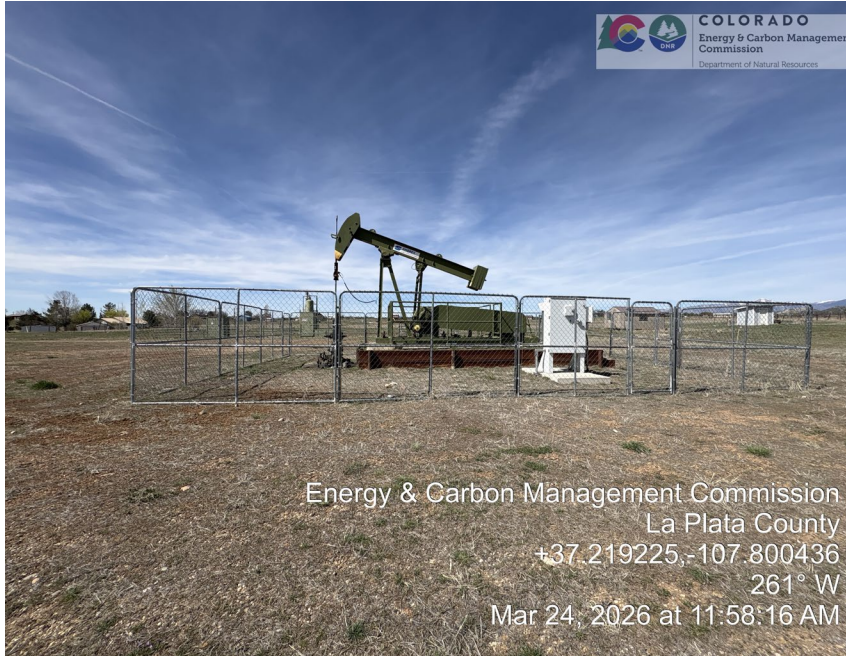
**11. Pump jack and electrical service panel.**

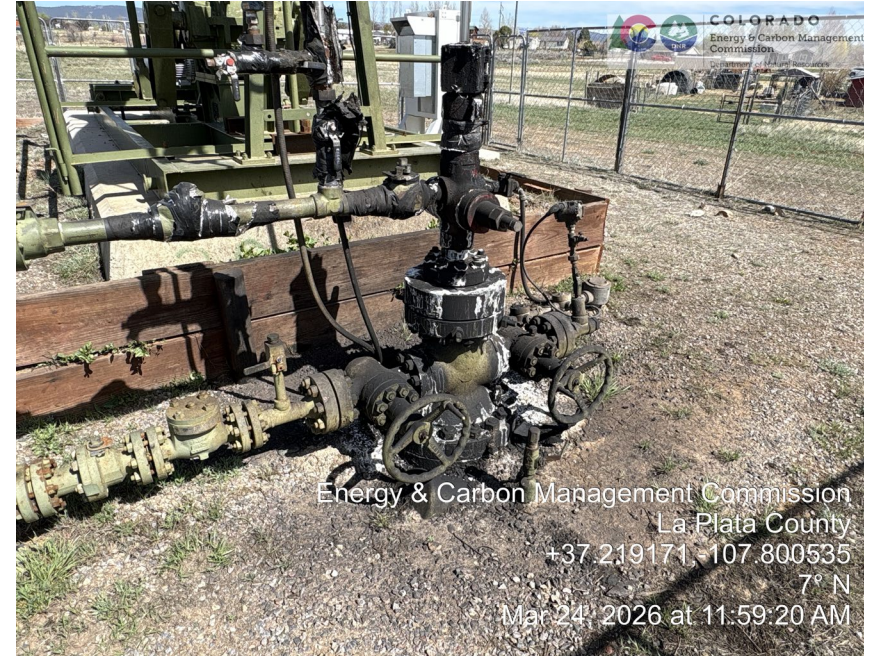
**12. Wellhead with mineral crust and stained gravel beneath. Gas bubbles can be seen each time the polished rod gets near the bottom of each stroke. There is some produced water seeping, but no standing water on ground. Soil is stained from polished rod oil and mineral crust. Video of bubbles attached to report.**

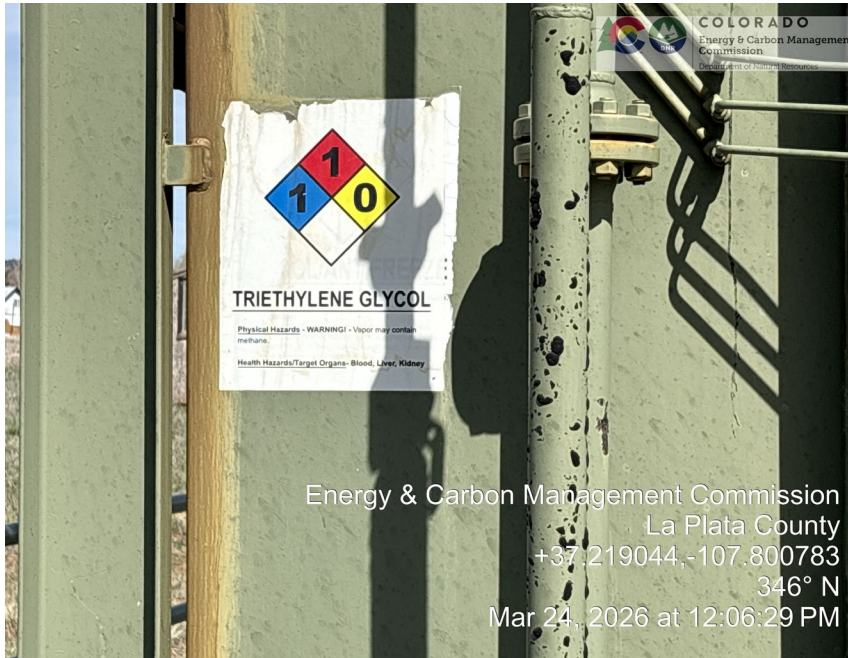
15. Hazcom placard on vertical heated separator.
