# Inspection Photos

Facility: 478837

Operator: **KP Kauffman**

Inspection Date: 3/20/26 and 3/22/26

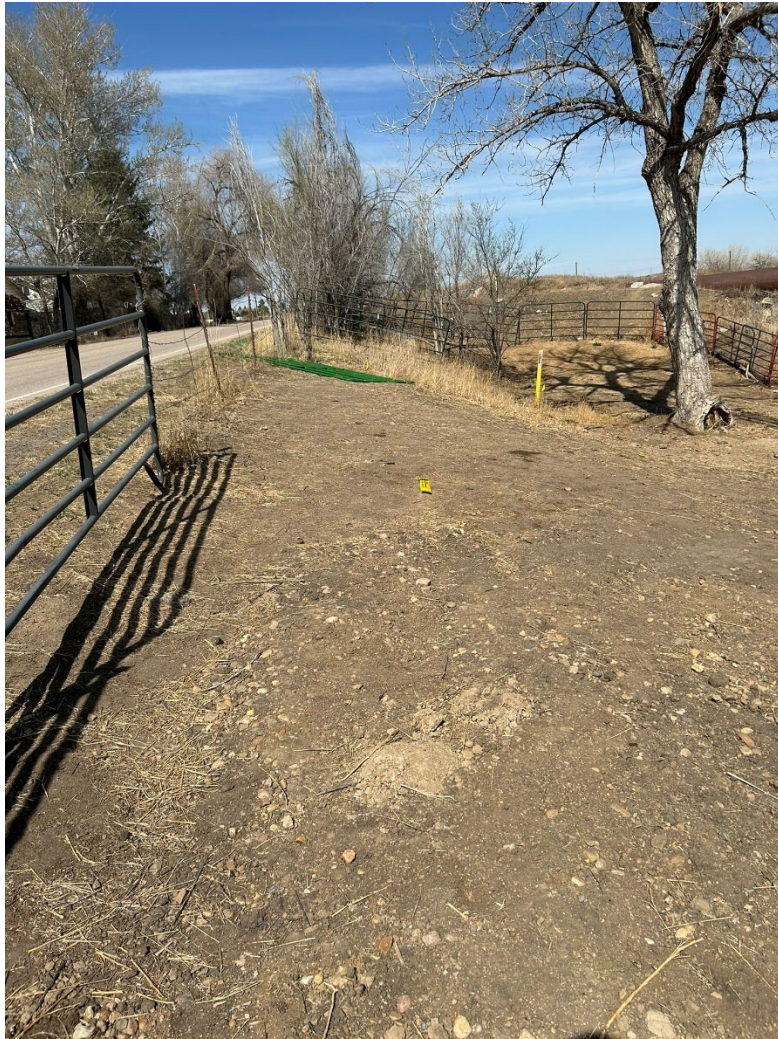
**Photo 1: Looking north (parallel to CR 19) at side slope towards Little Dry Creek. Corridor pictures locate flags for two KPK locates.**

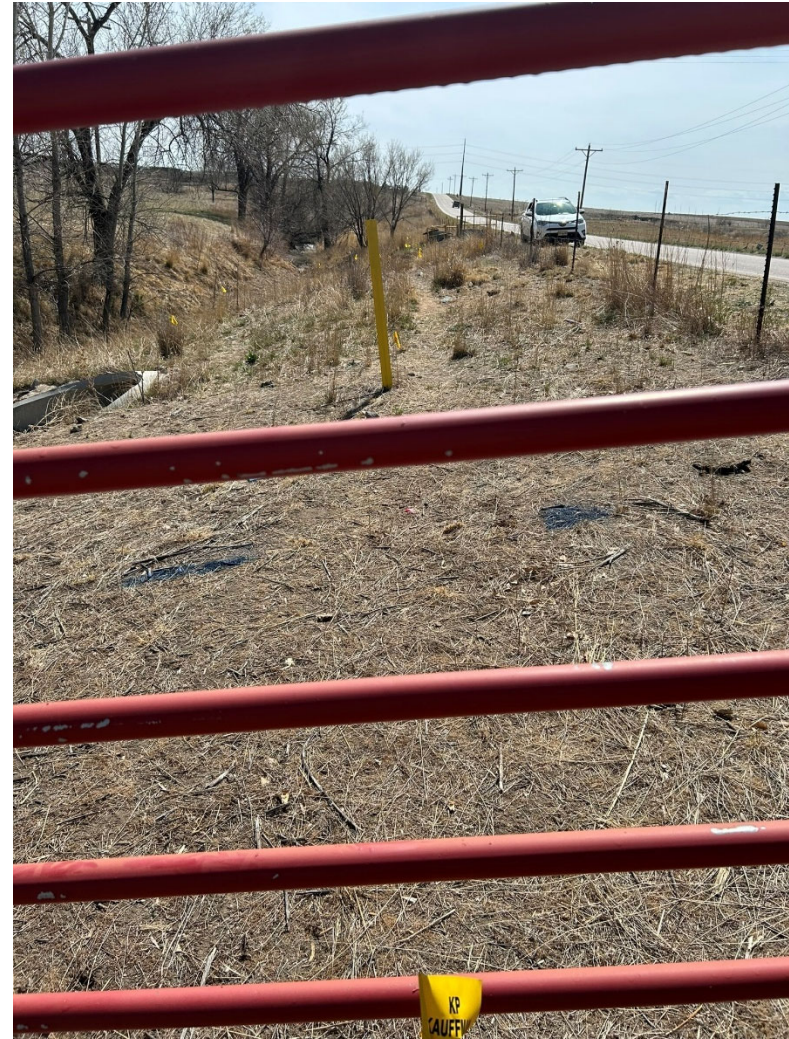
**Photo 2: Looking south (parallel to CR 19) at valve cans depicting side slope towards Little Dry Creek. Corridor pictures locate flags for two KPK lines and DCP line from west to east.**

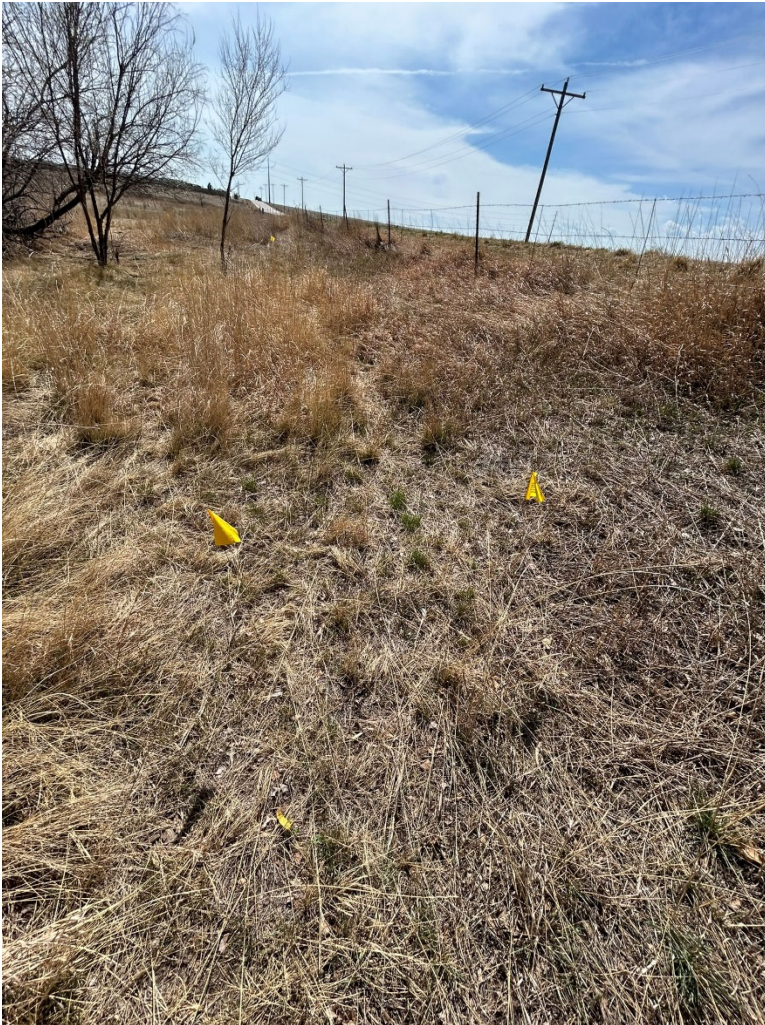
Photo 3: Looking south - locate flags for only two lines south of valve cans.

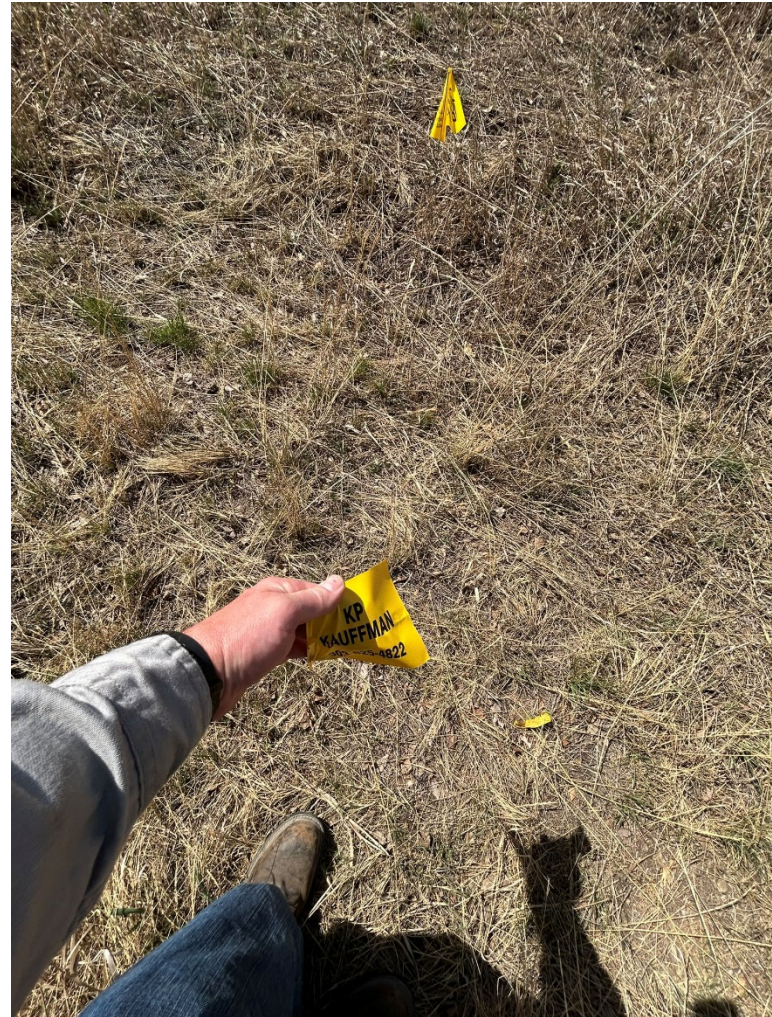
Photo 4: Looking east at KPK, then DCP locate flags.

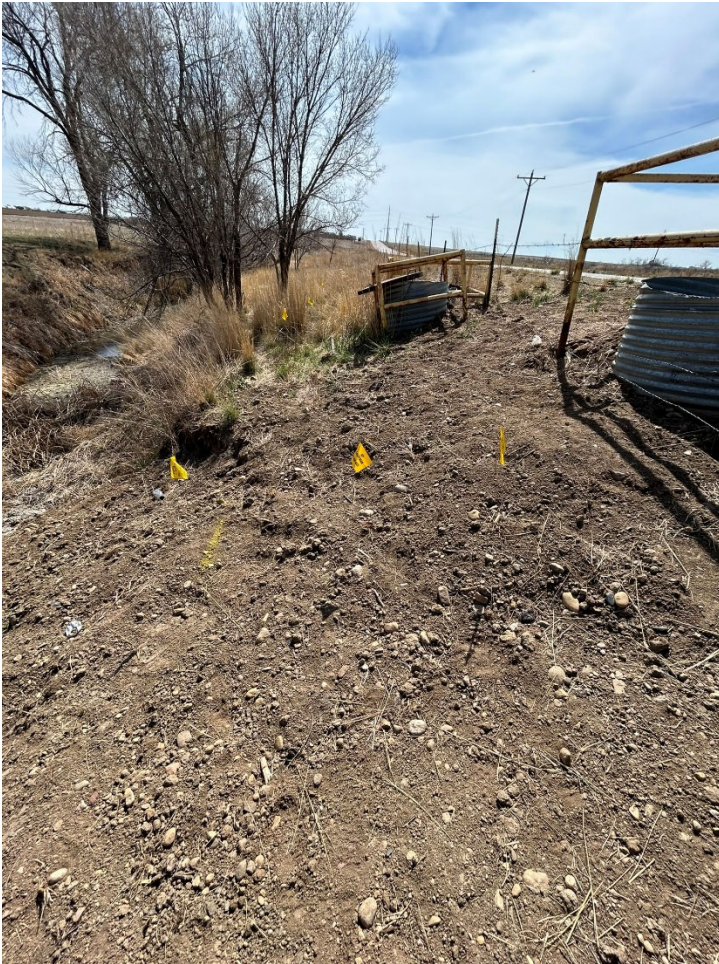
**Photo 5: Looking south at two smaller valve cans with third line entering corridor presumably from McCannon consolidation line across CR 19.**

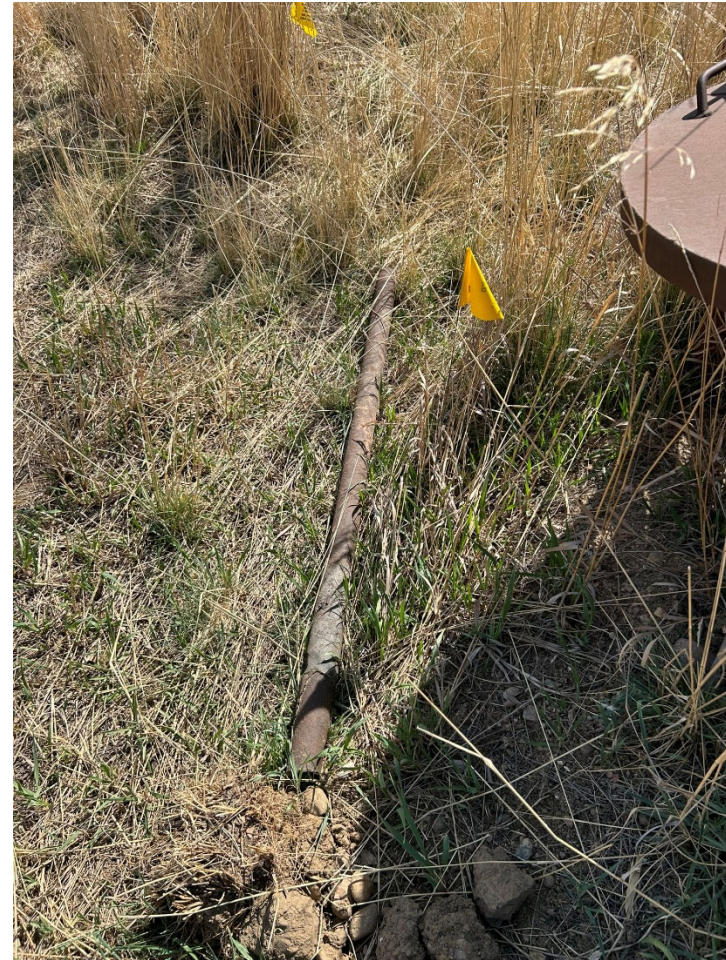
**Photo 6: Unused pipe debris east of southern valve can.**
