Final Reclamation Inspection

Operator: KLABZUBA OIL & GAS INC - #10148

Location ID: 393816

Location Name: ADENA J SAND UNIT #W-54

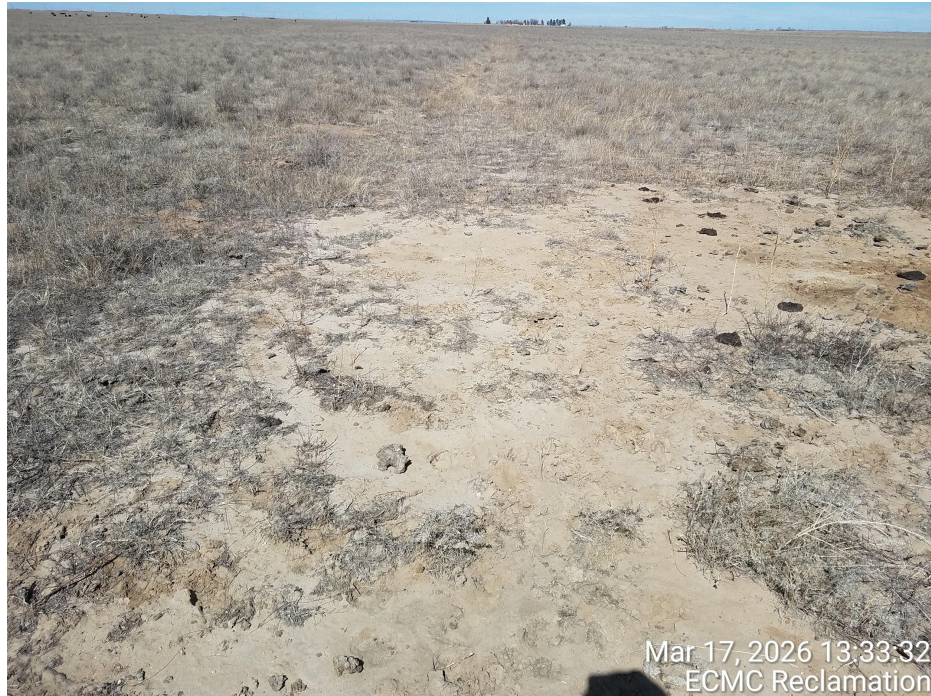
Photo 1. Photo taken from the well location, facing North. Photo illustrates an approximate 20' x 20' bare area; otherwise, vegetation meets Rule 1004 standards with the establishment of perennial, native grasses.

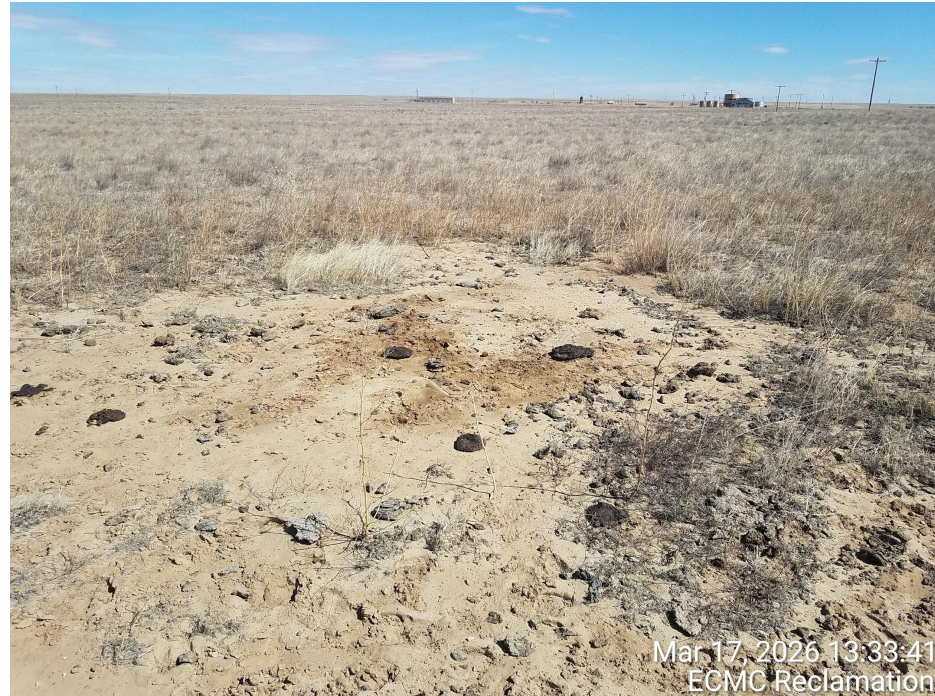
Photo 2. Photo taken from the well location, facing East. See comments under Photo 1.

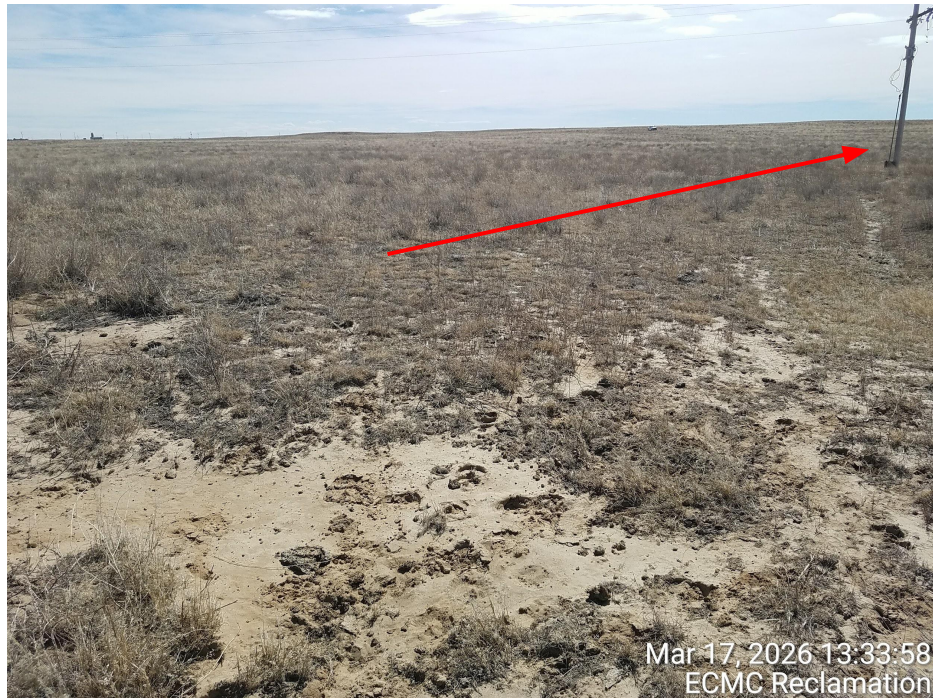
Photo 3. Photo taken from the well location, facing South. See comments under Photo 1.

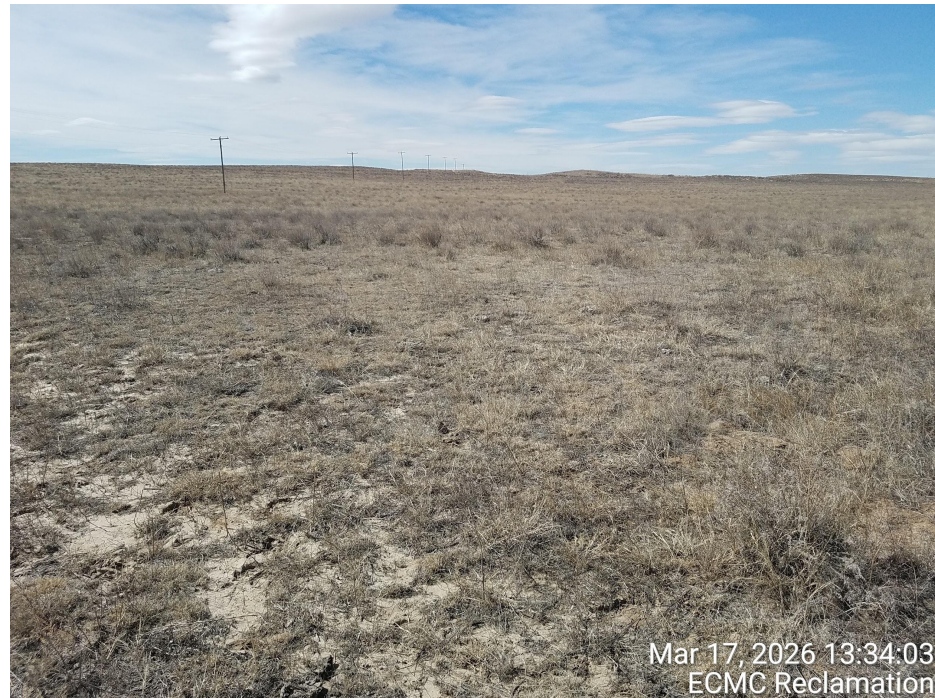
Photo 4. Photo taken from the well location, facing West. See comments under Photo 1.

Red arrow points to used utility equipment- refer to Photos 5-6.

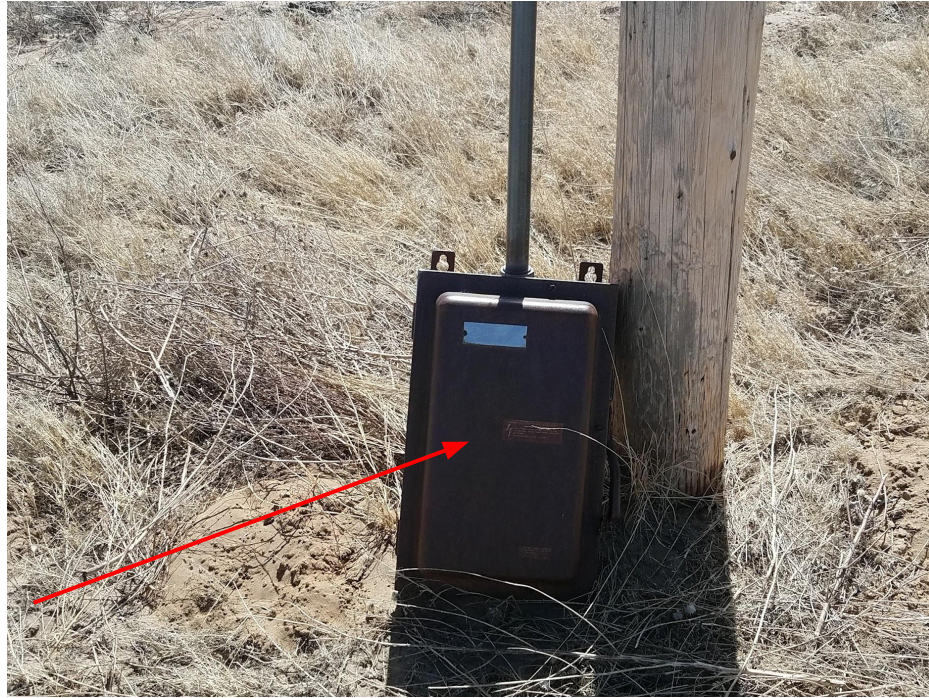
Photo 5. Photo taken from the well location, illustrating unused utility equipment.

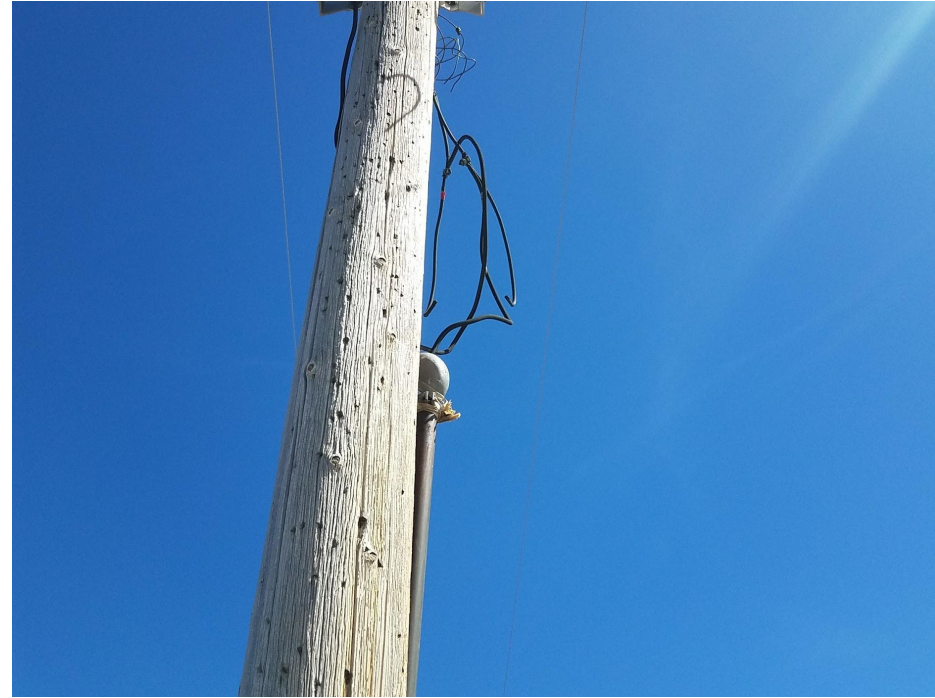
Photo 6. Photo taken from the well location. Photo illustrates the utility power has been disconnected and is no longer in use.

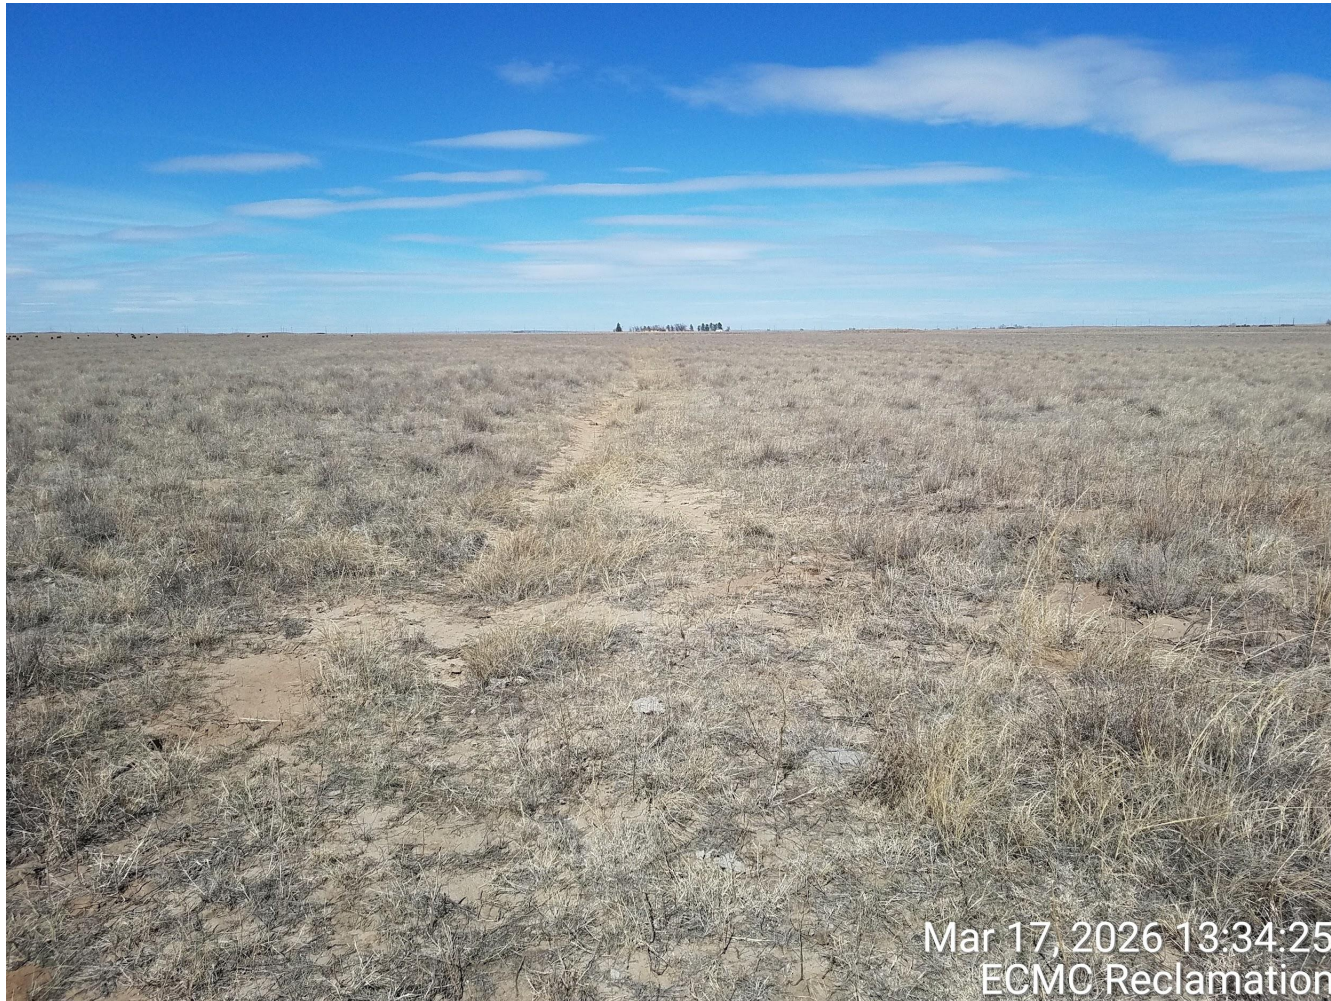
Photo 7. Photo taken from the well location, facing North. Photo illustrates the access road vegetation meets Rule 1004 standards with the establishment of perennial, native grasses.

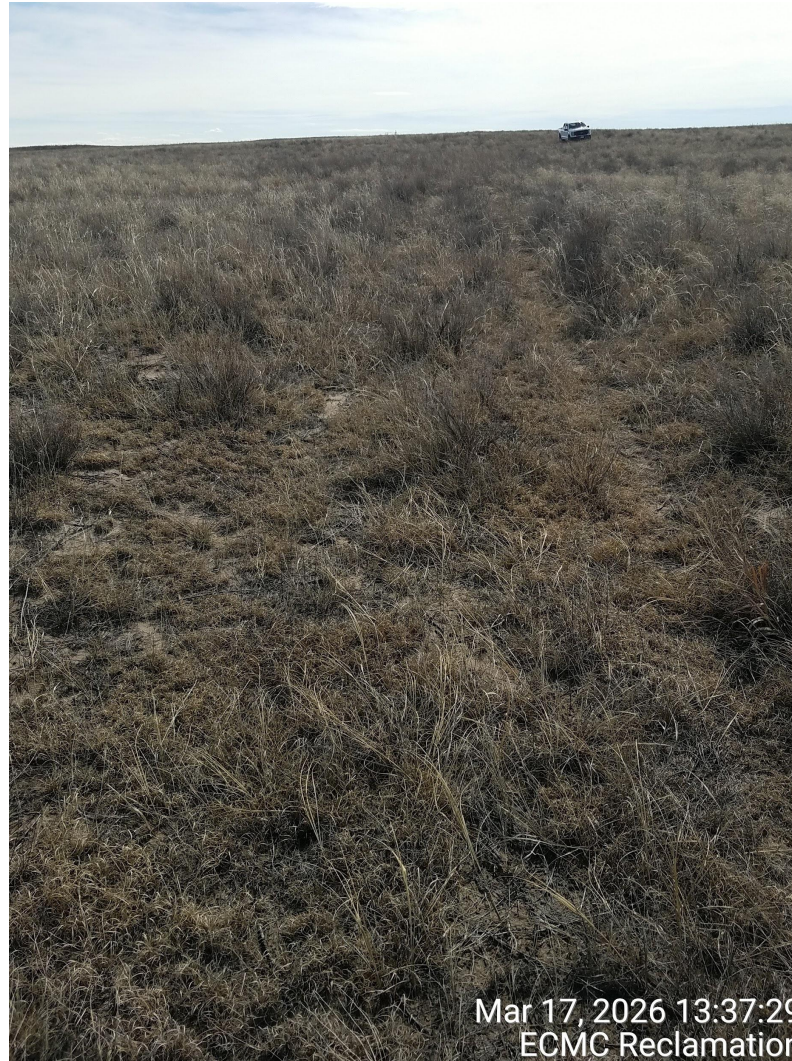
Photo 8. Photo taken along another portion of the access road south of location, facing South. Photo illustrates the access road vegetation meets Rule 1004 standards with the establishment of perennial, native grasses.
